SITE INVESTIGATION REPORT

Client: NSW Land & Housing Corporation
Address: 71-81 Viccliffe Avenue, Campsie
Proposed Development: Residential Development

**SITE INVESTIGATION
71-81 VICLIFFE AVENUE, CAMPSIE
BOREHOLE AND PENETROMETER LOCATIONS**

Drawing No: 15/2870

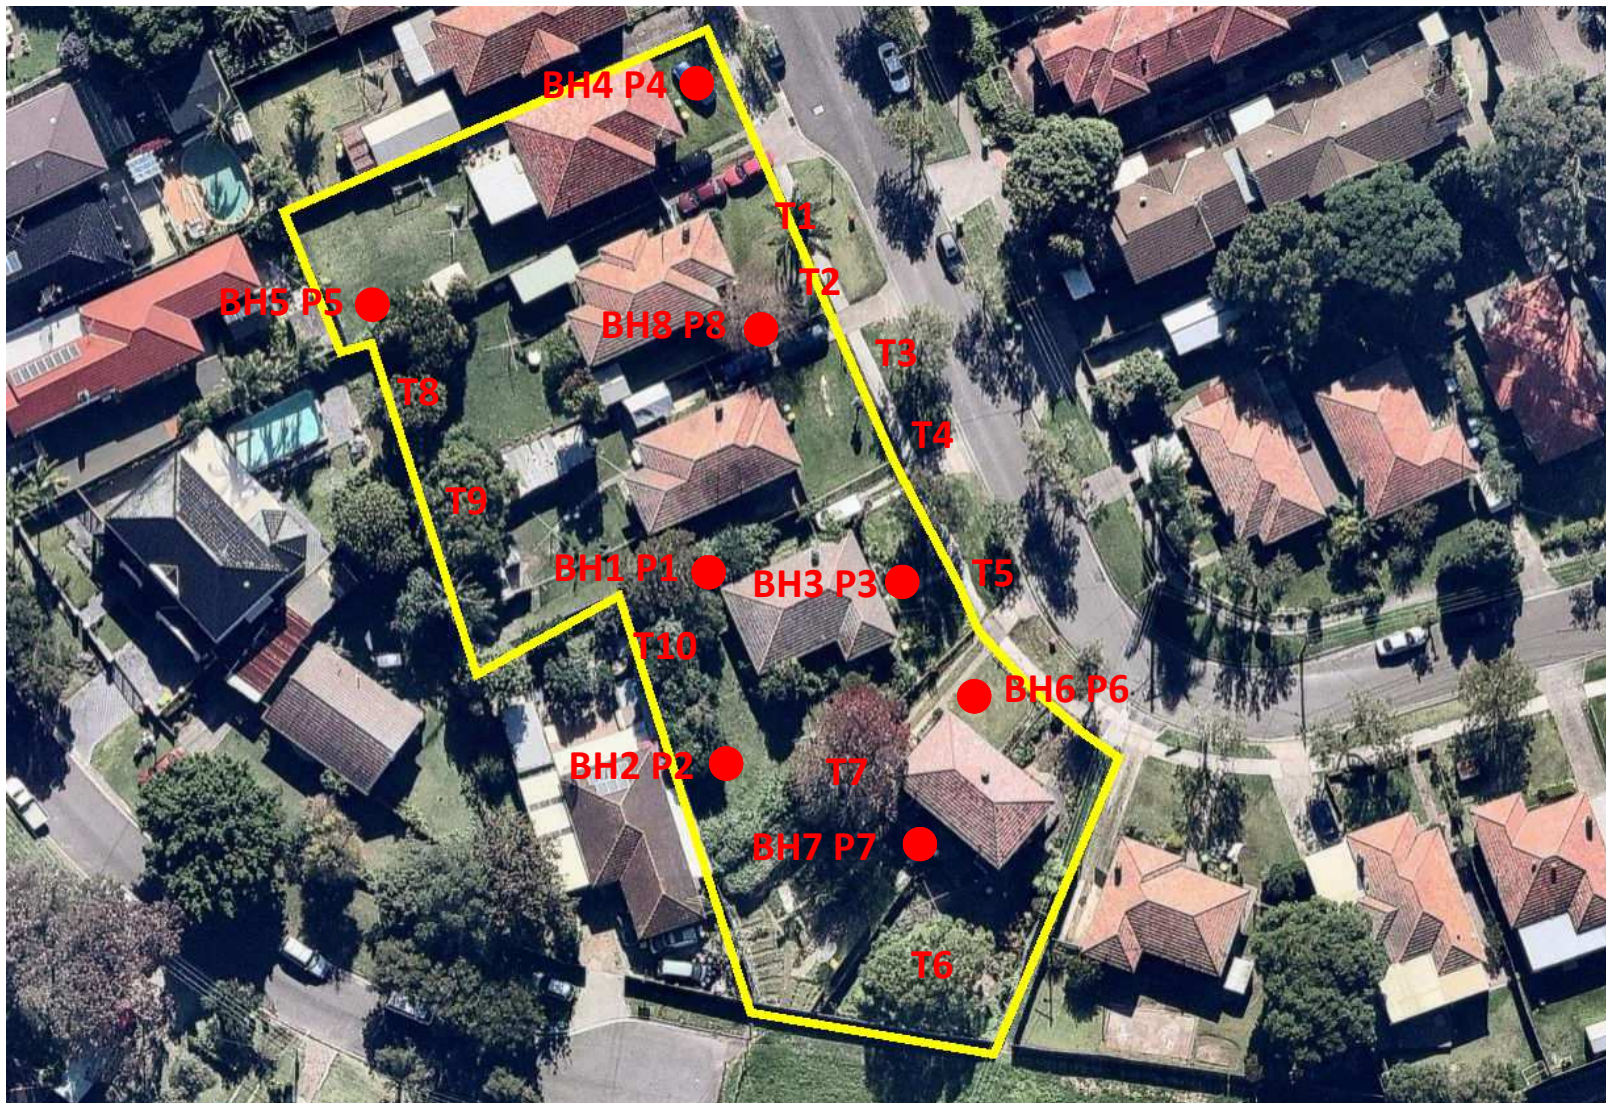
Eight boreholes were drilled and eight Dynamic cone penetrometer (DCP) tests were carried out on September 29, 2015 at the locations shown on Drawing No. 15/2870. Restricted site access dictated the borehole locations. ***Because there was no access for the drilling rig BH2, BH5 and BH7 were drilled using a hand auger.*** The subsurface conditions encountered are shown on the attached borehole logs. Explanation sheets and notes relating to geotechnical reports are also attached.
