# GEOTECHNICAL INVESTIGATION

# **NSW Land and Housing Corporation**

16 – 22 Funda Crescent, Lalor Park, New South Wales

Report No: 22/0595

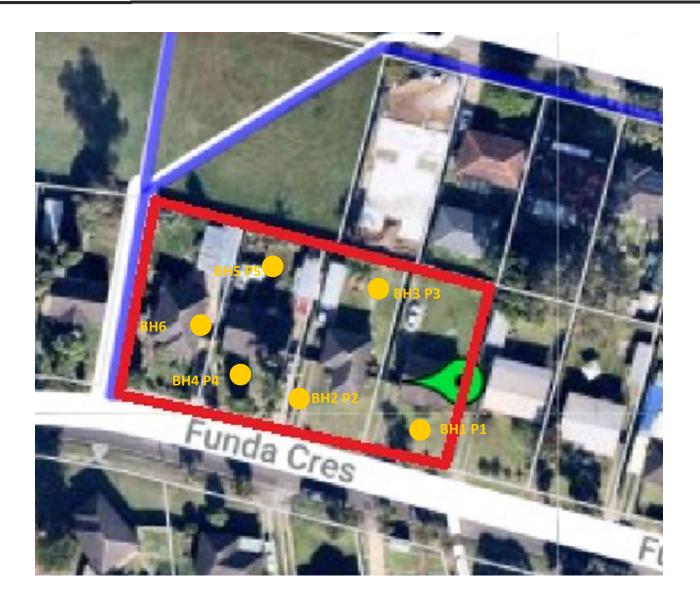
Drawing No: 22/0595

GEOTECHNICAL INVESTIGATION
16-22 FUNDA CRESCENT, LALOR PARK
BOREHOLE AND PENETROMETER LOCATIONS

The fieldwork consisted of drilling six (6) boreholes numbered BH1 to BH6 (inclusive), at the locations shown on attached Drawing No. 22/0595. Restricted site access dictated the borehole locations. Except for BH3 and BH5, the boreholes were drilled using a utility mounted Edson RP70 Drilling rig, owned, and operated by STS. Because there was no access for the drilling rig, BH3 and BH5 were drilled using a hand auger. Soil strengths were assessed by carrying out a Dynamic Cone Penetrometer (DCP) tests adjacent to each borehole location.
