# GEOTECHNICAL INVESTIGATION

## NSW LAND & HOUSING CORPORATION

*1 – 3 Walker Street & 2 – 4 Caldwell Avenue, East Lismore, New South Wales (BGYYD)*

*Report No: 22/2247*

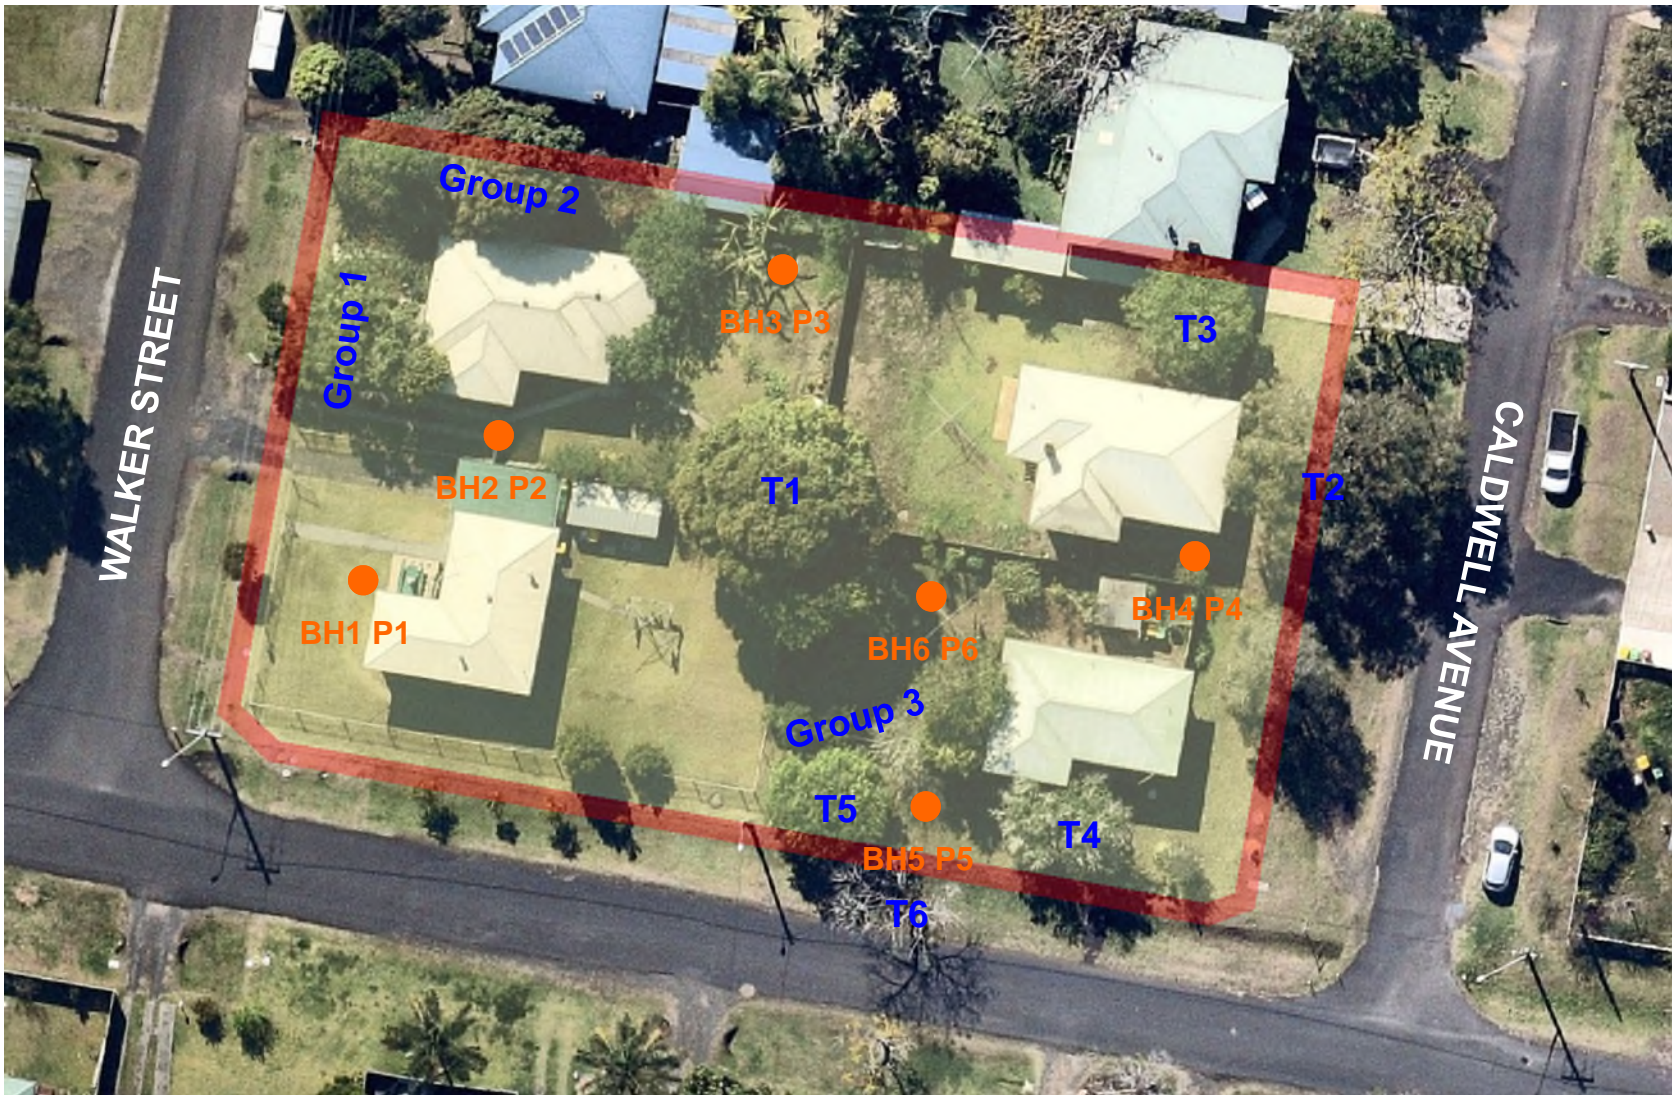
Drawing No: 22/2247

The fieldwork consisted of drilling six (6) boreholes numbered BH1 to BH6, at the locations shown on Drawing No. 22/2247. Except for BH3 and BH6 the boreholes were drilled using a utility mounted Edson RP70 drilling rig owned and operated by STS. ***Because there was no access for the drilling rig BH3 and BH6 were drilled using a hand auger.*** Soil strengths were determined by undertaking Perth Sand Penetrometer (PSP) tests at each borehole location.

GEOTECHNICAL INVESTIGATION  
1-3 WALKER STREET & 2-4 CALDWELL AVENUE, EAST LISMORE  
BOREHOLE AND PENETROMETER LOCATIONS

Site No.	P1	P2	P3	P4	P5	P6
Location	Refer to Drawing No. 22/2247	Refer to Drawing No. 22/2247	Refer to Drawing No. 22/2247	Refer to Drawing No. 22/2247	Refer to Drawing No. 22/2247	Refer to Drawing No. 22/2247
Date Tested	9/6/2022	9/6/2022	9/6/2022	9/6/2022	9/6/2022	9/6/2022
Starting Level	Surface Level	Surface Level	Surface Level	Surface Level	Surface Level	Surface Level
Depth (m)	Penetration Resistance (blows / 150mm)
