# GEOTECHNICAL INVESTIGATION

# NSW LAND & HOUSING CORPORATION

*10 – 16 Albert Street, Casino*

*Report No: 22/3050*

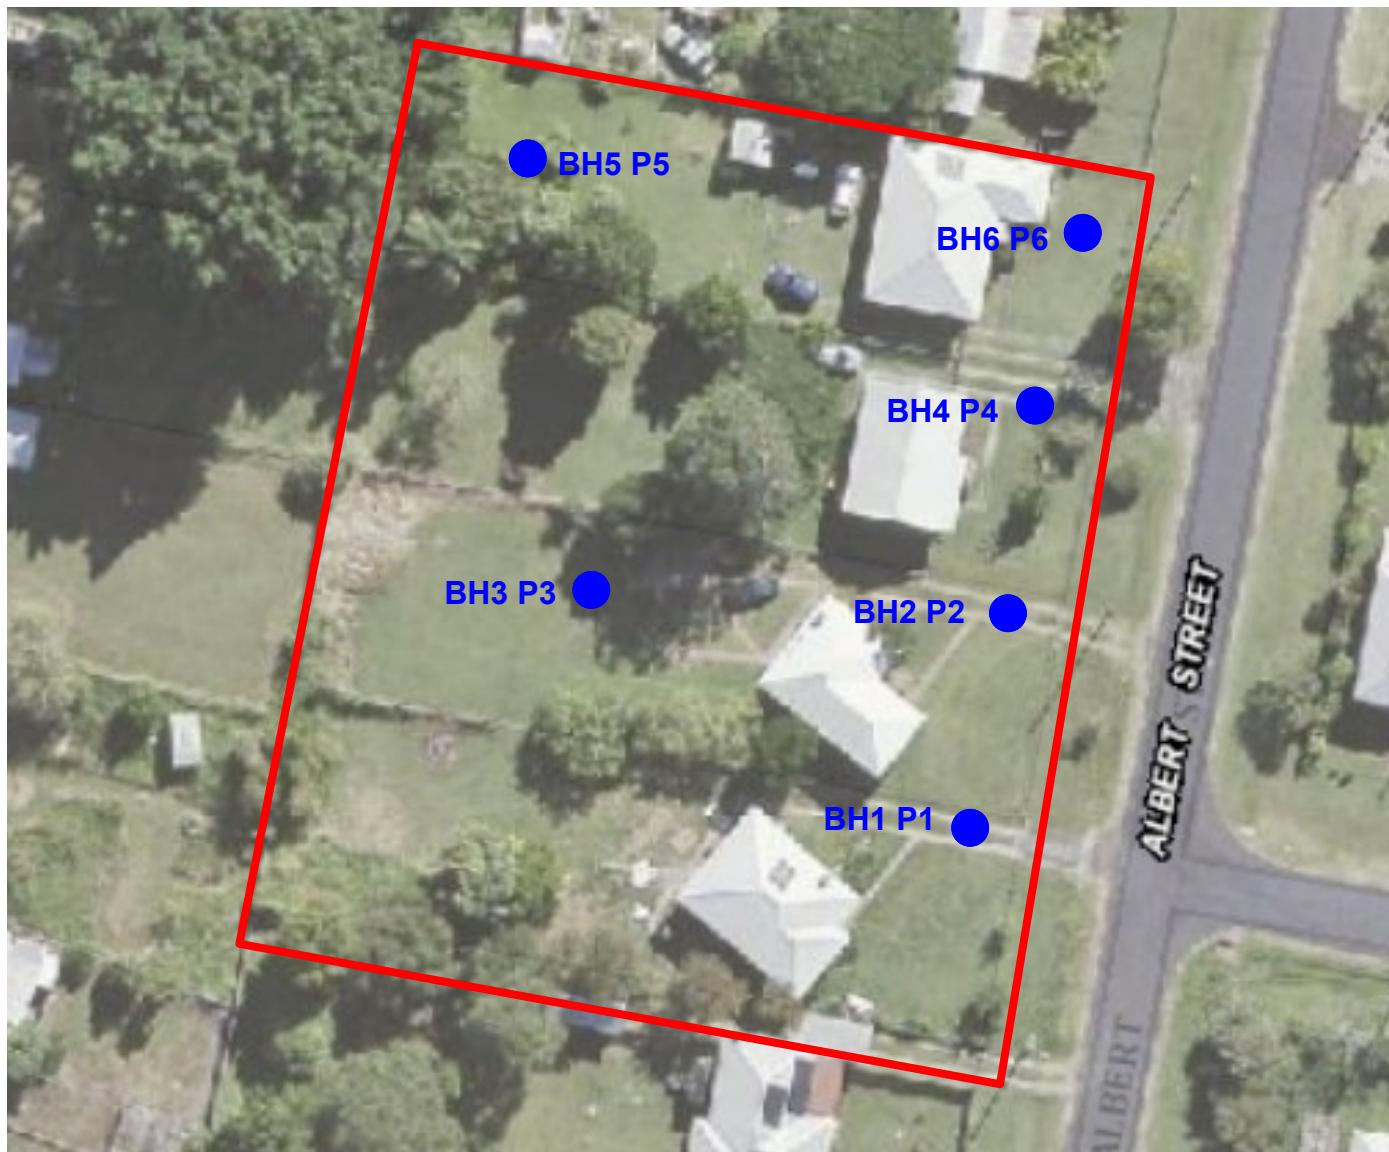
Drawing No: 22/3050

**GEOTECHNICAL INVESTIGATION  
10-16 ALBERT STREET, CASINO  
BOREHOLE AND PENETROMETER LOCATIONS**

The fieldwork consisted of drilling six (6) boreholes numbered BH1 to BH6, at the locations shown on Drawing No. 22/3050. The boreholes were drilled using a Christie drilling rig owned and operated by STS. Soil strengths were determined by undertaking Dynamic Cone Penetrometer (DCP) tests adjacent to each borehole location.
