## Bushfire Protection Assessment

### **Milton Public School Upgrade**

NSW Department of Education (DoE)

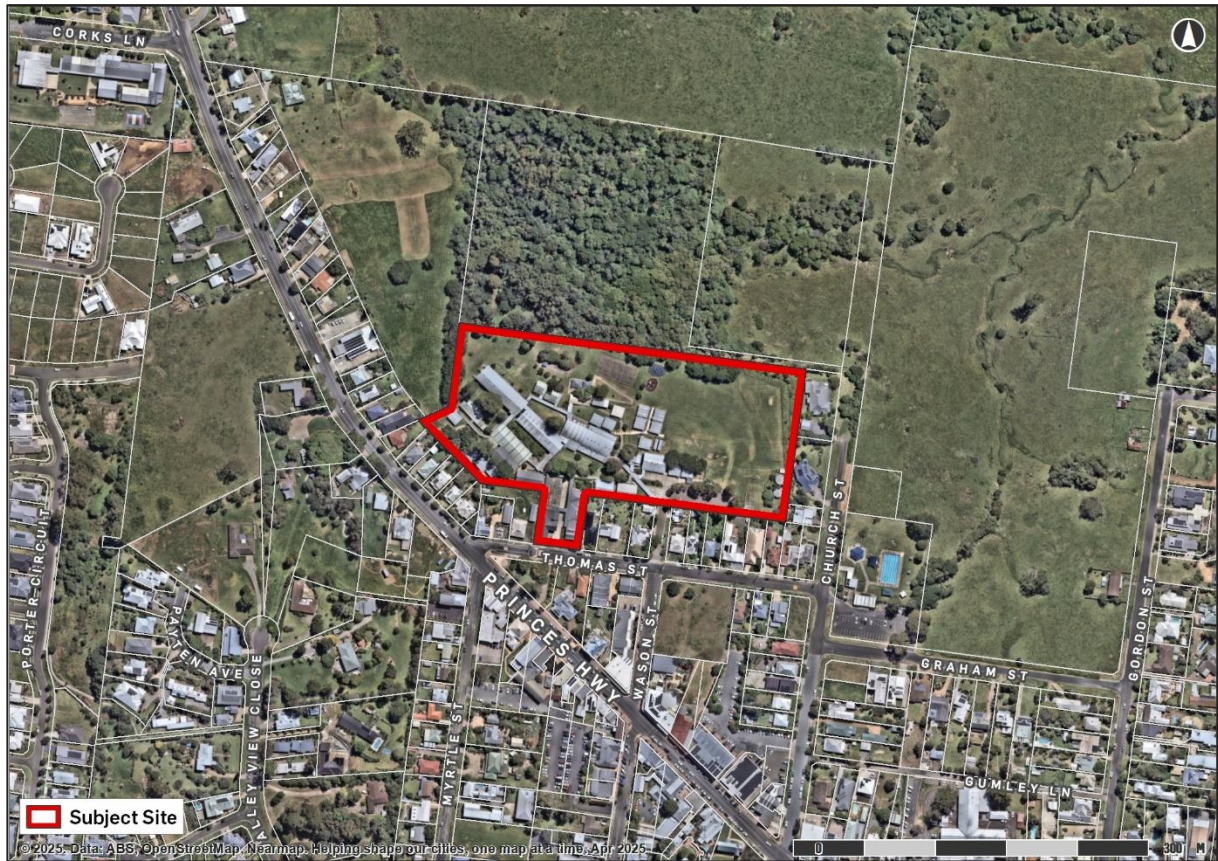
Figure 1: Aerial Photograph (Source: Urbis, April 2025)

The site is located at 9 Thomas Street, Milton, NSW, 2538 (the site) . The site is legally referred to as Lot 1 in Deposited Plan 861814 and is within the Shoalhaven Local Government Area (LGA) and has an approximate area of 4 hectares. An aerial photograph of the site is provided at Figure 1.

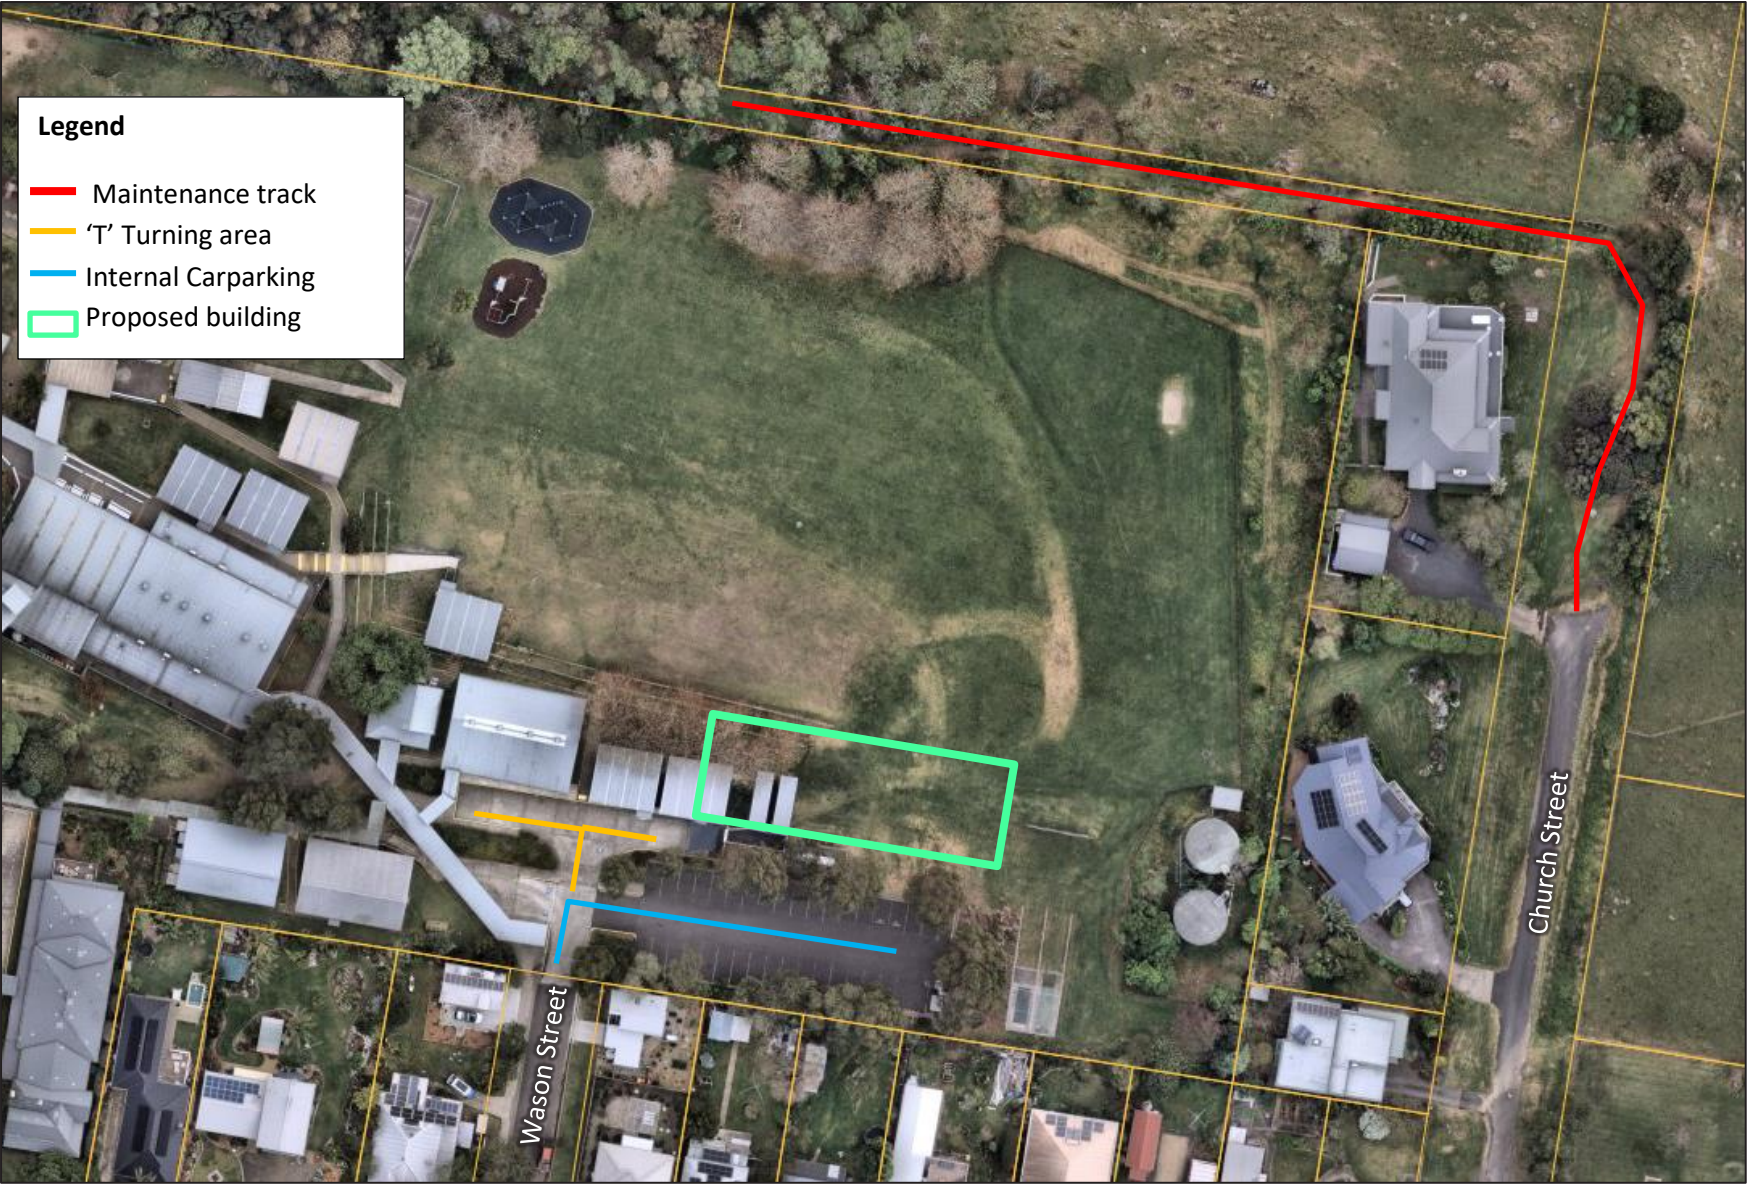
Figure 5: Vehicular Access (Source: ELA)

- The rainforest bushfire hazard to the north abuts the northern boundary of the site and is accessible via the maintenance track off Church Street (Figure 5);
- The grassland bushfire hazard to the east is accessible from Church Street and the maintenance track (Figure 5);
- The surrounding bushfire hazard is of lower risk consisting mainly of grassland aside from the remnant (4 ha) rainforest to the north. Therefore, the progress of a bushfire would be highly visible and under a worst-case scenario Church Street would only be impacted for a short period of time; and
- Furthermore, evacuation of the school and surrounding properties will be via Wason/Thomas Street with the northern section of Church Street only servicing three (3) residential properties, therefore unlikely to become congested during an emergency evacuation.

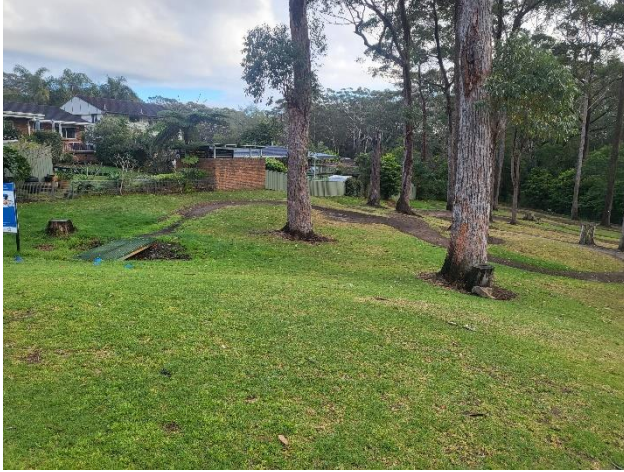
**Photo 1: Developed land to NW and bushfire hazard N**

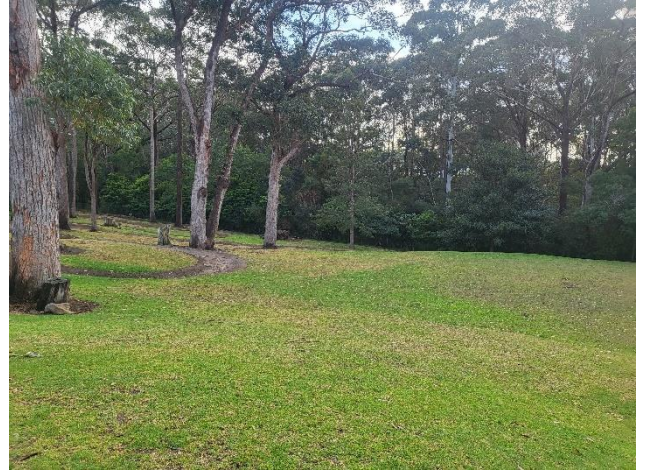
**Photo 2: Bushfire hazard to N**

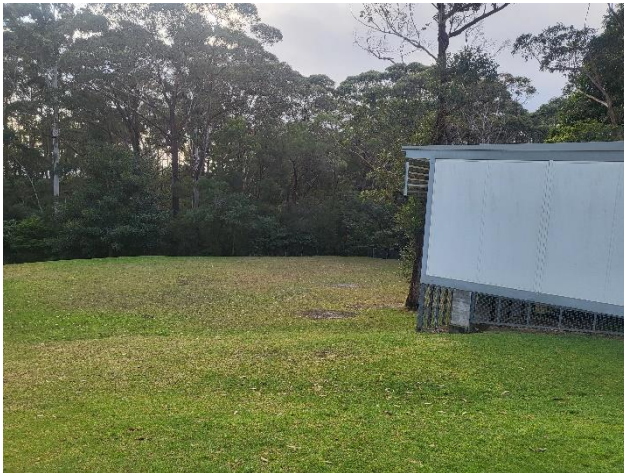
**Photo 3: Bushfire hazard to N**

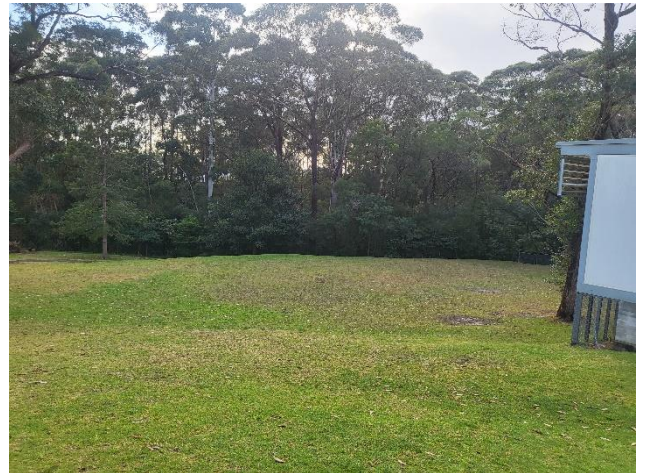
**Photo 4: Bushfire hazard to N**
