# GEOTECHNICAL INVESTIGATION

## HOMES NSW

*37 – 39 Munro Road, Crestwood, New South Wales (BH2NN)*

*Report No: 24/1224*

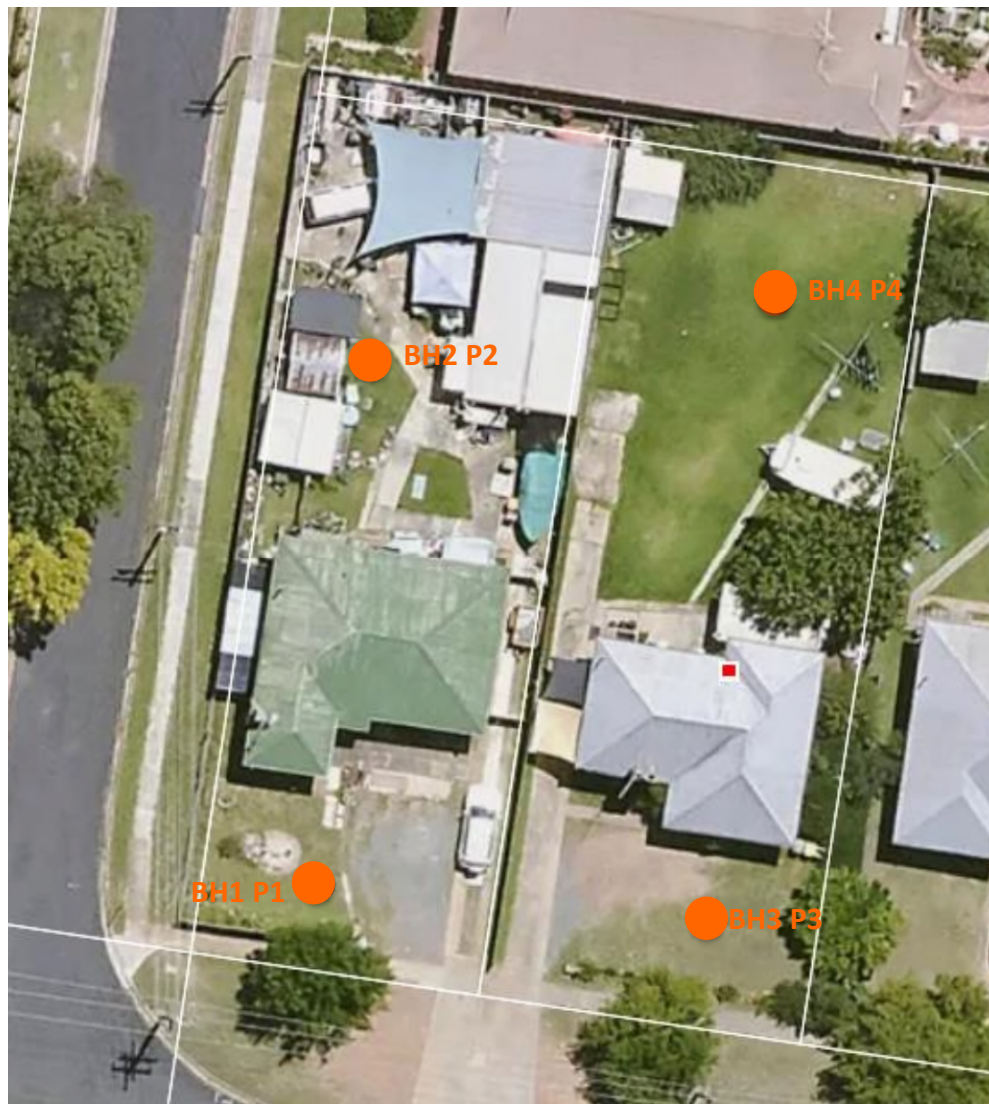
## Borehole and Penetrometer Locations

Client:	HOMES NSW	Project No.	32670/8654D-G	Date:	May 2024
Site Address:	37-39 Munro Rad, Crestwood	Drawing No.	24/1224	Scale:	Unknown
Work:	Geotechnical Investigation	Revision No.	0

The fieldwork consisted of drilling four (4) boreholes numbered BH1 to BH4, inclusive, at the locations shown on Drawing No. 24/1224. BH1, BH3, and BH4 were drilled using a utility mounted Christie drilling rig, owned, and operated by STS. ***Because there was no access for the drilling rig, BH2 was drilled using a hand auger.*** Soil strengths were determined by undertaking a Dynamic Cone Penetrometer (DCP) test adjacent to each borehole location.
