# PINE RIDGE SOLAR FARM

## Visual Analysis and Reflectivity Statement

SLR Ref: 631.20527.00000 Version No: -v1.0 JUNE 2021

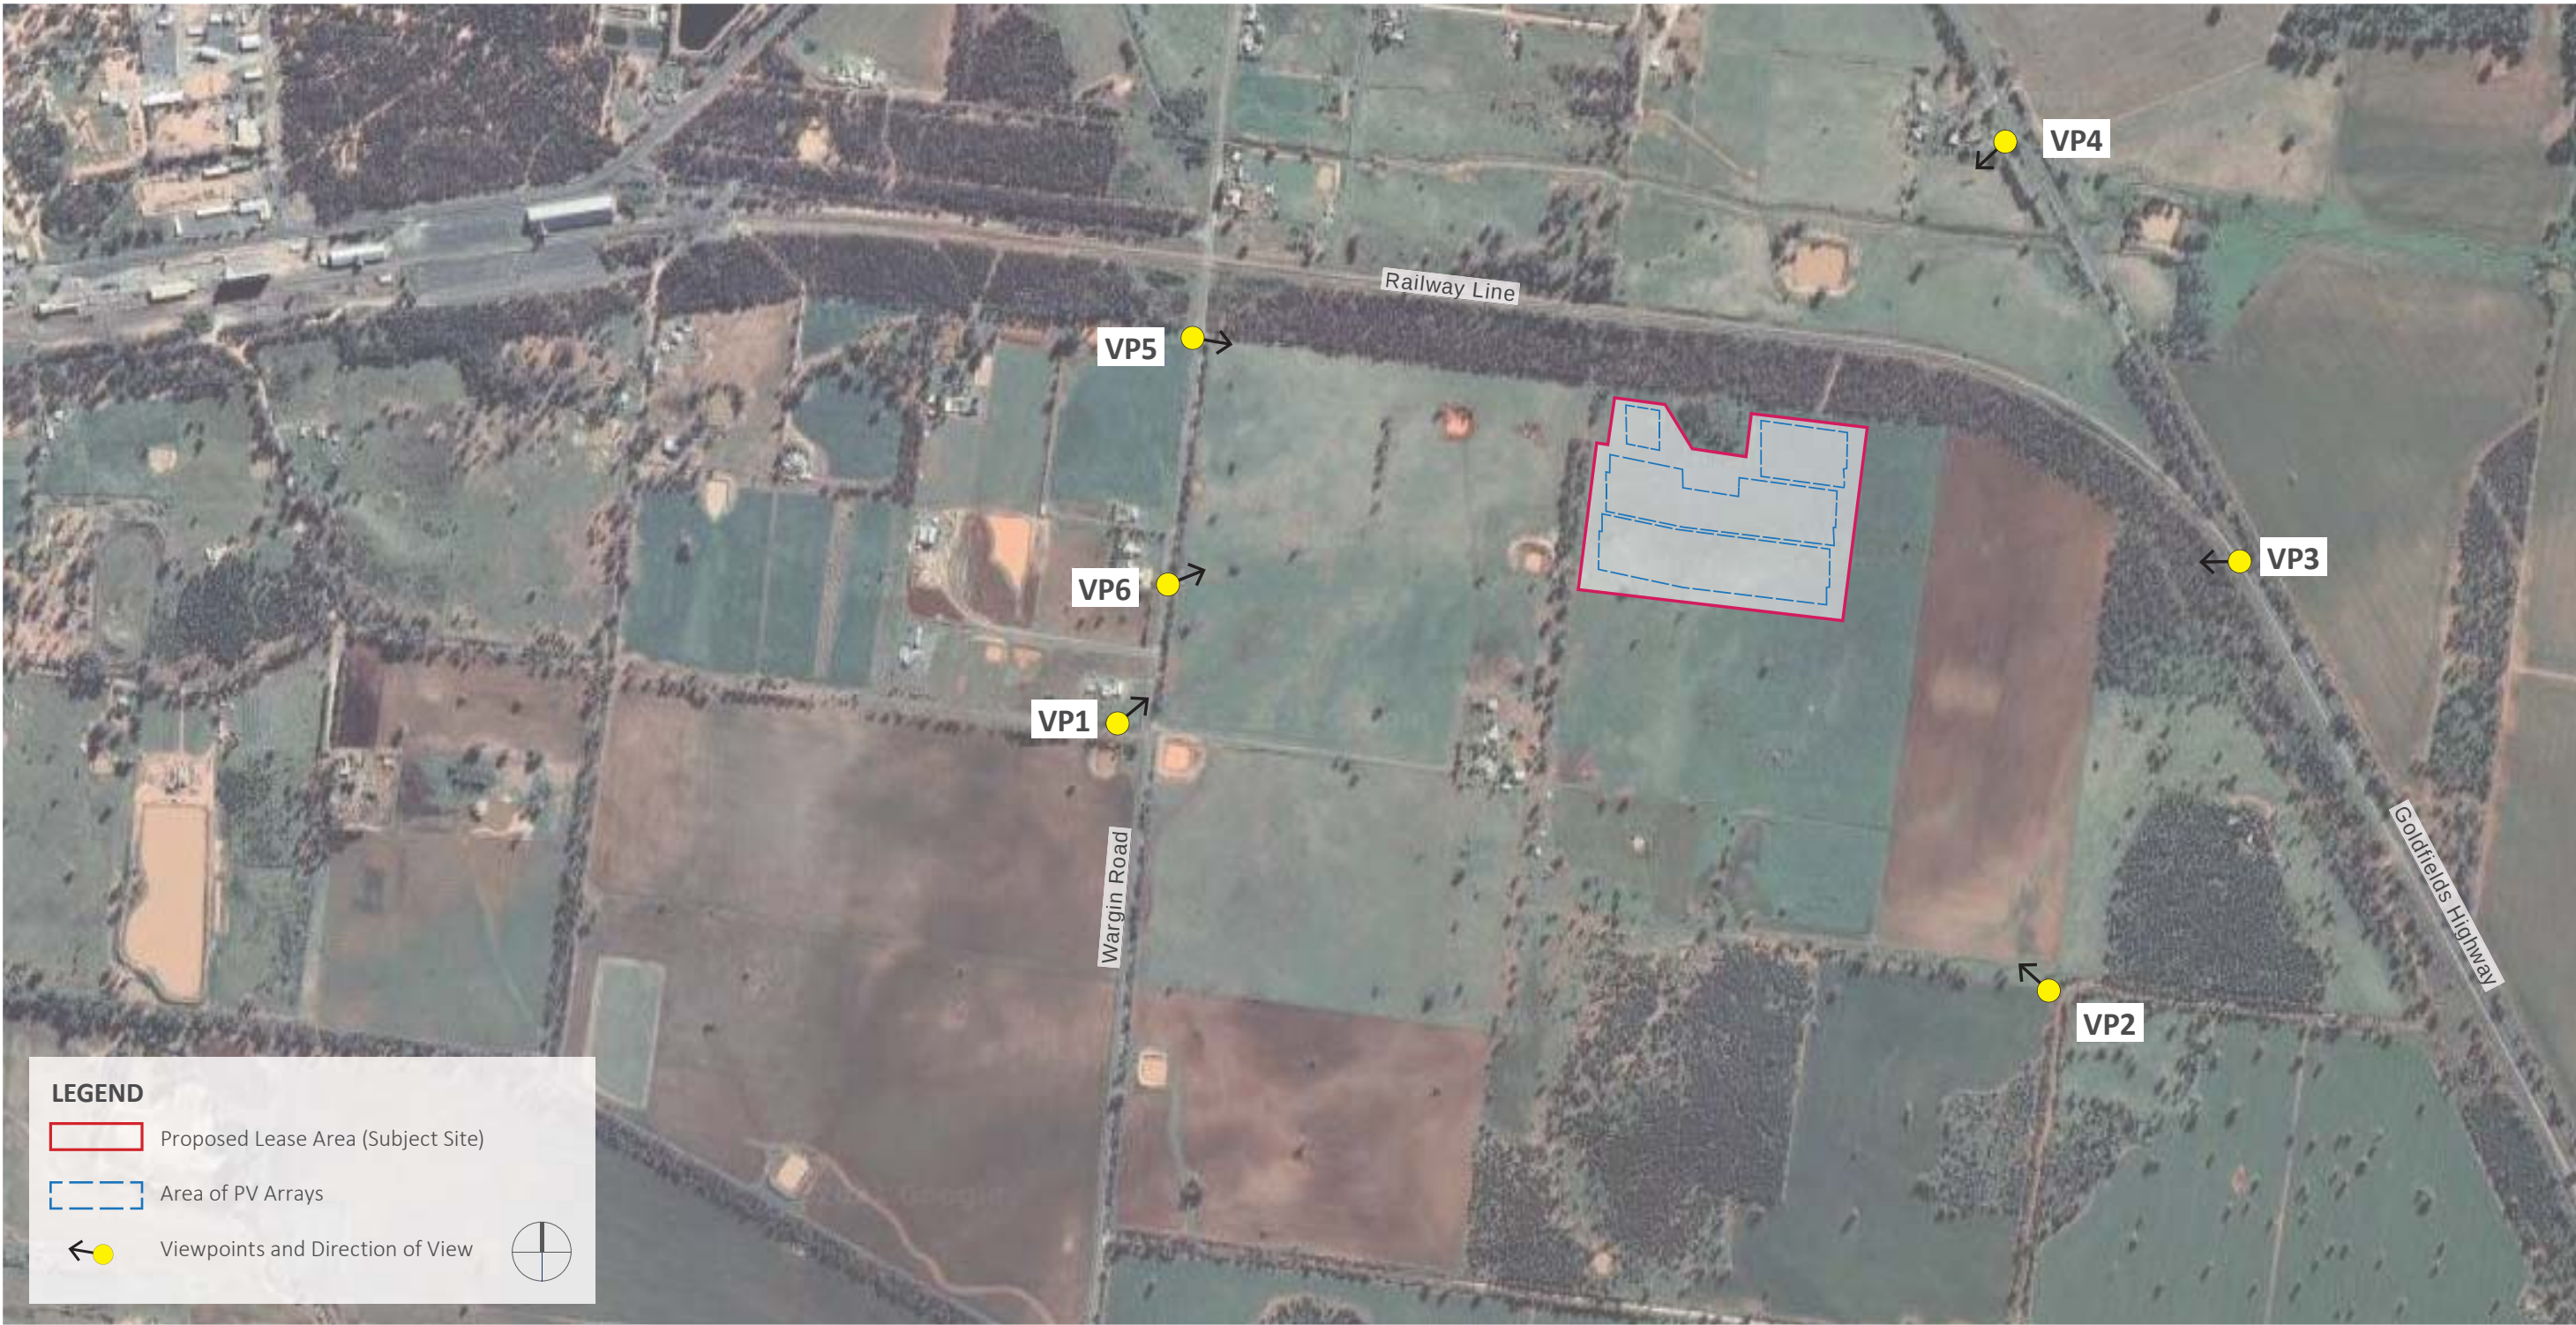
Figure 3. Selected Visual Receptors and Direction of View

During the site inspection of the site and local area, detailed photographic documentation was made of the landscape character and conditions in order to inform this report. There were a number of locations other than the listed viewpoints where photographs were taken to determine the degree of visibility of the site within the local area. These viewpoints although useful in determining the contextual character of the area did not provide clear and unencumbered views of the site and therefore were not used in the determination of potential visual impacts of the Solar Farm on the surrounding environment.

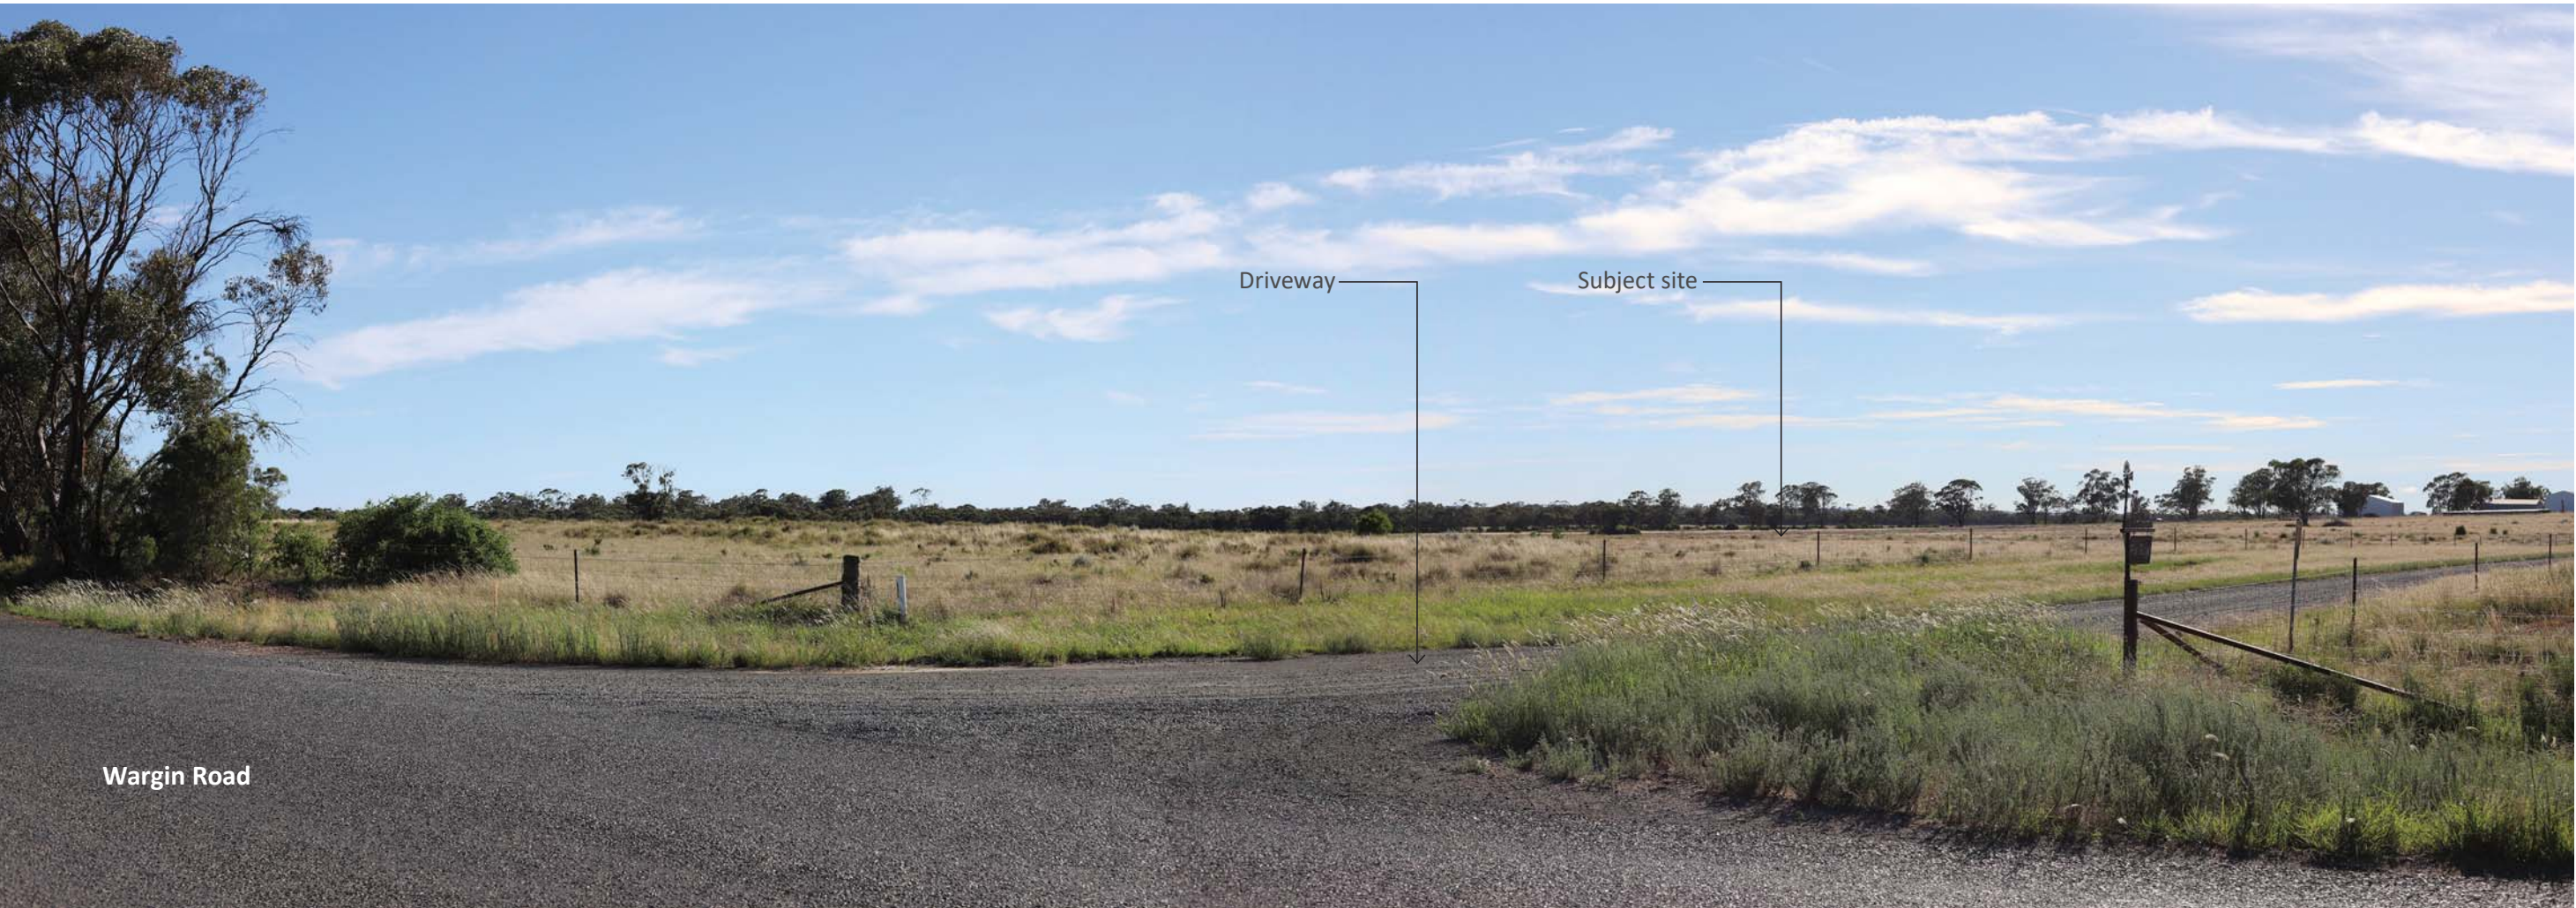
5.6.2 Viewpoint 1 - Existing

| Receptor - VP1 | Location |
|---|---|
| Comments <ul style="list-style-type: none"><li>Rural landscape dominated by Wargin Road in the foreground.</li><li>Vegetation along the road and northern edge of site terminates views from this viewpoint.</li></ul> | |

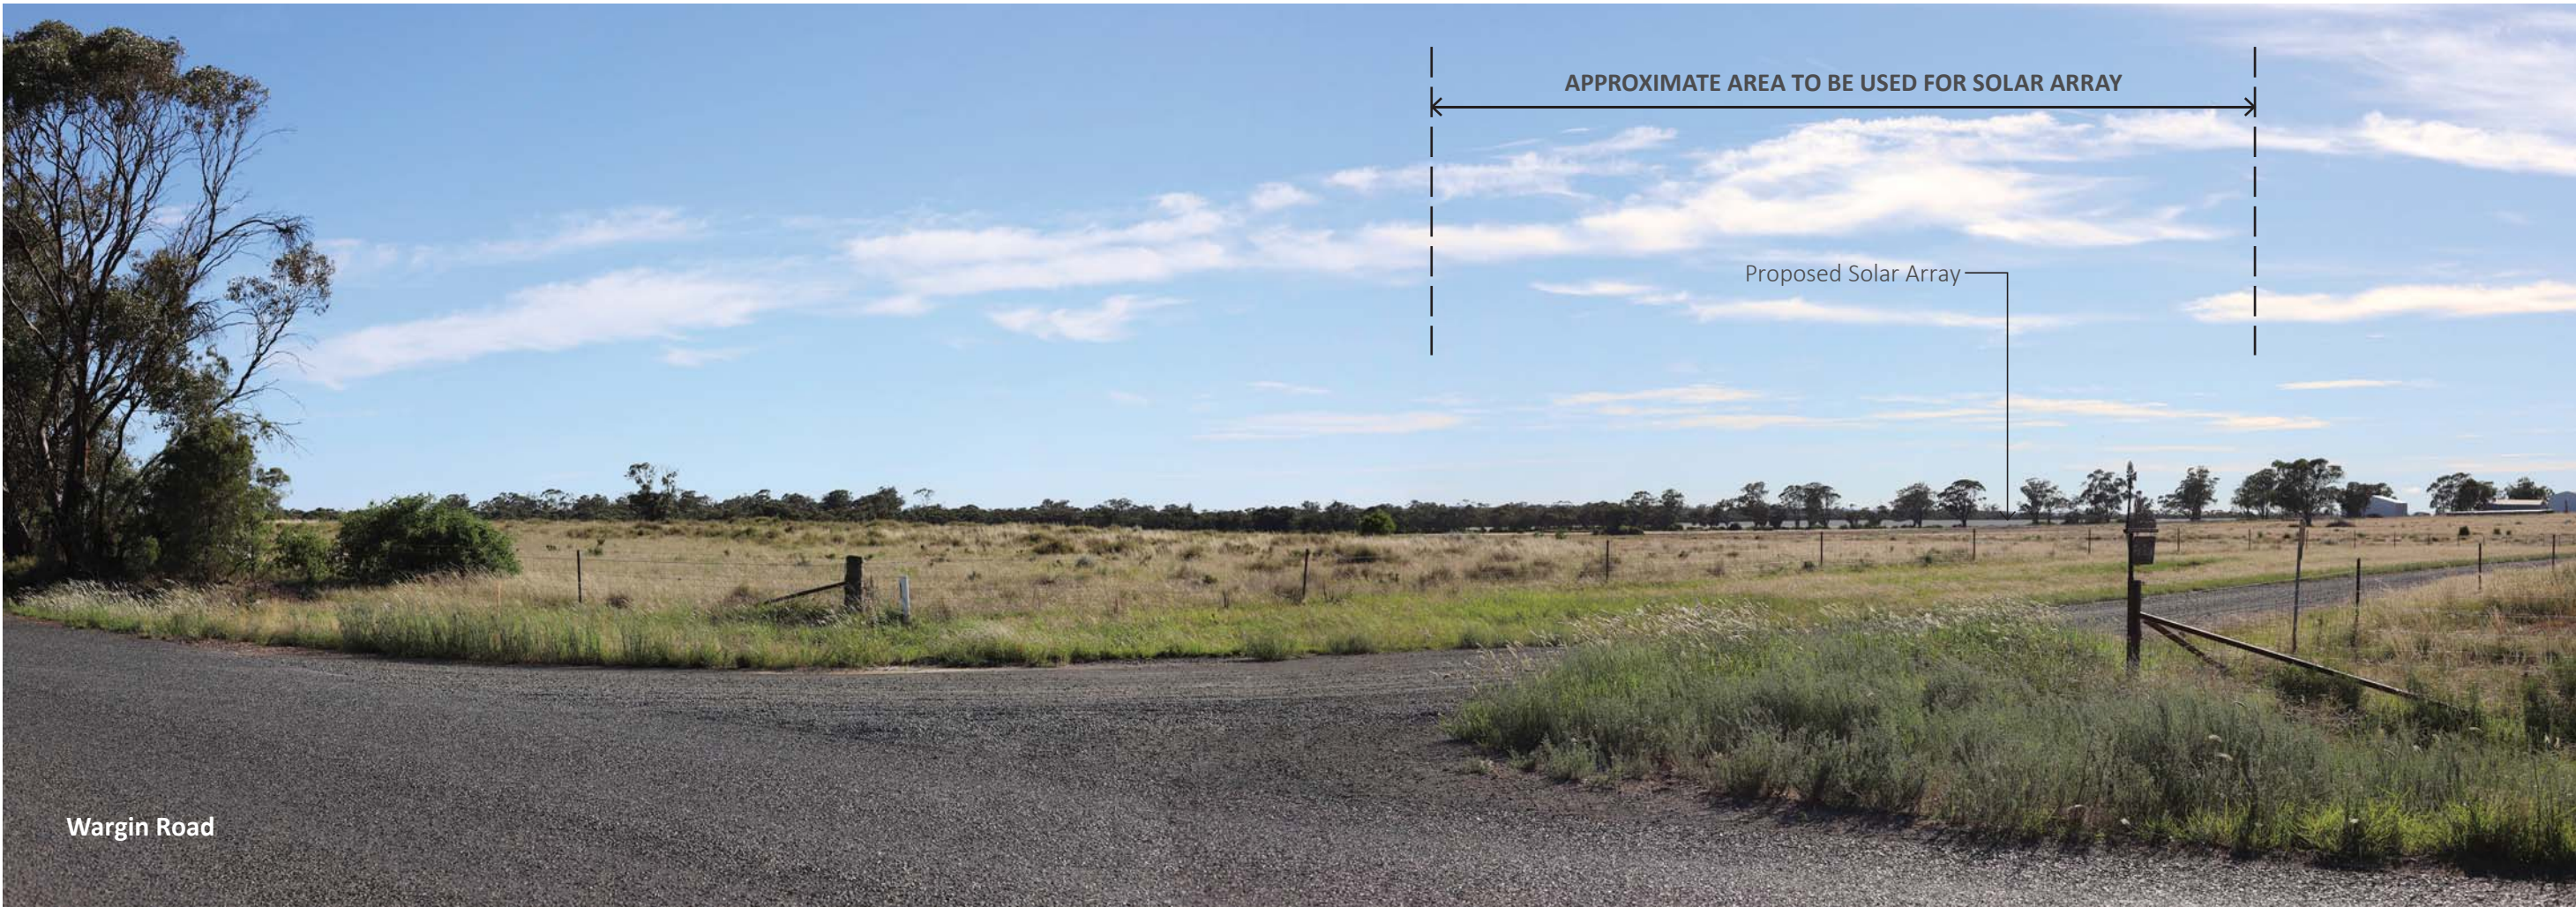
5.6.3 Viewpoint 1 - Proposed

| Receptor - VP1    Summary of Impact Assessment | |
| Receptor Sensitivity | Negligible |

| Receptor - VP1    Summary of Impact Assessment | |
|---|---|
| Mitigation Measures | <ul style="list-style-type: none"><li>From this viewpoint no mitigation measures are considered necessary.</li></ul> |

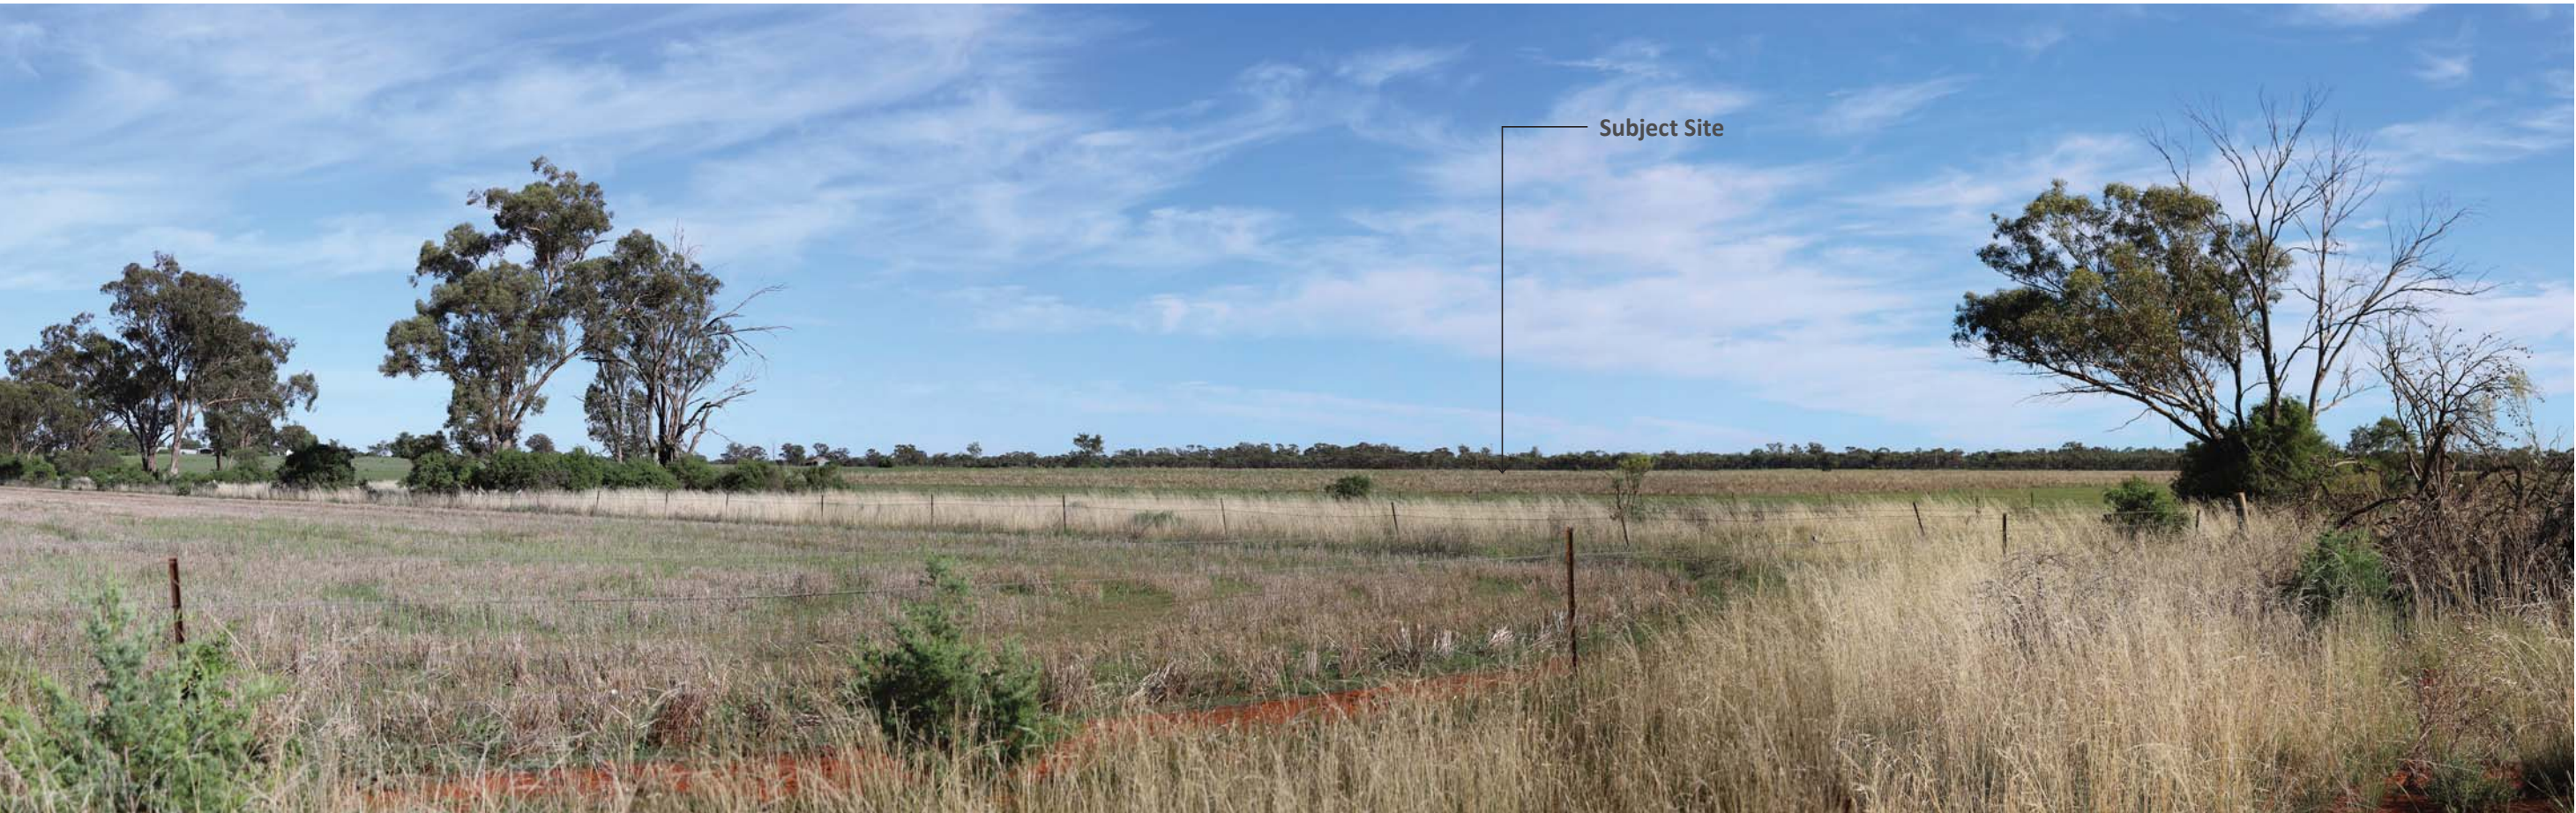
5.6.4 Viewpoint 2 - Existing

| Receptor - VP2 | Location |
|---|---|
| Comments <ul style="list-style-type: none"><li>Rural landscape dominated by open fields in the foreground.</li><li>Vegetation along the northern edge of site terminates views from this viewpoint while vegetation along the fence and boundary lines breaks up open views.</li></ul> | |

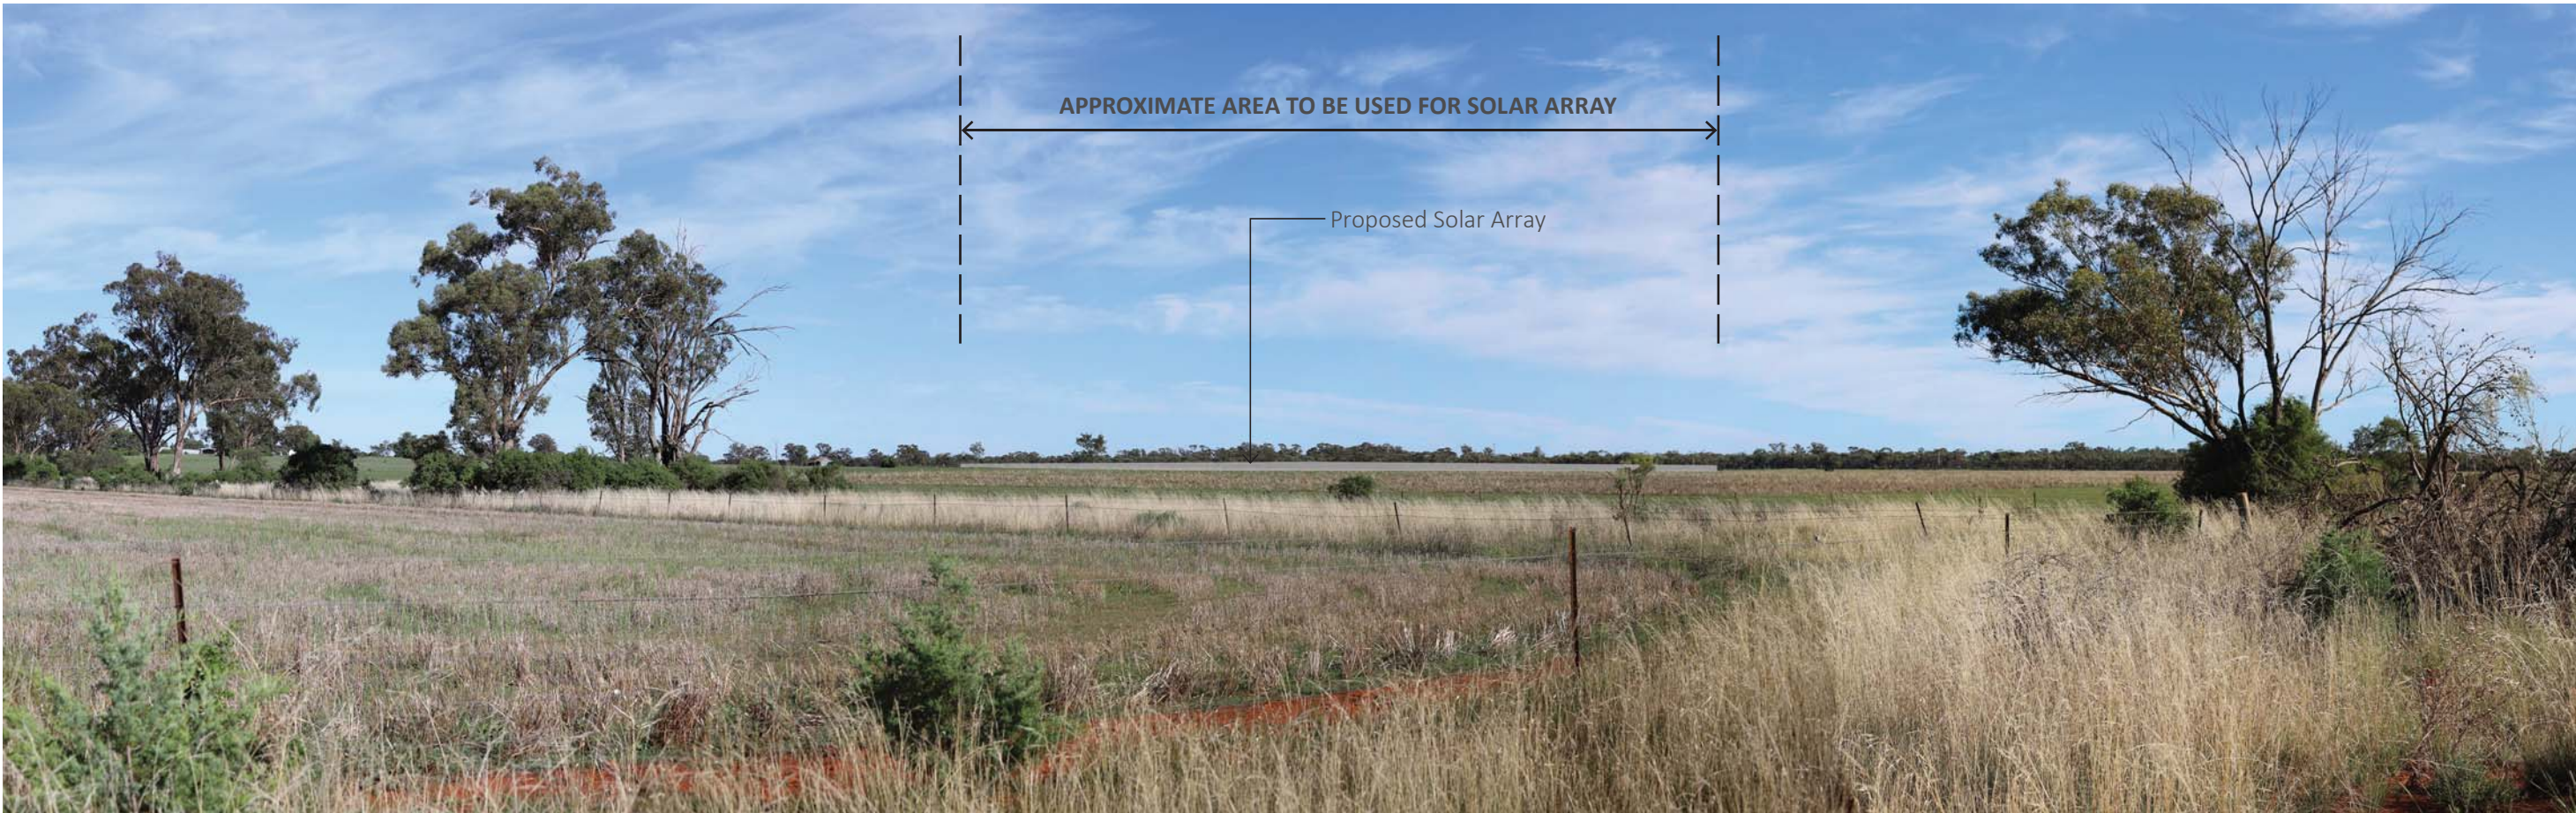
5.6.5 Viewpoint 2 - Proposed

| Receptor - VP2 Summary of Impact Assessment | |
| Receptor Sensitivity | Negligible |

| Receptor - VP2 Summary of Impact Assessment | |
|---|---|
| Mitigation Measures | <ul style="list-style-type: none"><li>From this viewpoint no mitigation measures are considered necessary.</li></ul> |

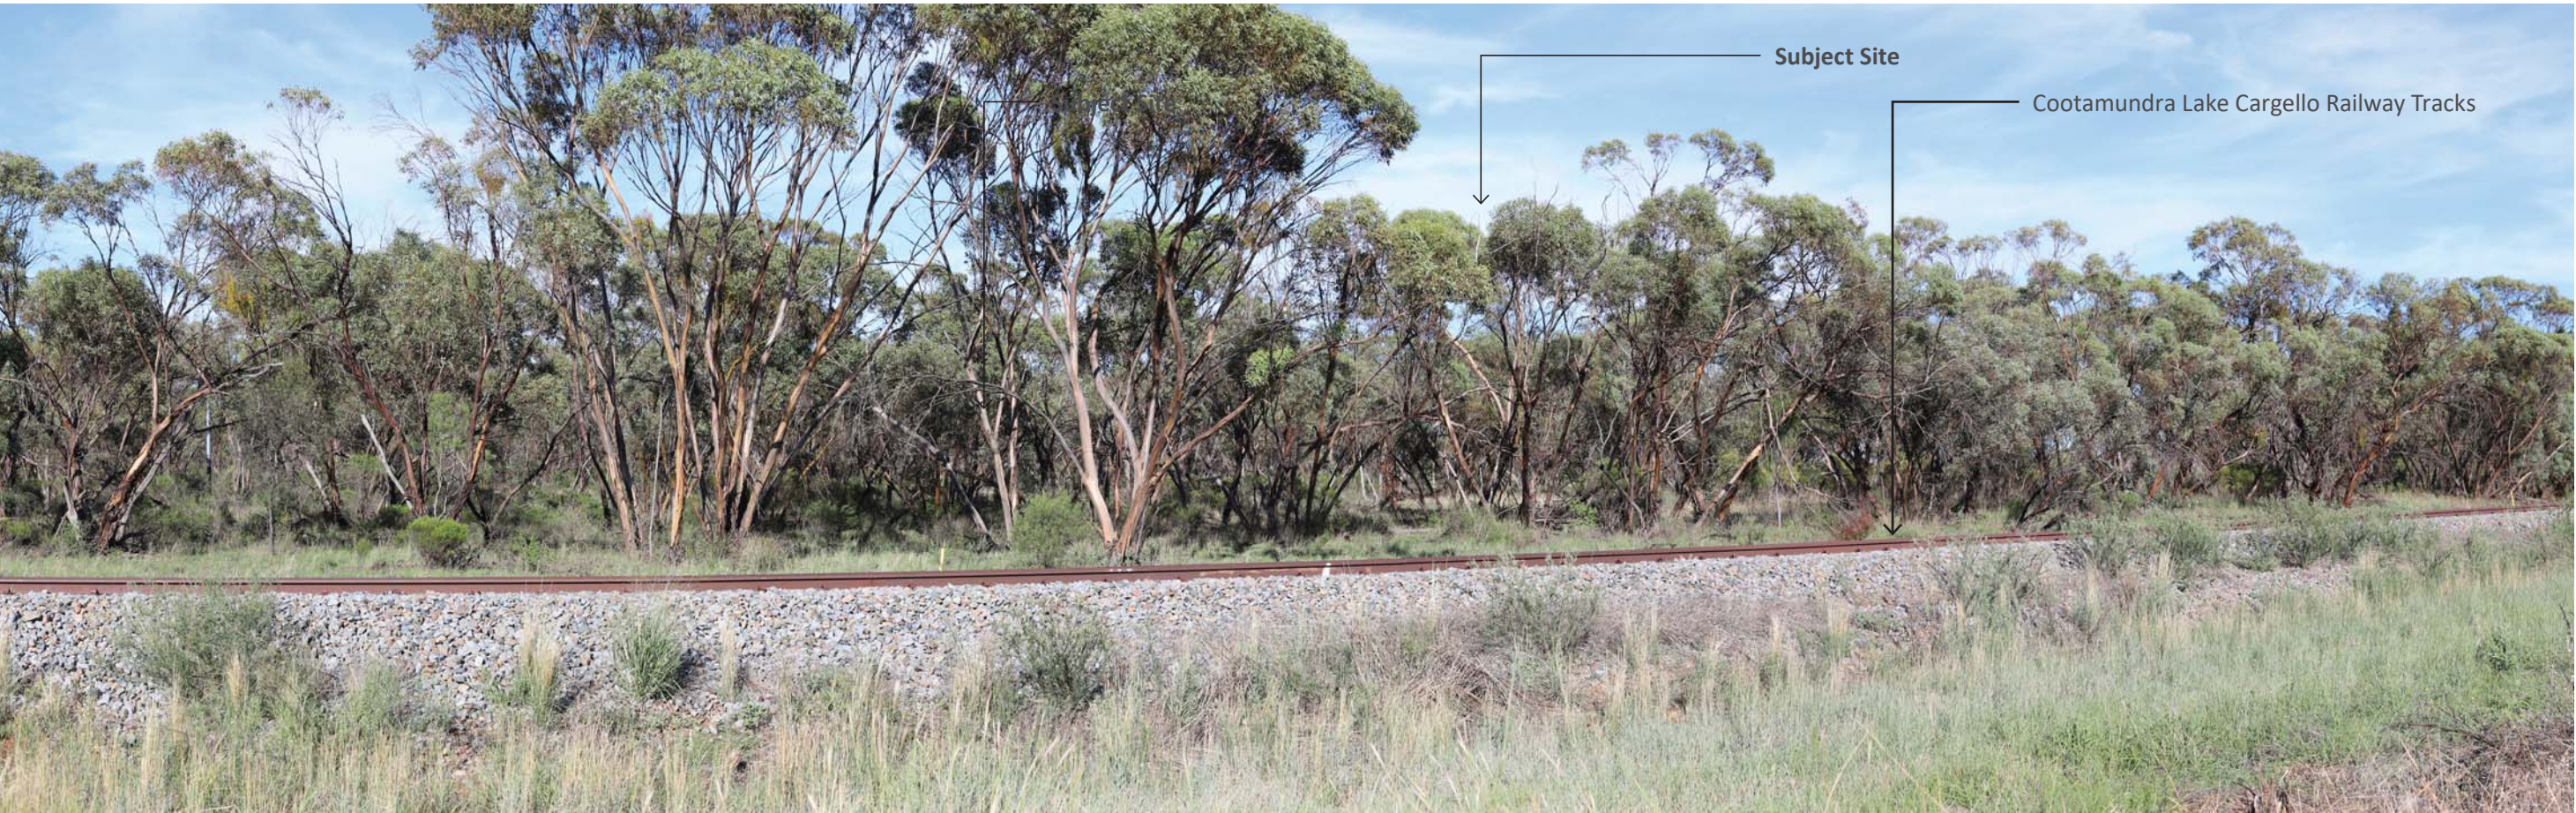
5.6.4 Viewpoint 3 - Existing

| Receptor - VP3 | Location |
|---|---|
| Comments <ul style="list-style-type: none"><li>Rural landscape dominated by the Cootamundra Lake Cargello Railway Tracks in the foreground.</li><li>Vegetation along the Western side of the railway tracks terminates views from this viewpoint.</li></ul> | |

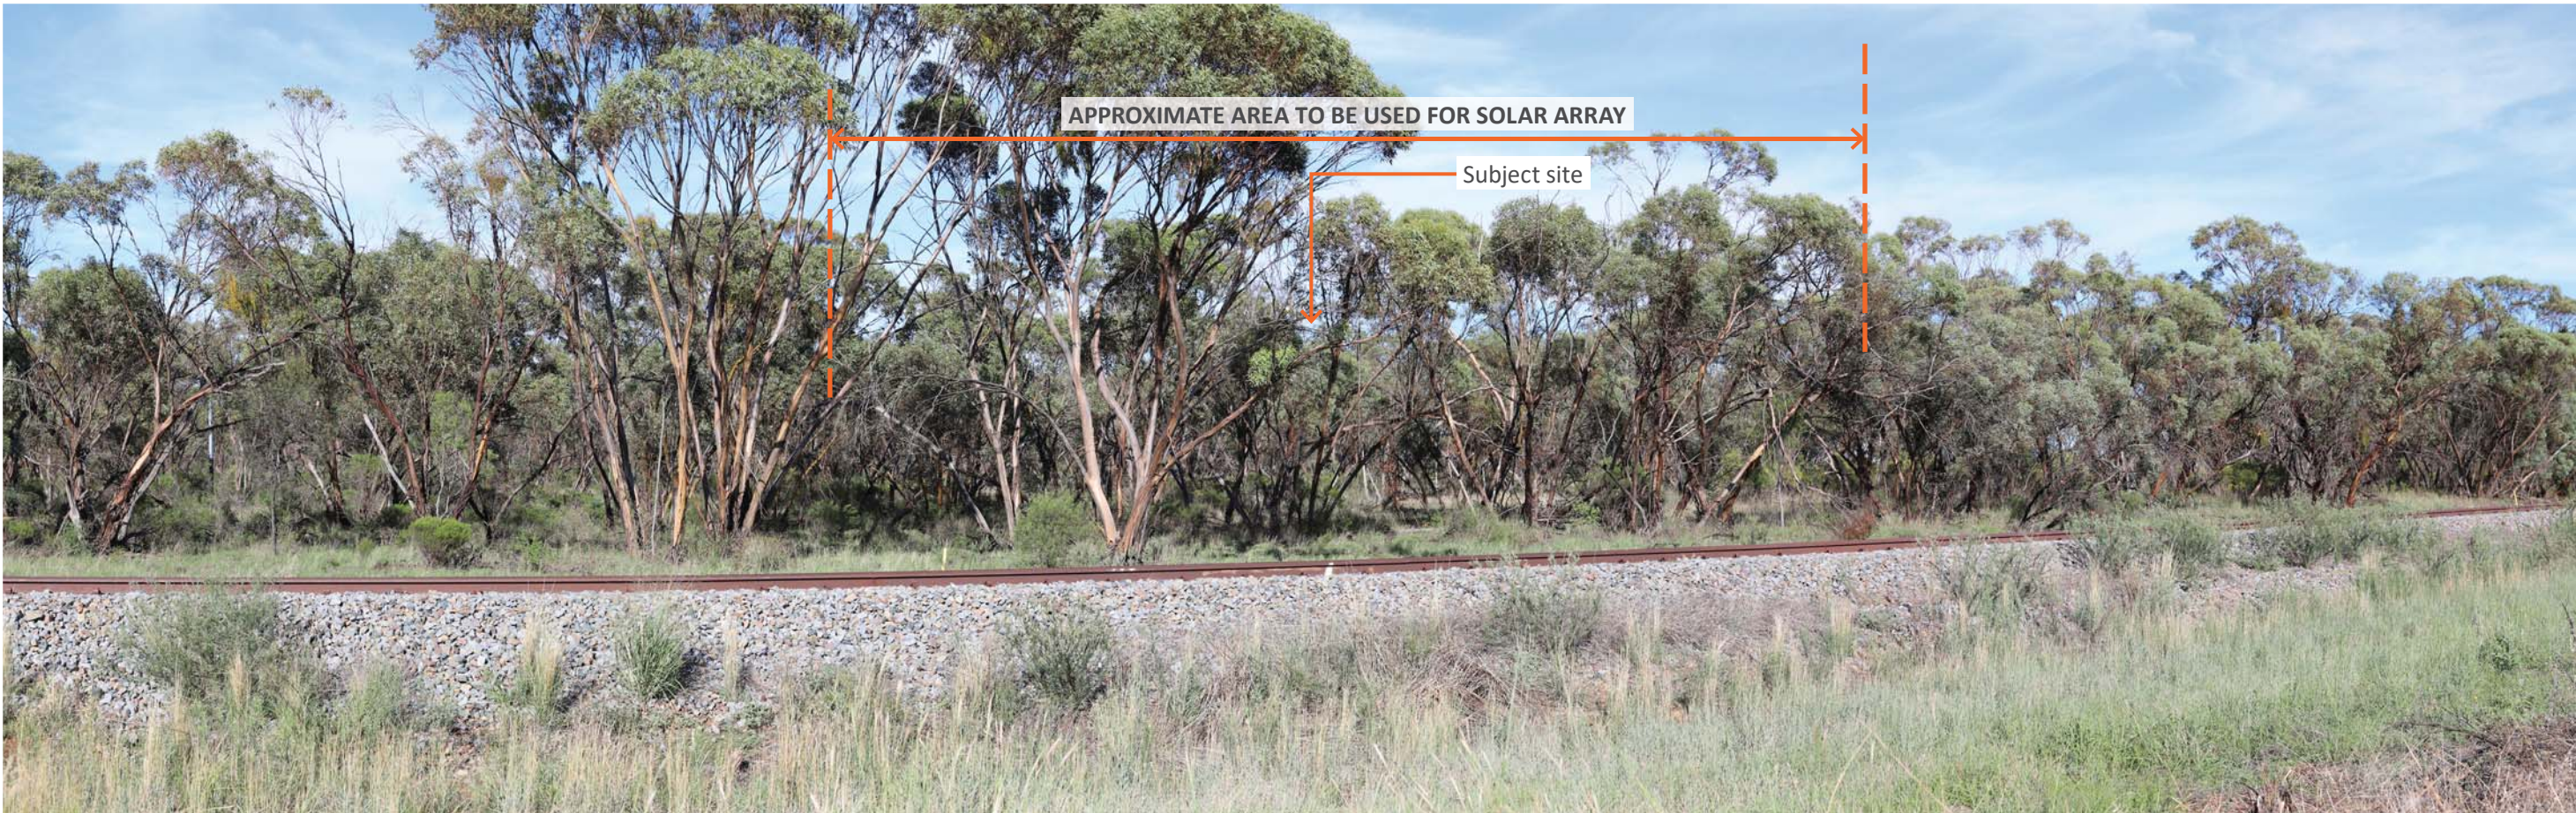
5.6.5 Viewpoint 3 - Proposed

| Receptor - VP3    Summary of Impact Assessment | |
| Receptor Sensitivity | Negligible |

| Receptor - VP3    Summary of Impact Assessment | |
|---|---|
| Mitigation Measures | <ul style="list-style-type: none"><li>From this viewpoint no mitigation measures are considered necessary.</li></ul> |

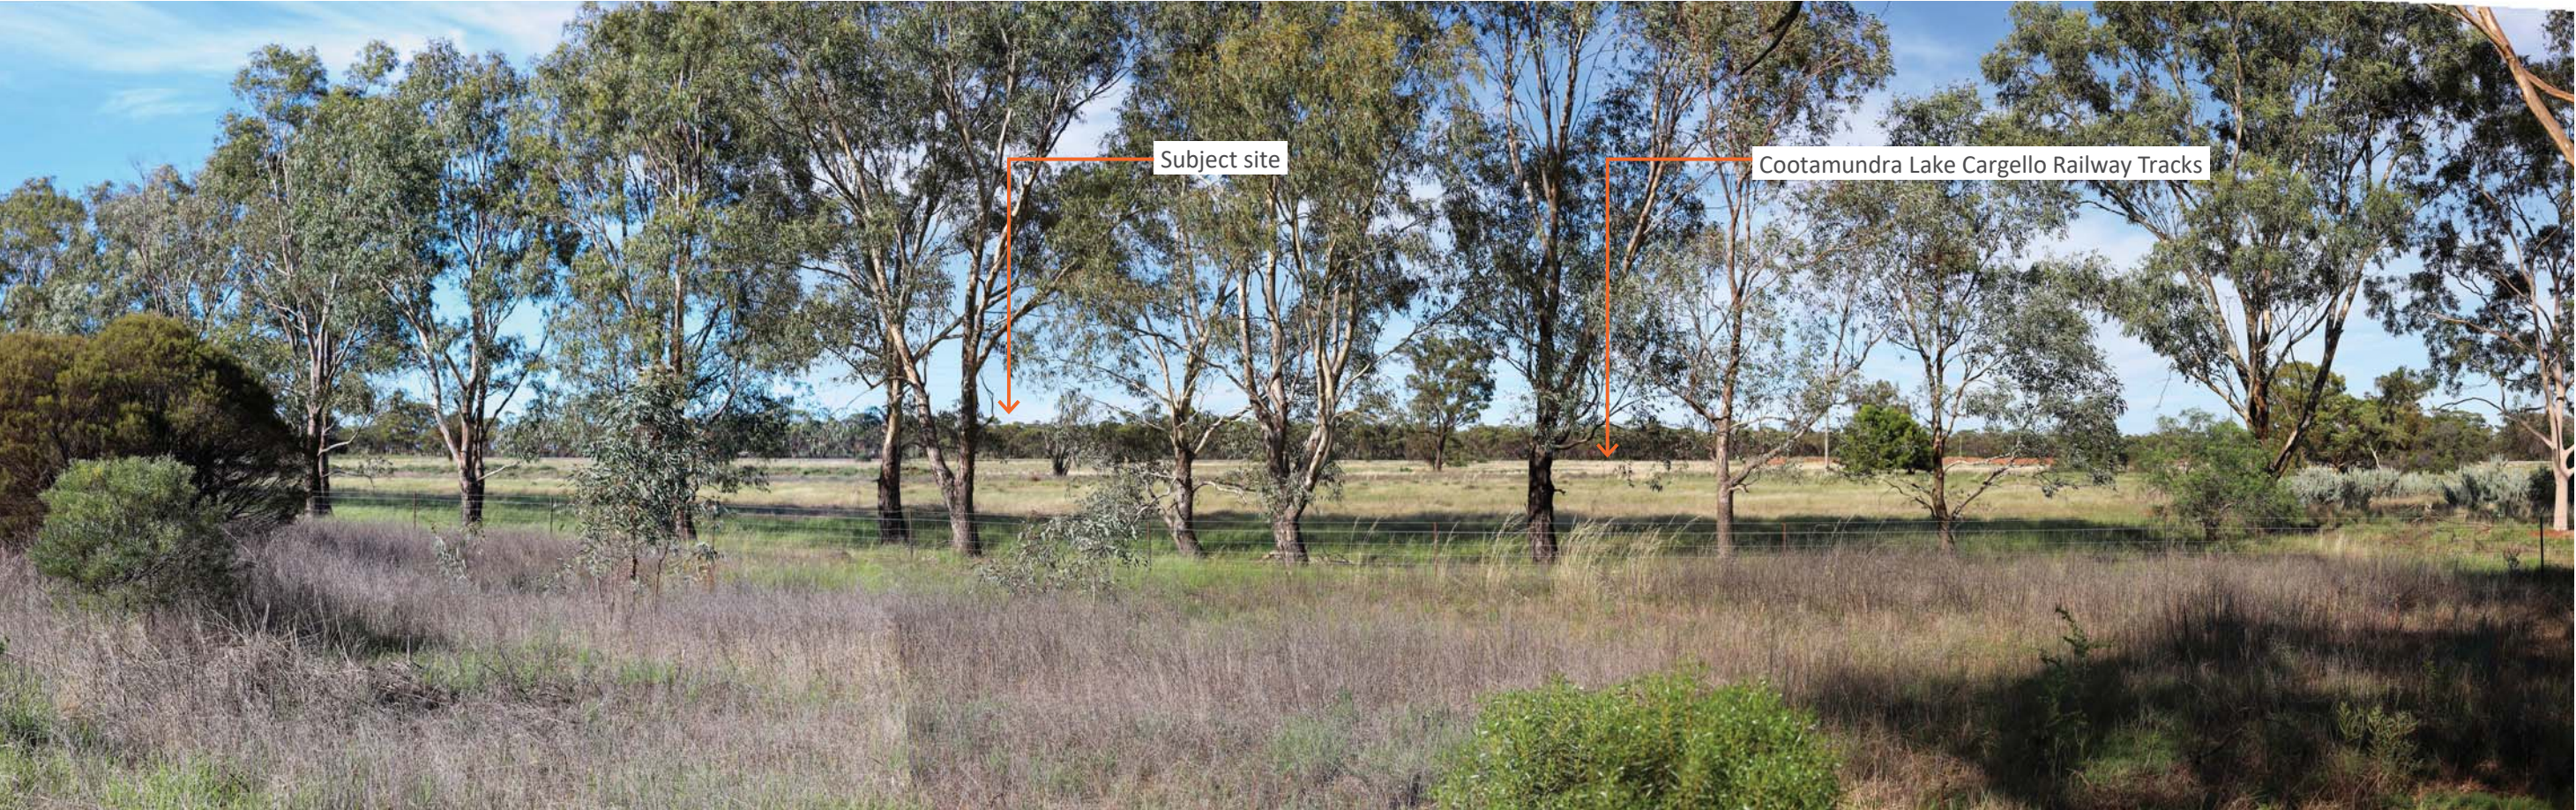
5.6.6 Viewpoint 4 - Existing

| Receptor - VP4 | Location |
|---|---|
| Comments <ul style="list-style-type: none"><li>Rural landscape dominated by boundary line vegetation in the foreground and open fields in the middle ground.</li><li>Vegetation along the northern edge of site (background of this view) terminates views from this viewpoint.</li></ul> | |

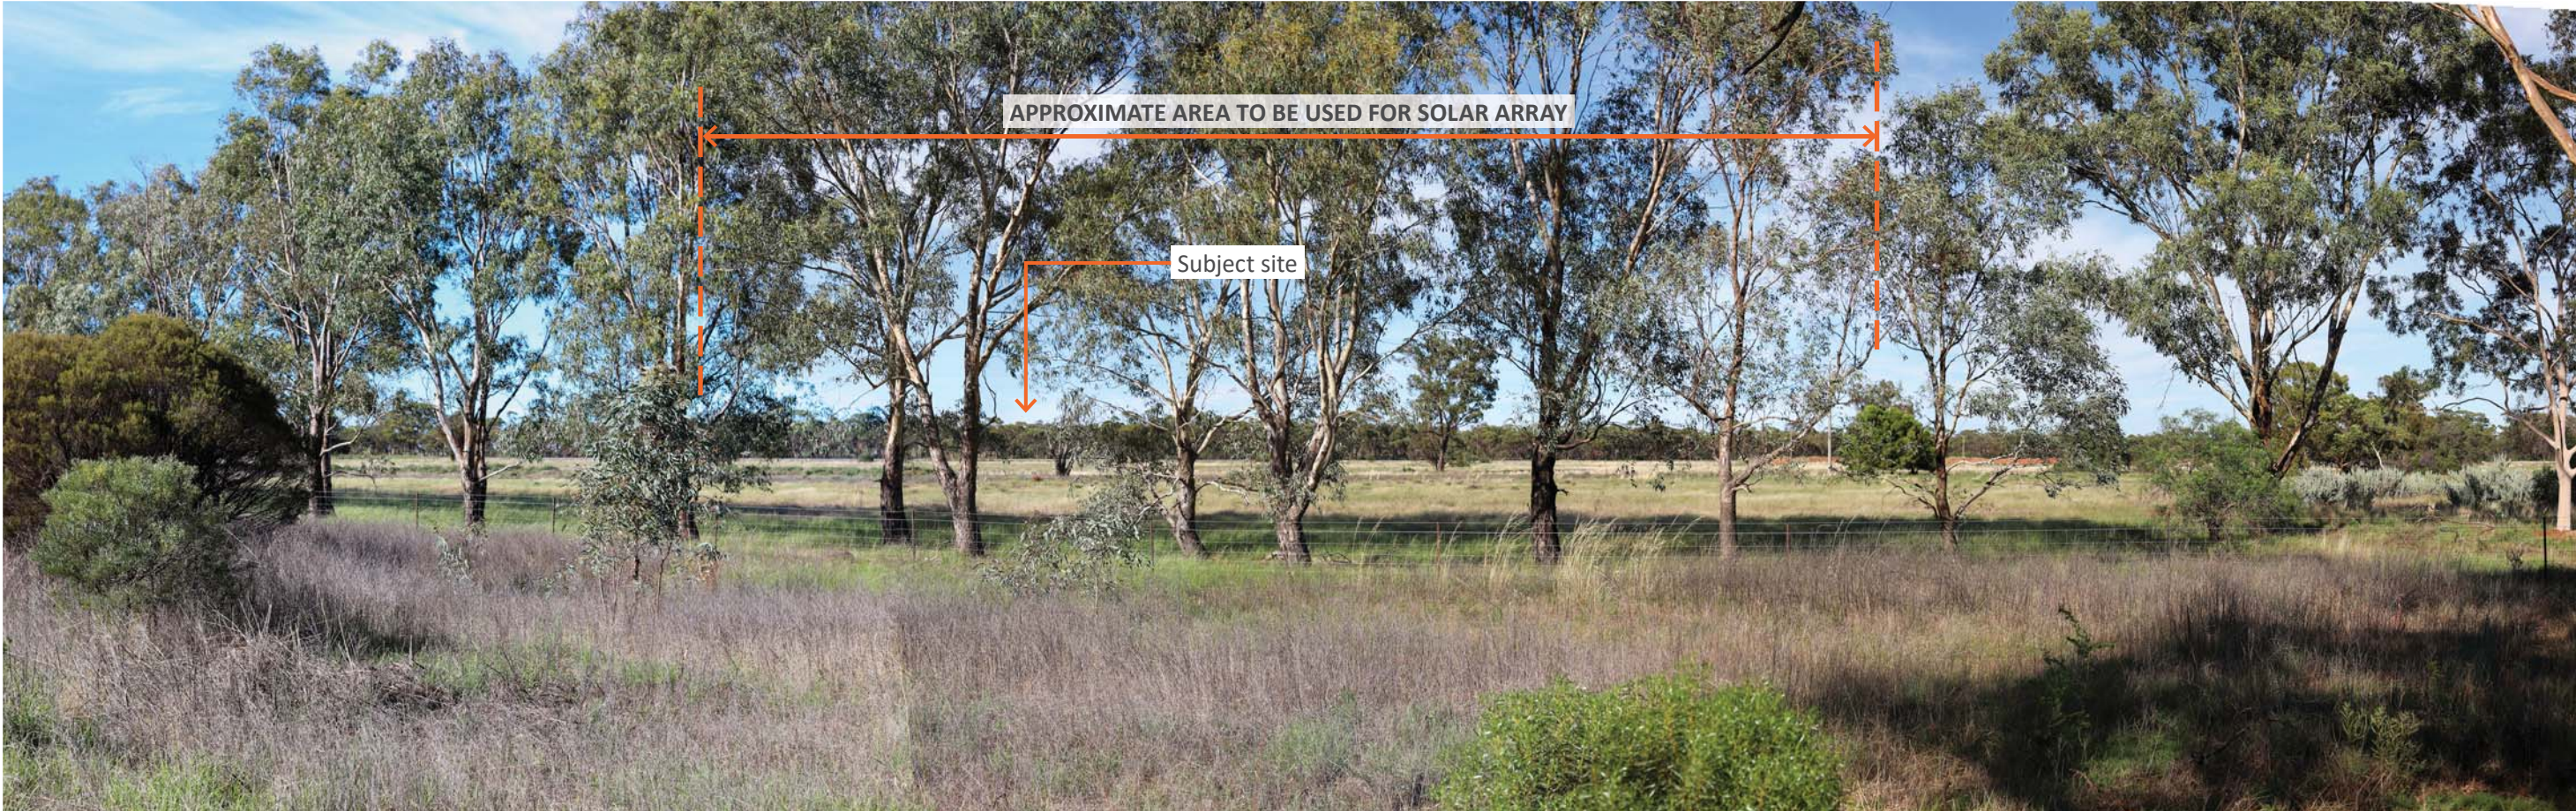
5.6.6 Viewpoint 4 - Proposed

| Receptor - VP4   Summary of Impact Assessment | |
| Receptor Sensitivity | Negligible |

| Receptor - VP4   Summary of Impact Assessment | |
|---|---|
| Mitigation Measures | <ul style="list-style-type: none"><li>From this viewpoint no mitigation measures are considered necessary.</li></ul> |
