# PINE RIDGE SOLAR FARM

## Visual Analysis and Reflectivity Statement

SLR Ref: 631.20527.00000 Version No: -v1.0 JUNE 2021

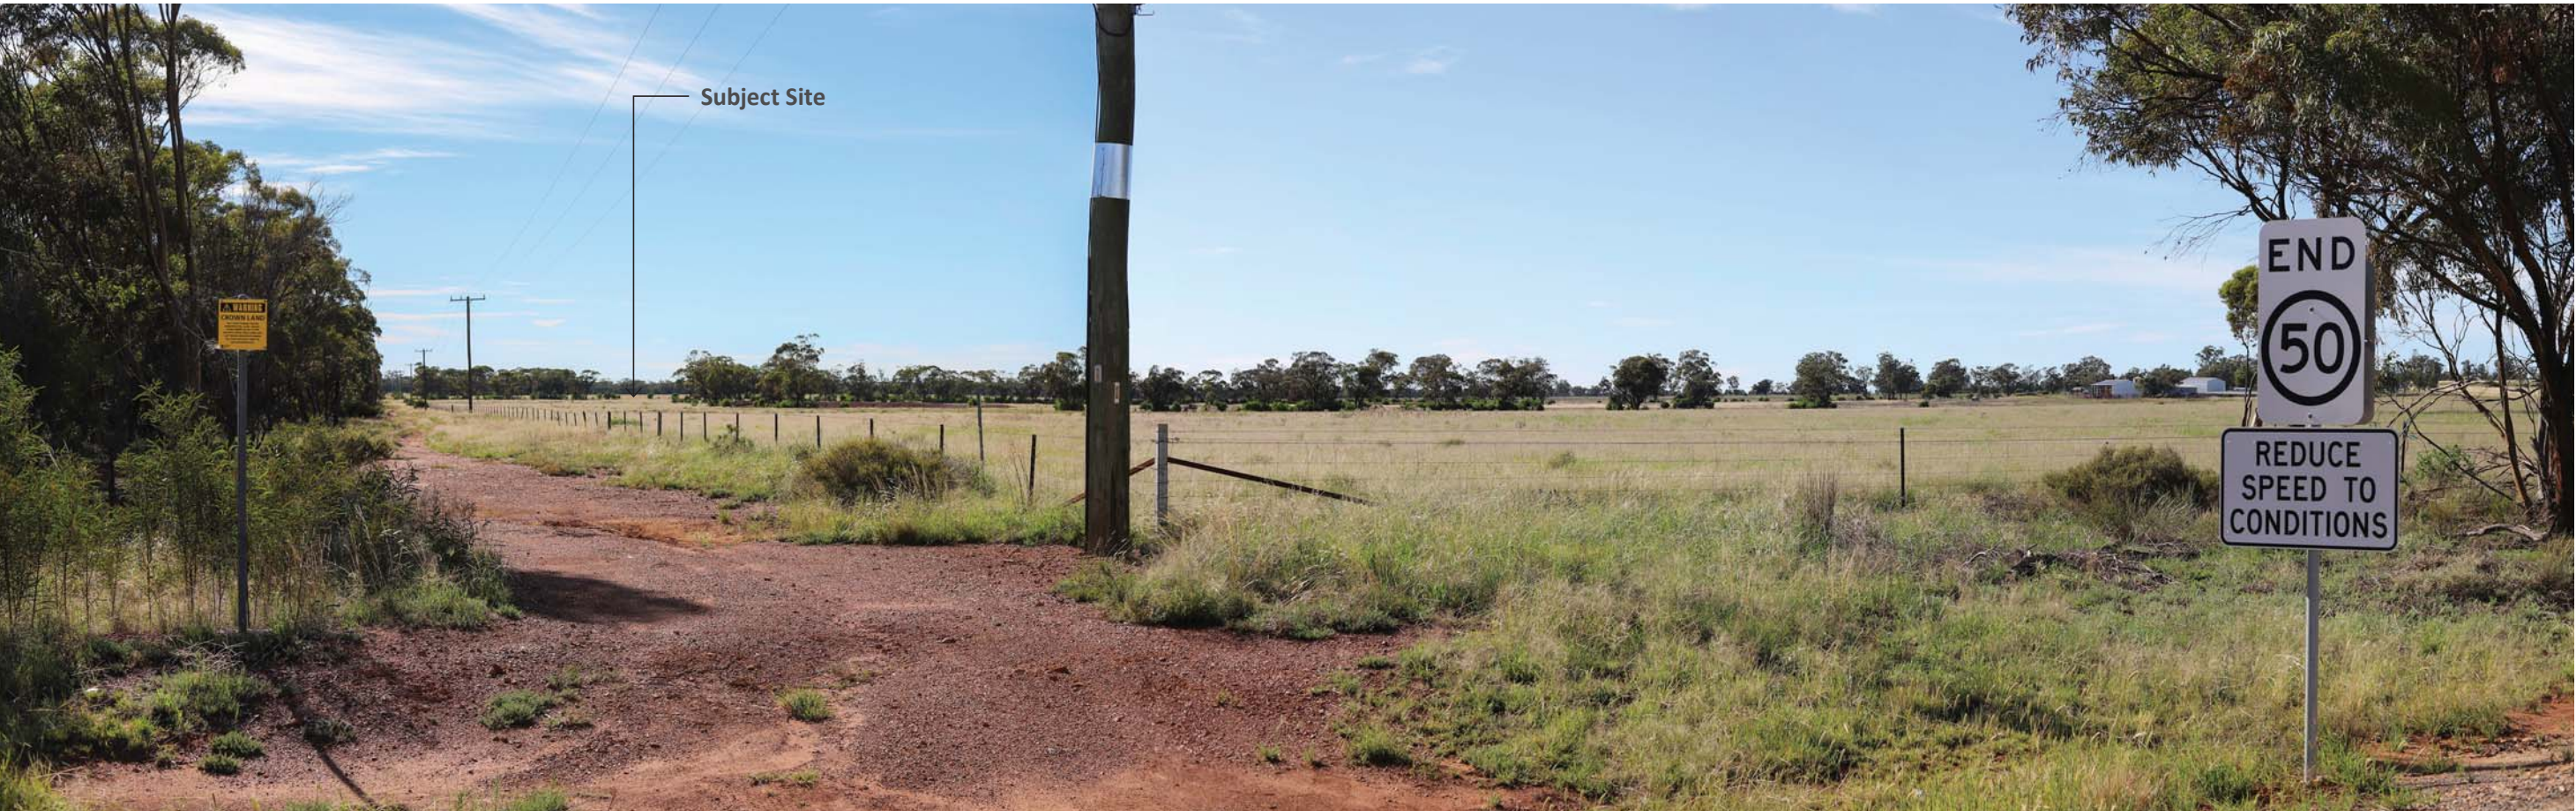
5.6.6 Viewpoint 5 - Existing

| Receptor - VP5 | Location |
|---|---|
| <ul style="list-style-type: none"><li>Rural landscape dominated by open fields in the foreground. Vegetation to either side of this view is also prominent.</li><li>Vegetation along Wargin Road and the northern edge of the site are prominent whilst views of vegetation along the boundary line in the middle ground breaks up open views.</li></ul> | |

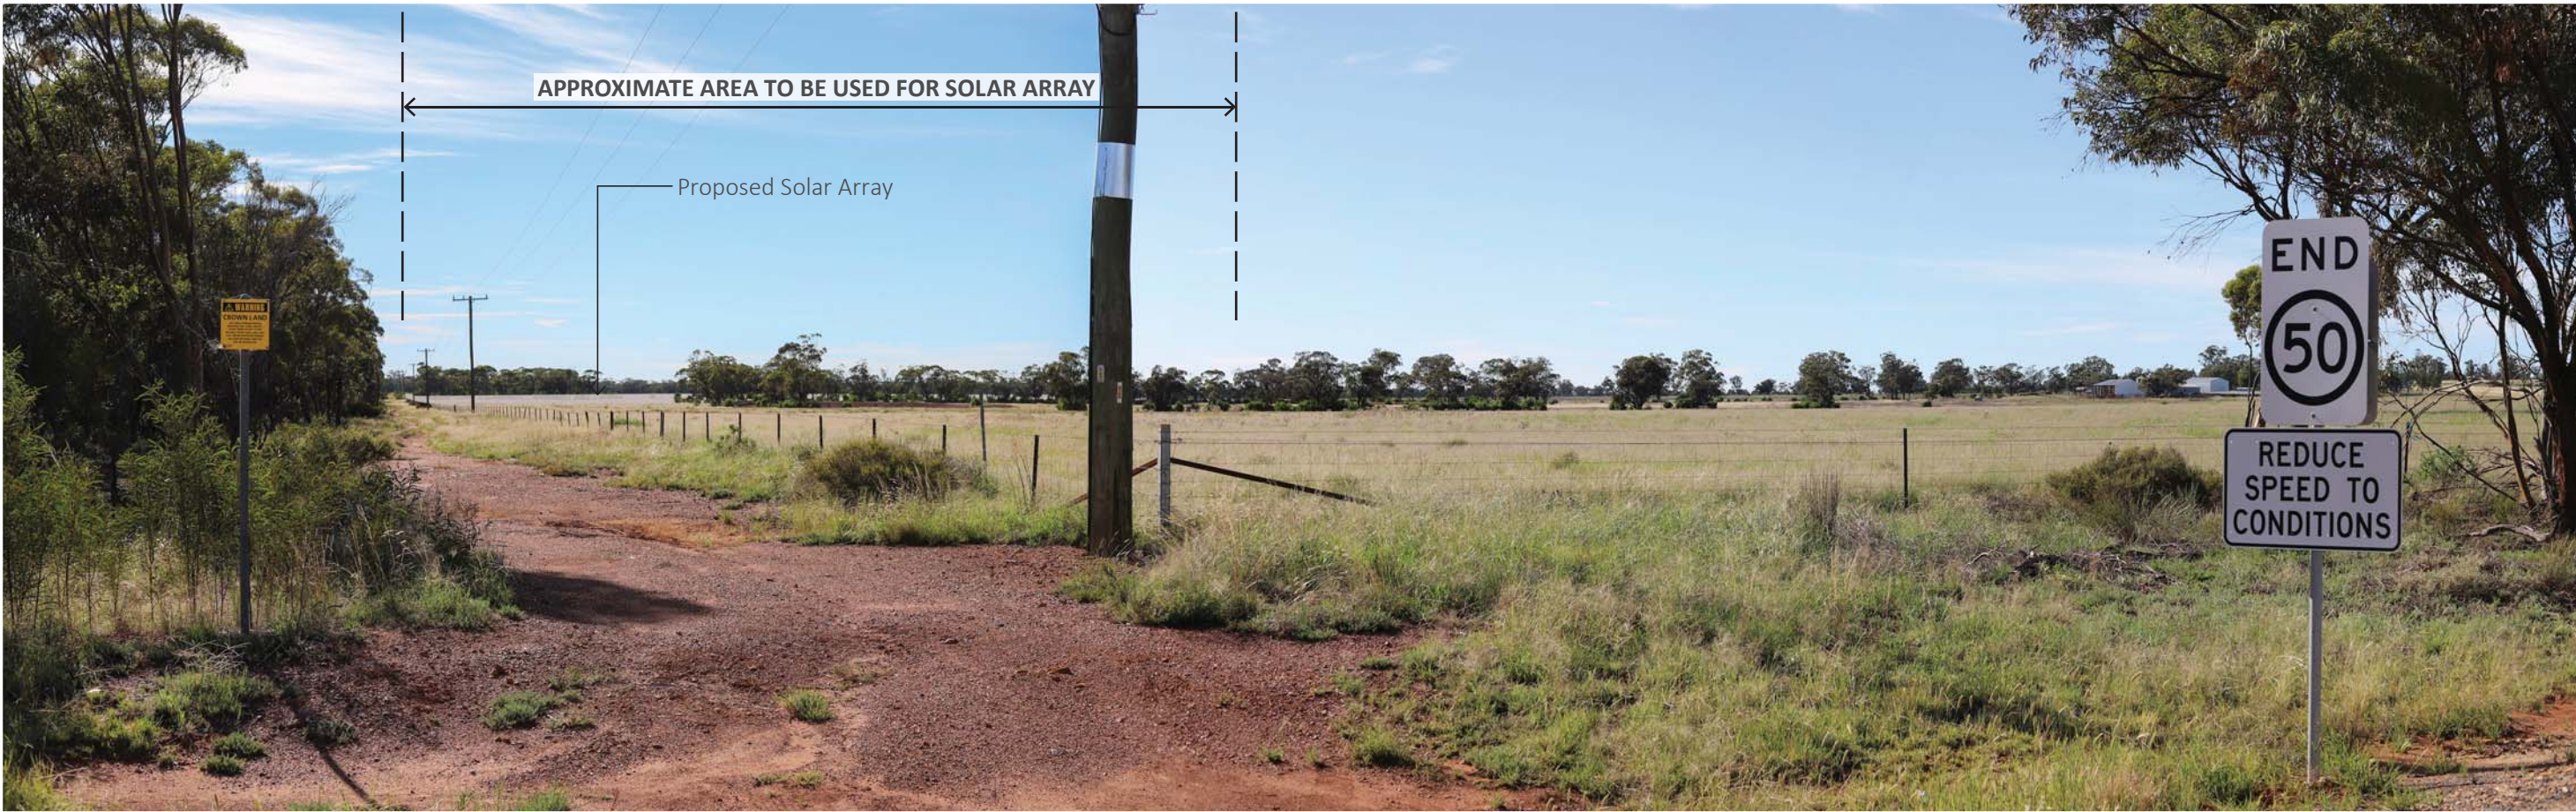
5.6.6 Viewpoint 5 - Proposed

| Receptor - VP5   Summary of Impact Assessment | |
| Receptor Sensitivity | Negligible |

| Receptor - VP5   Summary of Impact Assessment | |
|---|---|
| Mitigation Measures | <ul style="list-style-type: none"><li>From this viewpoint no mitigation measures are considered necessary.</li></ul> |

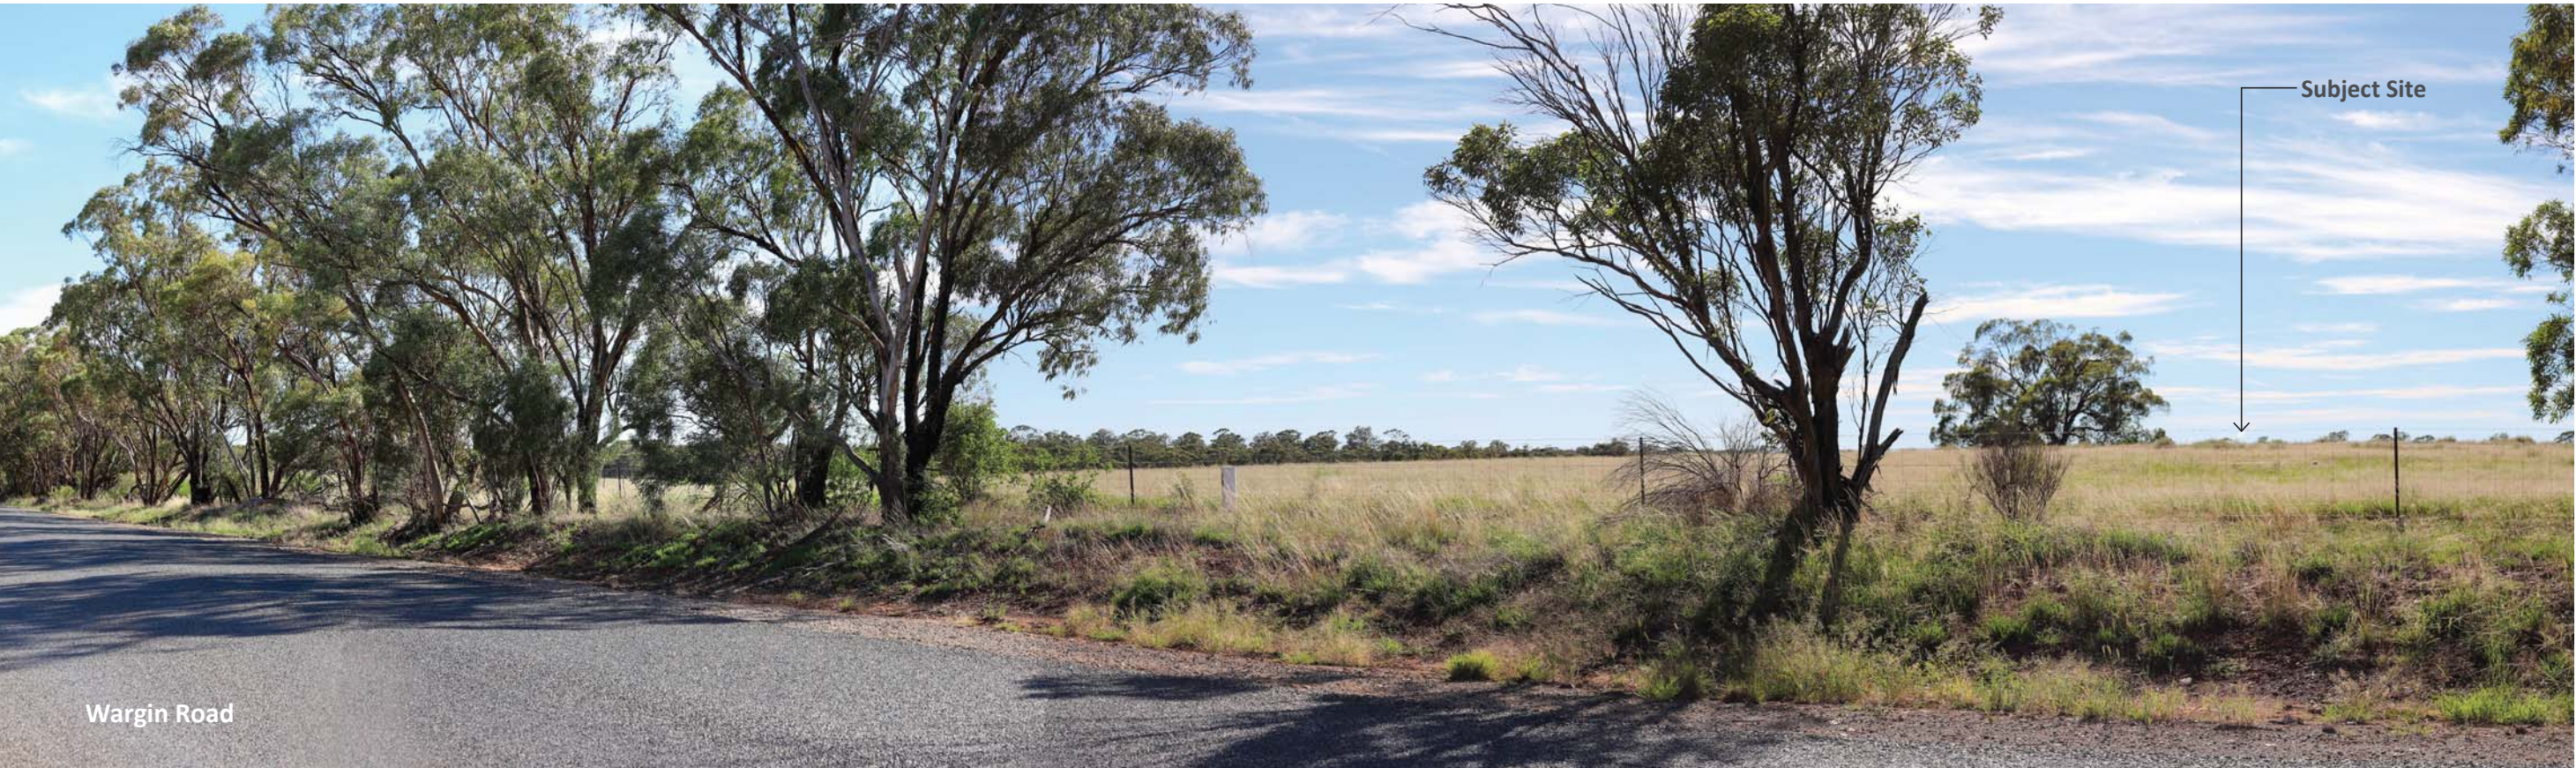
5.6.6 Viewpoint 6 - Existing

| Receptor - VP6 | Location |
|---|---|
| Comments <ul style="list-style-type: none"><li>Rural landscape dominated by Wargin Road in the foreground.</li><li>Vegetation along the road and northern edge of site terminates views from this viewpoint.</li></ul> | |

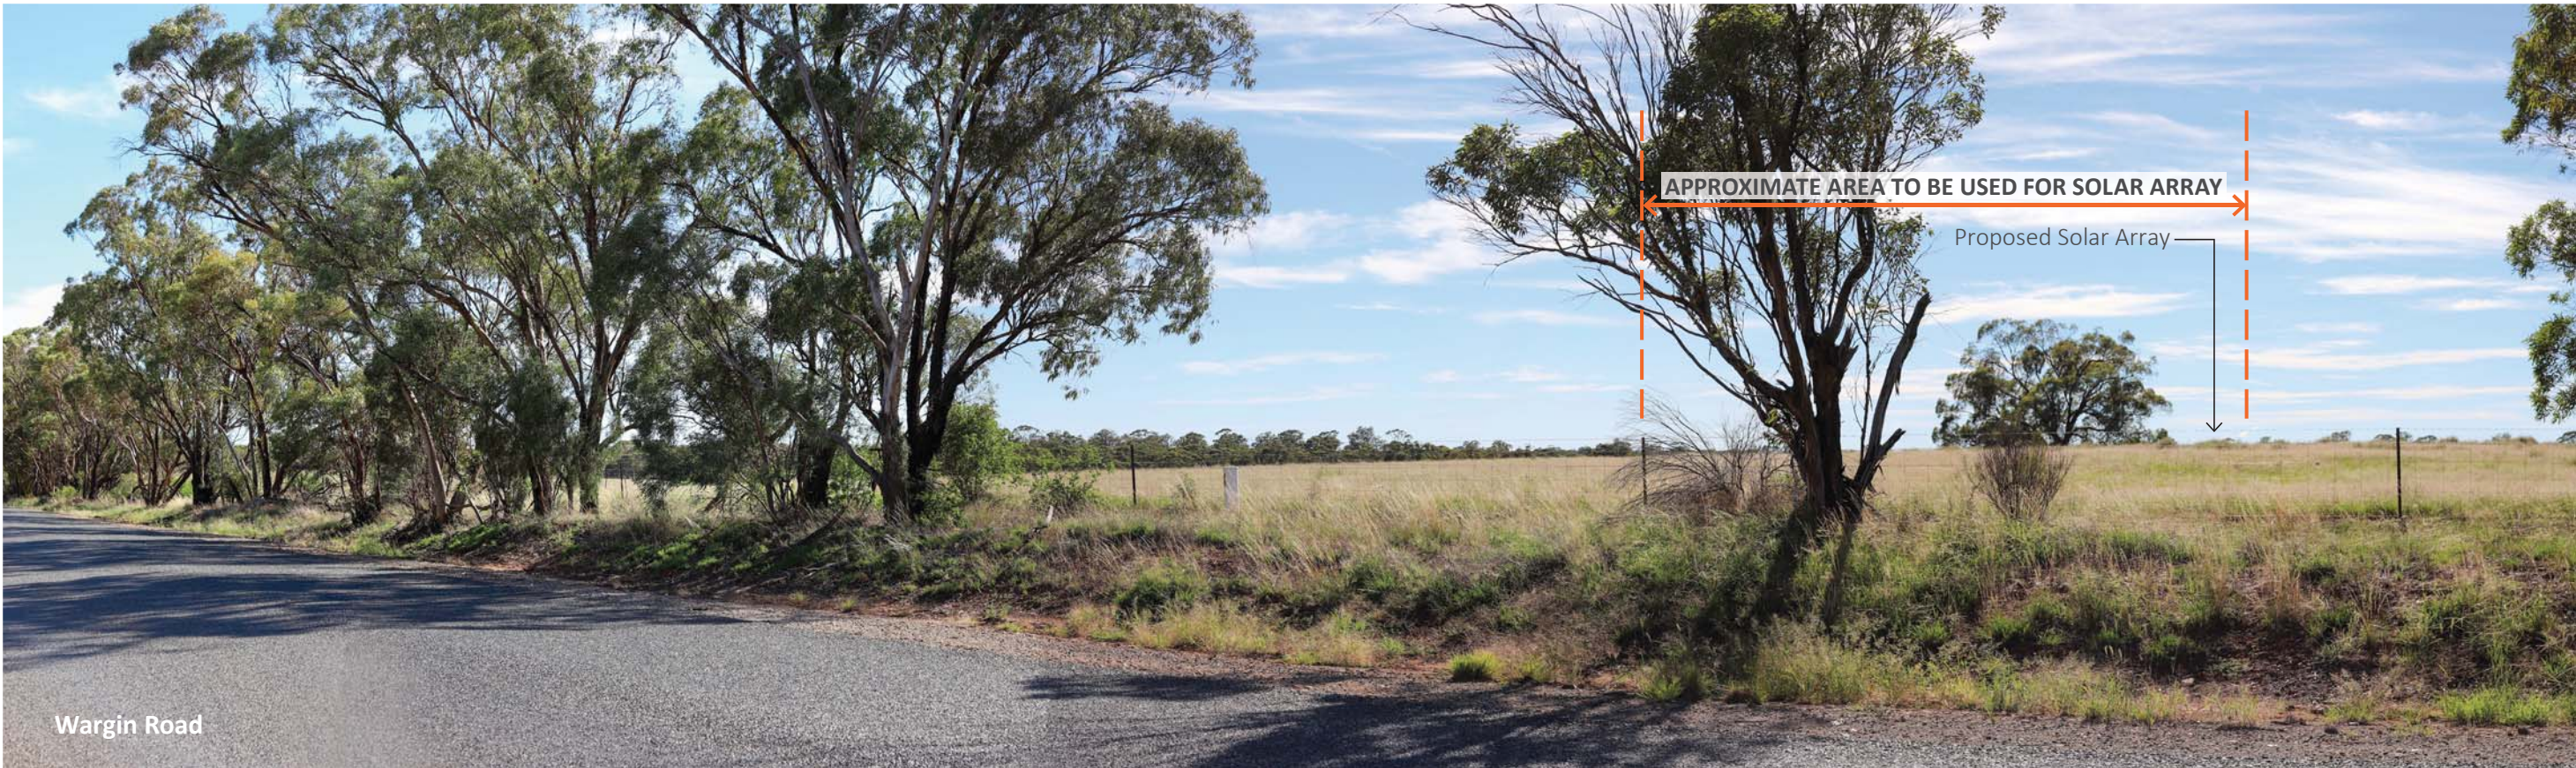
5.6.6 Viewpoint 6 - Proposed

| Receptor - VP6 Summary of Impact Assessment | |
| Receptor Sensitivity | Negligible |

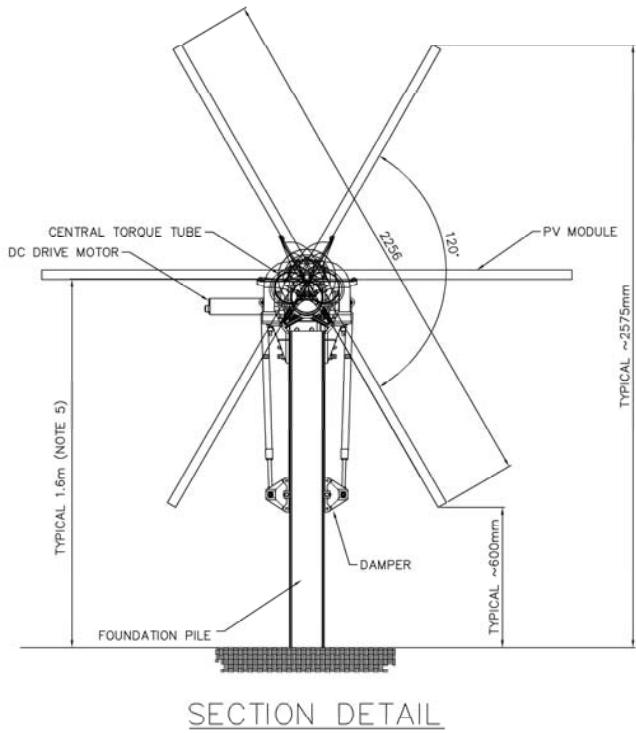
Figure 4 Pine Ridge Solar Farm Single-Axis Trackers

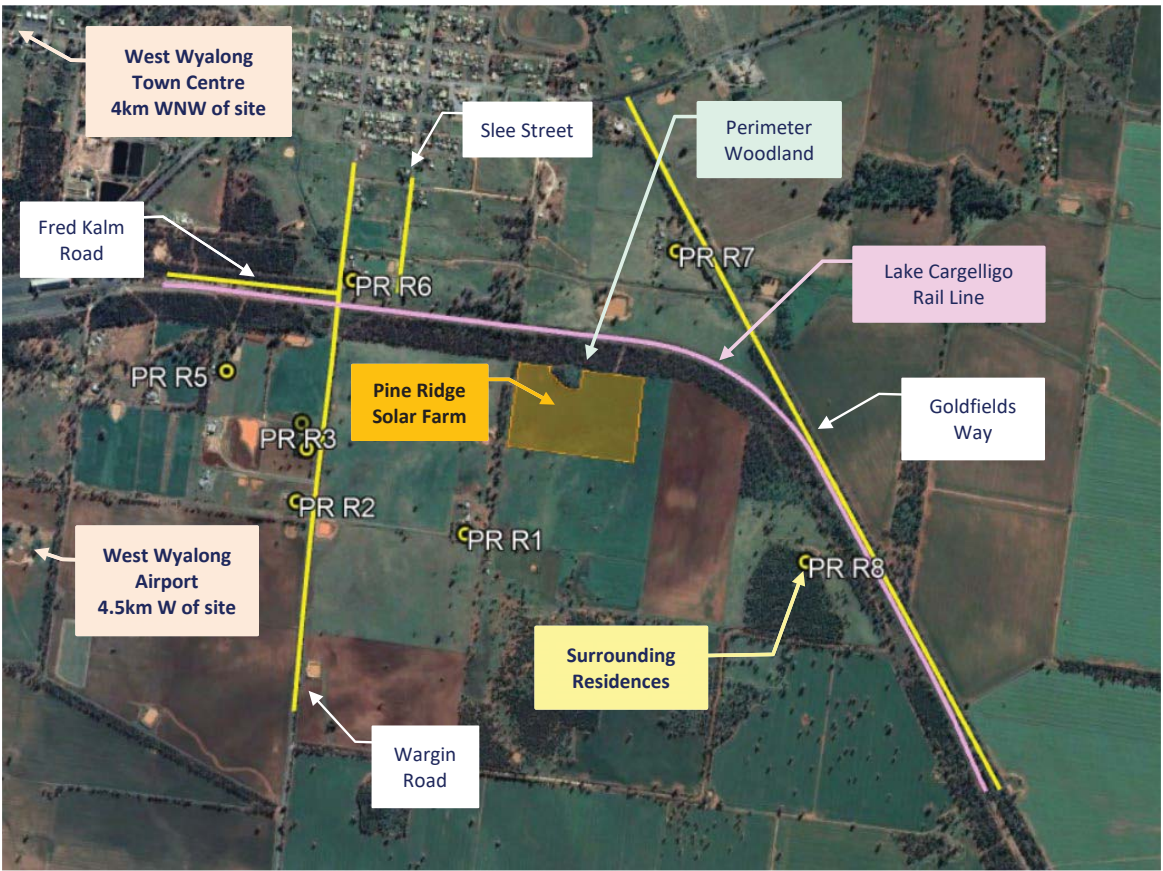
Figure 5 Surrounding Receivers of Interest

SLR has carried out TI Value calculations for the receivers shown in Figure 5, to gain an understanding of the potential for nuisance glare conditions from the project.

- For receivers R1, R6, R7 and R8, TI Values were NIL all-year-round for all Fixed Tilt modes (horizontal, east or west tilt).
- With no allowance for blockage by landscaping, trees, etc, reflections may potentially be visible at receivers R2, R3, R4 and R5, for a Fixed Tilt mode involving panels being left with a slight WEST tilt: early in the morning for several months around the equinoxes. The visibility condition would last less than 2 minutes.
- Given the negligible TI Values involved and the added potential for landscaping blockage, no glare condition is predicted.

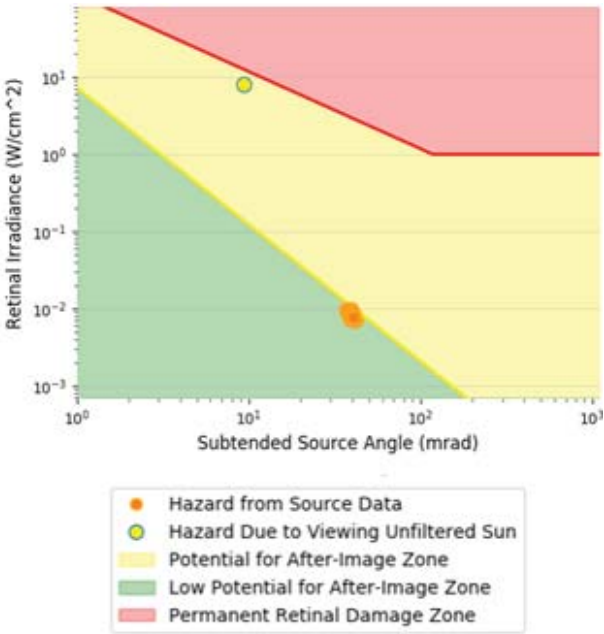
A sample SGHAT Ocular Hazard Plot is shown in **Figure 6**. The analysis contained in this plot is derived from solar simulations that extend over the ENTIRE CALENDAR YEAR in 1-MINUTE intervals, sunrise to sunset.

Figure 6 Example SGHAT Plot

In **Figure 6**, the following is noted:

- GREEN: low potential to cause “after-image”
  - YELLOW: potential to cause temporary “after-image”
  - RED: potential to cause retinal burn (permanent eye damage)

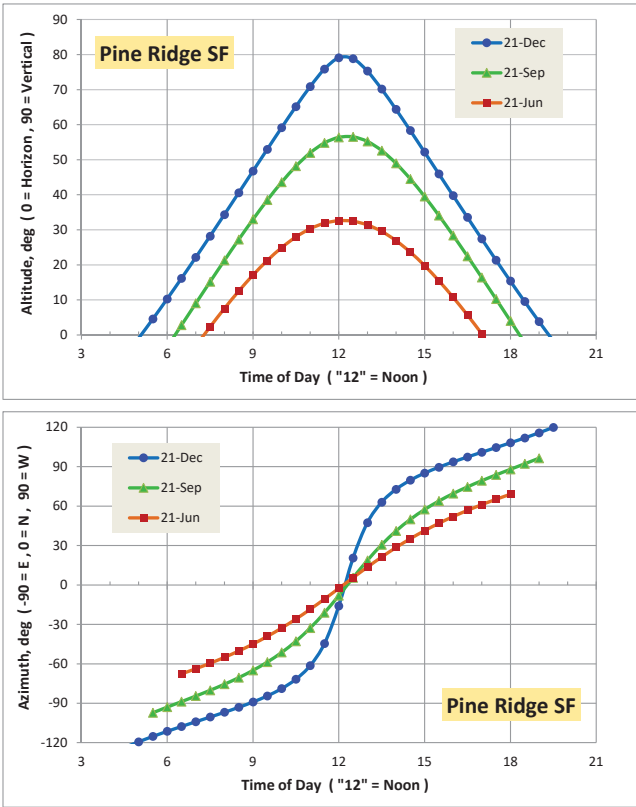
Figure 7 Project Site Solar Angle Variations

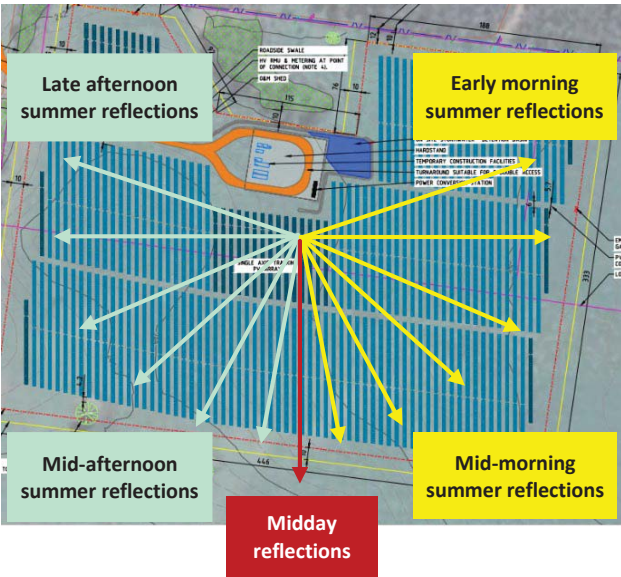
The project will use single-axis tracking panels with a north-south axis of rotation). In “plan” view, reflections from the Project’s panels will be directed as shown in **Figure 8** for a representative area of panels, with the direction of reflected rays shown for typical mid-summer days. As a result of the tracking motion of the solar panels throughout the day, reflections will generally be directed upwards and hence not visible by ground-based receivers at roughly the same elevation as the facility.

Figure 8 Potential Summer Reflection Angles

Due to the distances involved (refer above) and the possible angles of reflections from the Project’s solar PV panels (refer **Figure 12**), potential glare conditions for aircraft on any possible approach paths for both of these nearest airports are deemed non-existent.

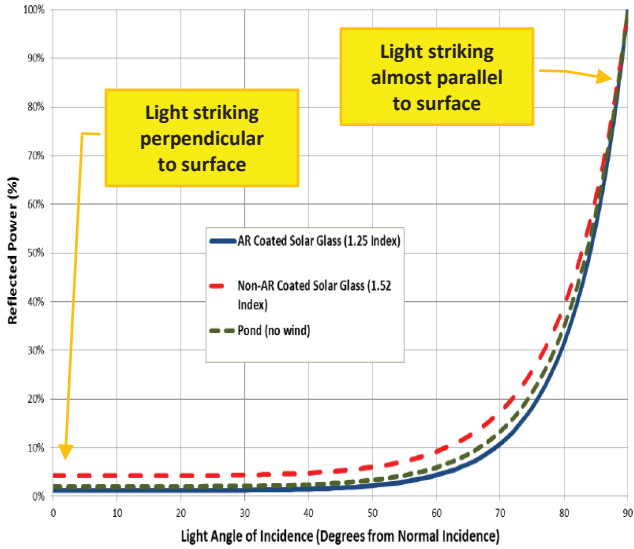
- It is only when an incoming solar ray strikes the panel at a large “incidence” angle, i.e. almost parallel to the panel, that reflectivity values increase. When this happens, reflections become noticeable and potentially at “glare” level for all solar panel surface types.

Figure 9 Typical Reflectivity v Incidence Angle

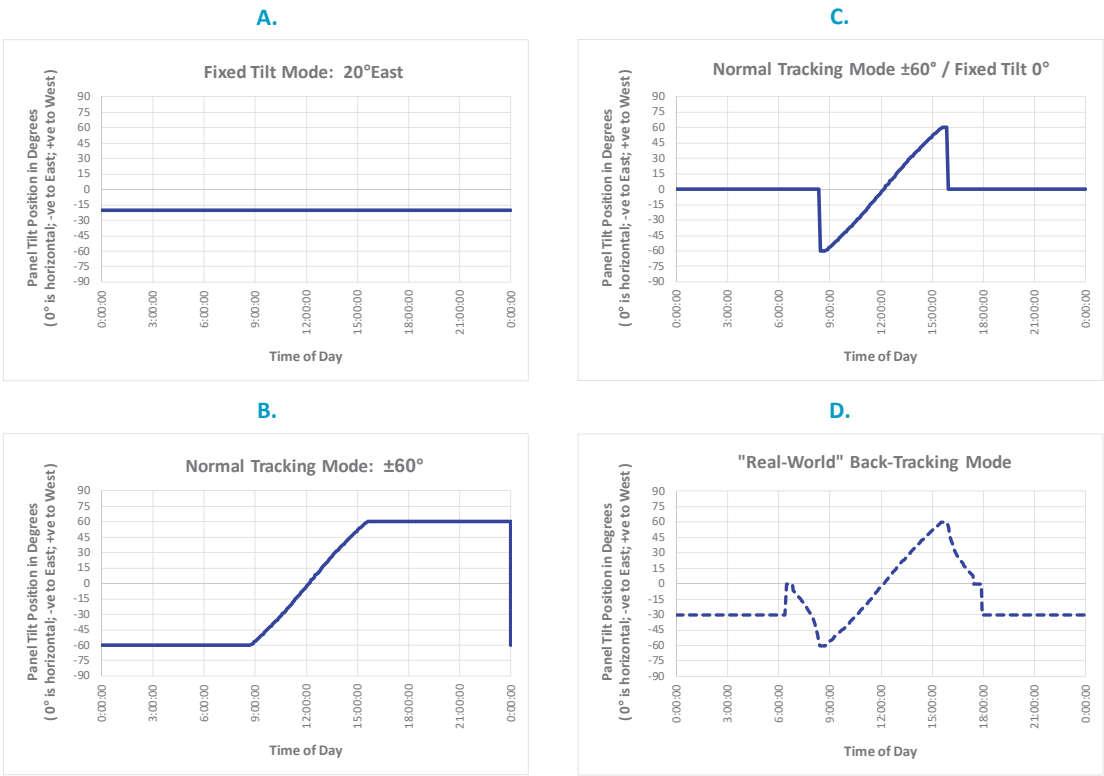
- “C”: Normal Tracking Mode / Fixed Tilt Stowed:** in this mode, panels move during the day in “normal tracking”: mode, but then move (instantaneously) to any user-defined fixed tilt angle at all other times, eg 0° (horizontal);

- “D”: “Real-World Back-Tracking”:** in this mode, panels move during the day in “normal tracking”: mode, but then gradually move to a horizontal position, thereby minimising shading of one panel array from adjacent arrays – the example shown is from an operating Solar Farm.

Figure 10 Single-Axis Tracking Mode Options

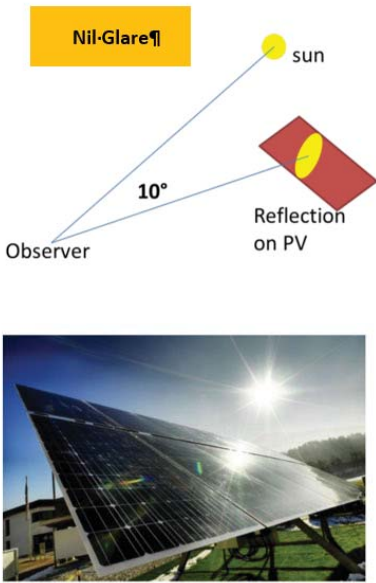
Figure 11 Nil Glare Condition for Residential Nuisance Glare

- If the angle difference between an incoming reflection and its originating solar ray is less than 10°, this condition cannot be considered “glare”.

This condition is shown in Figure 11.

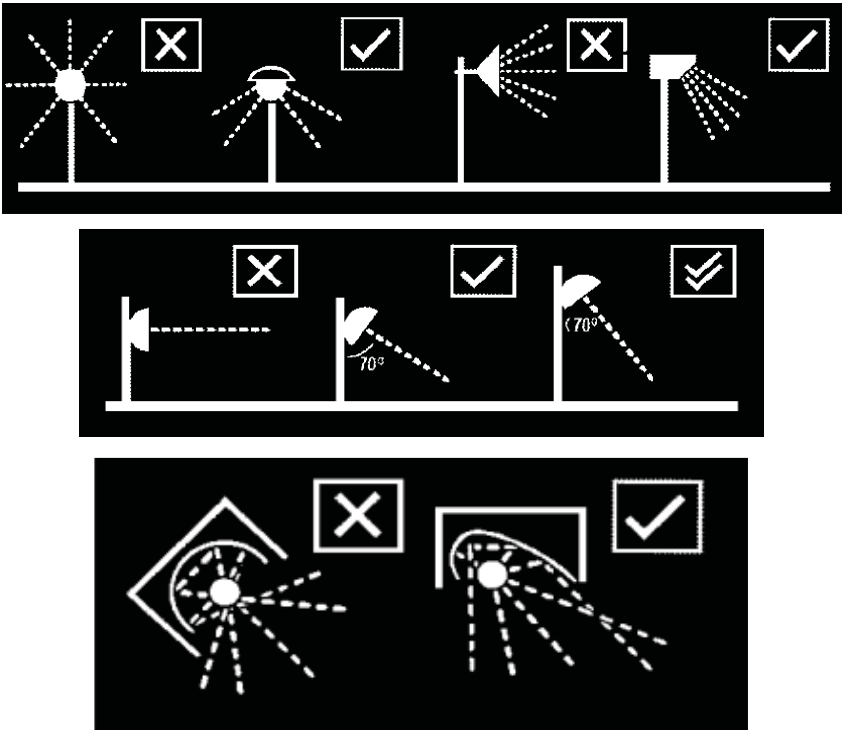
Figure 12 Luminance Design Features that Minimise Light Spill

Recommendations have been made to ensure that the potential for any future possible night-time illumination glare will be non-existent.
