Site Environmental Management Plan (SEMP)

Merritts Mountain House Restaurant Services Upgrade

Thredbo Alpine Resort
Kosciuszko National Park, NSW

March 2022

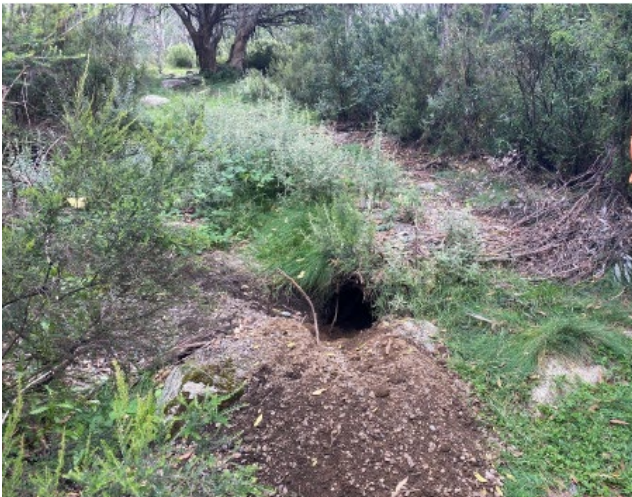
<p><i>Active wombat burrow between the existing UV building and Merritts Creek (Source: ELA 2022)</i></p> <p>Biosecurity</p> <ul style="list-style-type: none"> • prior to the commencement of construction works, all weed species identified within the construction corridor will be treated in accordance with best practice methods to ensure these weeds are not spread further within the site or throughout KNP; • project machinery and vehicles to arrive/depart from KNP and the Project site in a clean condition, free of mud and vegetative propagules and pathogens; • all vehicles and machinery entering Thredbo must adhere to the Standard Operating Procedure: Use and Maintenance of Wash Down Bay, March 2019 (KT055) which requires all vehicles and machinery to utilise the weed wash-down bay prior to entering site to ensure no new weed seeds are introduced to the site and KNP; • machinery to be regularly maintained and manoeuvred to prevent the spread of weeds and pathogens; • storage of plant and machinery is to be restricted to the designated disturbed areas within the construction corridor; and • follow up weed control to be carried out if deemed necessary.

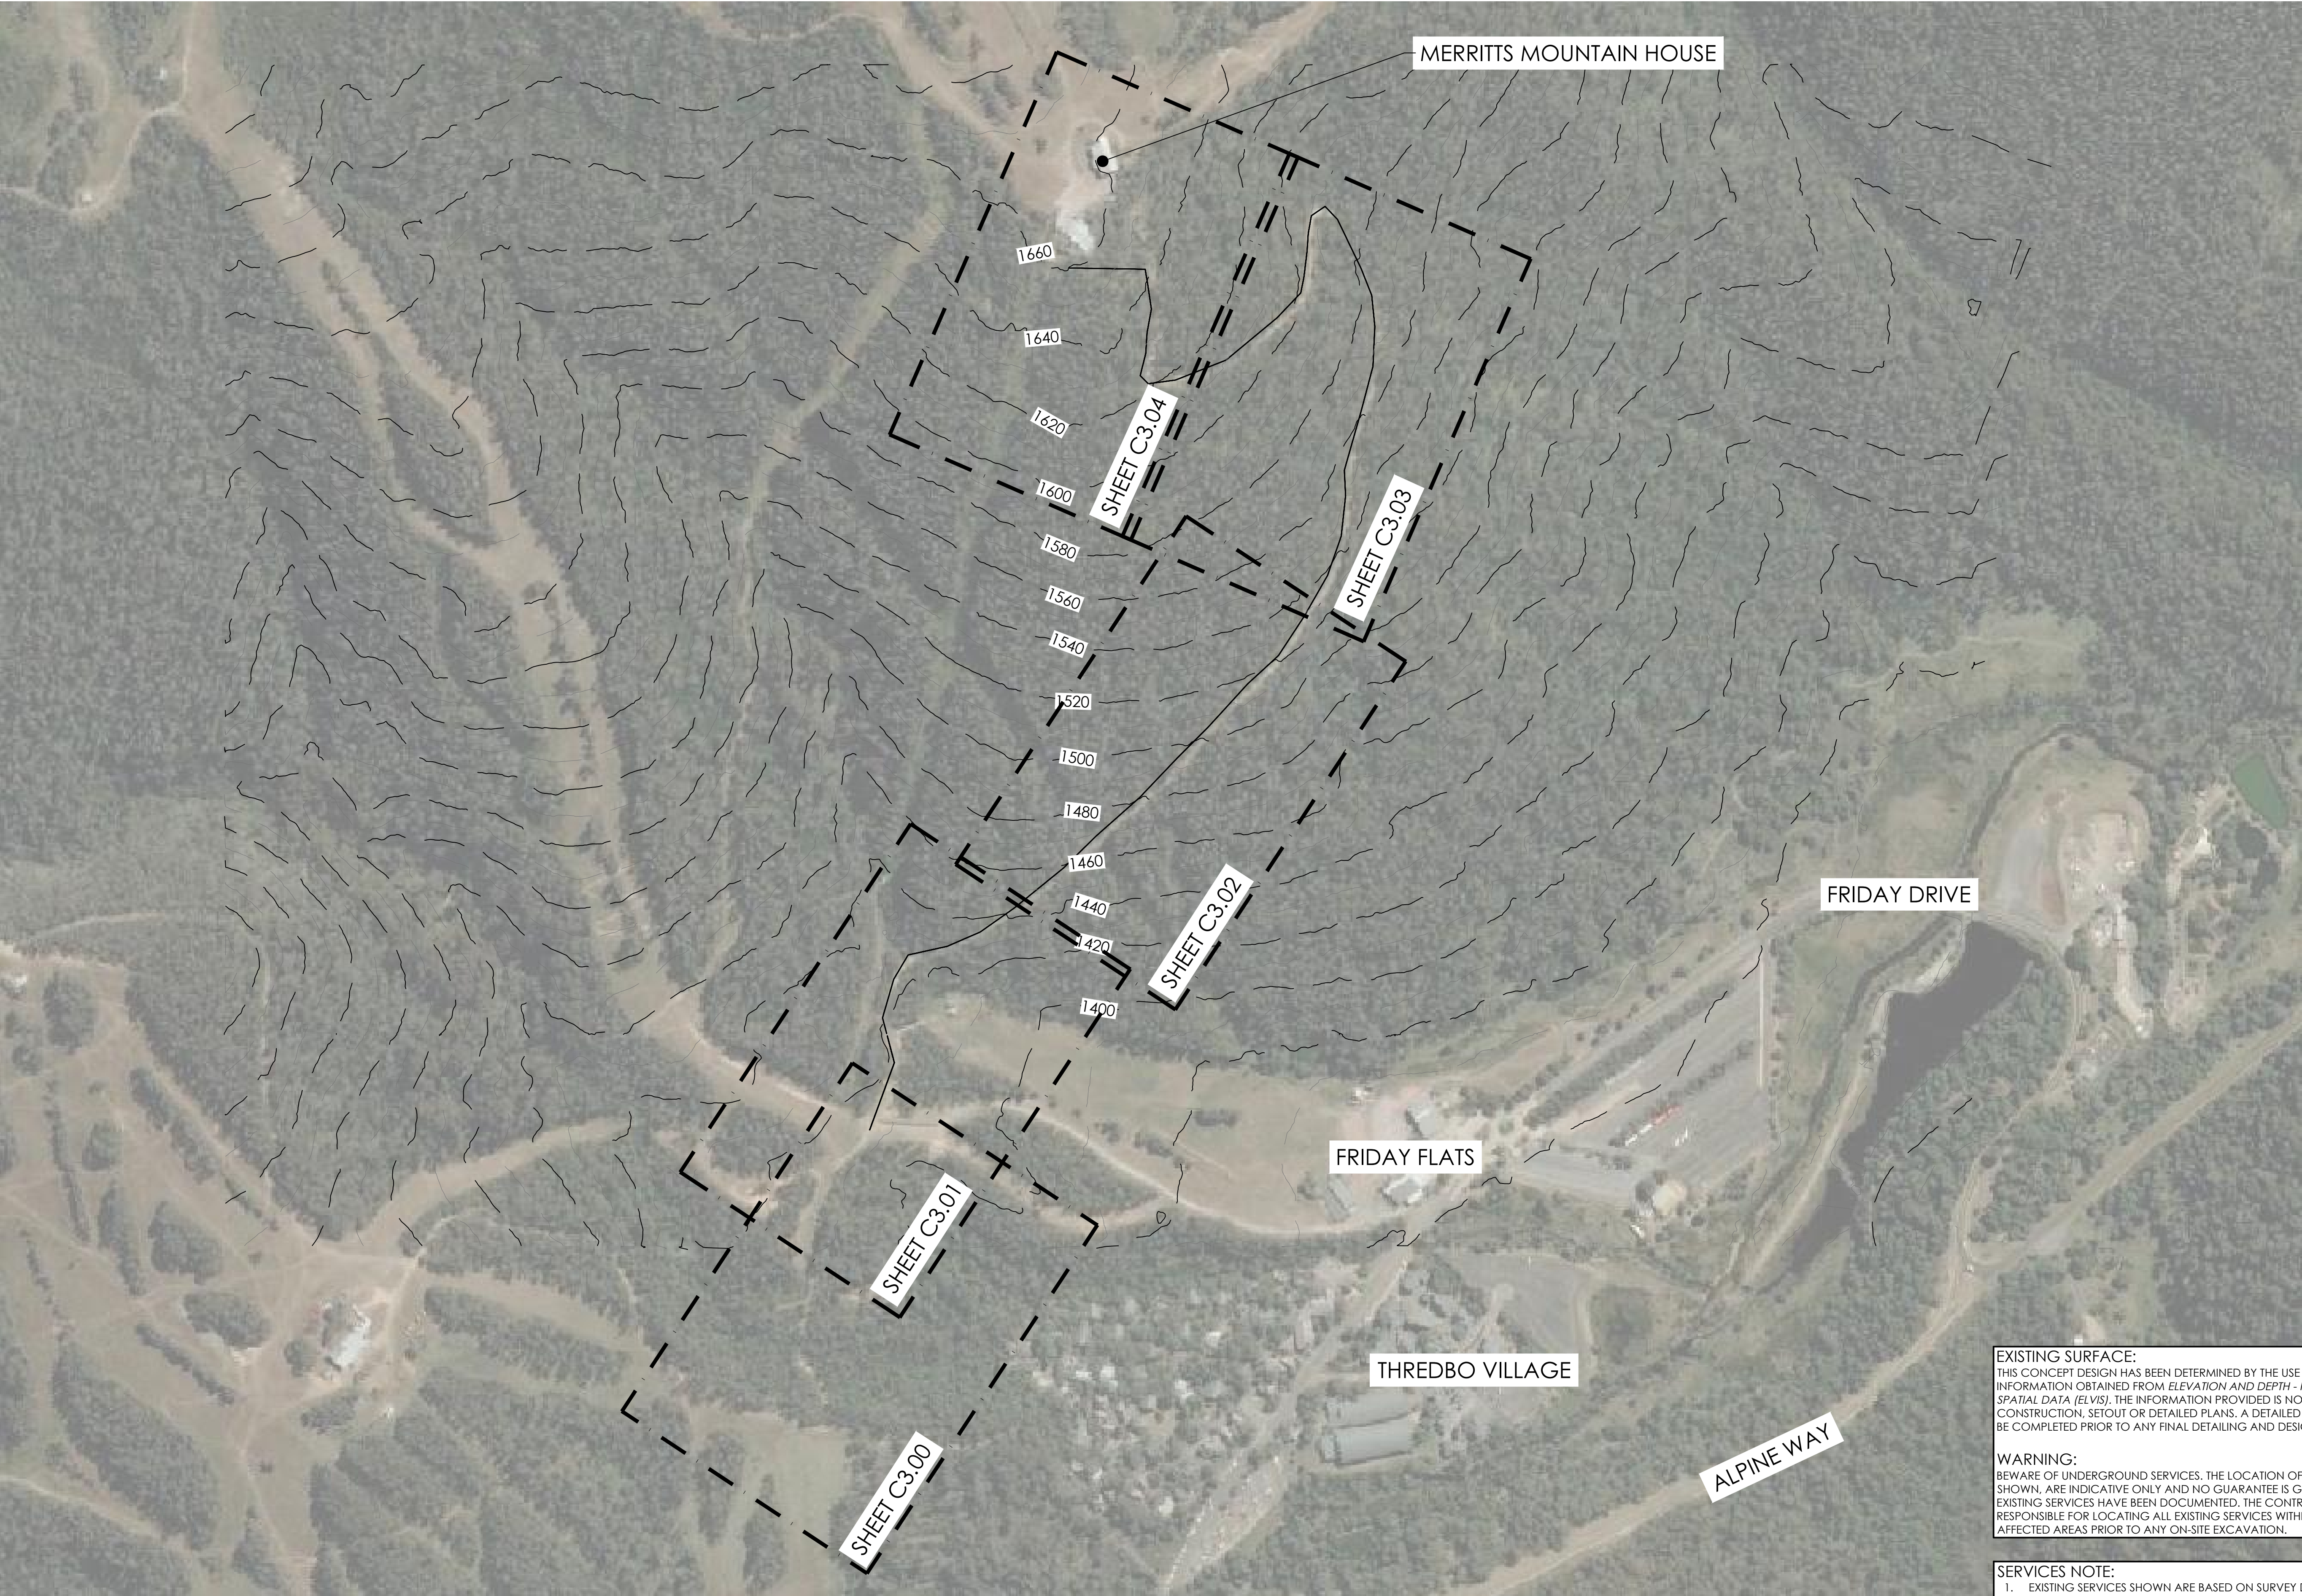
KEY PLAN
N.T.S.

SYMBOL	DESCRIPTION
	CONTOUR MAJOR (5m)
	CONTOUR MINOR (1m)
	PROPOSED ELECTRICAL CONDUIT 150mm NOM
	EXISTING SEWER (APPROX. LOCATION)
	SEWER PRESSURE - DN75 PE100 SDR11
	WATER SUPPLY - DN100 DICL PN35
	WATER LINE - RING MAIN

NOTE:
SUBJECT TO CONFIRMATION OF DETAILED HYDRAULIC ANALYSIS THE DN100 DICL PN35 WATER SUPPLY PIPELINE MAY TRANSITION TO HDPE TOWARDS THE UPPER ELEVATION OF THE PIPELINE

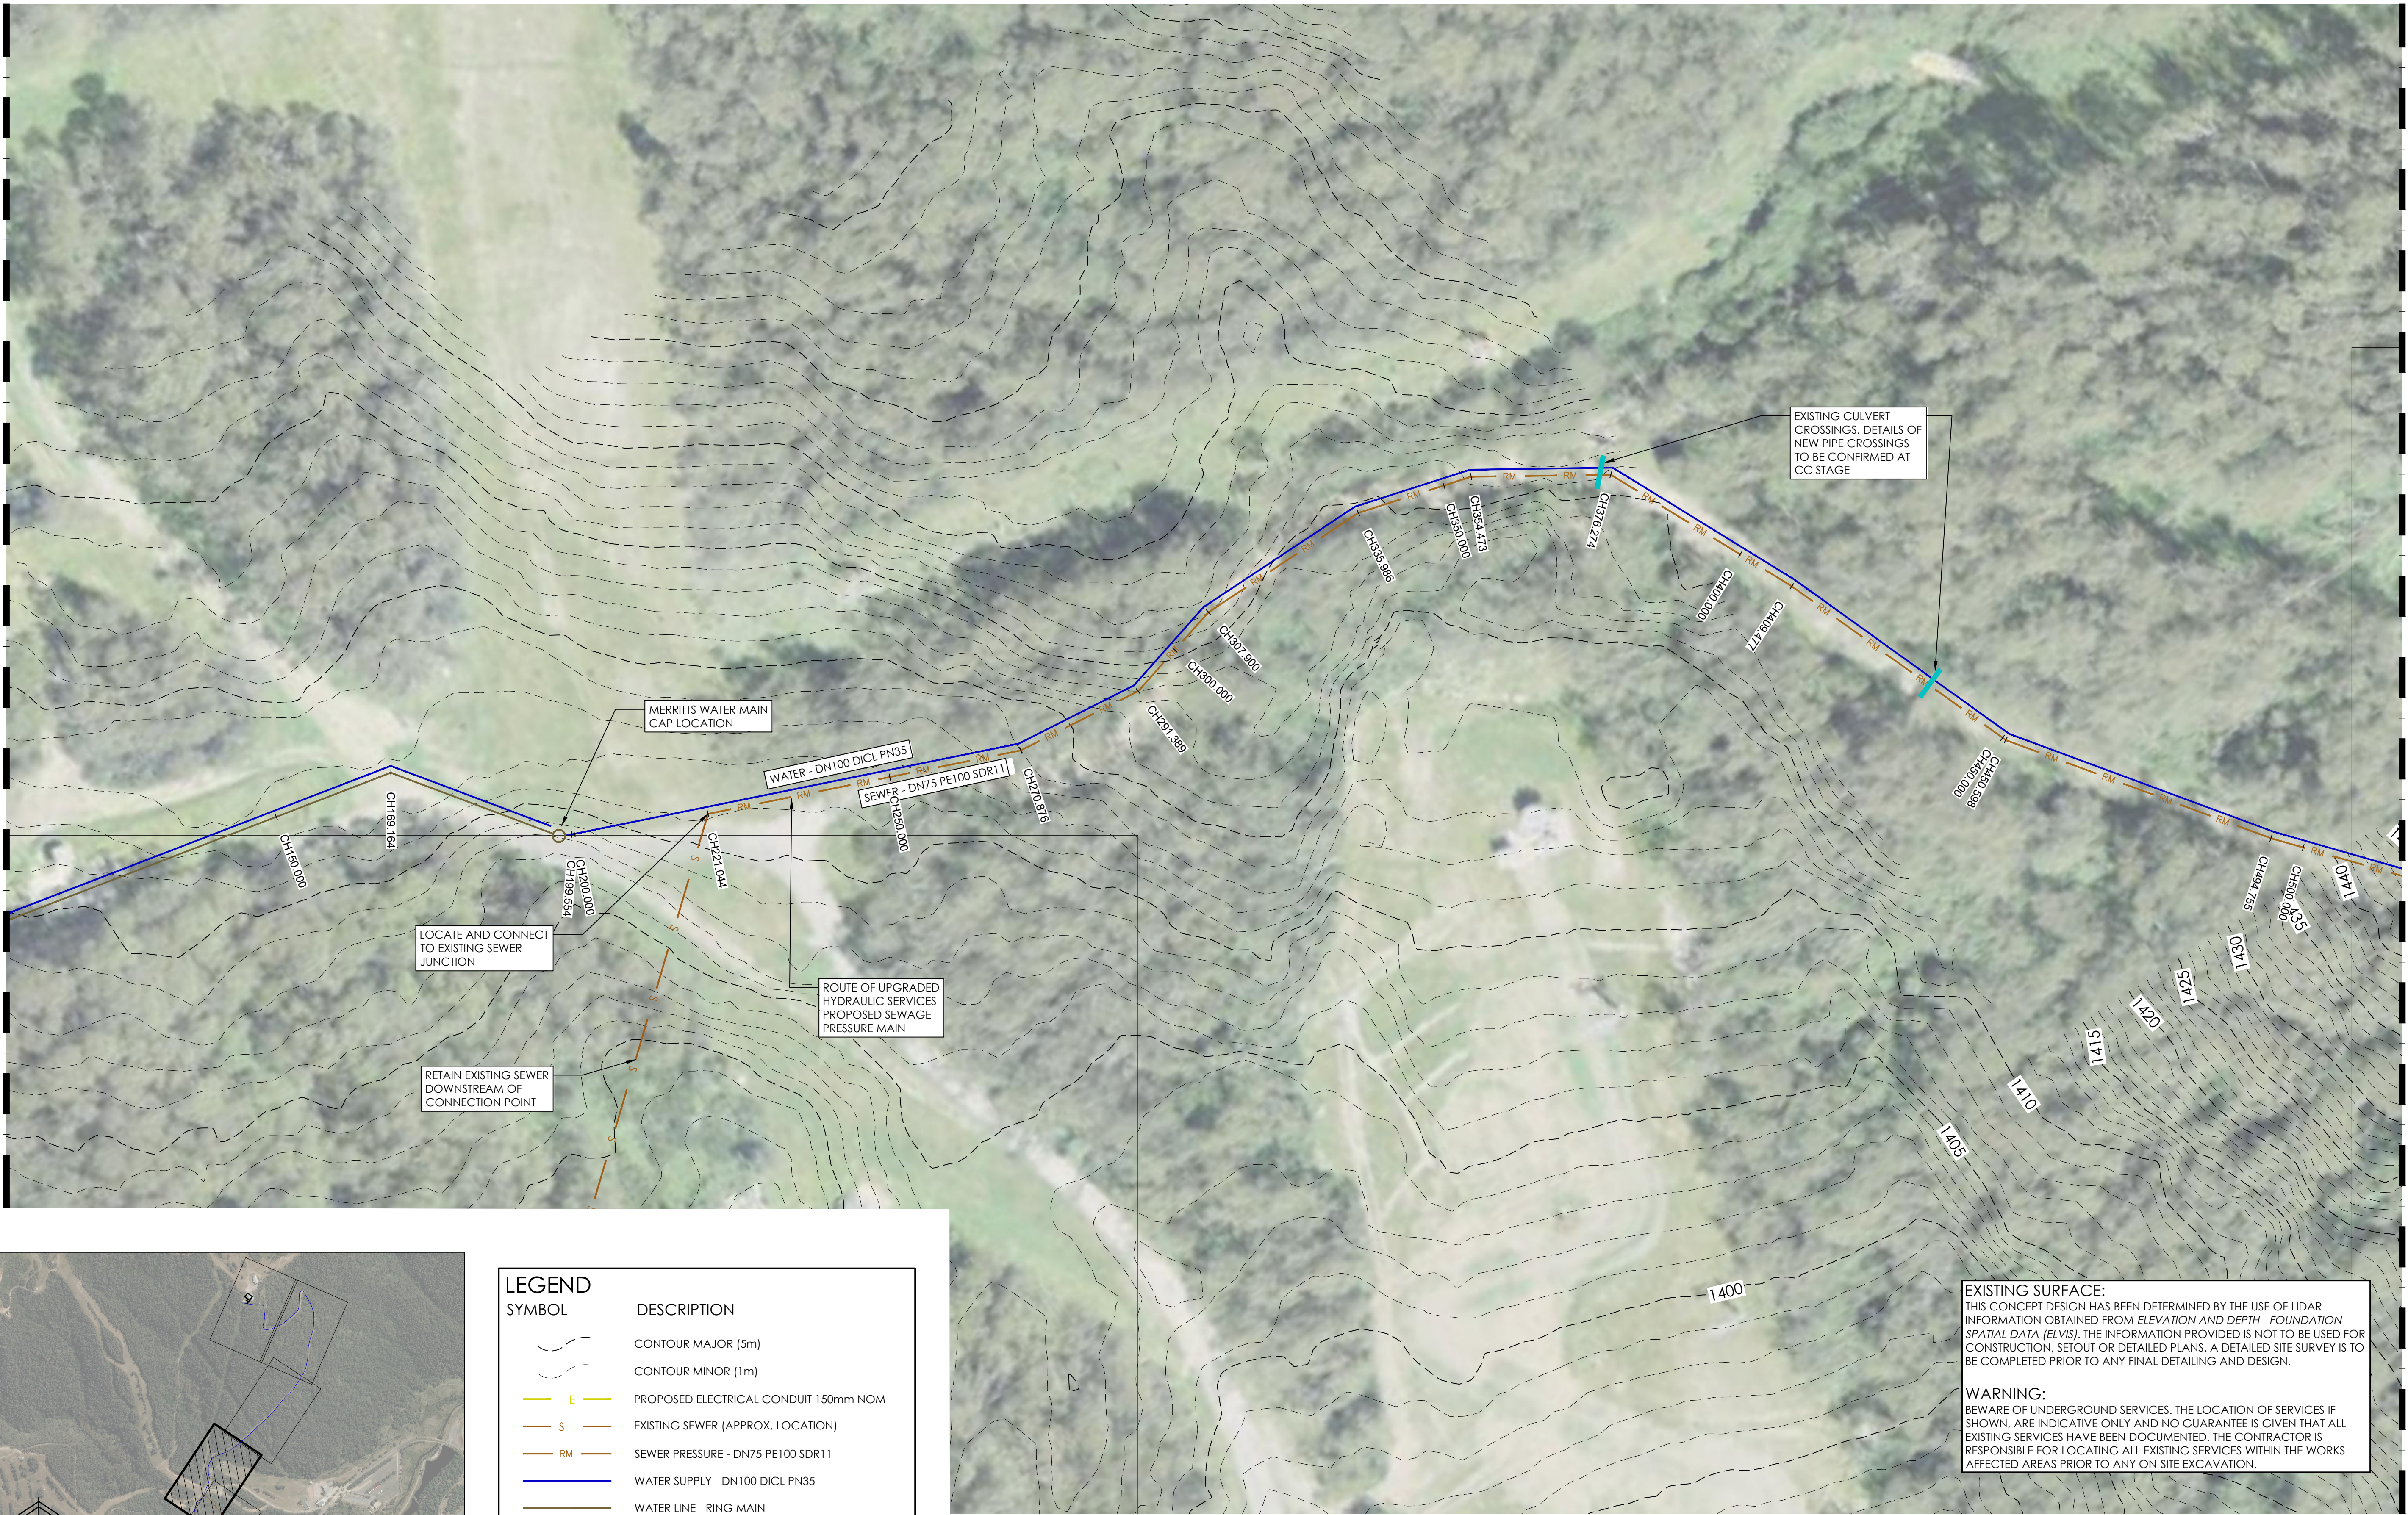
DRAWING TITLE
RIISING MAIN PLAN SHEET 2 OF 5

SYMBOL	DESCRIPTION
	CONTOUR MAJOR (5m)
	CONTOUR MINOR (1m)
	PROPOSED ELECTRICAL CONDUIT 150mm NOM
	EXISTING SEWER (APPROX. LOCATION)
	SEWER PRESSURE - DN75 PE100 SDR11
	WATER SUPPLY - DN100 DICL PN35
	WATER LINE - RING MAIN

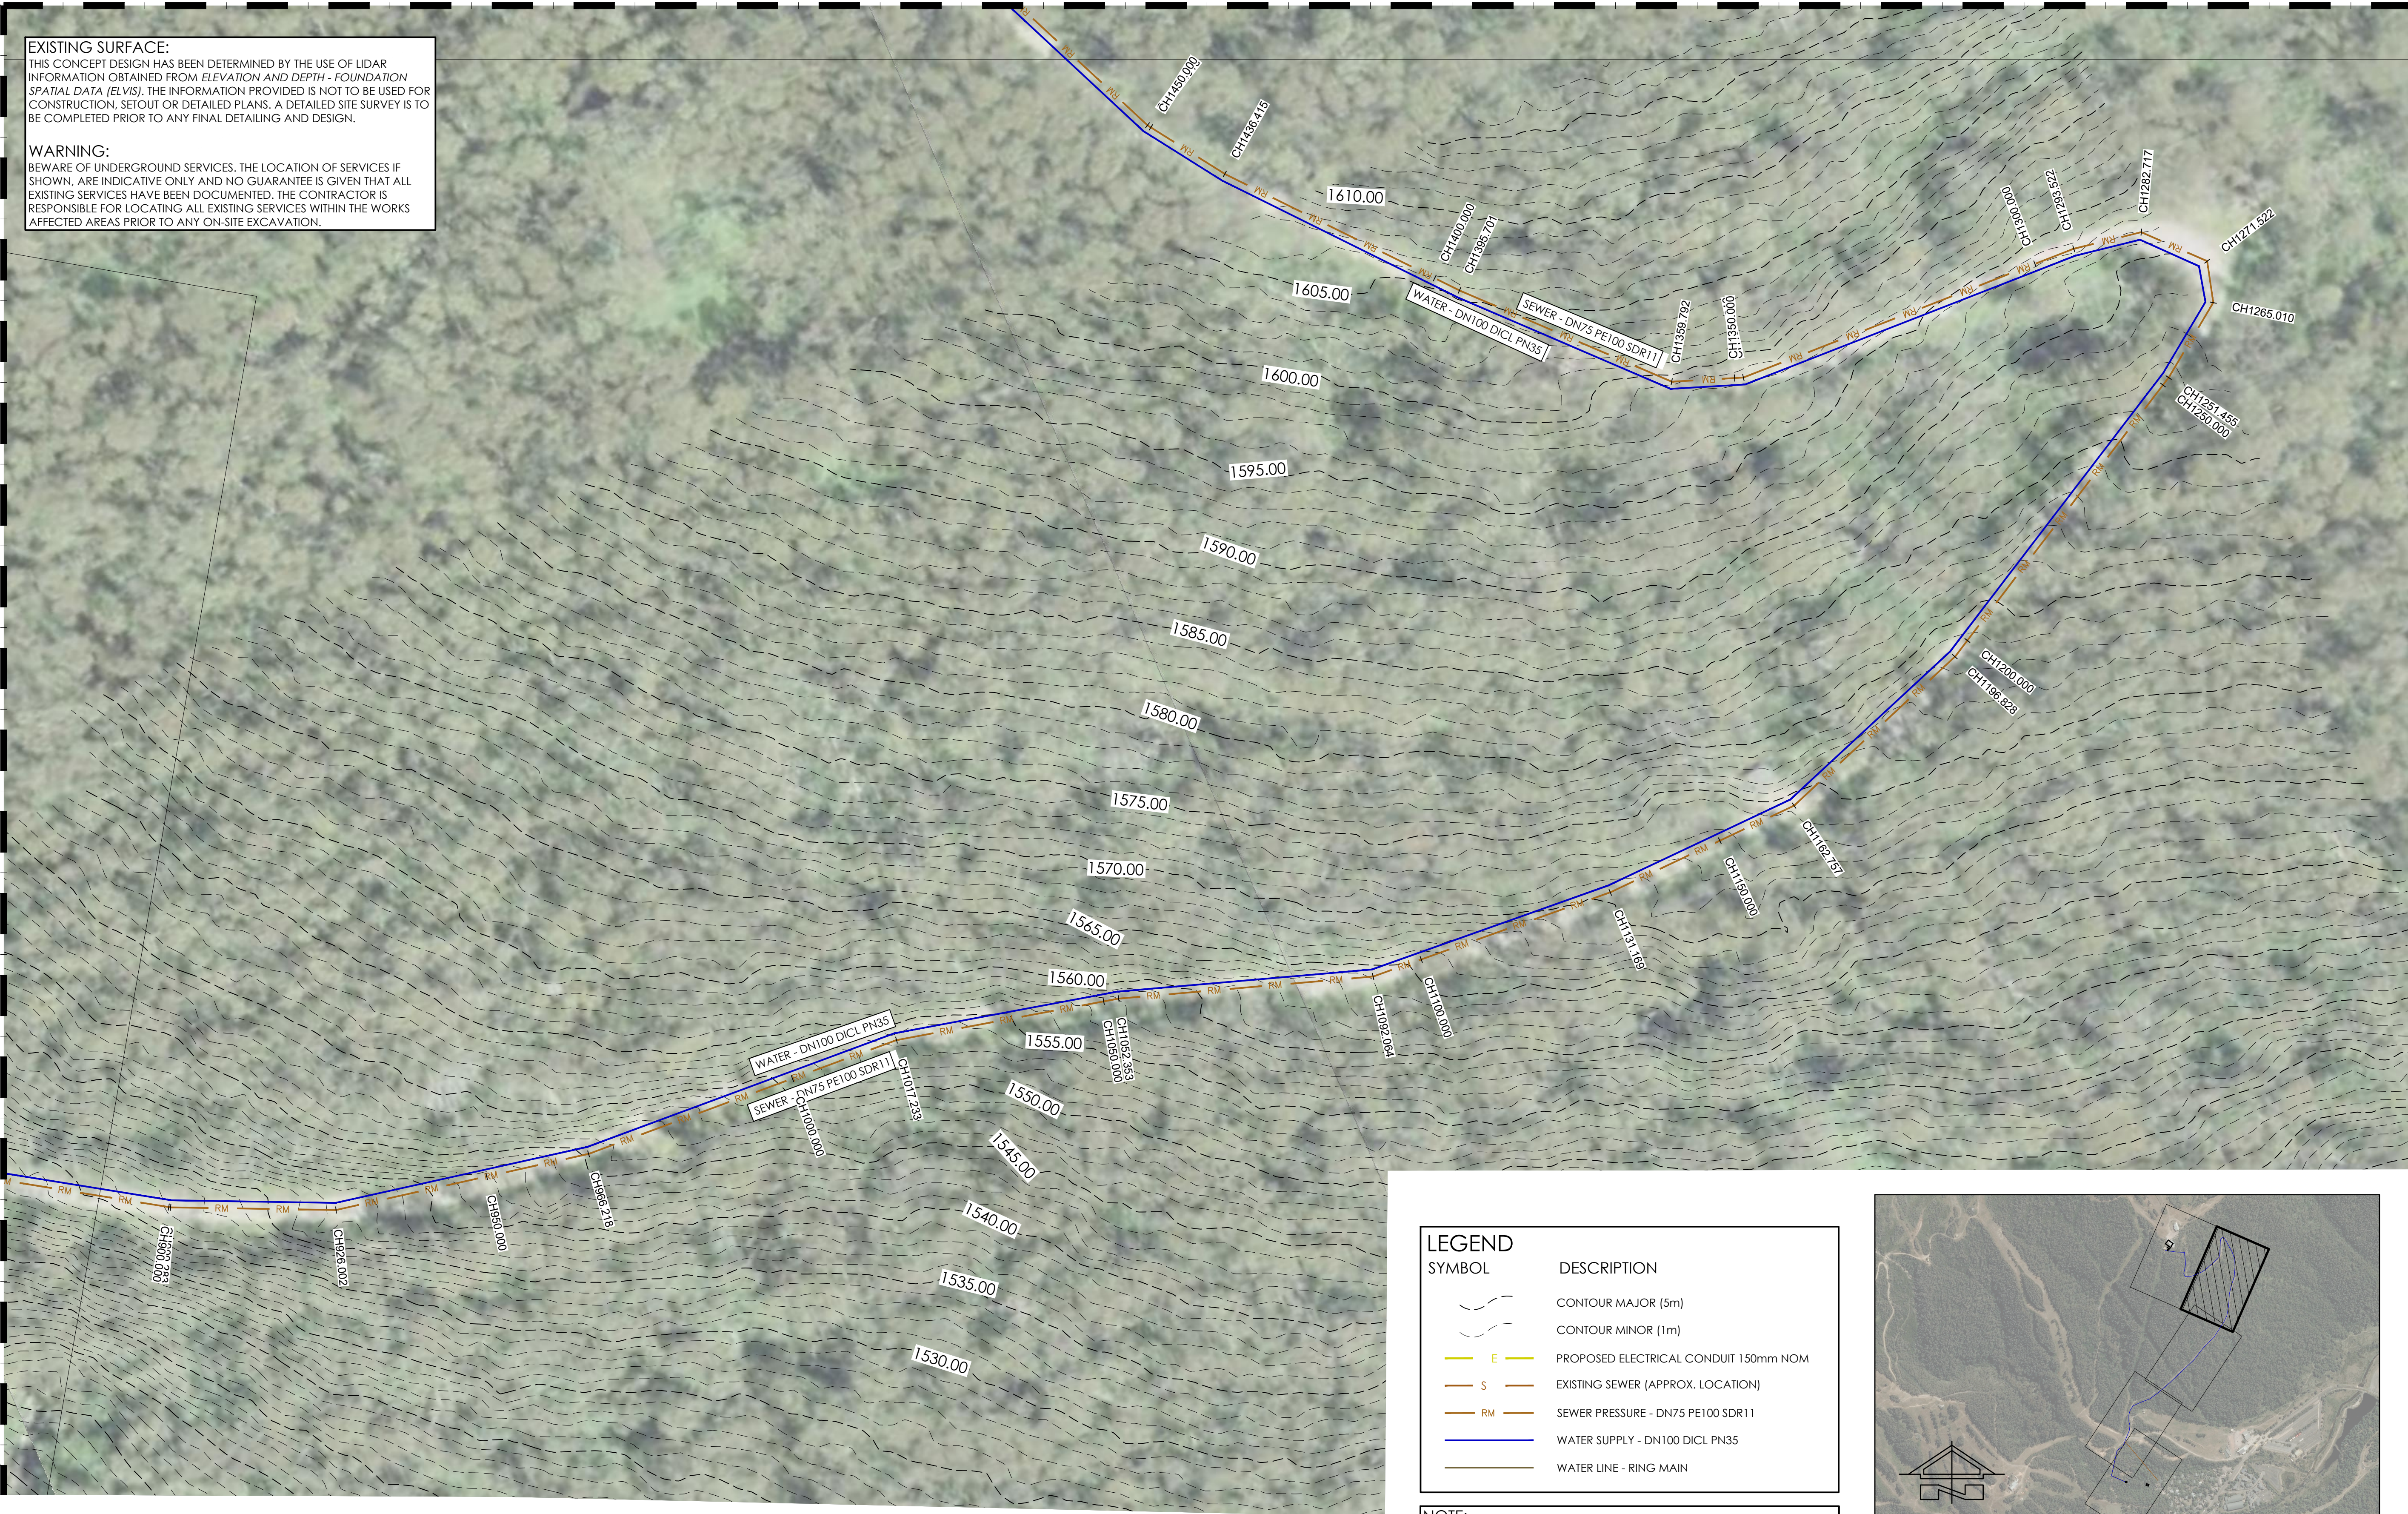
RIISING MAIN PLAN 4 OF 5
SCALE 1:500 AT A1

LEGEND	
SYMBOL	DESCRIPTION
	CONTOUR MAJOR (5m)
	CONTOUR MINOR (1m)
	PROPOSED ELECTRICAL CONDUIT 150mm NOM
	EXISTING SEWER (APPROX. LOCATION)
	SEWER PRESSURE - DN75 PE100 SDR11
	WATER SUPPLY - DN100 DICL PN35
	WATER LINE - RING MAIN

NOTE:
SUBJECT TO CONFIRMATION OF DETAILED HYDRAULIC ANALYSIS THE DN100 DICL PN35 WATER SUPPLY PIPELINE MAY TRANSITION TO HDPE TOWARDS THE UPPER ELEVATION OF THE PIPELINE

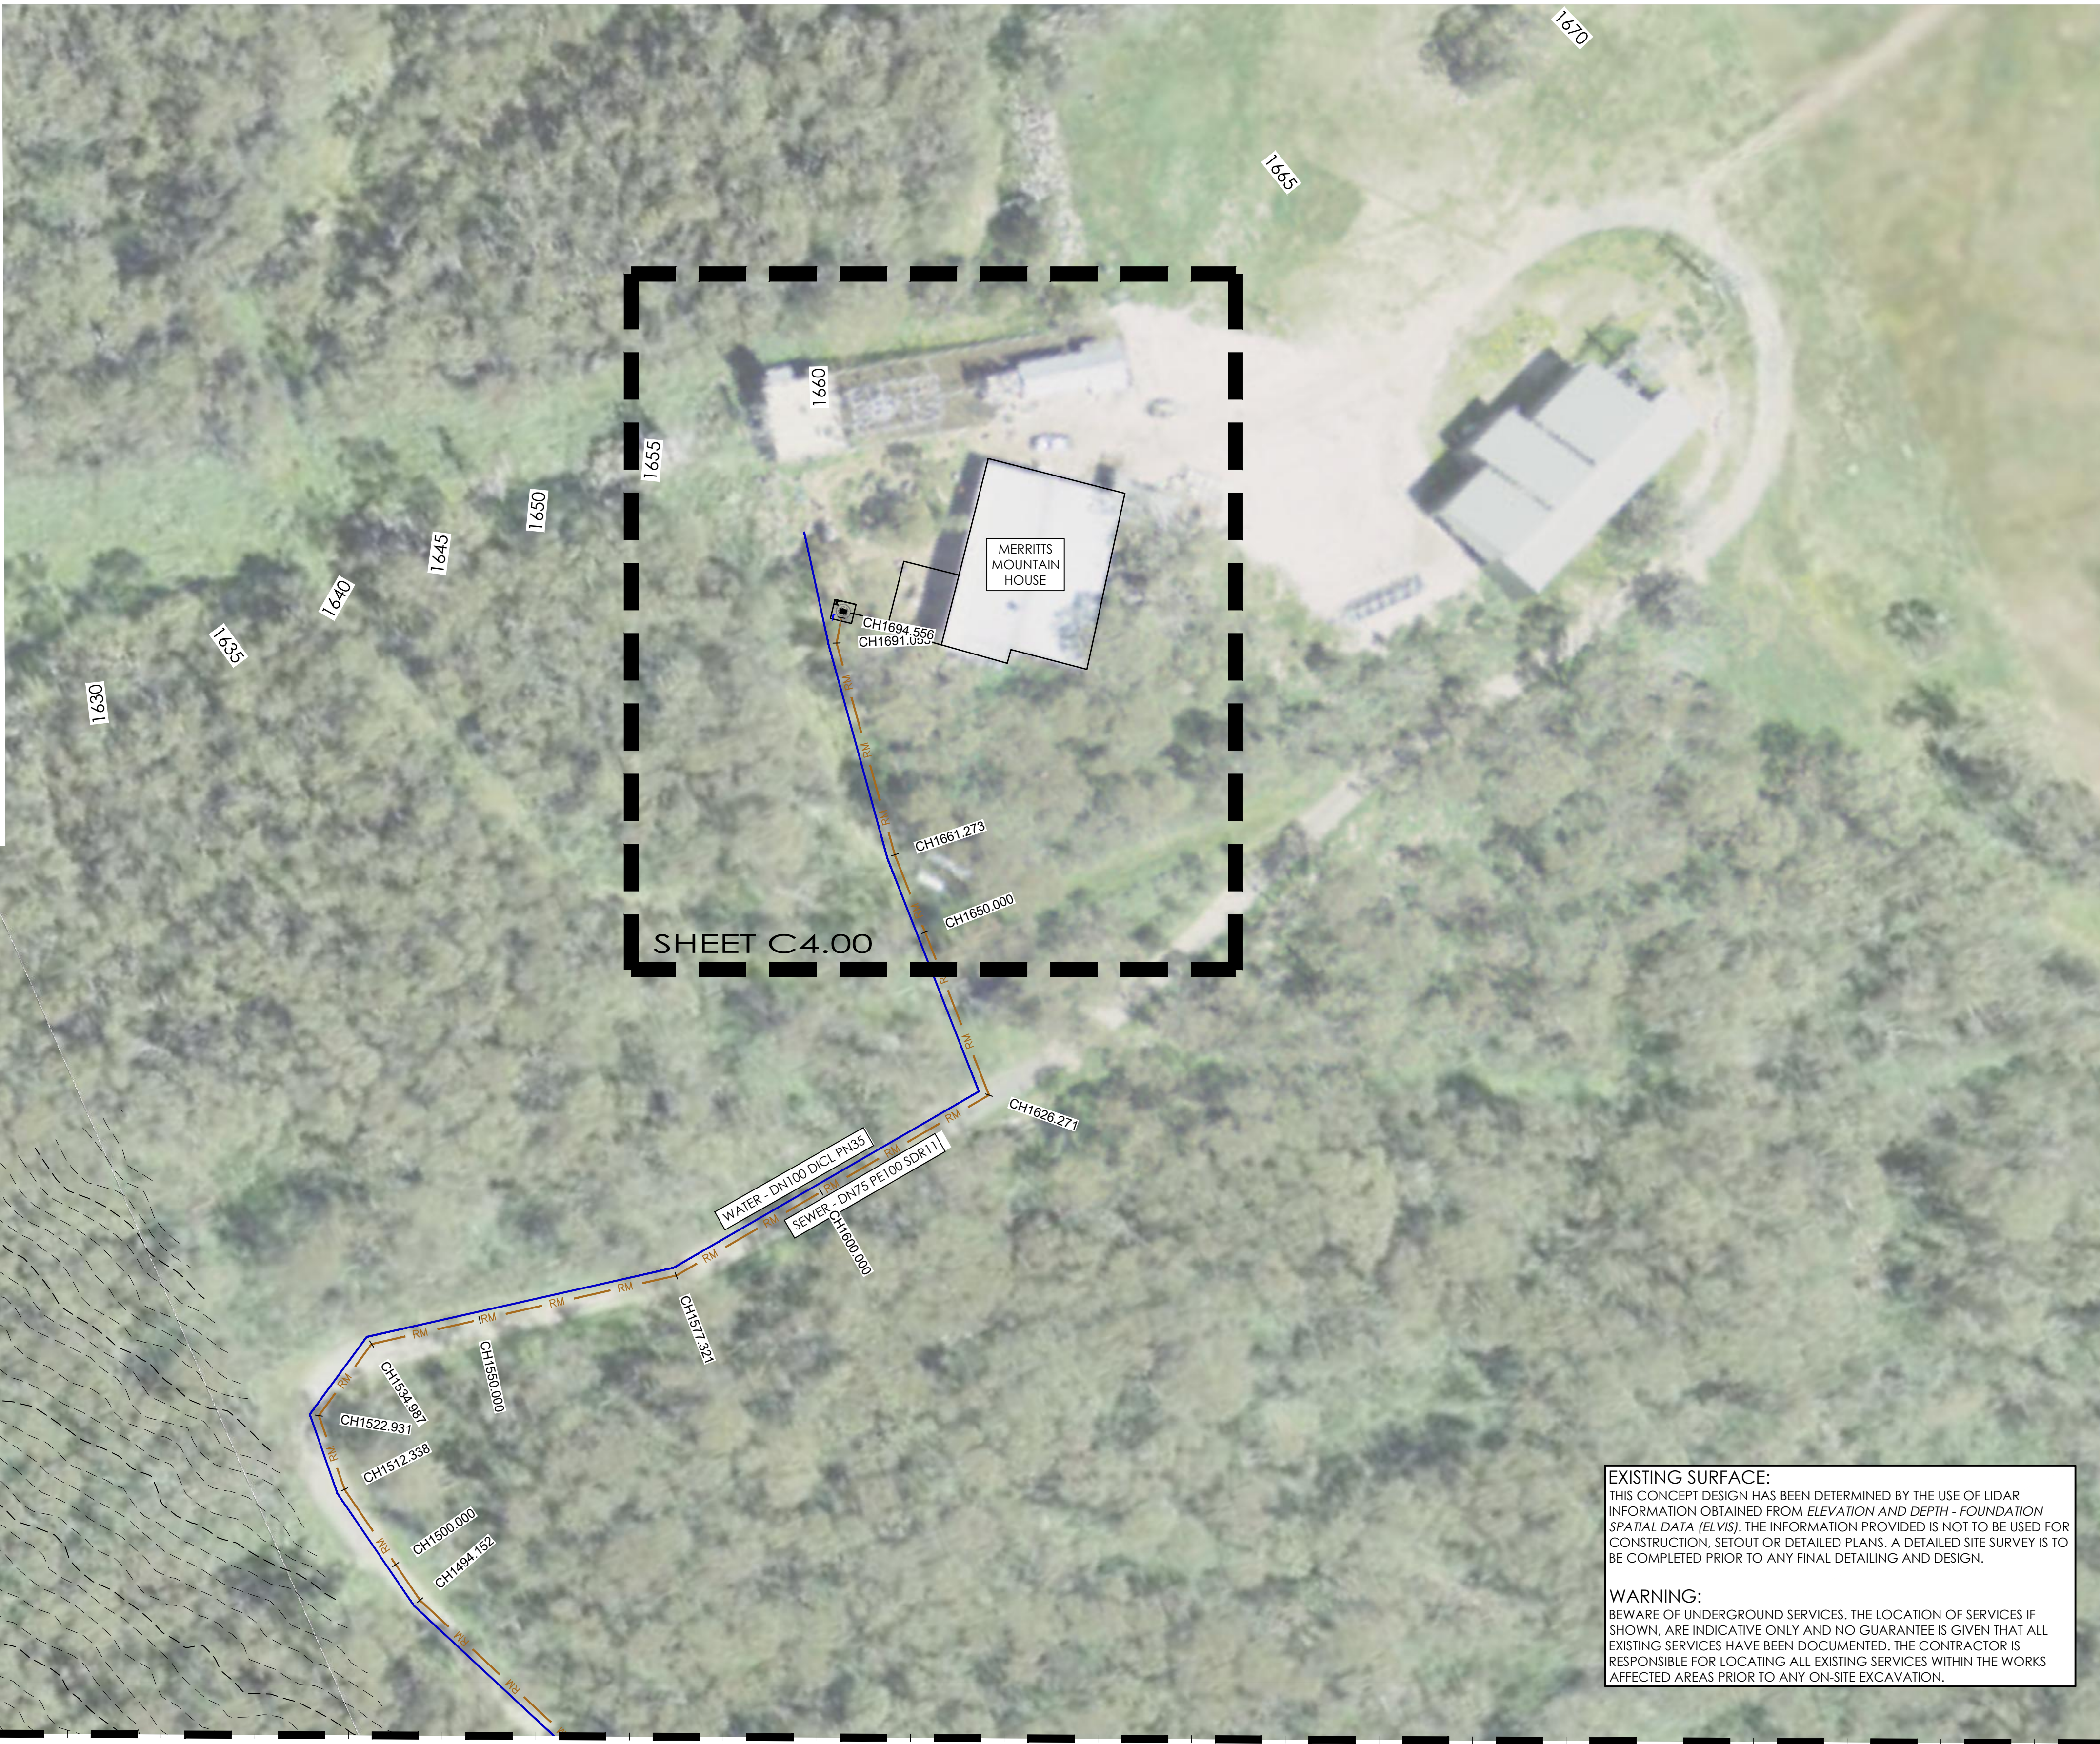
SYMBOL	DESCRIPTION
	CONTOUR MAJOR (5m)
	CONTOUR MINOR (1m)
	PROPOSED ELECTRICAL CONDUIT 150mm NOM
	EXISTING SEWER (APPROX. LOCATION)
	SEWER PRESSURE - DN75 PE100 SDR11
	WATER SUPPLY - DN100 DICL PN35
	WATER LINE - RING MAIN

NOTE:
SUBJECT TO CONFIRMATION OF DETAILED HYDRAULIC ANALYSIS THE DN100 DICL PN35 WATER SUPPLY PIPELINE MAY TRANSITION TO HDPE TOWARDS THE UPPER ELEVATION OF THE PIPELINE

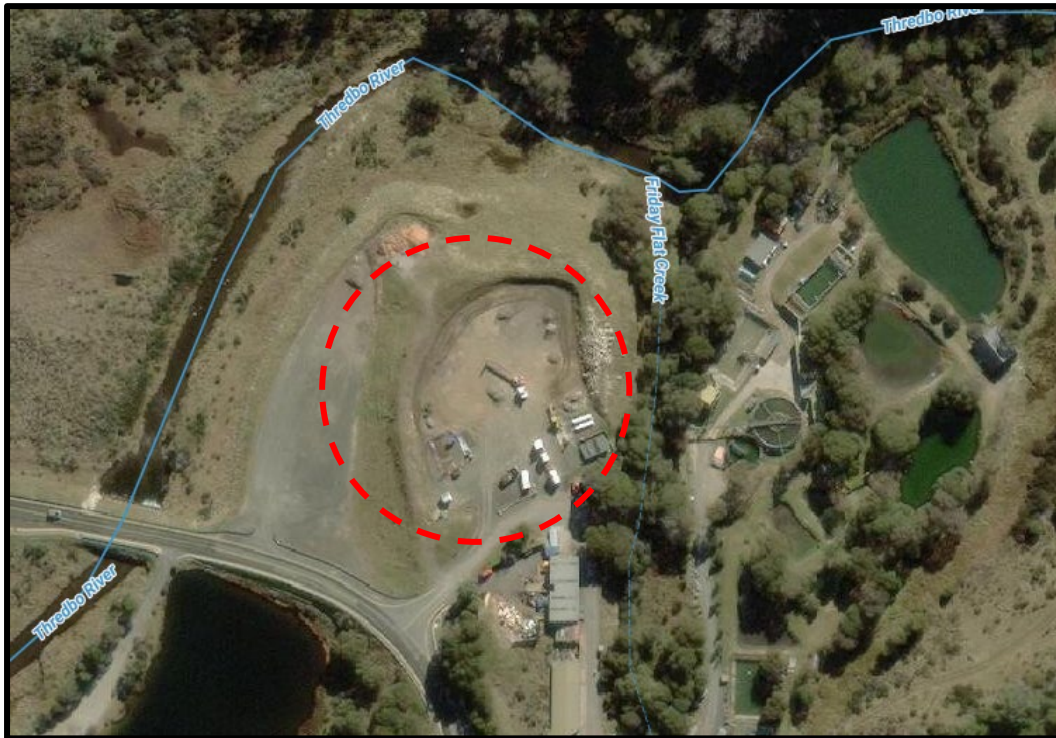
Main stockpile locations located at the carpark adjacent to the Thredbo Waste Transfer Station

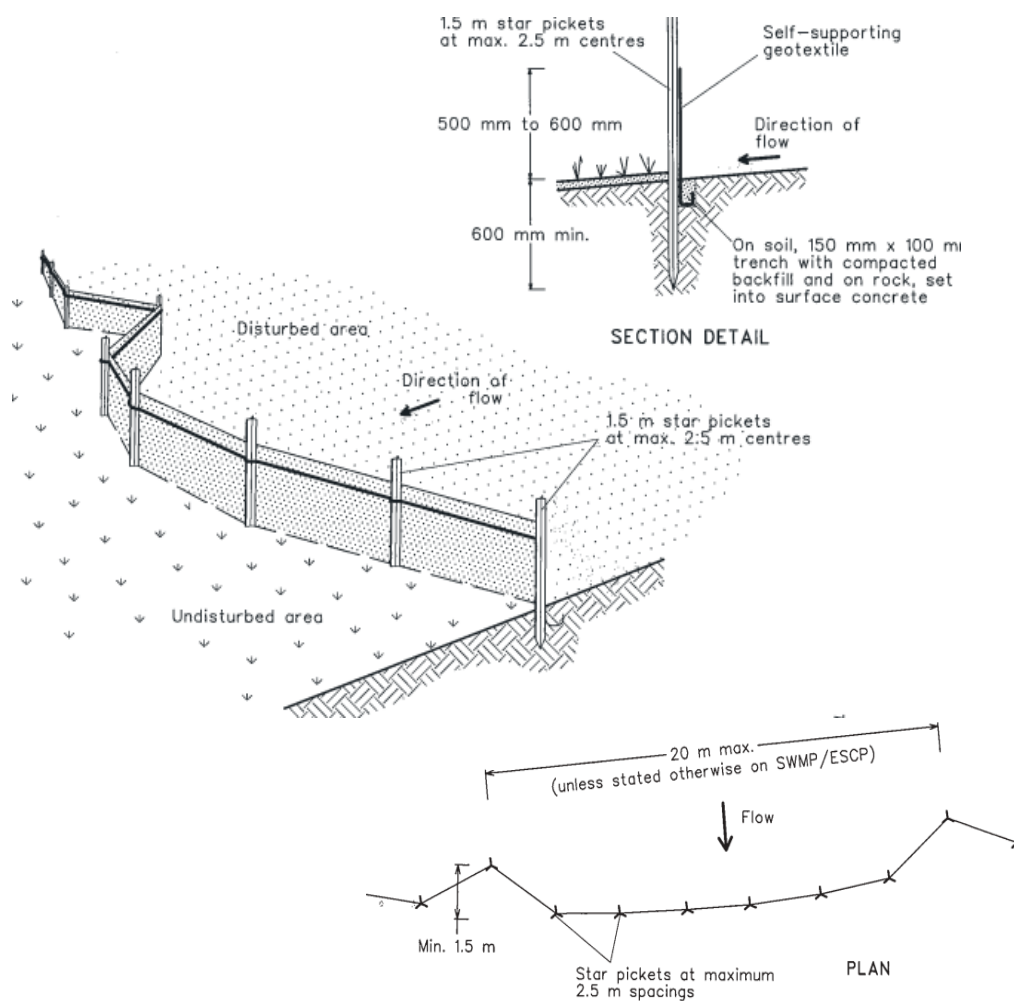
Standard Sediment Fence Installation (Source: Landcom 2004)

- 1) Construct sediment fences as close as possible to being parallel to the contours of the site, but with small returns to limit the catchment area of any one section. **The catchment area should be small enough to limit water flow if concentrated at one point to 50 L/s in the design storm event, usually the 10-year event.*
- 2) Dig a 150 mm deep trench along upslope line of fence for the bottom of the fabric to be entrenched.
- 3) Install 1.5 m long star pickets into ground at 2.5 m intervals (max) on the downslope edge of the trench. **Fit star pickets with safety caps.*
- 4) Fix geotextile to the upslope side of the posts ensuring it goes to the base of the trench.

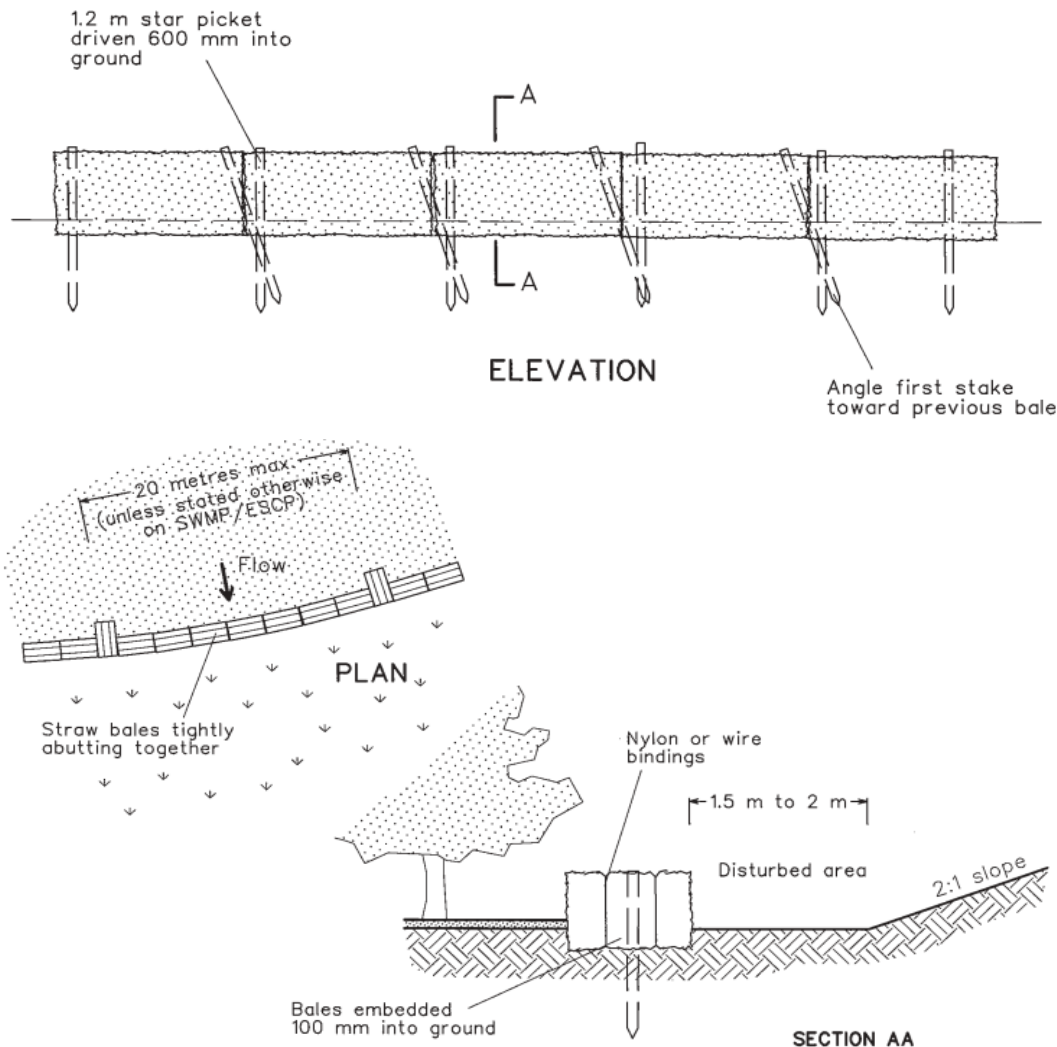
Standard Straw Bale Filter Installation (Source: Landcom 2004)

- 1) Construct the straw bale filter as close as possible to being parallel to the contours of the site.
- 2) Place bales lengthwise in a row with ends tightly abutting (1 bale = max height of filter). Fill gaps between bales with straw and wrap with geofabric where necessary.
- 3) Embed each bale in the ground 75-100 mm and anchor with two 1.2 m stakes/star picket. Angle the first stake in each bale towards the previously laid bale. Stakes should be driven 600 mm into ground, sitting flush with top of bale (if possible). **If using star pickets which protrude above bales, fit with safety caps.*
- 4) Where a straw bale filter is constructed downslope from a disturbed batter, ensure the bales are placed 1-2 m downslope from the toe.

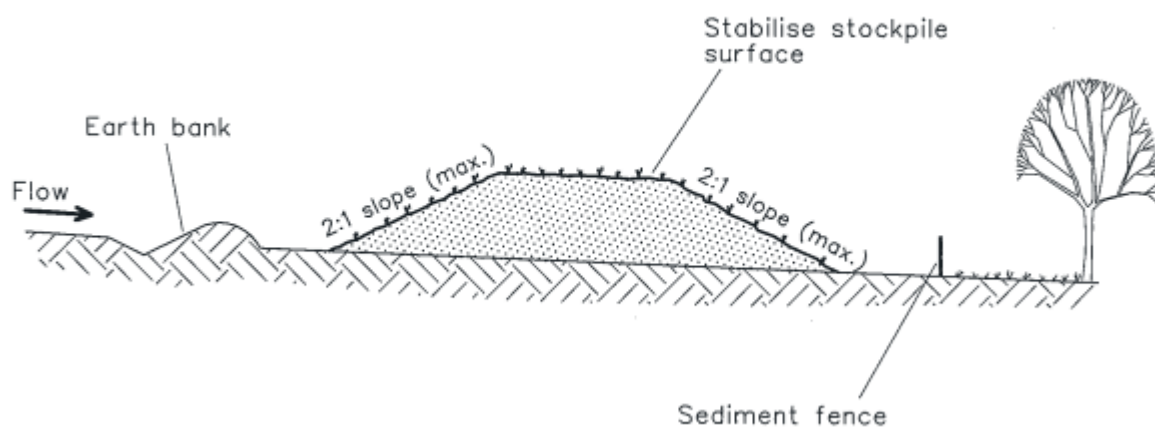
Stockpile Management (Source: Landcom 2004)

- 1) Stockpiles should be located at least 2 m (preferably 5 m) from existing vegetation and waterbodies, concentrated water flows, roads and hazard areas. Recommended location within weed free, disturbed area if possible.
- 2) Construct stockpiles as low, flat mounds (<2 m high) with a slope <50% (26°).
- 3) Install appropriate sediment controls (e.g. sediment barriers 1-2 m downslope) around stockpiles.
 - It is recommended to cover stockpiles (e.g. with anchored geofabric) during strong wind or high rainfall events.
 - Straw bales used for sediment and erosion control must be certified weed free.
