Statement of Environmental Effects

Cruiser Beginner Mountain Bike Trail and Parks

Thredbo Alpine Resort Kosciuszko National Park, NSW

September 2022

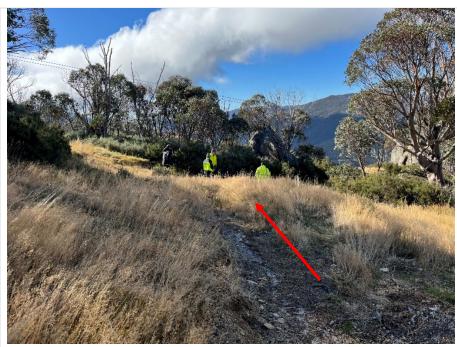
The Trail then crosses the Mountain access road into a berm. Riders will be able to either continue on the Trail or chose to take the link trail.

Trail to follow predominately disturbed area, into native vegetation island (facing east)

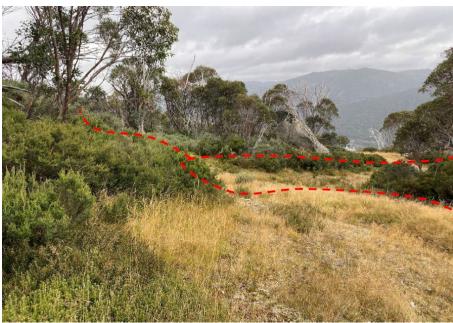
The berm takes advantage of an existing disturbed area (Source: Smithers 2022)

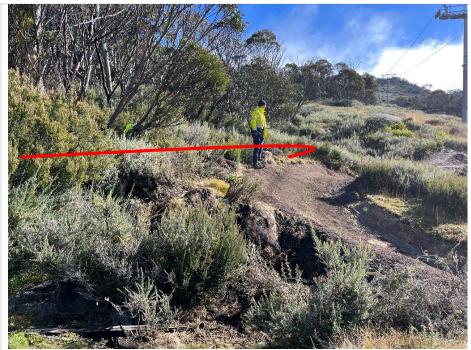
Link trail
A link trail (approx.
20 m long) diverts
before the berm
(through native
vegetation island)
onto the existing
Upper N4 trail
(facing east).

Linking trail will depart native vegetation island onto existing Upper N4 trail (looking uphill)

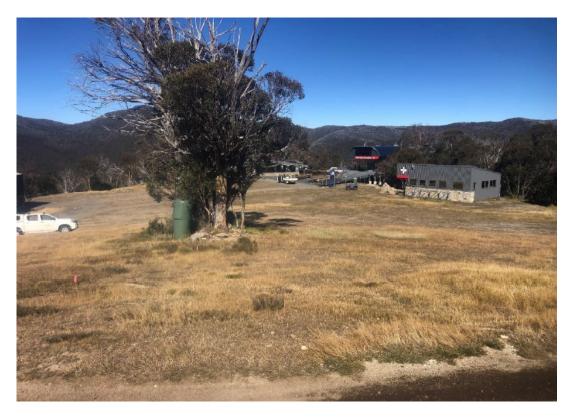
Figure 6: Beginner Skills Park Location (Smithers 2022)

The Skills Park will incorporate a series of features to provide introductory skills suitable for negotiating trails within the Cruiser bike park, such as fun boxes, seesaws, berms (**Figure 7**) and rockeries.

The Skills Park (refer Figure 6) is accessible via the existing Upper N4 trail

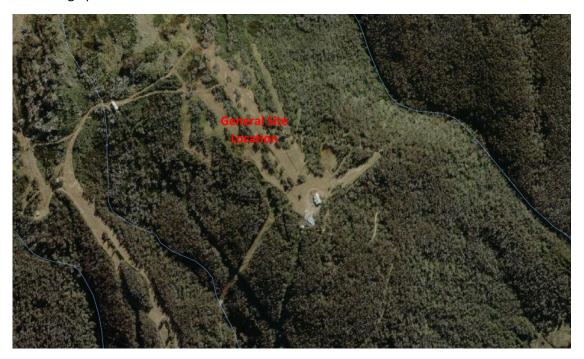
Figure 8: Watercourses within proximity of the Project site (Source: NSW Government 2022d)

Surface water diversion is an important component of trail construction. If not managed appropriately, water run-off could result in erosion of the trail surface and pooling of water resulting in soft boggy conditions for riders.

During construction appropriate drainage controls will be implemented to divert and/or manage stormwater run-off entering and leaving the site. The incorporation of rolling contours, grade reversals and outsloping the trail will minimise the potential impacts associated with surface water run-off during operation of the trail.

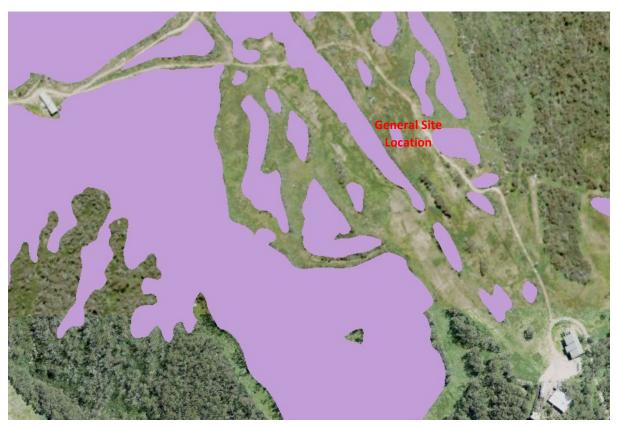
Figure 10: Biodiversity Values Map (NSW Government 2022b)

A review of the BVM and Threshold Tool was undertaken on 13 May 2022 which identified a portion of the Project site is located within an area mapped on the BVM (**Figure 10**).

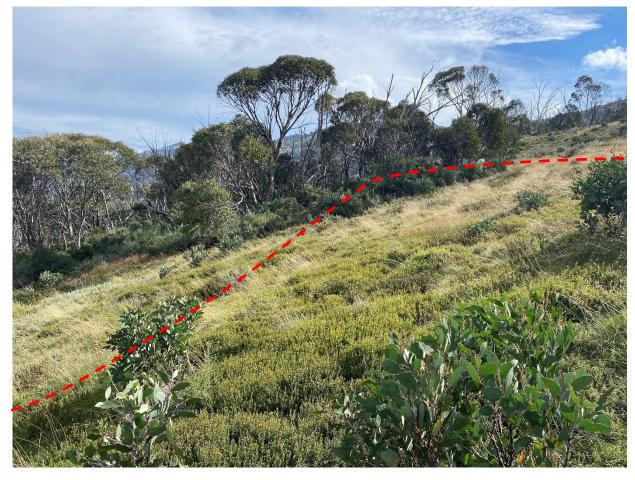
Photo 4: After diverting from the existing All Mountain Trail at its most southerly point on the edge of Ballroom Ski Run, the trail goes into a berm on the margins of a tree island.

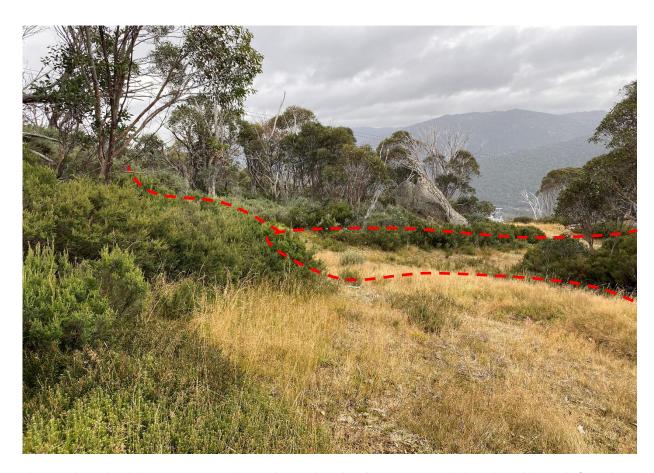
Photo 7: The trail includes an approximately 20 m long Link Trail to the Upper N4 trail. The Link Trail diverts before a berm on the Beginner Trail which takes advantage of disturbed area.
