GUTHRIE'S DOUBLE CHAIR LIFT CHARLOTTE PASS SNOW RESORT

GEOTECHNICAL INVESTIGATION REPORT

MAY 2021

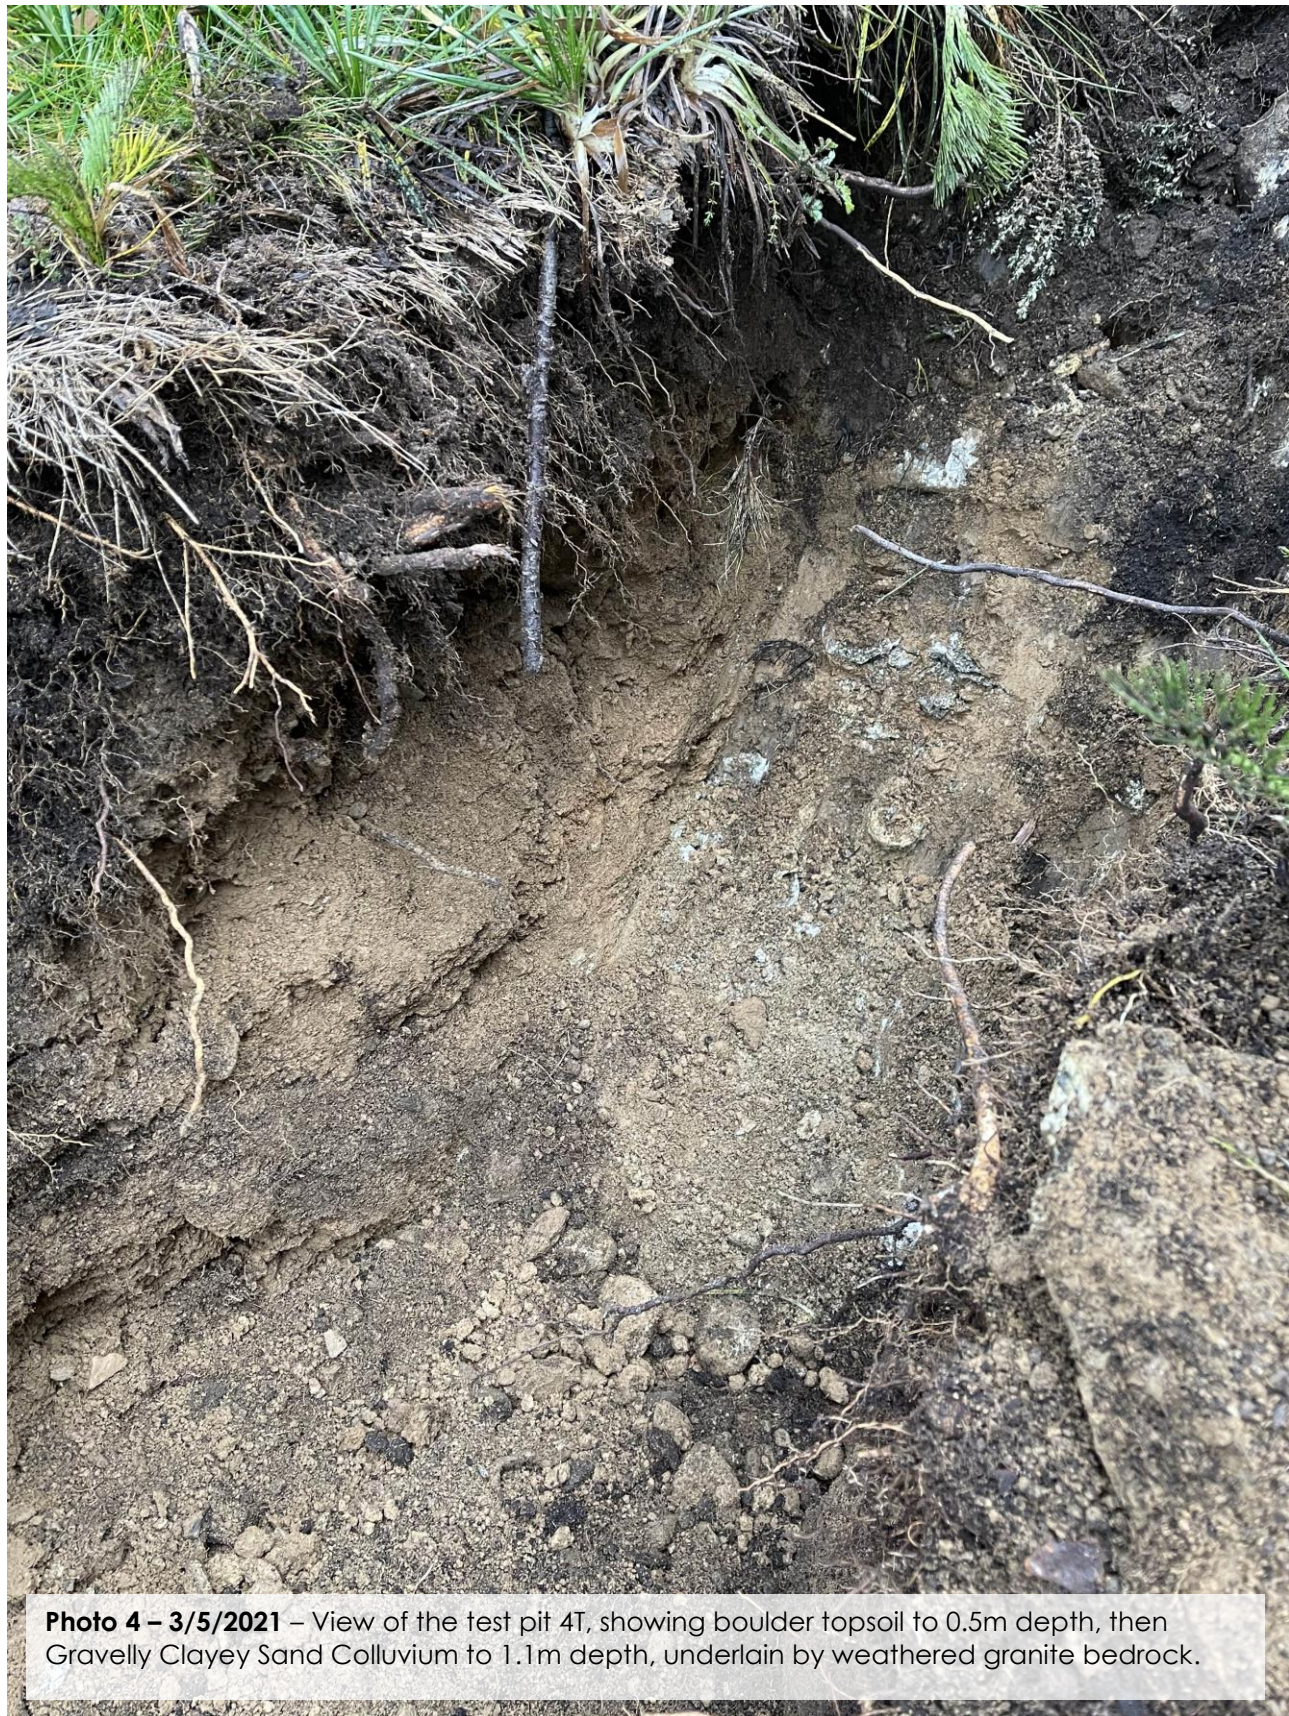
FIGURE 8

Photo 4 – 3/5/2021 – View of the test pit 4T, showing boulder topsoil to 0.5m depth, then Gravelly Clayey Sand Colluvium to 1.1m depth, underlain by weathered granite bedrock.
