# **ACT Geotechnical Engineers Pty Ltd**

## **GUTHRIE'S DOUBLE CHAIR LIFT CHARLOTTE PASS SNOW RESORT**

**GEOTECHNICAL INVESTIGATION REPORT**

**MAY 2021**

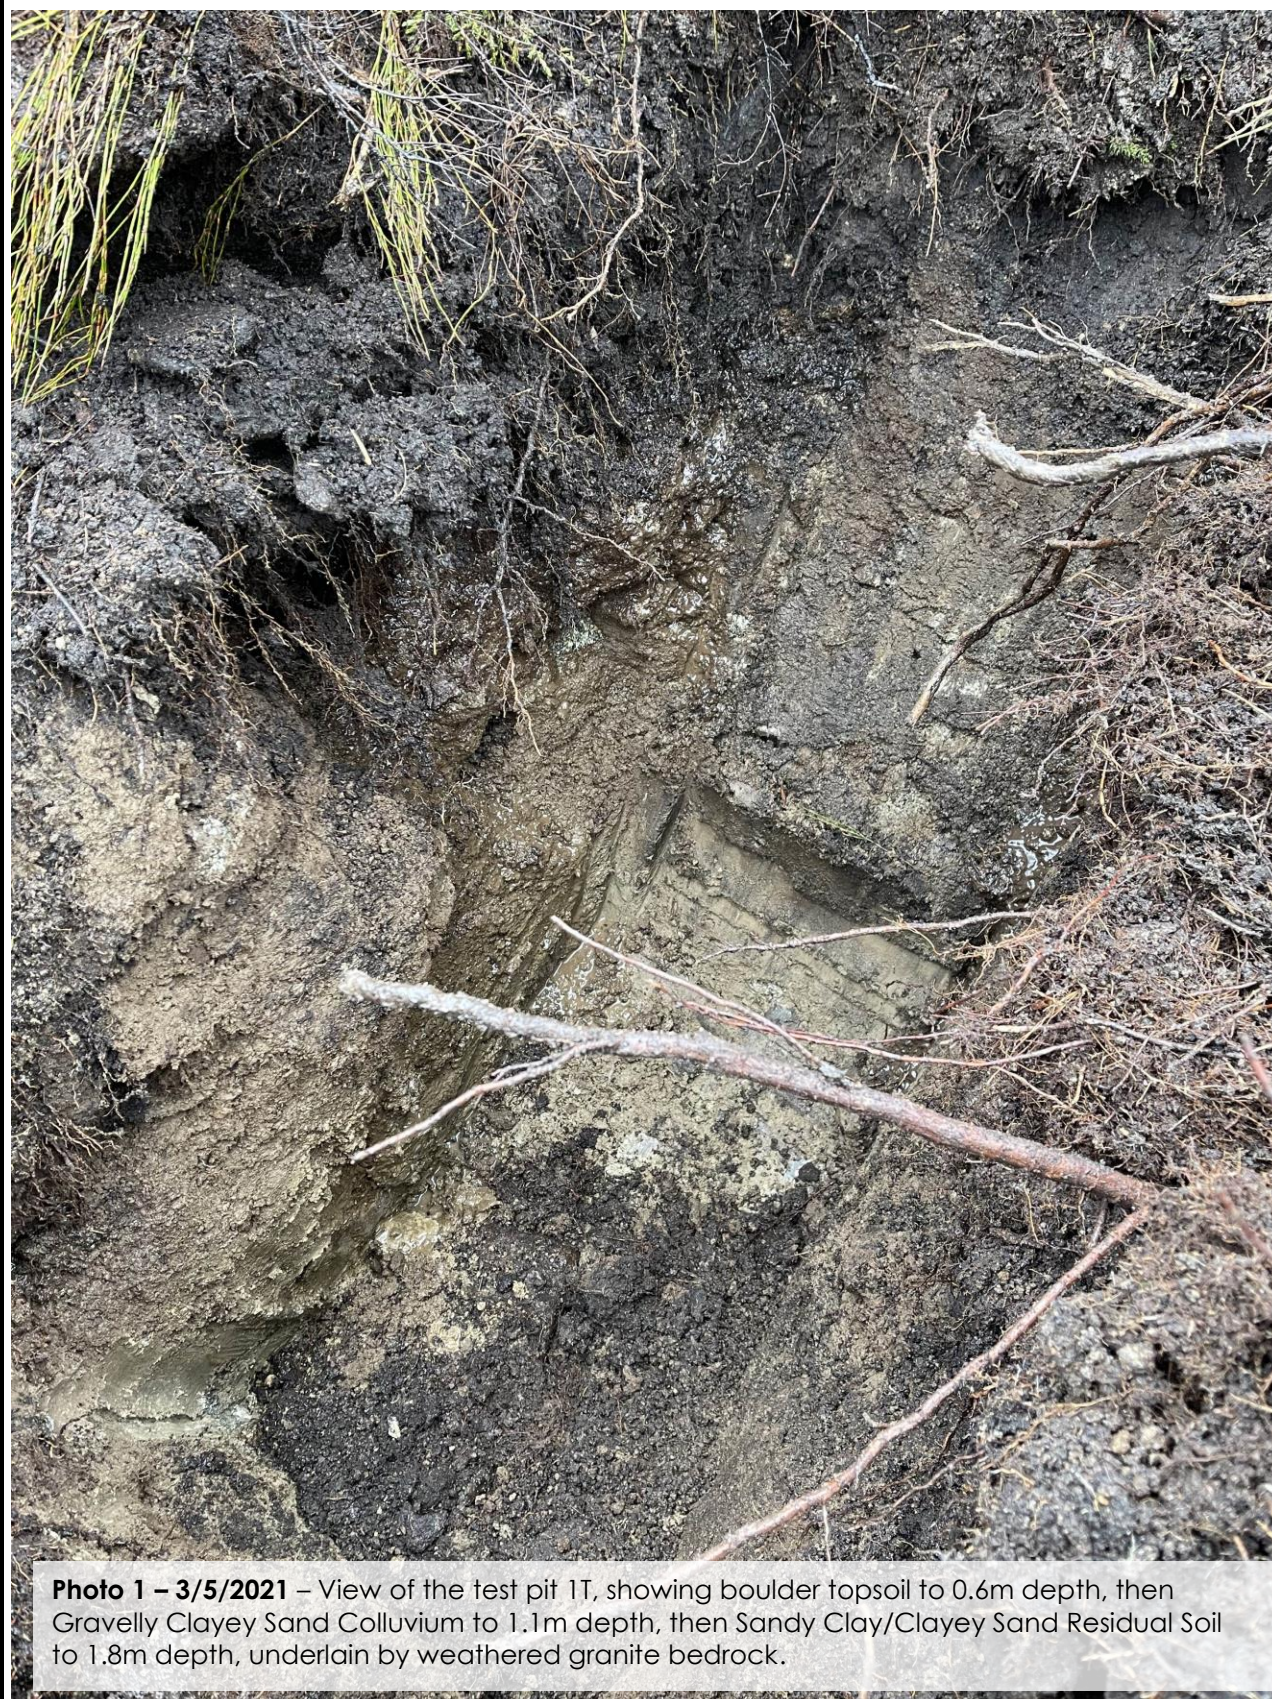
**FIGURE 5**

**Photo 1 – 3/5/2021** – View of the test pit 1T, showing boulder topsoil to 0.6m depth, then Gravelly Clayey Sand Colluvium to 1.1m depth, then Sandy Clay/Clayey Sand Residual Soil to 1.8m depth, underlain by weathered granite bedrock.

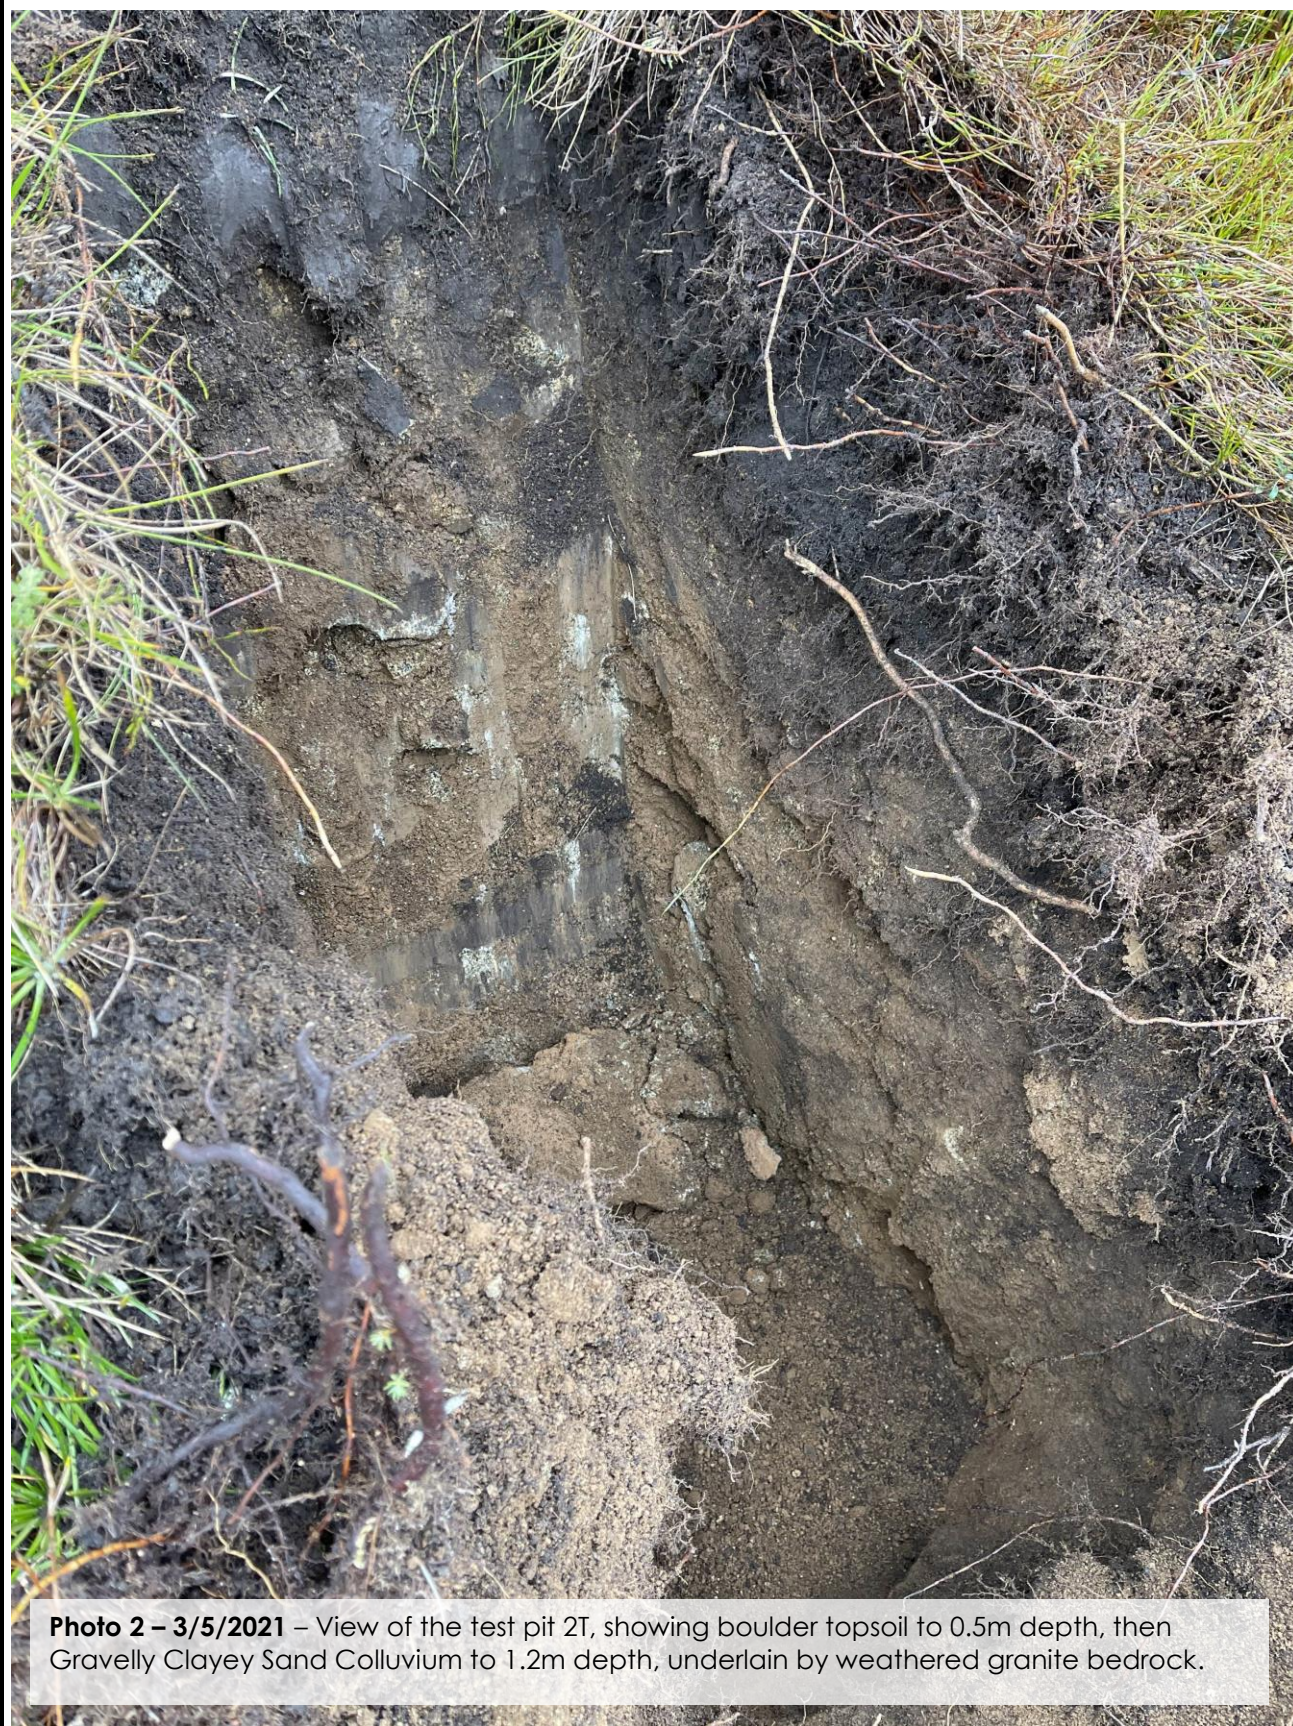
**Photo 2 – 3/5/2021** – View of the test pit 2T, showing boulder topsoil to 0.5m depth, then Gravelly Clayey Sand Colluvium to 1.2m depth, underlain by weathered granite bedrock.

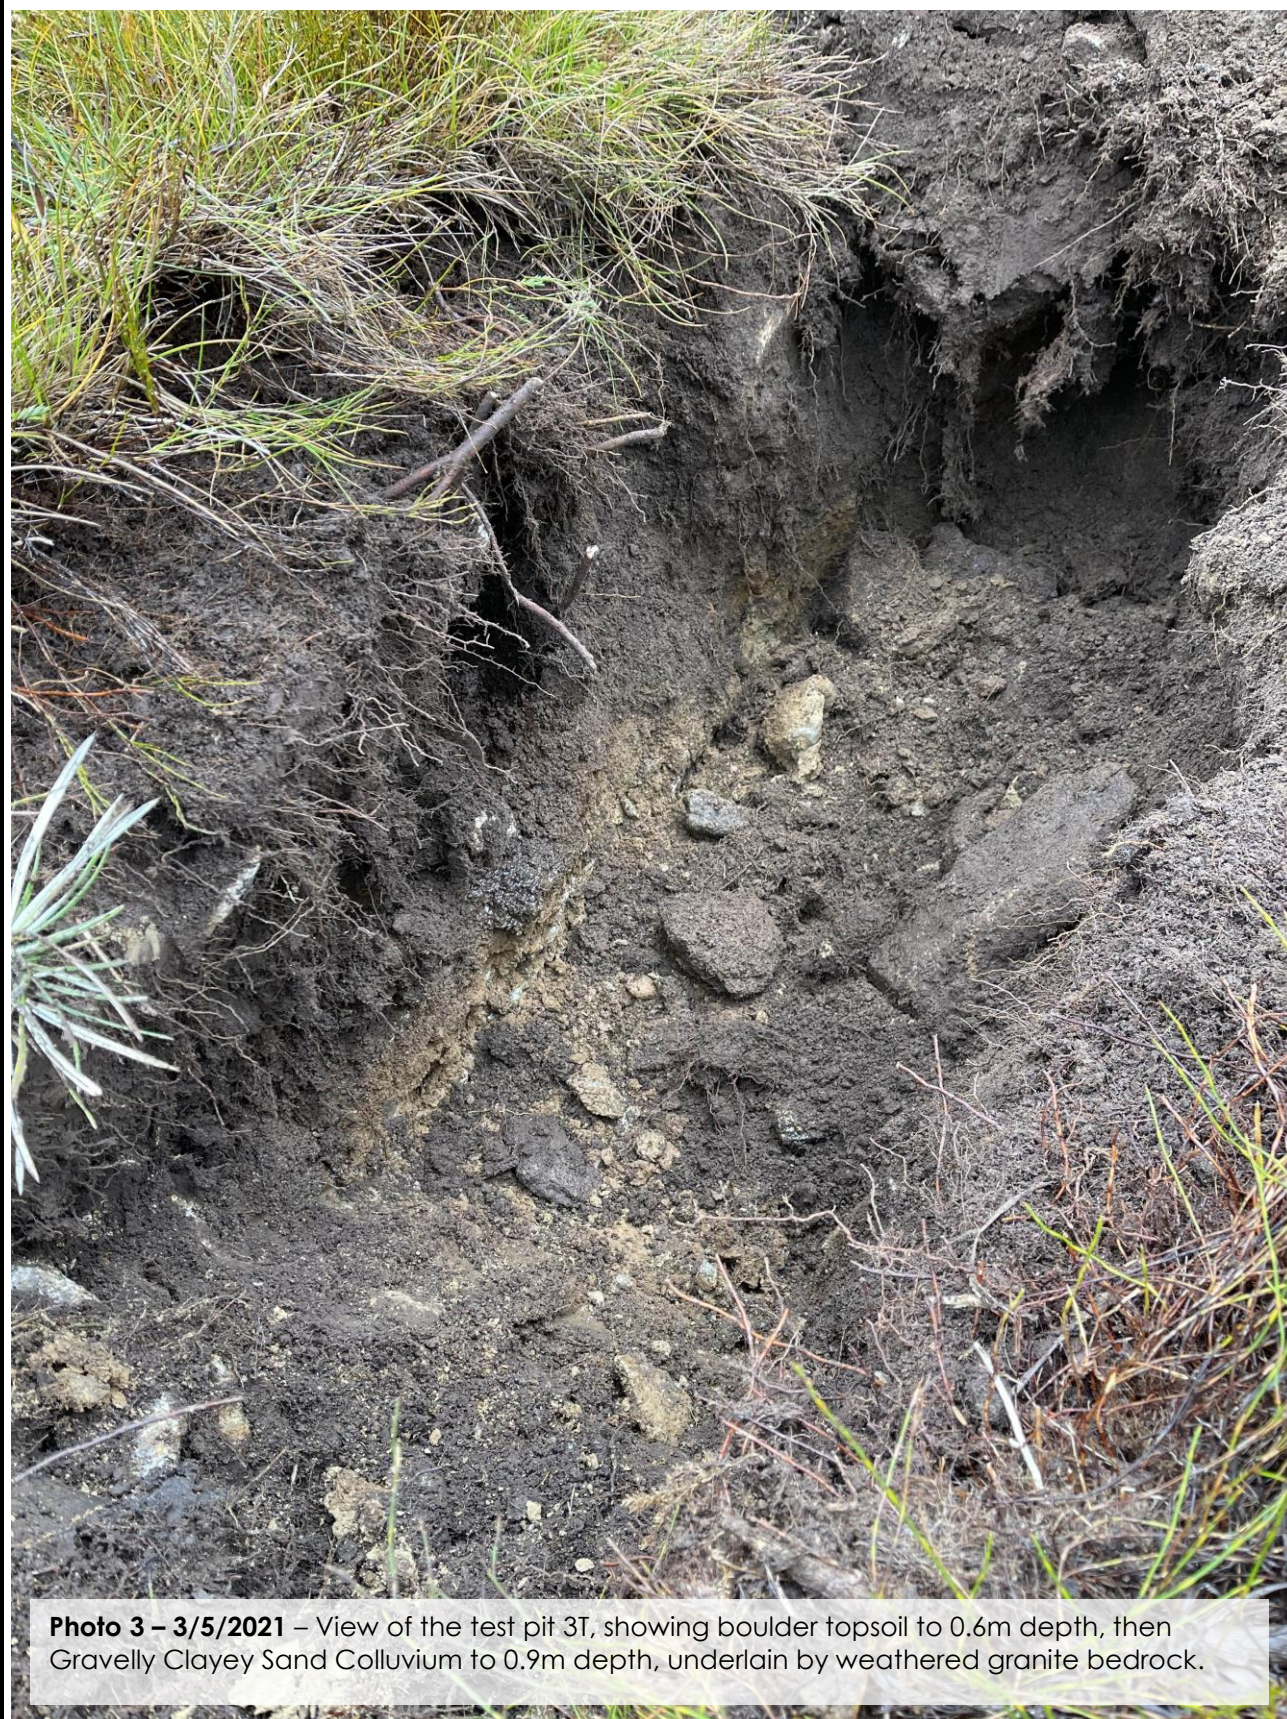
**FIGURE 7**

**Photo 3 – 3/5/2021** – View of the test pit 3T, showing boulder topsoil to 0.6m depth, then Gravelly Clayey Sand Colluvium to 0.9m depth, underlain by weathered granite bedrock.

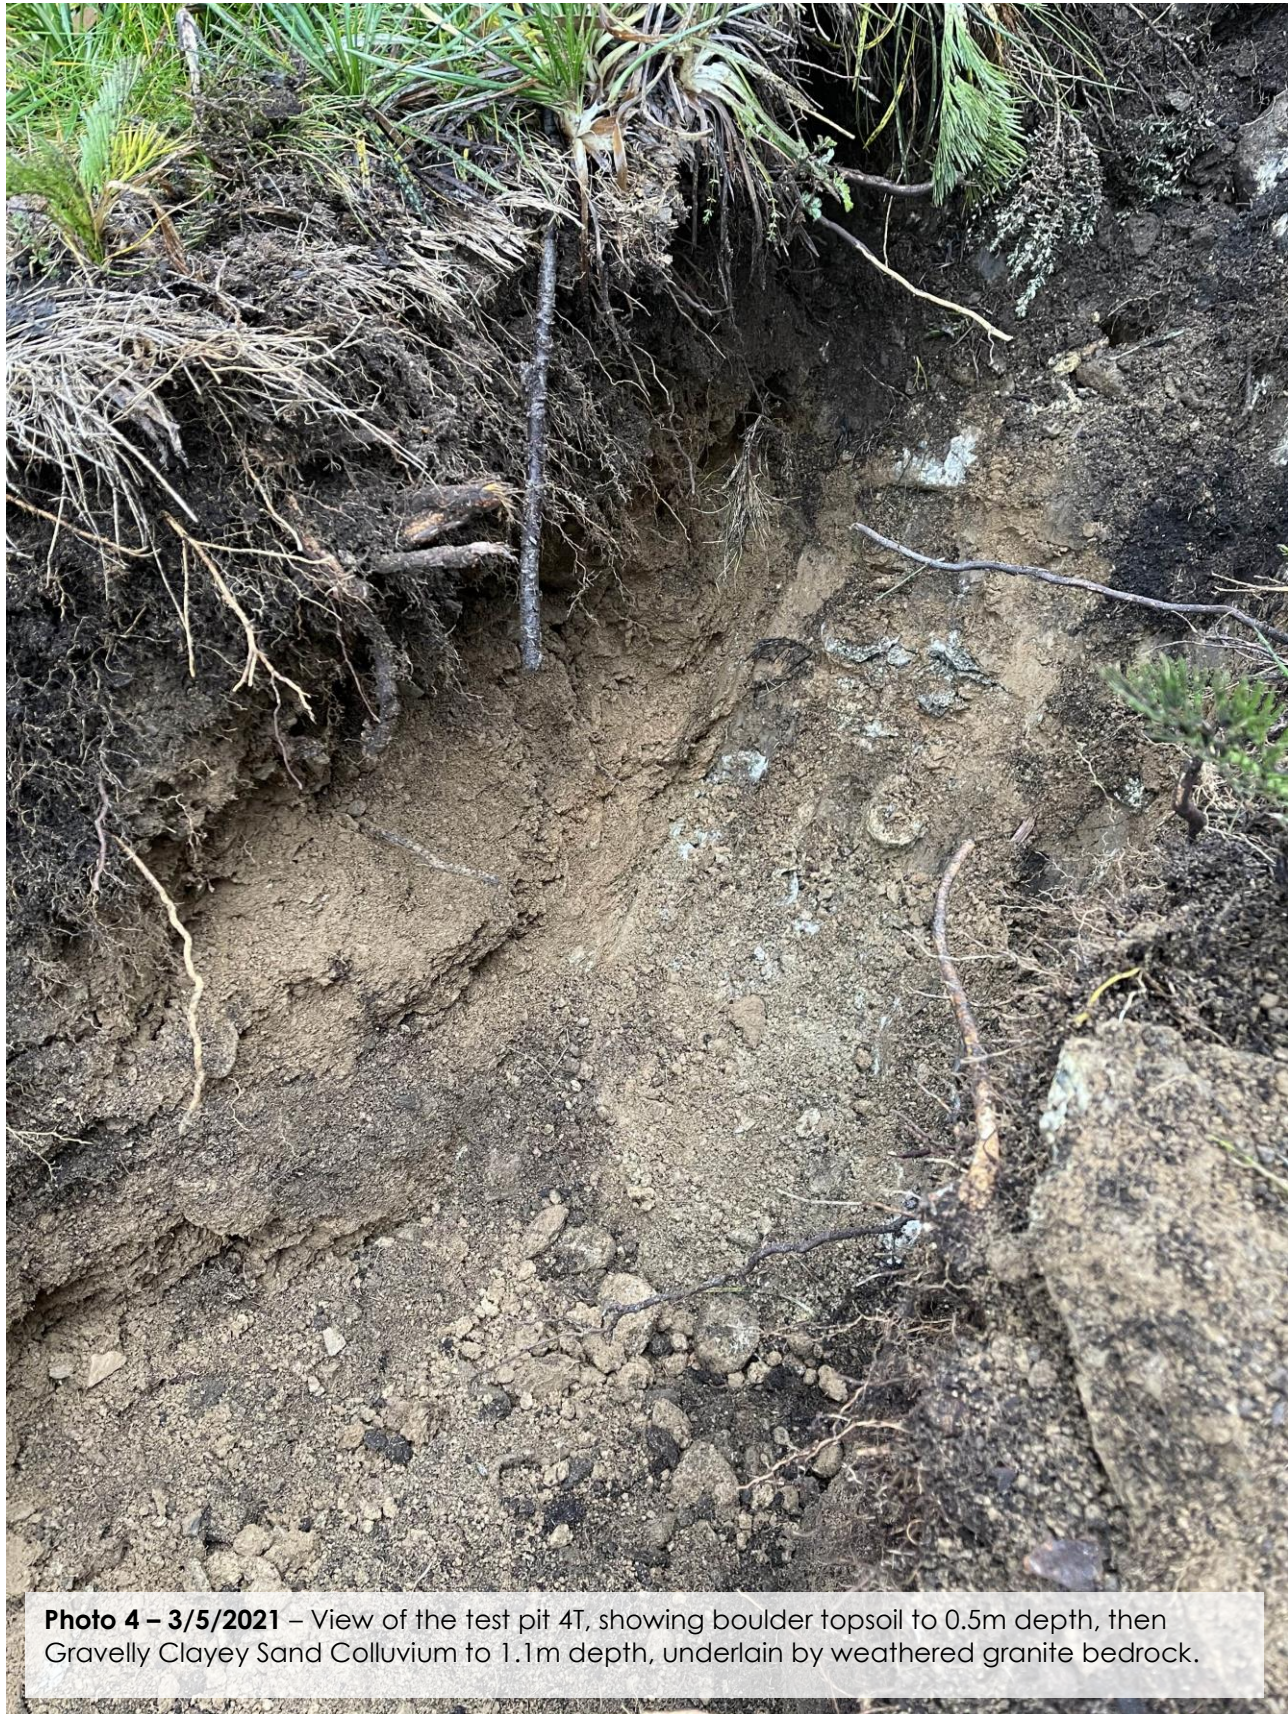
**FIGURE 8**

**Photo 4 – 3/5/2021** – View of the test pit 4T, showing boulder topsoil to 0.5m depth, then Gravelly Clayey Sand Colluvium to 1.1m depth, underlain by weathered granite bedrock.
