BUSHFIRE HAZARD ASSESSMENT REPORT

EXTERNAL MAINTENANCE WORK TO VALLEY TERMINAL BUILDING

FRIDAY DRIVE, THREDBO VILLAGE
KOSCIUSZKO NATIONAL PARK NSW 2625
LOT 862 DP1128686

DATE: NOVEMBER 2022
REPORT NO: 22134
REVISION: 01
PREPARED FOR: KOSCIUSZKO THREDBO C/- ANDREW HARRIGAN
PREPARED BY: ACCENT TOWN PLANNING

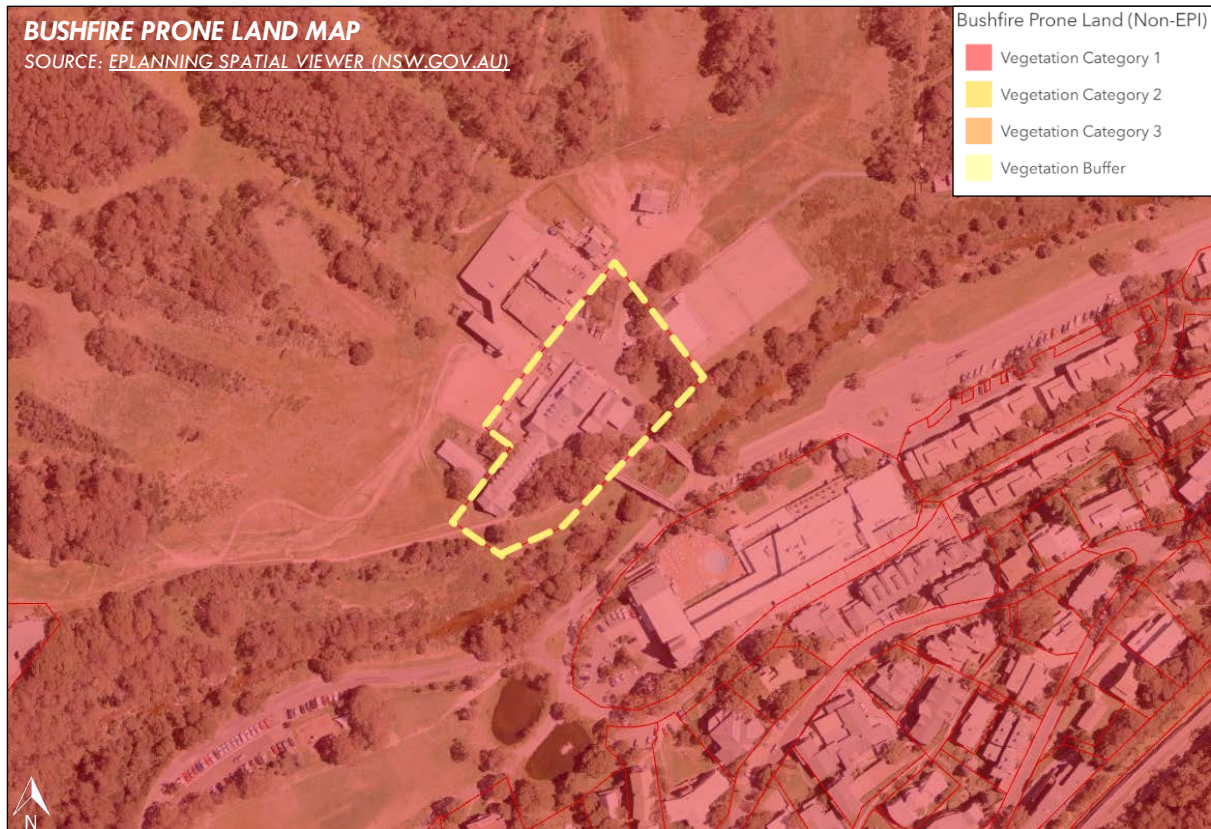
FIGURE 4 BUSHFIRE PRONE MAP

MAP	FIGURE	DESCRIPTION
BUSHFIRE PRONE LAND MAP	4	The subject lot is mapped as "Vegetation Category 1".
LEP ZONE MAP	5	The subject lot is zoned as "C1 – National Parks and Nature Reserves".
VEGETATION MAPPING	6	<p>The vegetation surrounding the VT building has been mapped as:</p> <ul style="list-style-type: none"> SUB-ALPINE SHRUB-GRASS WOODLAND <p>According to Keith (2004) this formation is classified as both "Woodland" and "Forest" depending on the density of the vegetation. Thredbo Valley primarily consists of <i>Sub Alpine Woodland</i> vegetation formations. However, the area has developed quite significantly. The subject area is surrounded by <i>Managed Land</i>. For this reason, the main threat no longer applies, and the vegetation type can be classified as <i>Managed Land</i>.</p>
BIODIVERSITY VALUES MAP	7	The subject lot does contain areas of High Biodiversity Values, which includes the Thredbo River and a small buffer on either side of the river. The proposed works will not be occurring in the areas identified with High Biodiversity Values, and the works do not have the potential to negatively impact upon these areas.

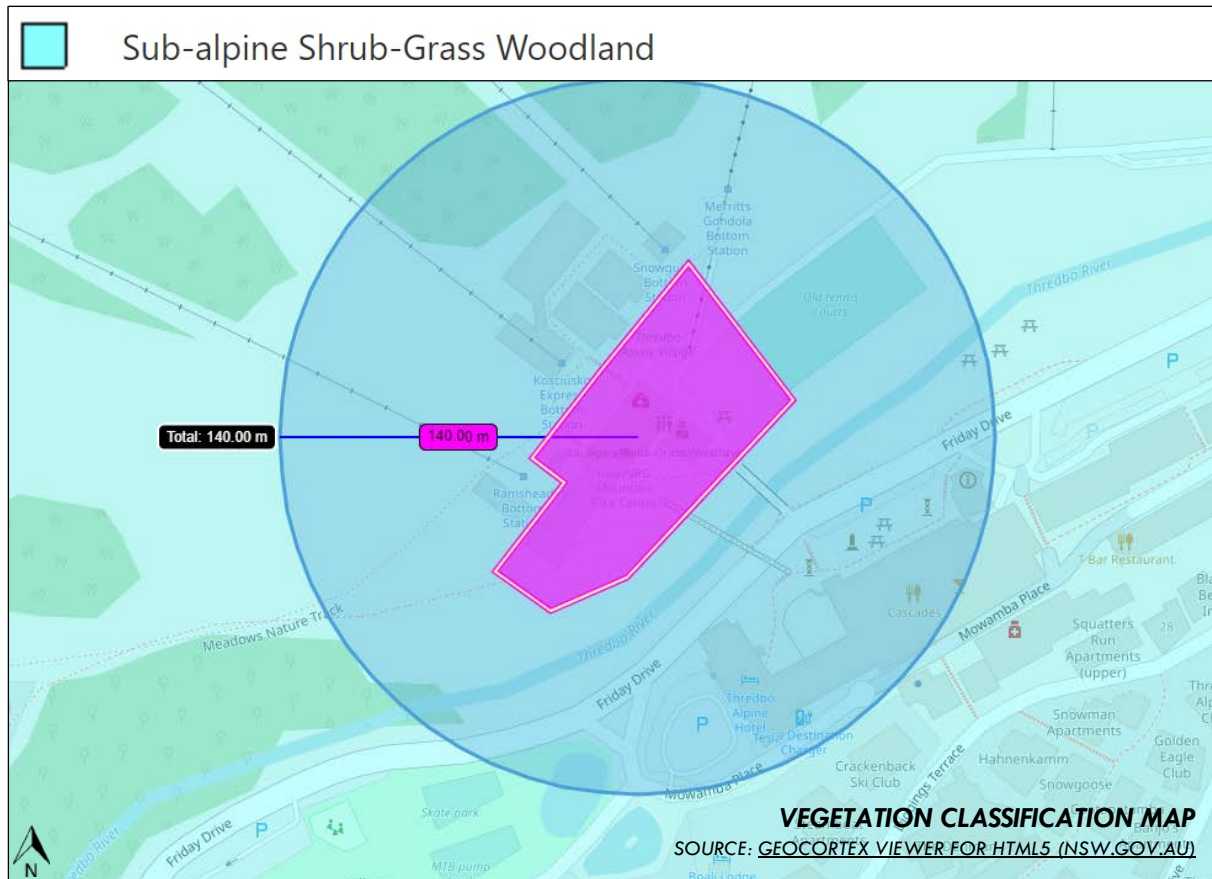
FIGURE 6 VEGETATION MAPPING

As seen in Figure 6, within 140m of the subject site there is one vegetation type:

→ **SUB-ALPINE SHRUB-GRASS WOODLAND**

Areas identified as *Sub-alpine Shrub-Grass Woodland* on mapping to the North-east and North-west are dominated by *Managed Land* that primarily consists of Grassland at the base of the ski slope nearest to Kosciuszko Express chairlift. There are some areas of *Sub-alpine Shrub-Grass Woodland* within the outer areas of the 140m, these areas present a discontinuous canopy and are appropriately separated from the VT building.

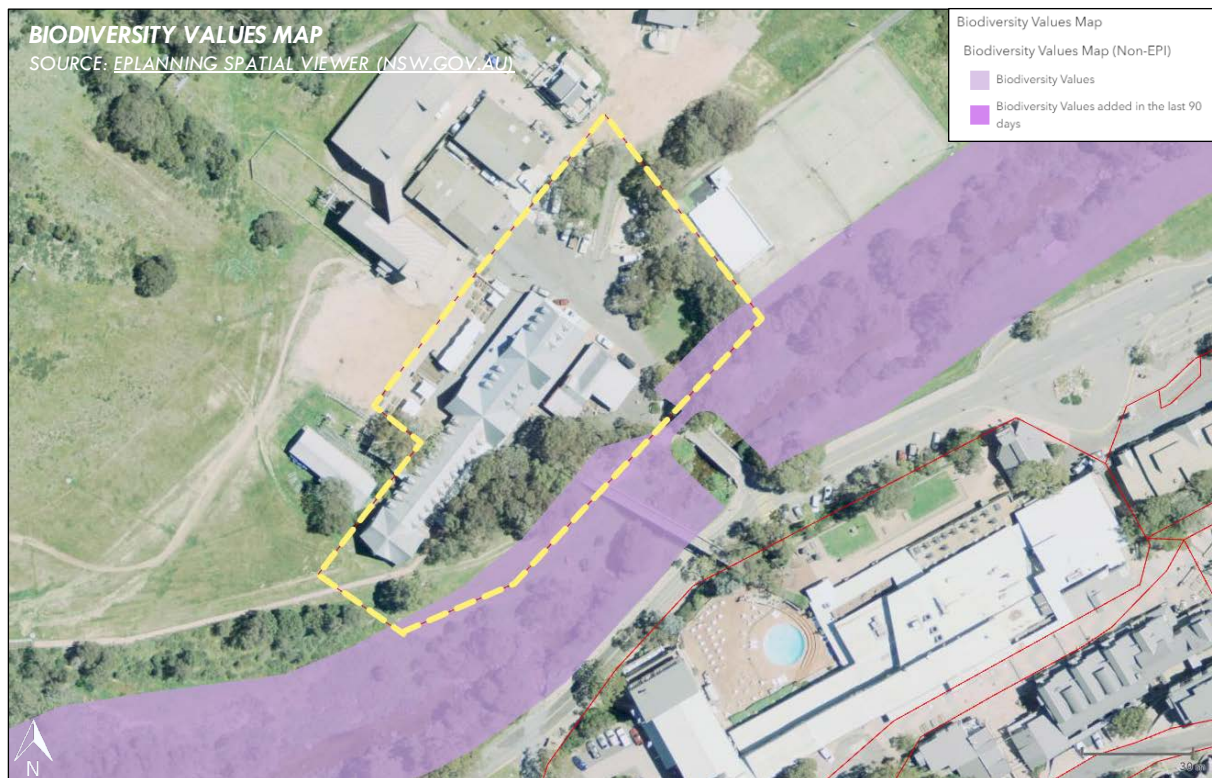
FIGURE 7 BIODIVERSITY VALUES MAP

In order to assess if the development is located within an area identified with Biodiversity Values, we have completed a search using the Biodiversity Values Map. As shown in Figure 7, the subject allotments do contain areas with high biodiversity values. However, no building works are proposed within these areas and the proposed works will not negatively impact these areas and hence does not trigger the Biodiversity Offsets Scheme.

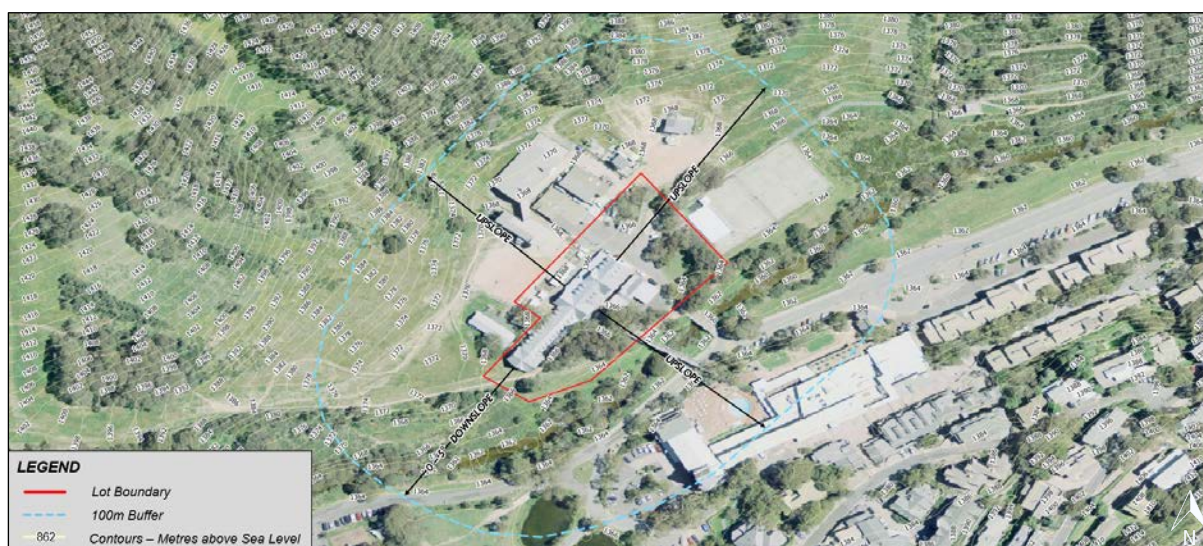
FIGURE 8 SLOPE

As can be seen in Figure 8 below, the land within 100m of the North-east and North-west elevations presents a gentle upslope which traverses across *Managed Land*. The land within 100m of the South-west elevation presents a 0 – 5° downslope which traverses across maintained public reserve area that consists of mown grass areas and native sub-alpine woodland shrubs and trees fringing both sides of the Thredbo River. The land within 100m of the South-east elevation presents an upslope which traverses across a mixture of managed land (Friday Drive and the Thredbo Alpine Hotel) as well as the maintained reserve surrounding the Thredbo River.

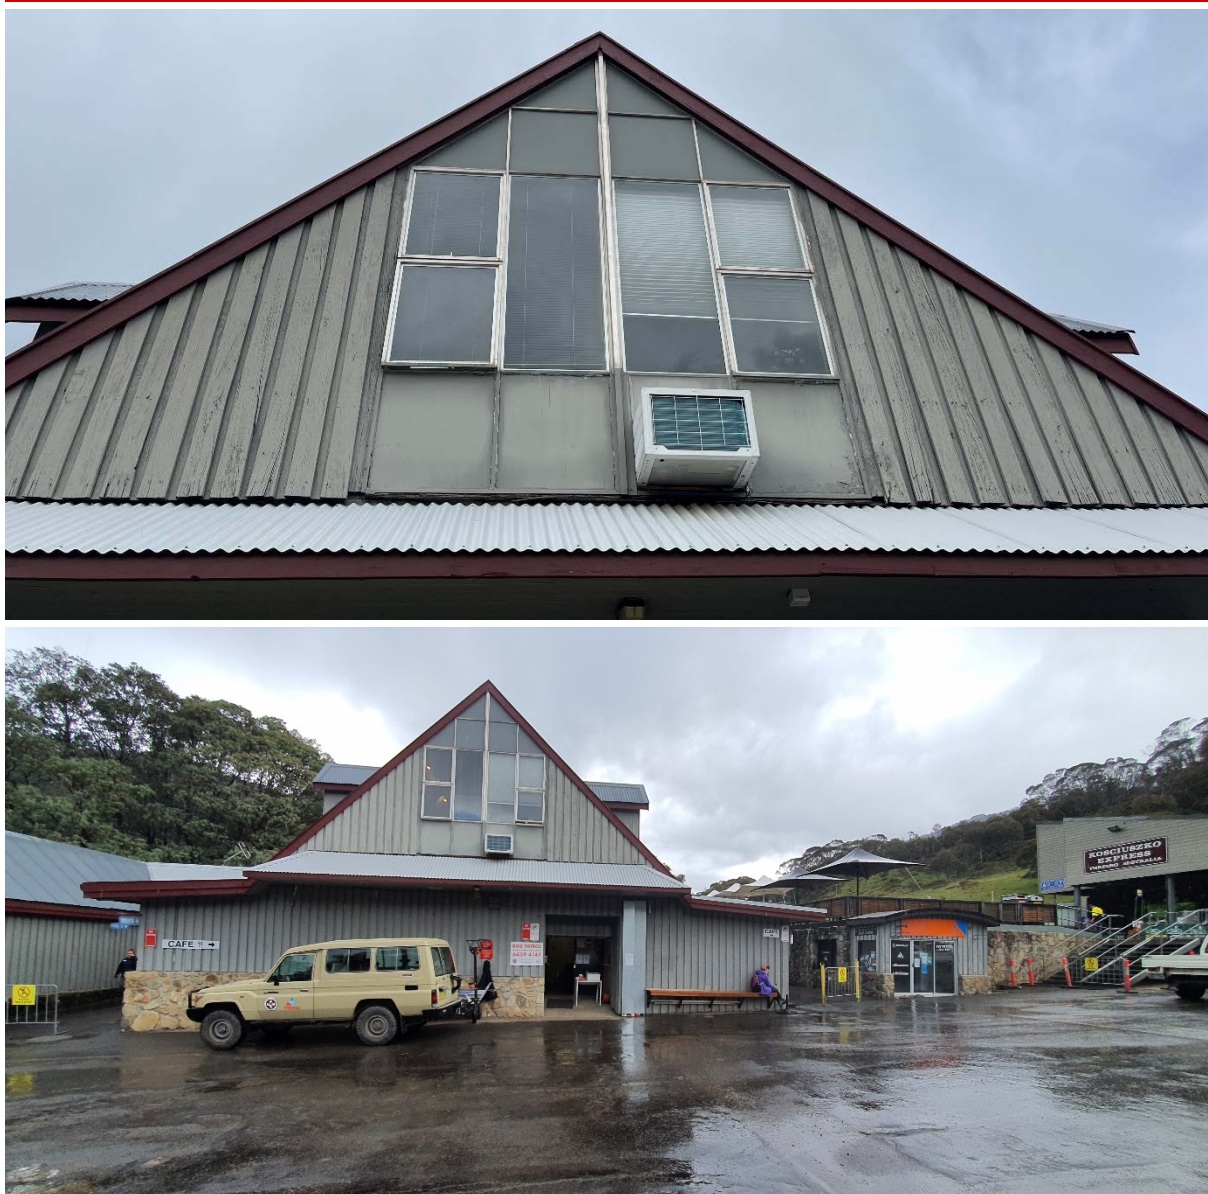
SITE PHOTOS**1: NORTH – EAST ELEVATION**

VEGETATION FORMATION	EFFECTIVE SLOPE	PHOTOS
NORTH – EAST	Managed Land	Upslope	1
NORTH – WEST	Managed Land	Downslope 0 – 5°	2
SOUTH – EAST	Managed Land	Downslope 0 – 5°	3
SOUTH – WEST	Managed Land	Upslope	4

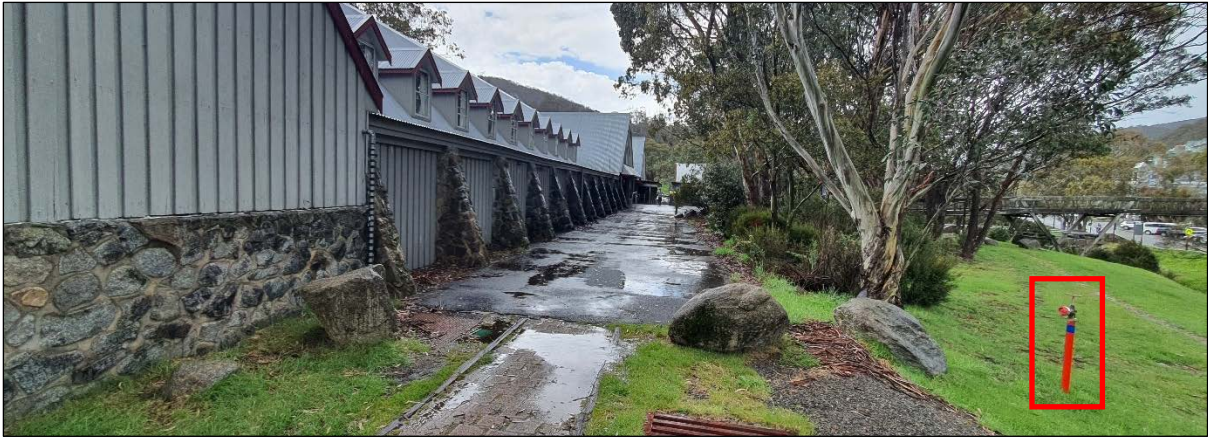
Thredbo is serviced by reticulated water. A hydrant system is located on the Southern elevation of the Valley Terminal Building. The location and distance to the hydrants will be consistent with the requirements of the PBP 2019.

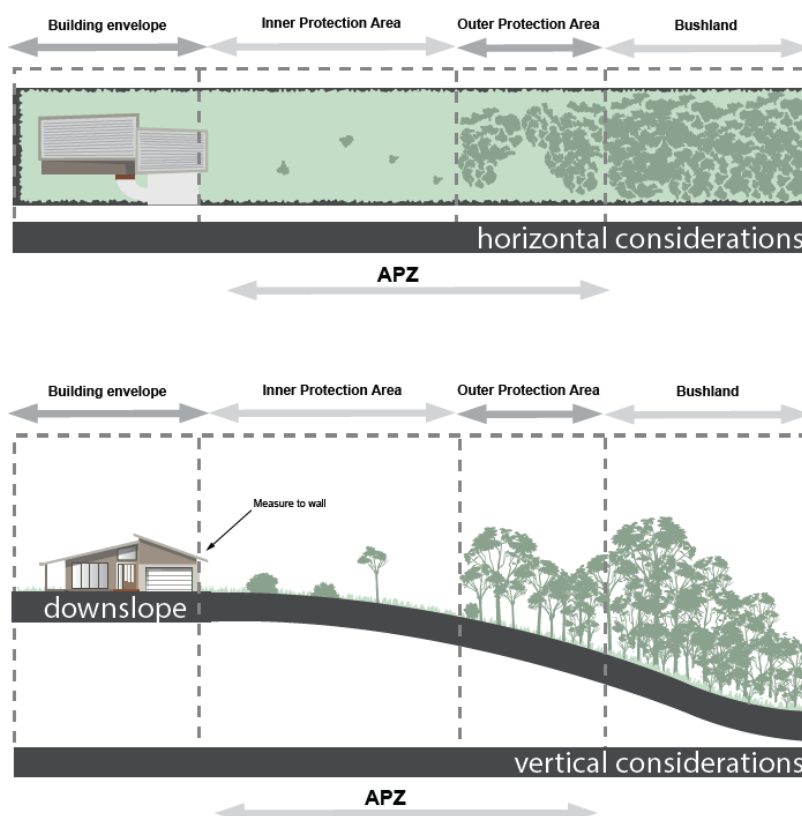
Typical Inner and Outer Protection Areas.

Vegetation within the APZ should be managed in accordance with APZ specifications for the purposes of limiting the travel of a fire, reducing the likelihood of direct flame contact and removing additional hazards or ignition sources. The following outlines some general vegetation management principles for APZs:

1. Discontinuous shrub layer (clumps or islands of shrubs not rows)
2. Vertical separation between vegetation stratum
3. Tree canopies not overhanging structures
4. Management and trimming of trees and other vegetation in the vicinity of power lines and tower lines in accordance with the specifications in "Vegetation Safety Clearances" issued by Energy Australia (NS179, April 2002)
5. Maintain low ground covers by mowing / whipper snipper / slashing; and
6. Non-combustible mulch e.g. stones and removing stores of combustible materials
7. Vegetation to be planted should consist of fire retardant/ less flammable species strategically located to reduce attack from embers (i.e. as ember traps when in small clumps and short wind breaks).
