Elements of Byron – Extension to Existing Geobag Coastal Protection Works

Coastal Engineering Assessment

Reference: PA3267-IB-RP-221121

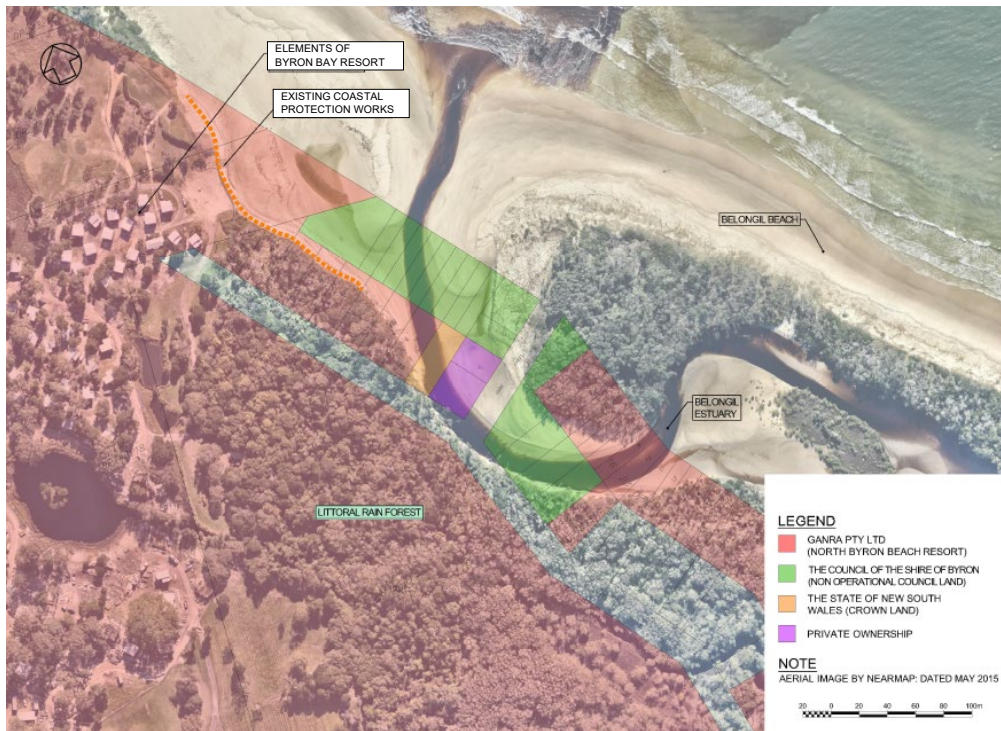
Figure 2-1 Plan showing longitudinal extent of the existing geobag coastal protection works and land ownership

Figure 2-1 shows the location of the existing geobag coastal protection works together with land ownership information. As noted earlier, the works are located wholly on private land owned by Ganra Pty Ltd (Elements of Byron).

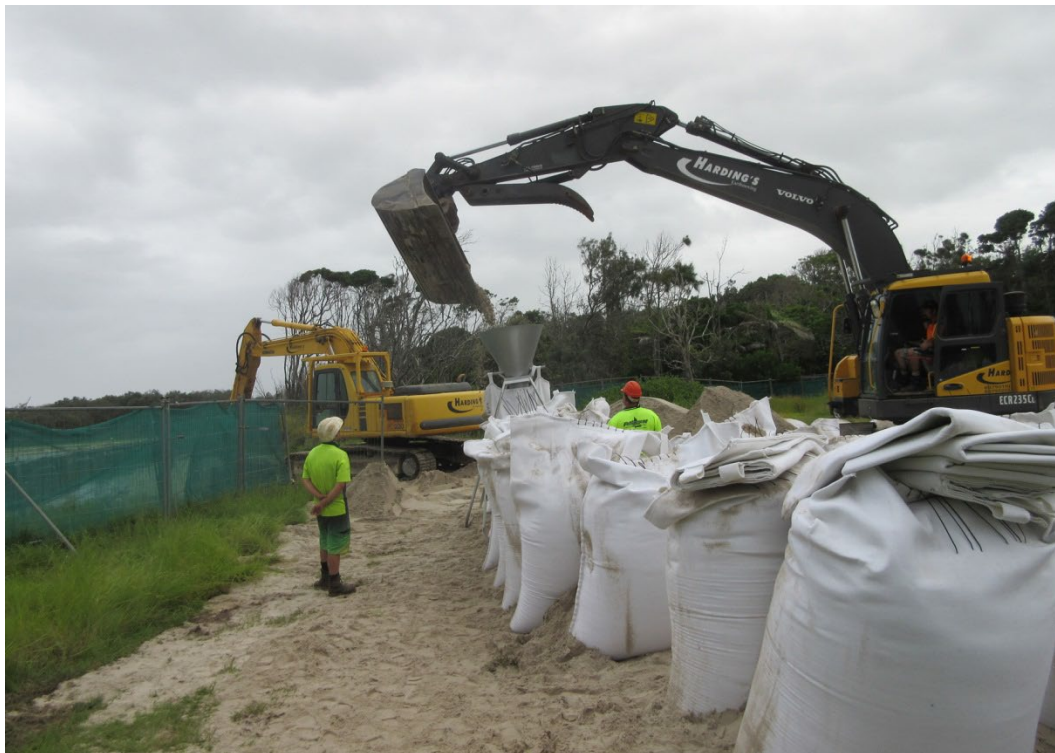
Figure 2-2 Filling geobags with sand from the imported sand stockpile using an excavator (March 2015)

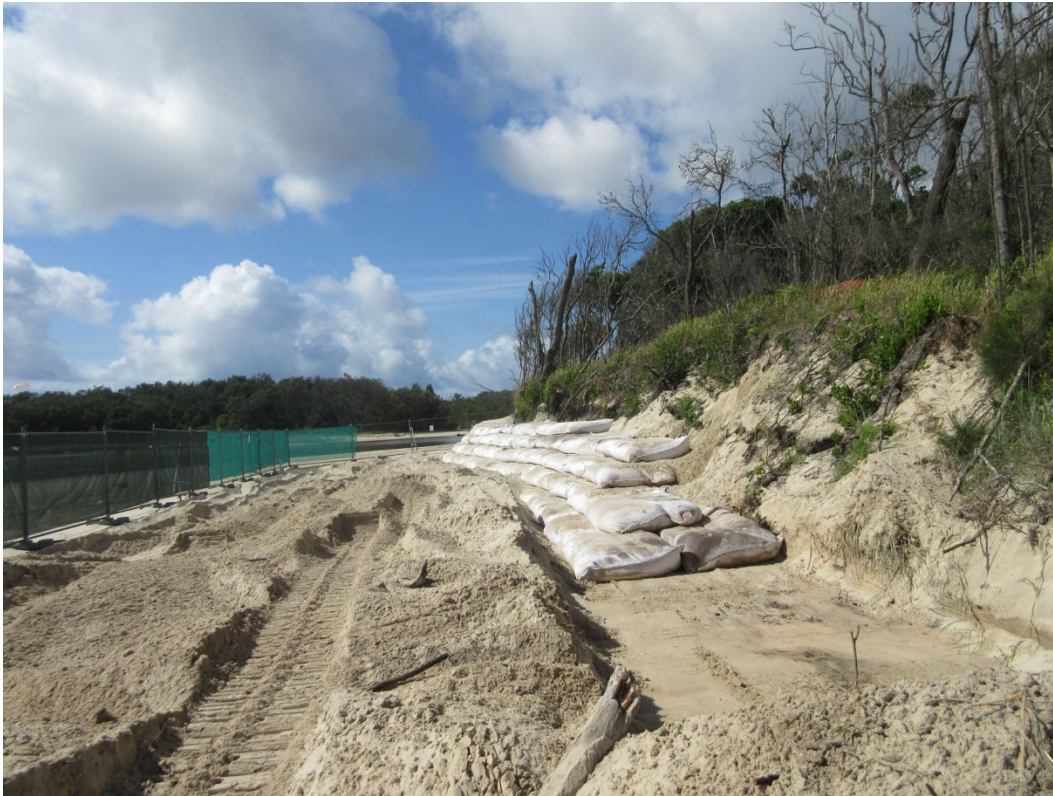
Figure 2-3 View looking southwards during construction showing the prepared foundation for the protection works and the rows of geobags (March 2015)

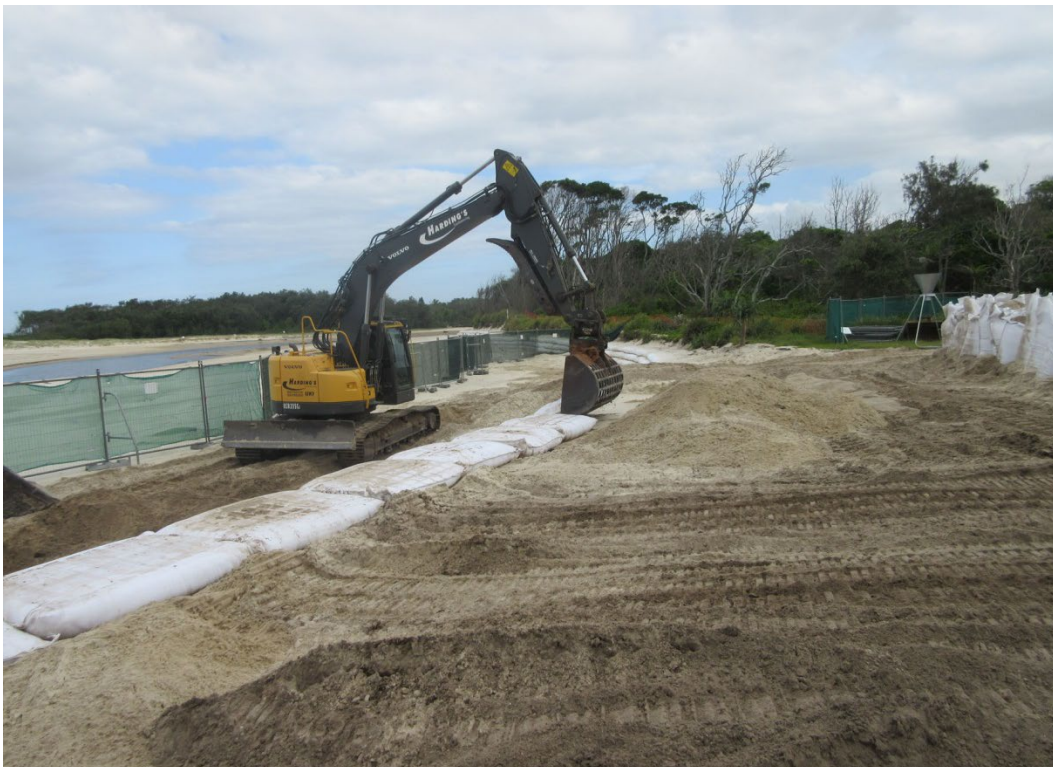
Figure 2-4 View showing excavator positioning geobags in the structure (March 2015)

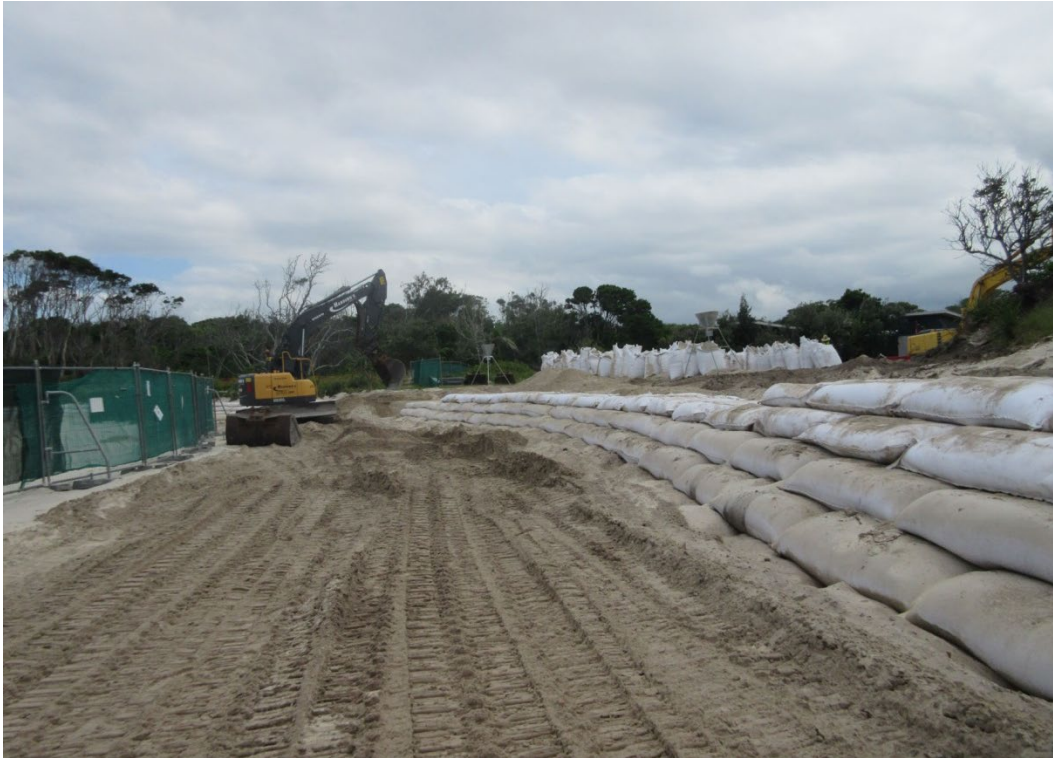
Figure 2-5 View of a section of the completed coastal protection works five units high (March 2015)

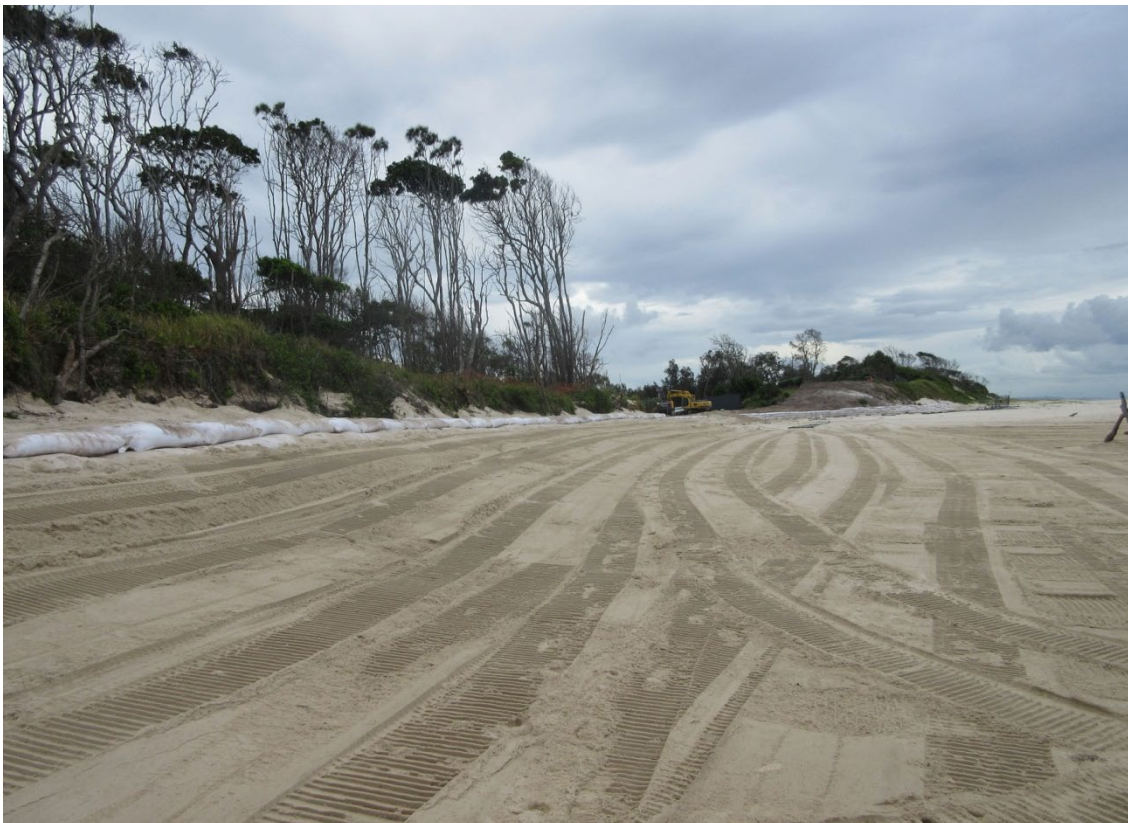
Figure 2-6 Reshaping and grooming of the beach in front of the protection works at completion (March 2015)

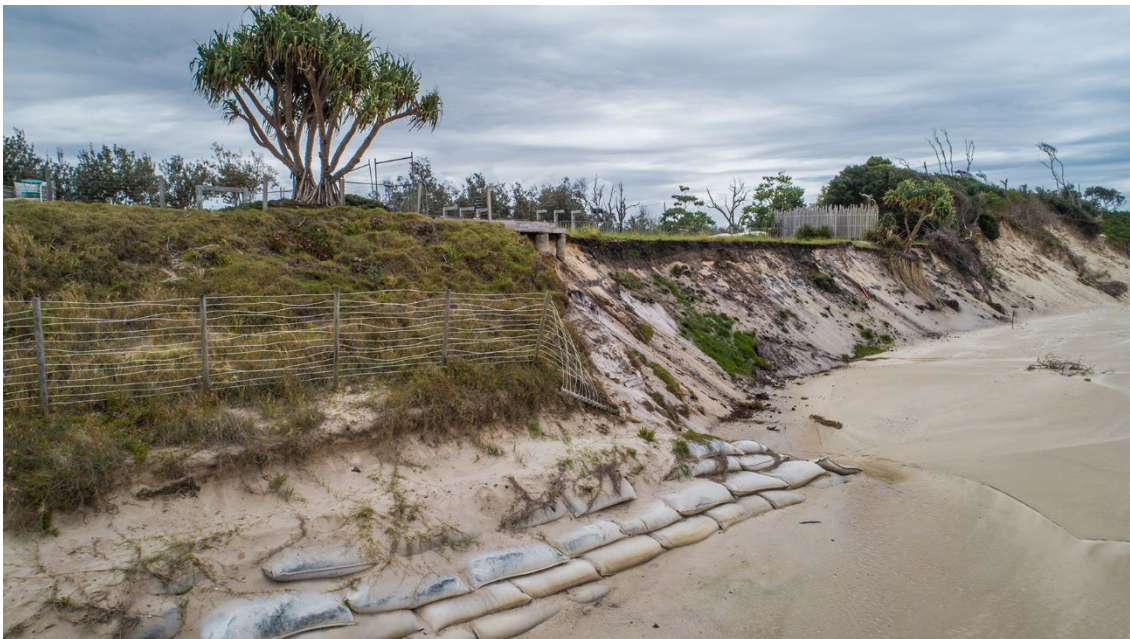
Figure 3-1 *Erosion immediately north of the existing geobag structure showing steep dune escarpment and undermining of foreshore assets (20 October 2022)*

The erosion of the foreshore which occurred in 2022 is shown in the various images in Figures 3-1 to 3-6 and described in the captions. The damage which is evident to the existing geobag coastal protection works will be repaired as part of the maintenance obligations of Elements of Byron under the approval for these existing works.

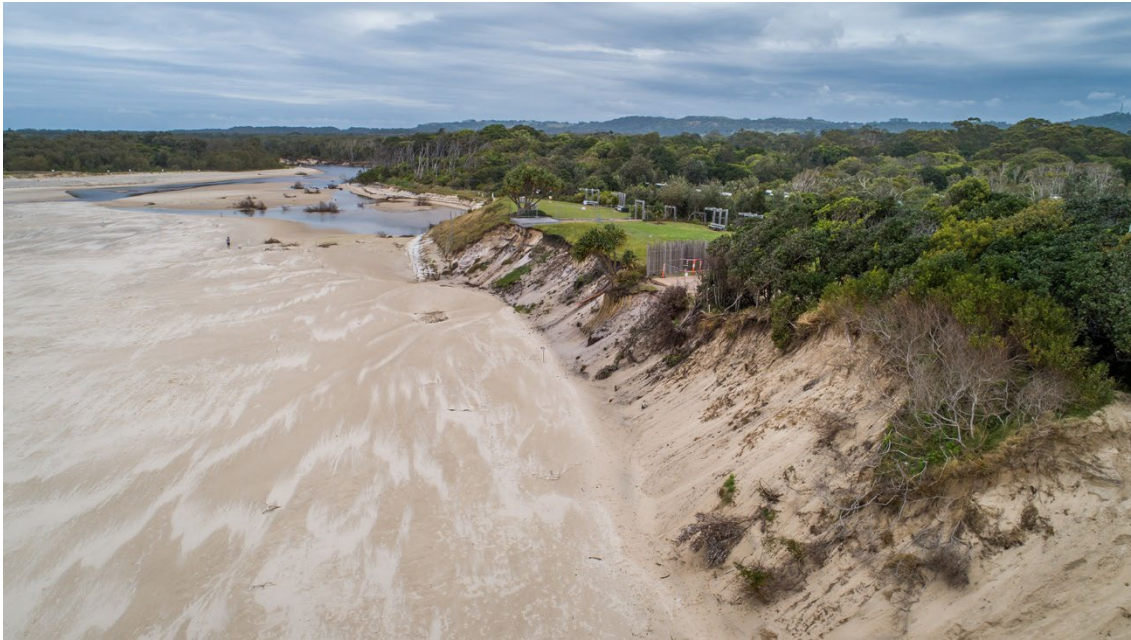
Figure 3-2 View looking southwards towards the existing geobag structure with erosion escarpment in the foreground (20 October 2022)

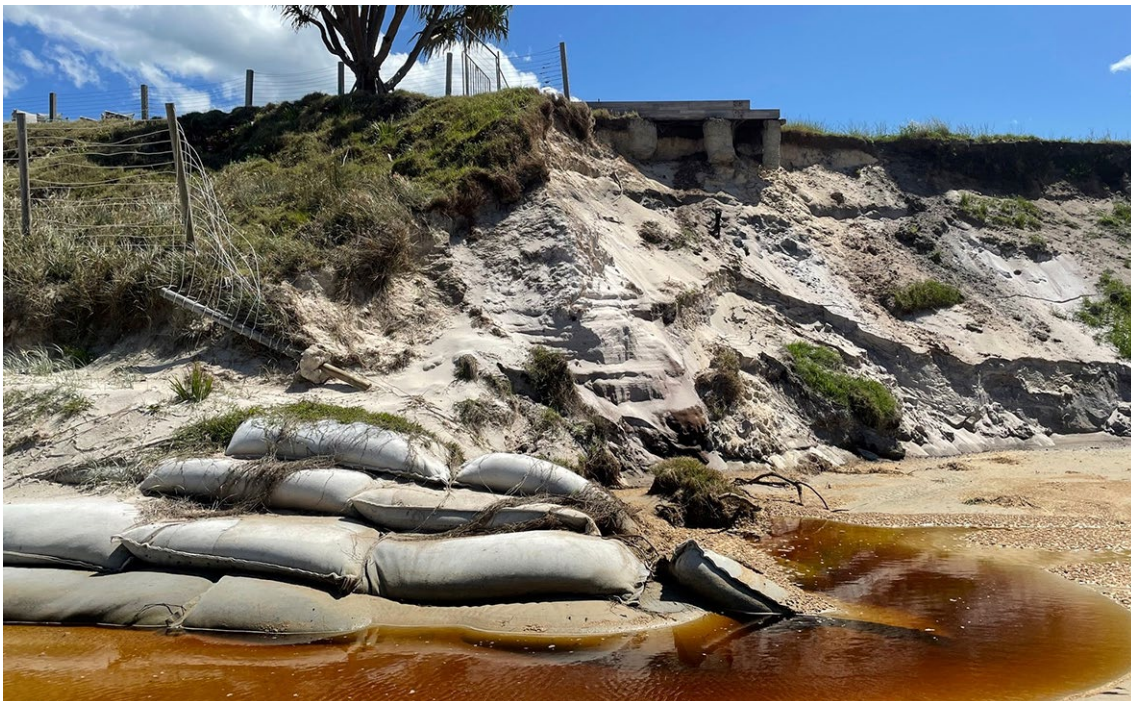
Figure 3-3 Close up view of the northern limit of the existing geobag structure and adjacent erosion (25 October 2022)

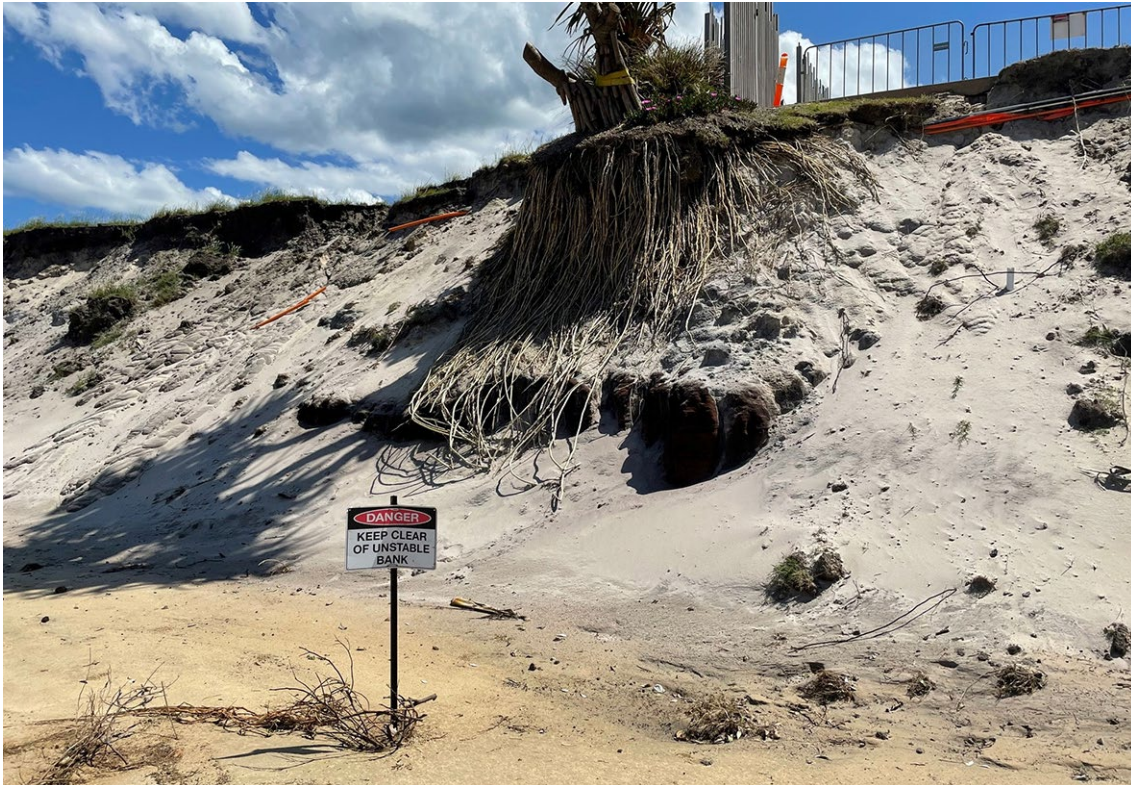
Figure 3-4 Warning signage 'Danger – Keep Clear of Unstable Bank' near the base of the erosion escarpment north of the geobag structure. The escarpment is at or near the natural angle of repose and is a potential public safety risk to users of the beach (25 October 2022)

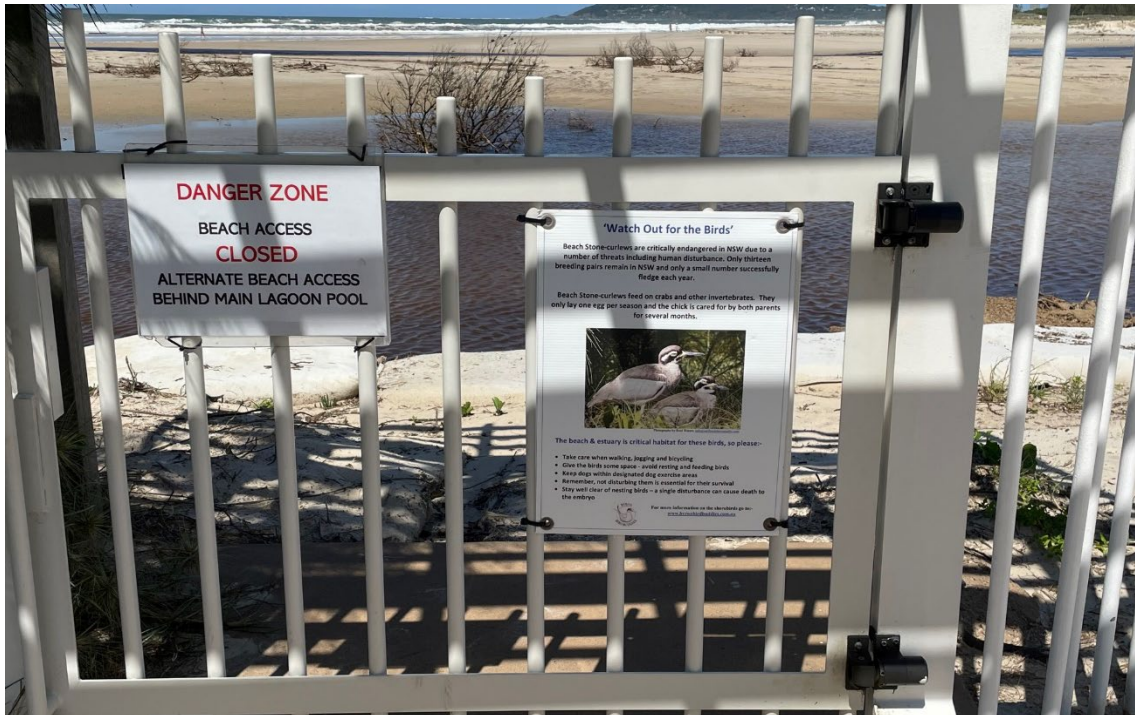
Figure 3-5 View of signage 'Danger Zone – Beach Access Closed' at the point of entry to the estuary entrance area from Elements of Byron (25 October 2022)

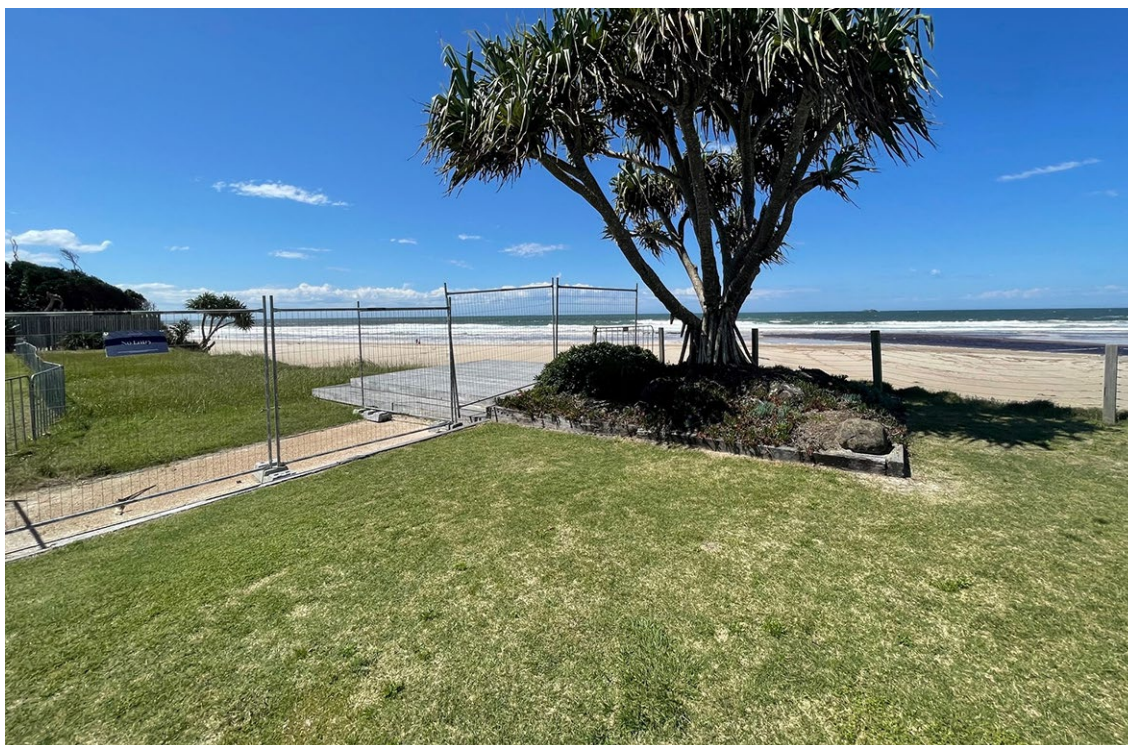
Figure 3-6 View of restricted access to the crest of the erosion escarpment and facilities due to the safety risk (25 October 2022)

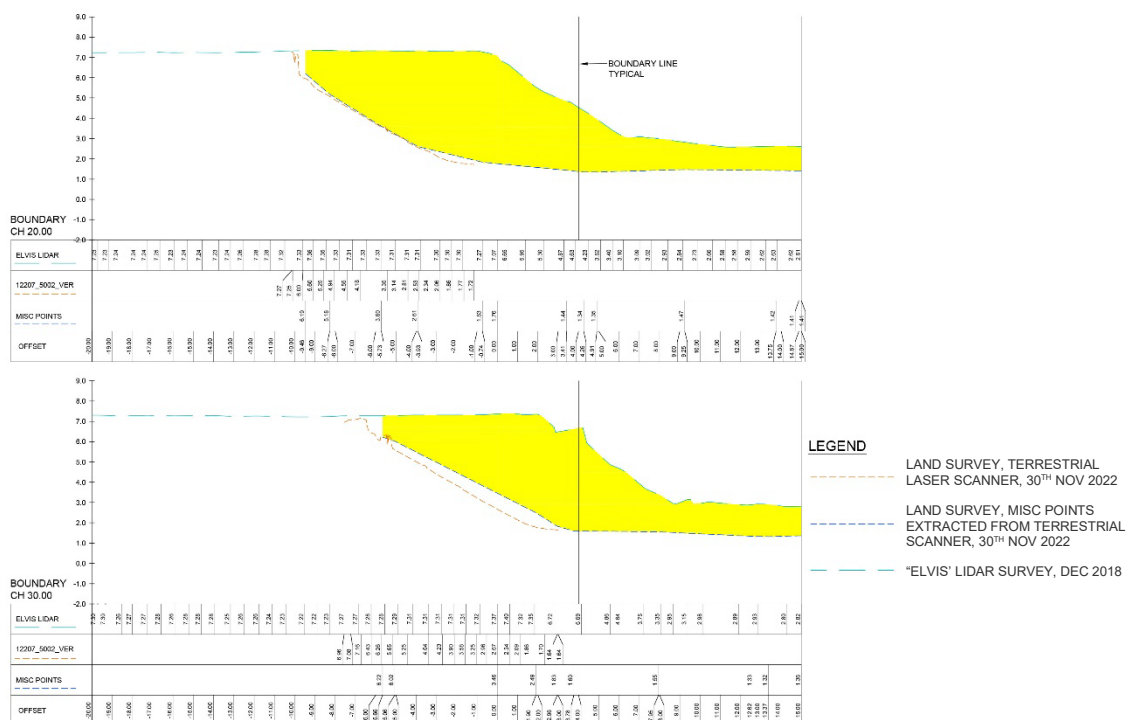
Figure 3-7 Comparison of the December 2018 and November 2022 land surfaces in the area 20m to 30m north of the end of the existing geobag coastal protection works. Difference between surfaces (sand loss) is shaded yellow.

The survey comparison in Figure 3-7 indicates that within 20 to 30m north of the end of the existing geobag coastal protection works there has been a loss of approximately 10m of private land over the period December 2018 to November 2022.

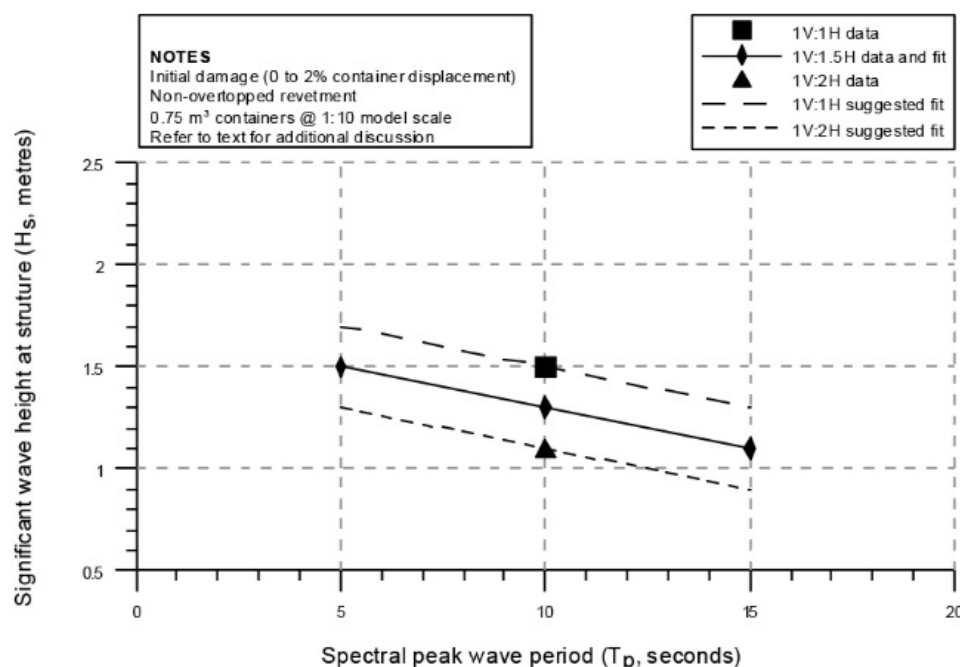
Figure 4-1 Significant wave height for 'Initial Damage' for 0.75m³ geobags as a function of spectral peak wave period

Design guidelines for geobag stability under wave attack were published in Coghlan et al (2009) and Hornsey et al (2011) based on the scale laboratory testing. The design curve for 0.75m³ geobags is shown in Figure 4-1. It shows the significant wave height (H_s) at the structure corresponding to 'Initial Damage' as a function of spectral peak wave period (T_p) for a double-layered structure in a stretcher bond arrangement incorporating an 'encapsulated self-healing toe', for different structure slopes; namely 1V:1H, 1V:1.5H and 1V:2H⁴. 'Initial Damage' was defined as less than 2% of the geobags moving (note that this is not zero damage).

It can be seen from Figure 4-1 that for a T_p value of say 13 seconds and a structure slope of 1V:1.5H, the significant wave height corresponding to initial damage would be approximately 1.2m. It is noted that the

It is evident that even in a 10 year ARI event with sand levels comparable to those surveyed in November 2022, breaking waves in the order of 0.5 to 0.8m could occur against the erosion escarpment. The fact that damage has occurred to the existing geobag coastal protection works in the 8 years since 2015, necessitating repair and maintenance, is indicative that wave heights at the back of the beach have exceeded 1.2m at times, having regard to the design guidelines for geobag stability under wave attack discussed in Section 4.1 (initial damage for wave height at approximately 1.2m, refer Figure 4-1).

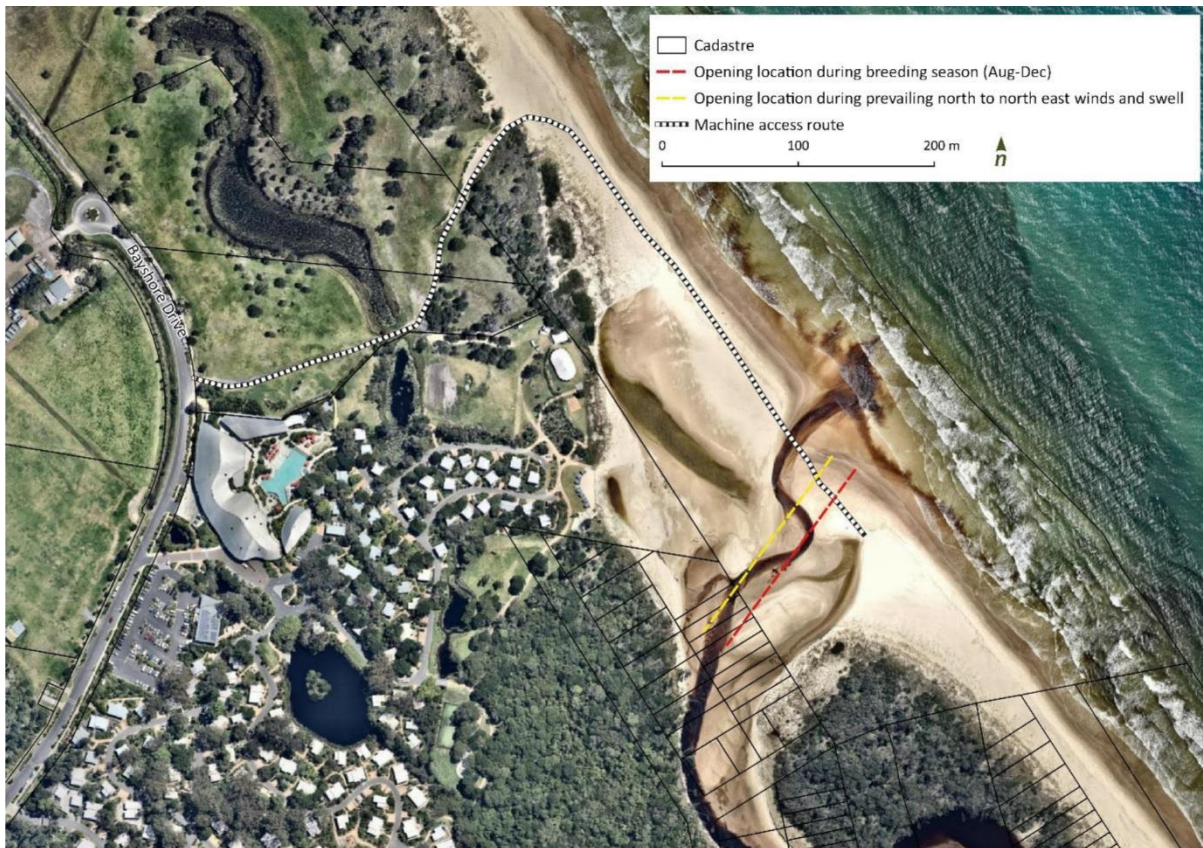
Figure 5-1 Entrance opening locations and access route to the site from Bayshore Drive (source: Entrance Opening Strategy – Revision 1.0, December 2021 – Figure 9)

It is noted that both of the entrance opening locations are located to the south of the proposed extension to the geobag coastal protection works.

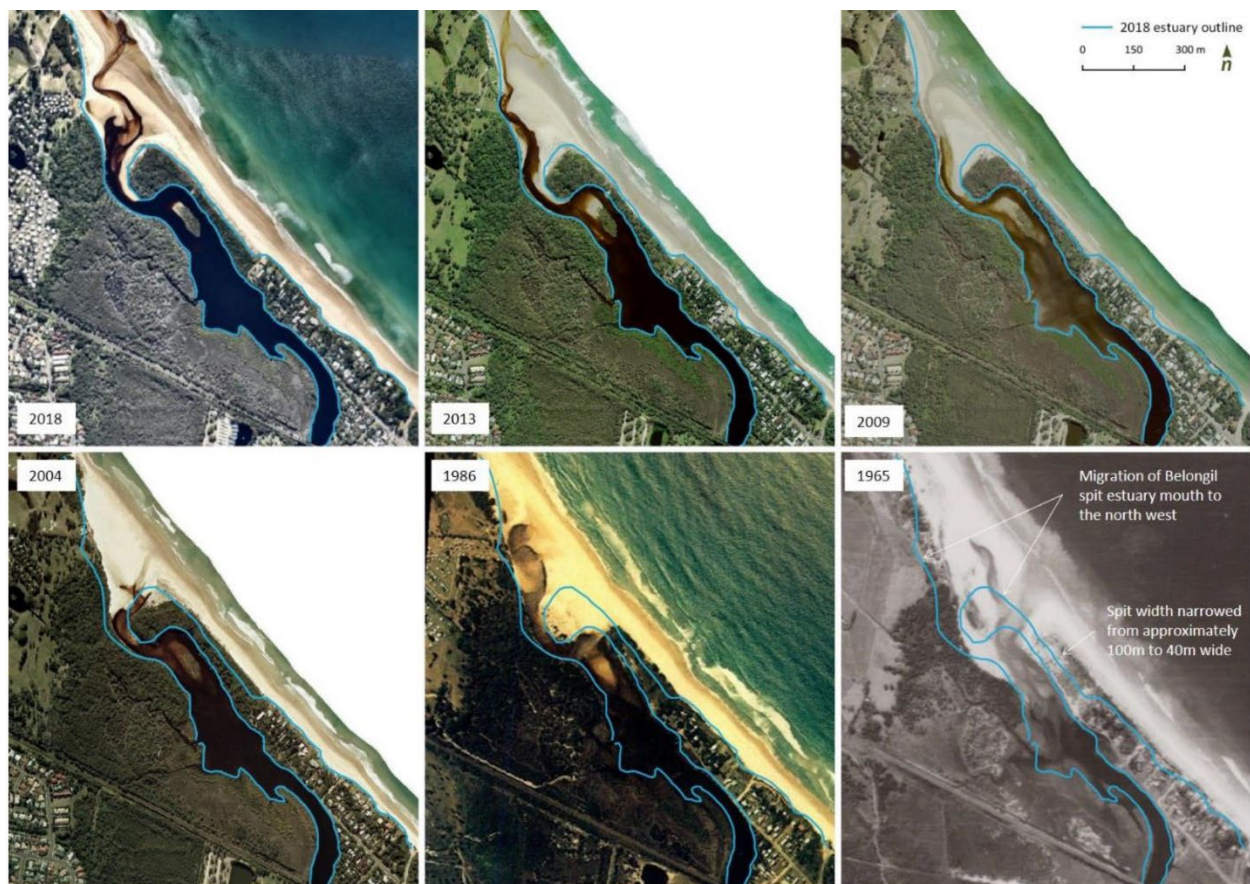
Figure 5-2 Historical aerial imagery comparison in the entrance area of the Belongil Estuary, with 2018 creek and vegetation outline shown in blue (source: Entrance Opening Strategy – Revision 1.0, December 2021 – part Figure 12)

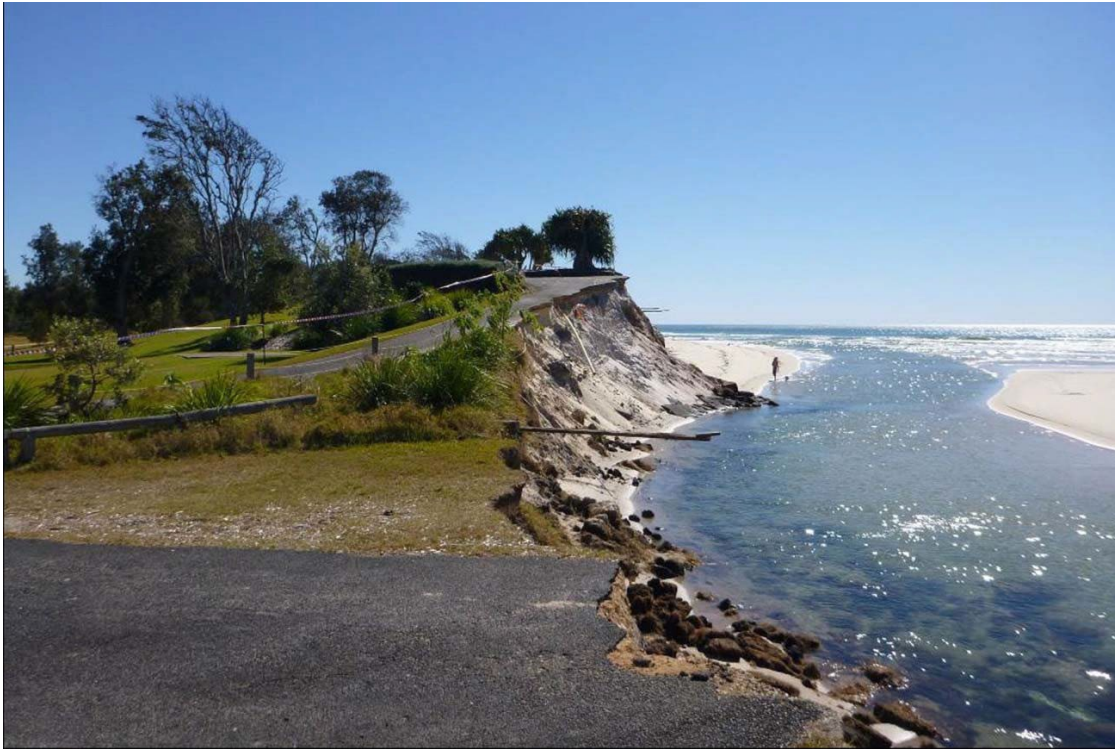
Figure 5-3 Entrance channel migration northwards and erosion of the dunal profile prior to construction of the existing coastal protection works

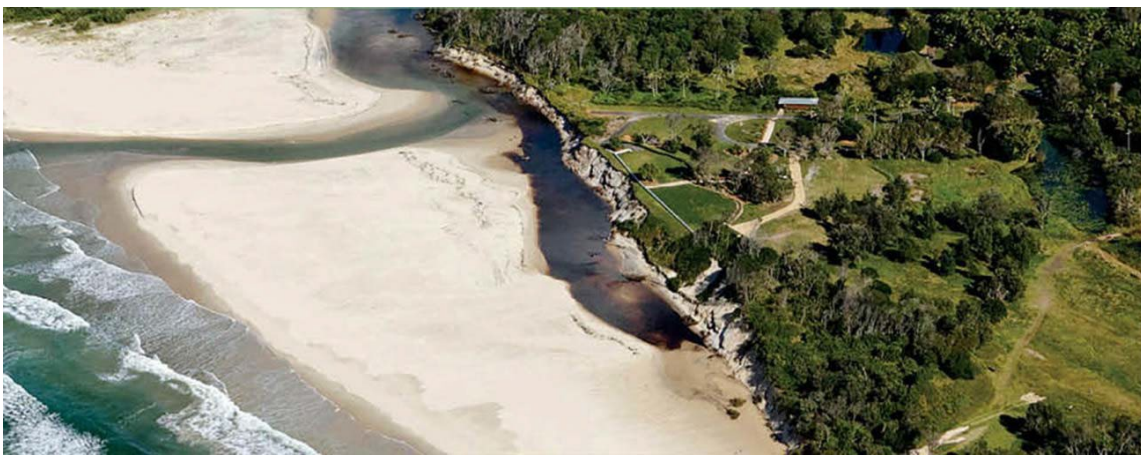
Figure 5-4 Evidence of historic entrance channel migration northwards (now a 'blind' channel) together with an existing channel further south

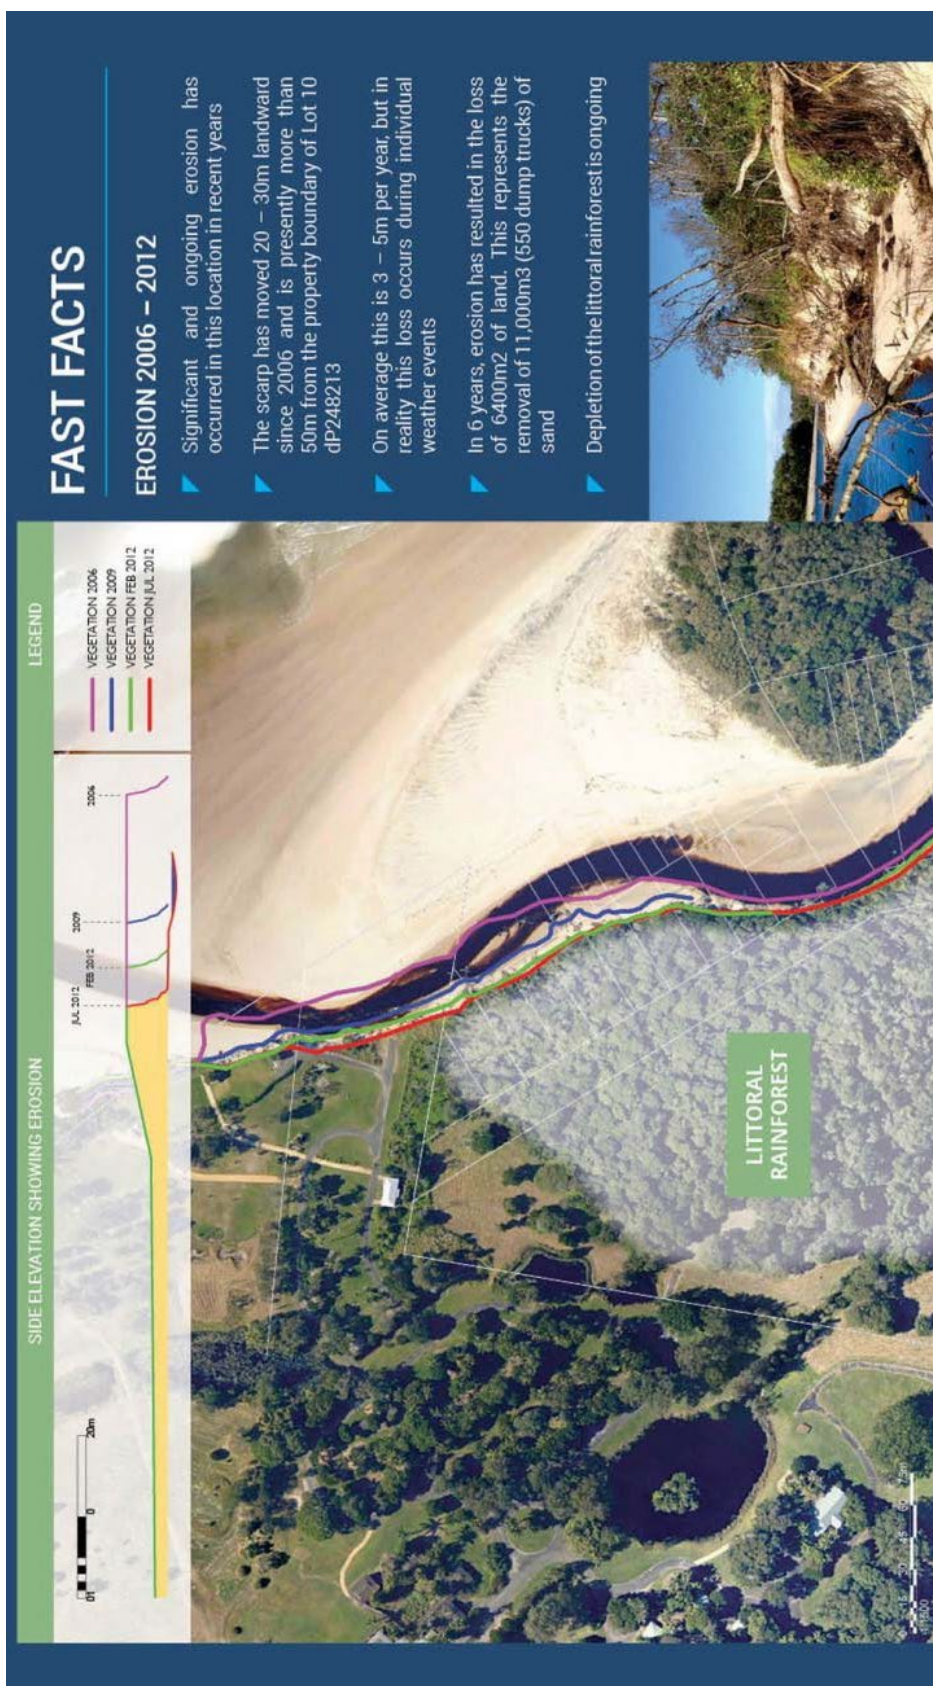
Figure 5-5 Erosion over the period 2006-2012

Erosion in the entrance area over the period 2006-2012 (prior to the existing coastal protection works), represented by movement of the vegetation line, is shown in Figure 5-5, taken from a handout prepared by the then North Byron Beach Resort. A number of 'Fast Facts' are included in the Figure including reference to a total movement of the erosion escarpment over the period 2006-2012 of some 20 to 30m.

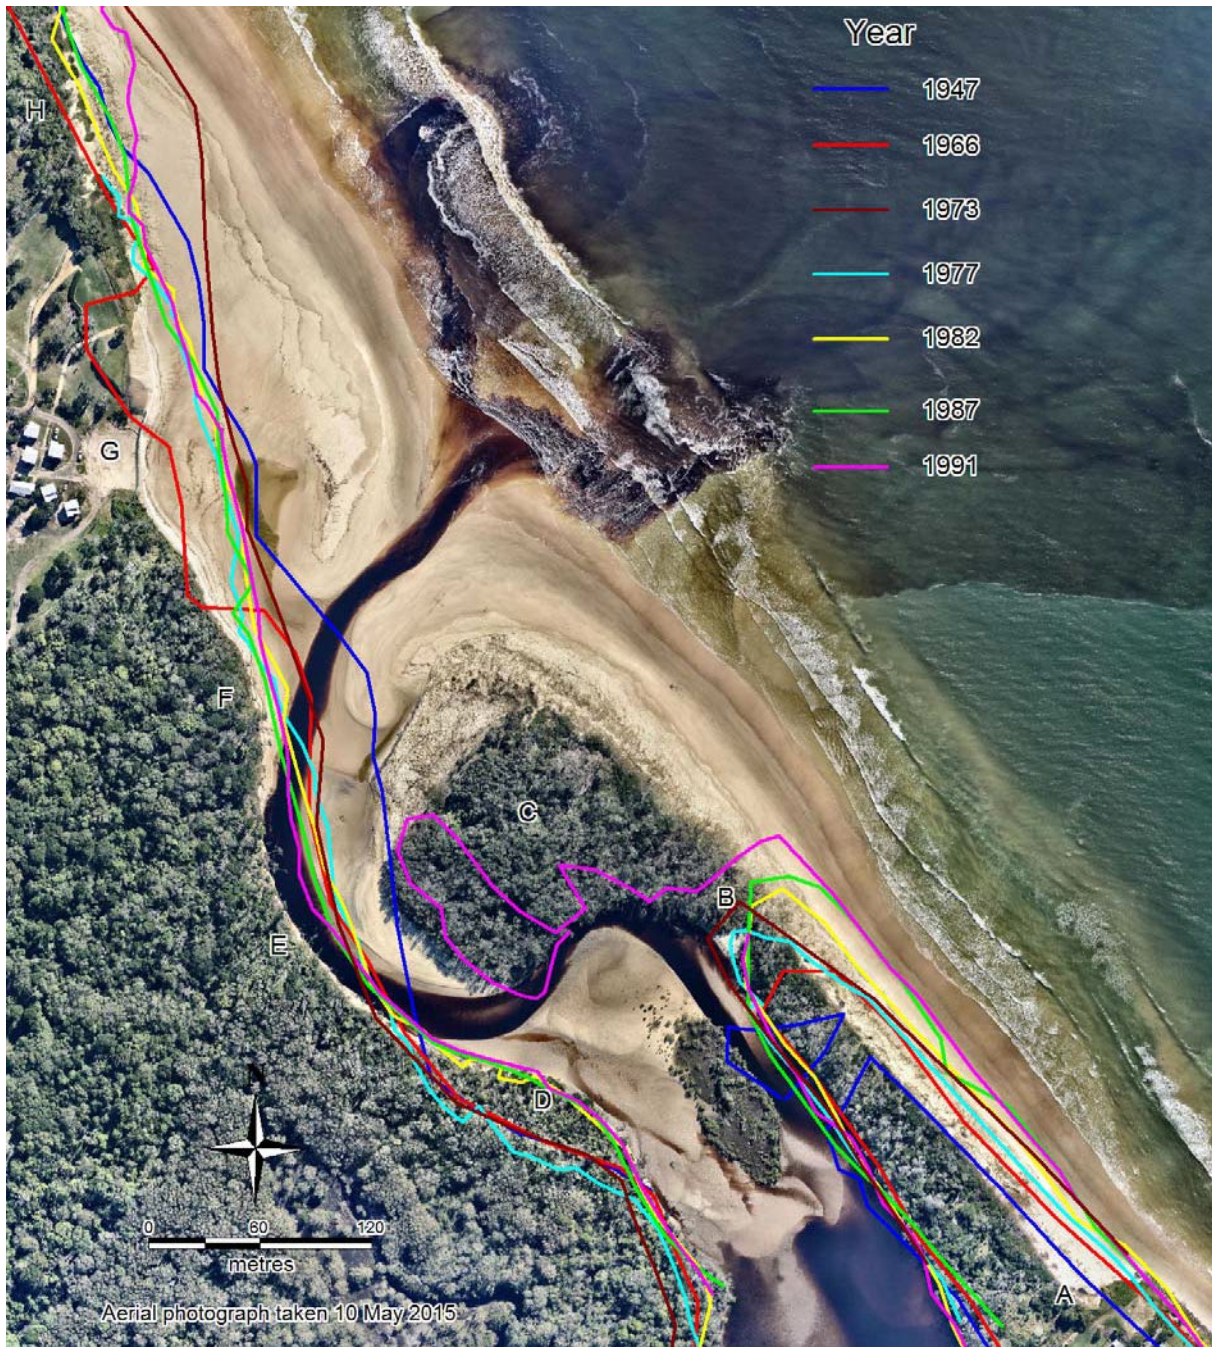
Figure 5-6 Movement of sand/vegetation interface in vicinity of Belongil Estuary entrance from 1947 to 1991

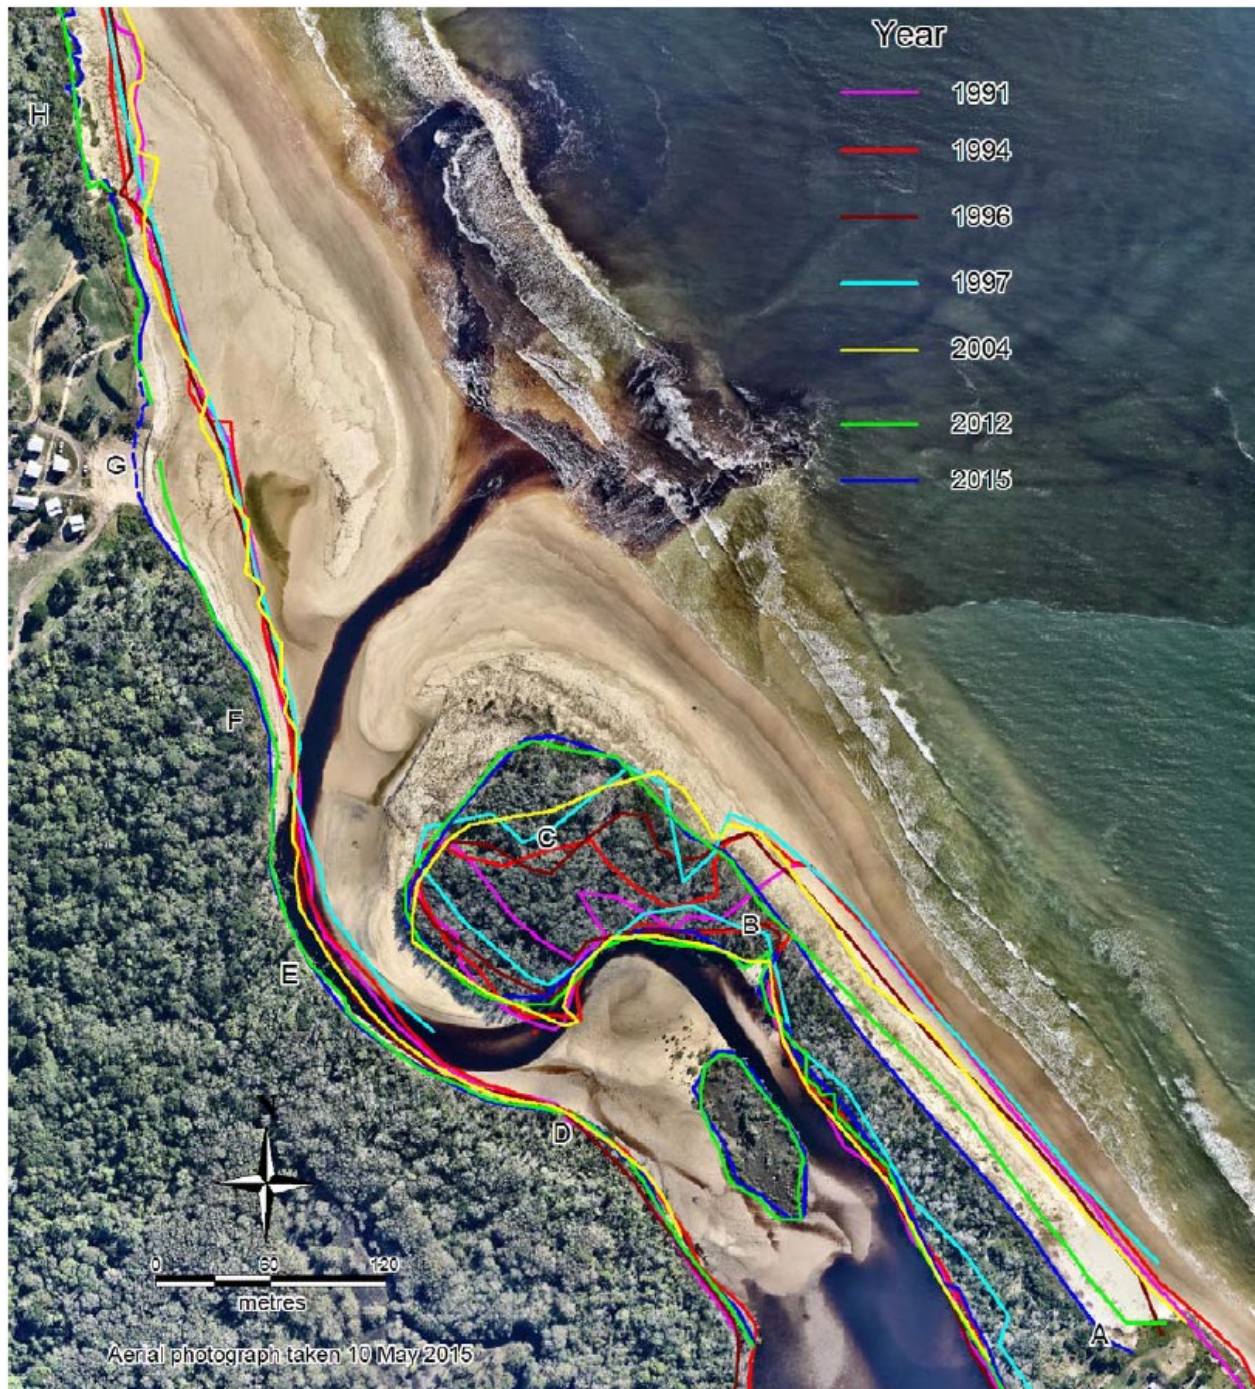
Figure 5-7 Movement of sand/vegetation interface in vicinity of Belongil Estuary entrance from 1991 to 2015

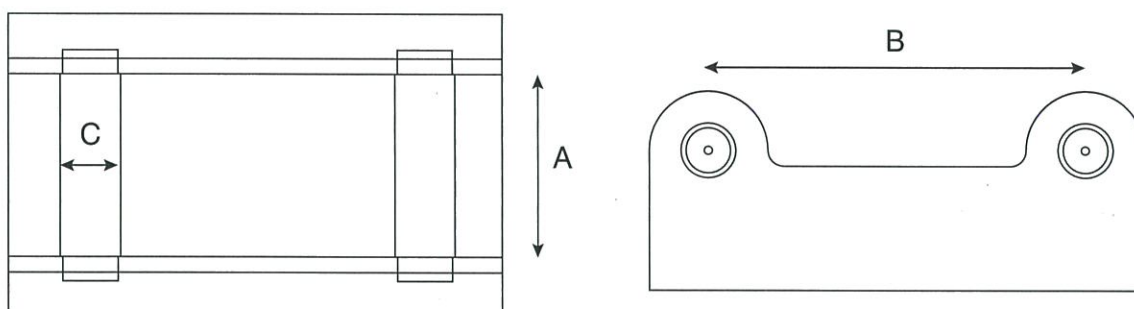
Figure 1: Quick Hitch Dimensions

Code	A Spread	B Pin Centres	C Pin Diameter
QH 141	221mm	407mm	65mm
QH 201	320mm	440mm	80mm
QH 301	350mm	515mm	90mm
QH 351	420mm	585mm	100mm

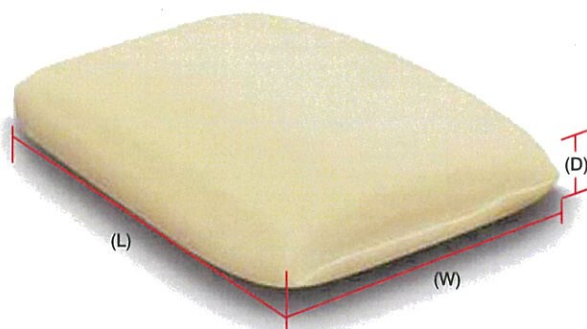
Dimension Range	
Depth (mm)	350-400
Width (mm)	1200-1500
Length (mm)	1600-1800

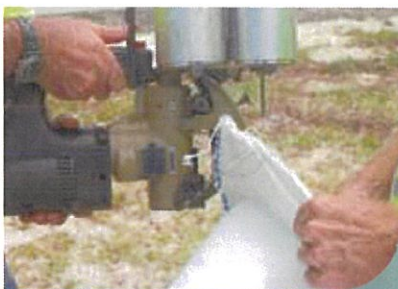
Figure 3.

Start sewing at the factory seamed edge (refer to Figure 3) and sew across the top of the sand container towards the folded edge, crossing first seam at least 5 times (refer to Figure 4 and Figure 5).

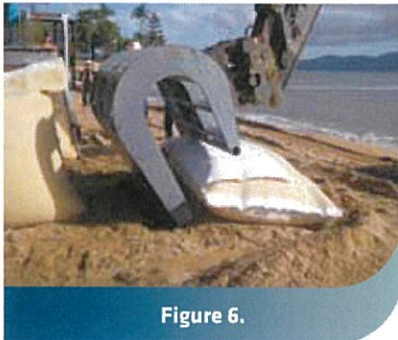
Figure 6.

1. Connect the excavator to the J-Bin quick hitch.
2. Push the container over onto its side, ensuring the longitudinal factory seam is parallel to the ground.
3. Pick up the sand container with the J-Bin (refer to Figure 6).
 - a. Push the nose of the J-Bin down into the sand until the upper bar touches the top of the container.
 - b. Rotate the J-Bin upwards to lift the container.
4. Shake the J-Bin from side to side to remove sand trapped below the container (refer to Figure 7).
5. Walk the excavator into position and place the sand container (refer to Figure 8). A slight backwards and forwards shaking movement of the J-Bin may be required to assist in allowing the sand container to slide forward out of the J-Bin. Ensure site seam is placed so that it is not exposed.
6. Press down on the top of the container using the back of the J-Bin to achieve desired height.
