# Statement of Environmental Effects

## Ricochet Mountain Bike Trail Realignment

Thredbo Alpine Resort  
Kosciuszko National Park, NSW

Project: 23004MO

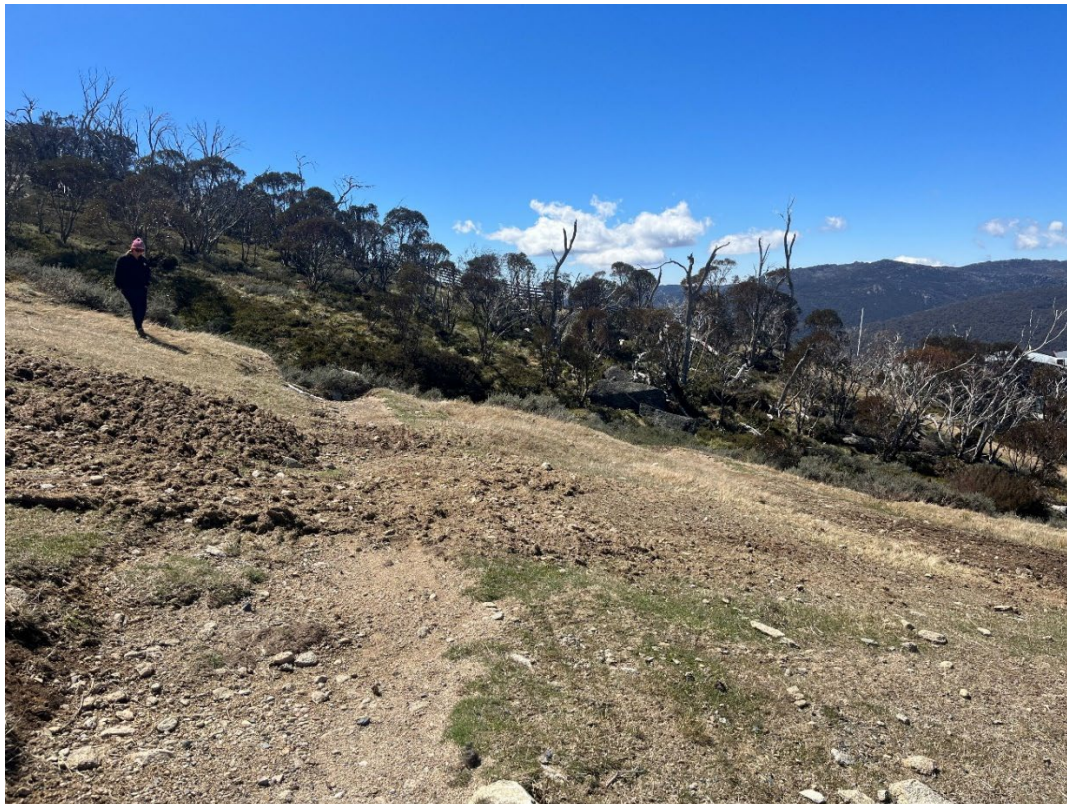
**Plate 1: Trail erosion and rock displacement from existing trail on Lenny's Leap ski run**

The trail realignment in 2020 failed to achieve IMBA guidelines for regular grade changes/reversals as the narrow (vertical) area of the Lenny's Leap ski run does not enable regular grade changes with each trail section on the ski run falling only one way to each corner exacerbating trail water flow/erosion.

During low snowfall winter seasons, exposed rocks from trail and berm construction on Lenny's Leap has created hazards for skiers and snowboarders. This was particularly evident during winter 2023 as documented by Thredbo's Ski Patrollers. The trail remains impacted by multiple road crossings which also creates rider safety concerns when riding at speed. There are several reported incidents in KT's DoneSafe incident reporting database along this section of trail to be closed.

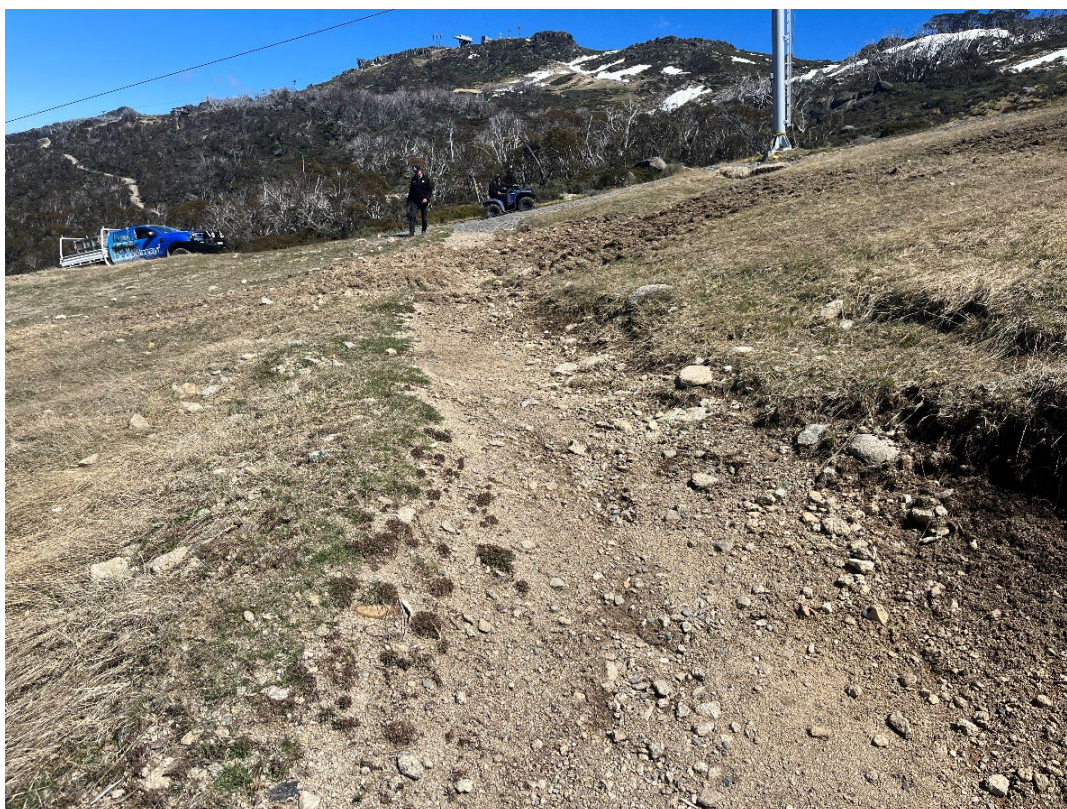
**Plate 2: Trail erosion on Lenny's Leap ski run facing towards Anton's tbar corridor**

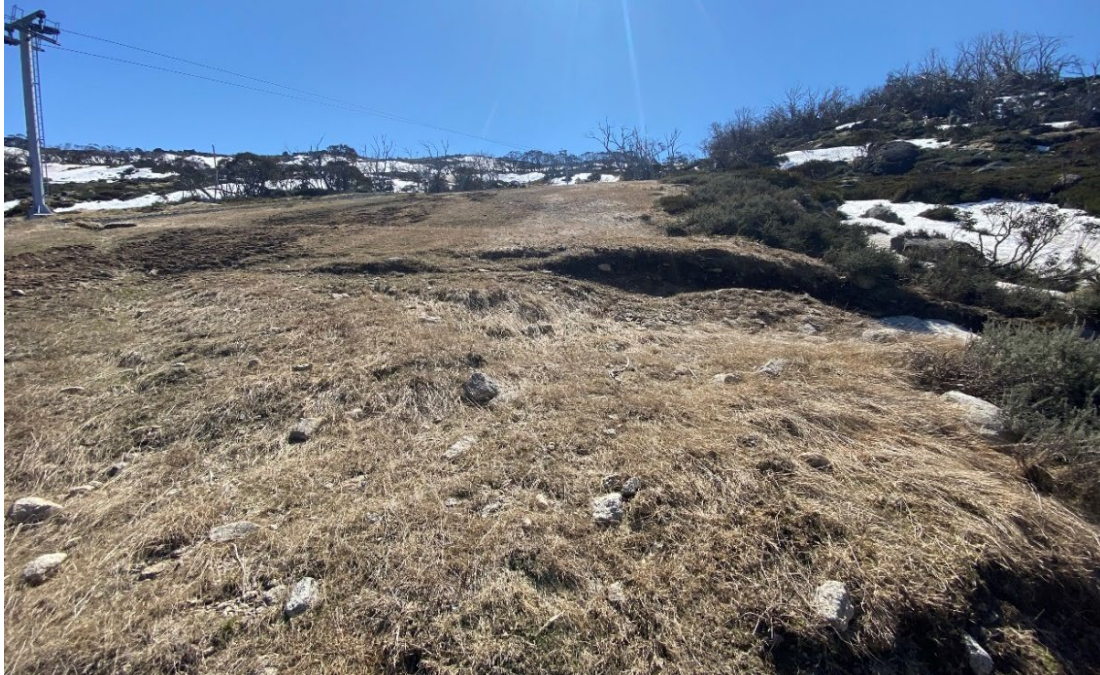
**Plate 3: Evidence of rock displacement associated with existing trail (post-winter 2023)**

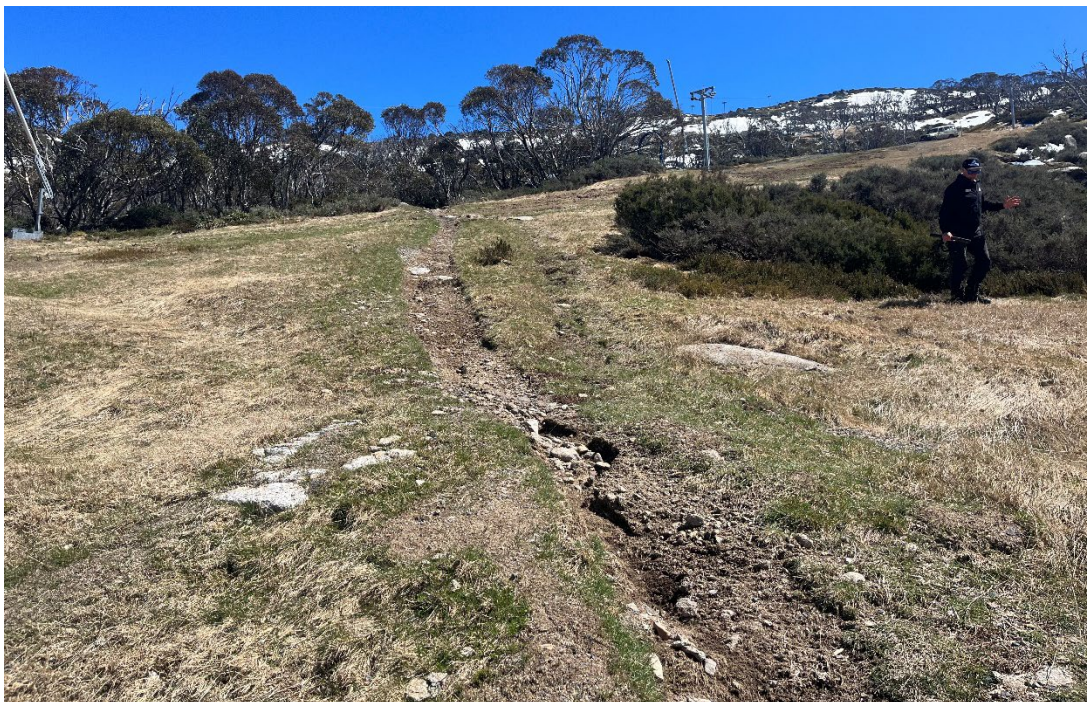
**Plate 4: Ricochet trail erosion and braiding (post-winter 2023)**

The section of trail below Frost Bite to be closed is steep and prone to erosion and trail braiding as shown in **Plate 4** and **Plate 5**.

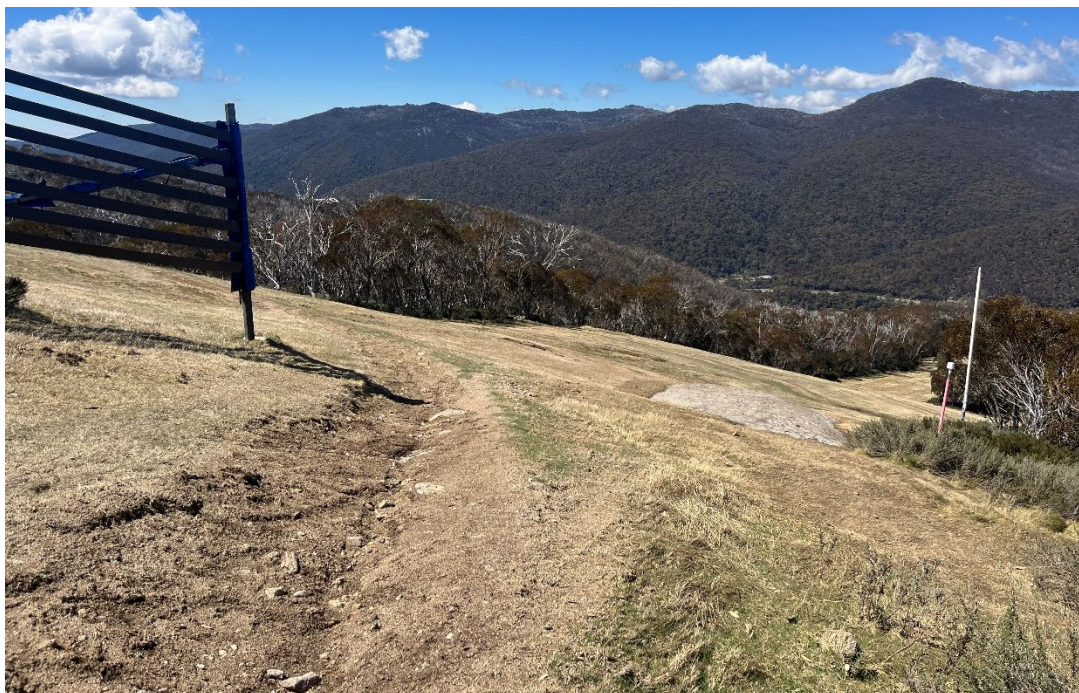
**Plate 5: Ricochet trail channel erosion on the Frostbite crossing (post-winter 2023)**

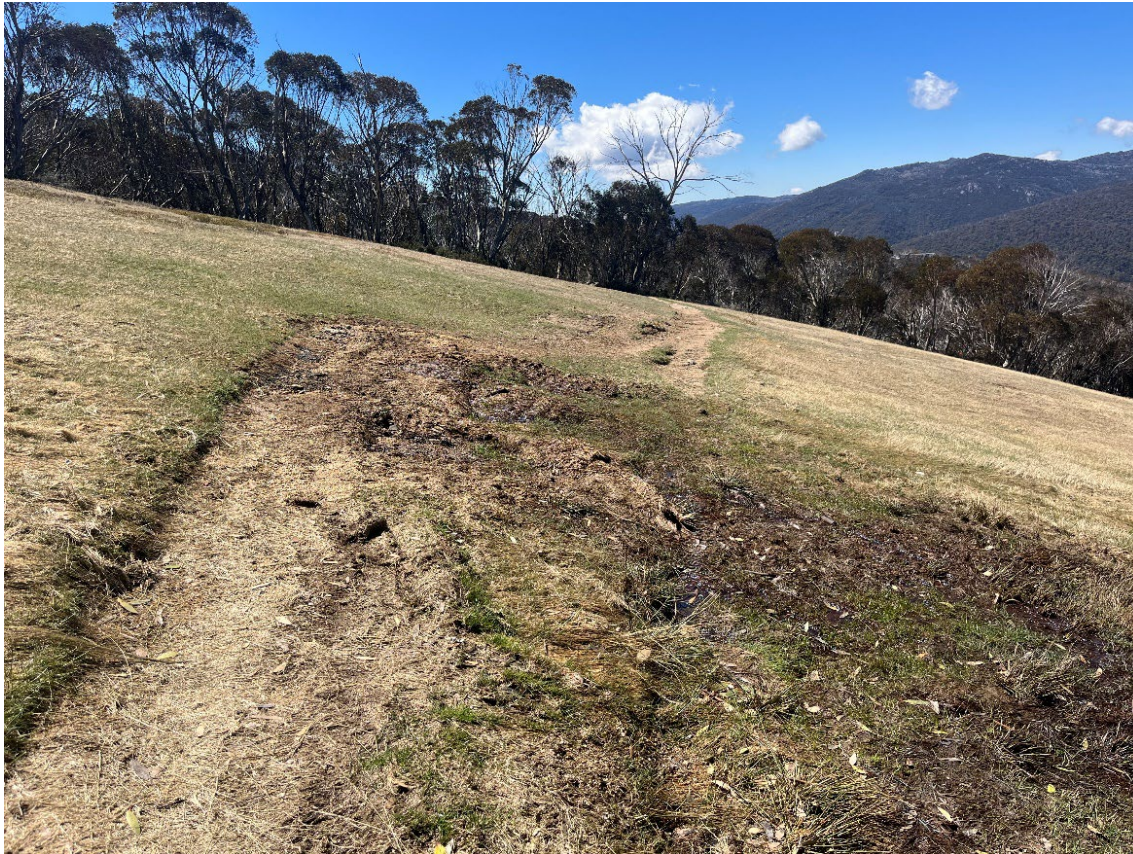
**Plate 6: Ricochet trail wet areas on High Noon ski run (post-winter 2023)**

Sections of the trail on Lenny's Leap and High Noon ski runs contain wet areas (potential springs) which make trail maintenance in these areas difficult (**Plate 6**). Removing the trail from these wet areas will avoid/minimise further environmental degradation in these locations.

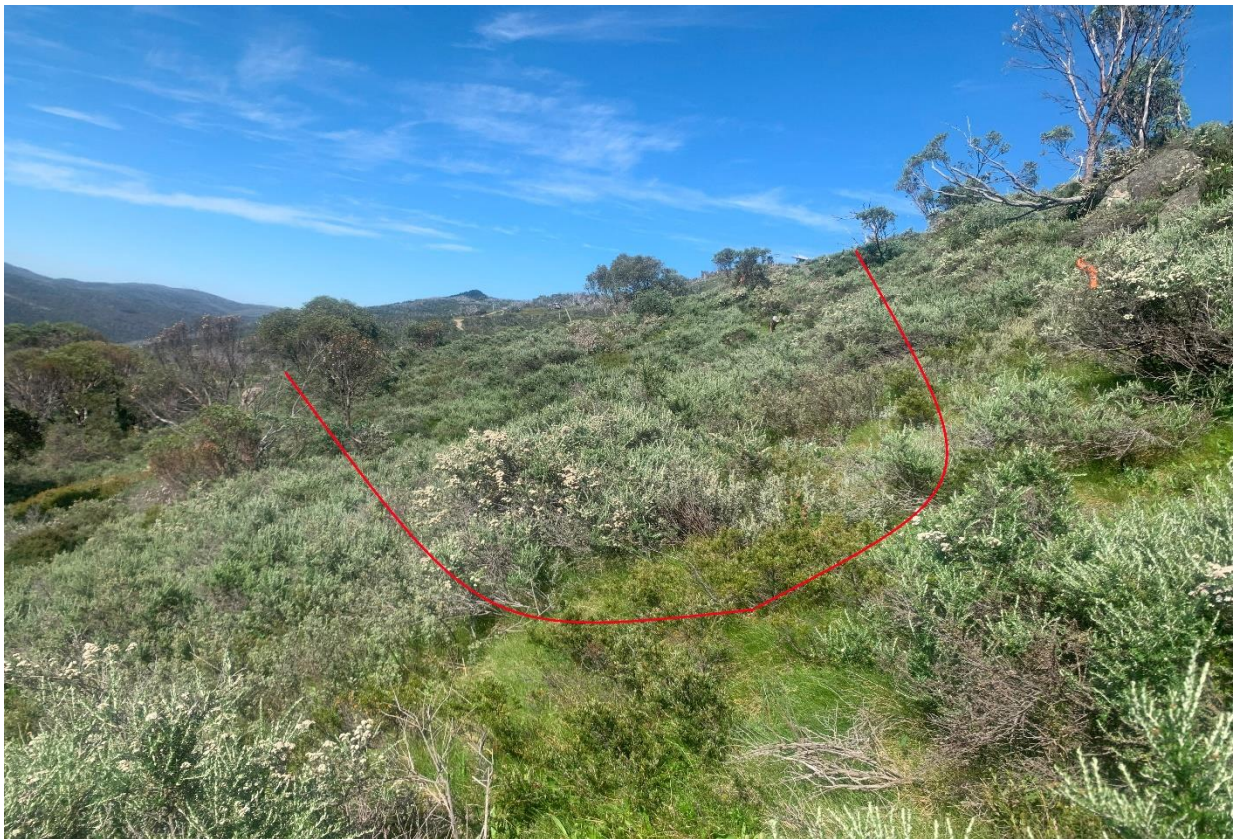
**Photo 4: The trail alignment has been selected to avoid the wet heath that occurs further downslope and to avoid the Anemone Buttercup patches which occur to the east of the proposed alignment.**
