Our ref: 7238-R2
1 August 2023

Kosciuszko Thredbo Pty Ltd / EVT
1 Friday Drive
Thredbo NSW 2625

Geotechnical Assessment for Snowmaking Upgrades - Lower Supertrail Thredbo NSW

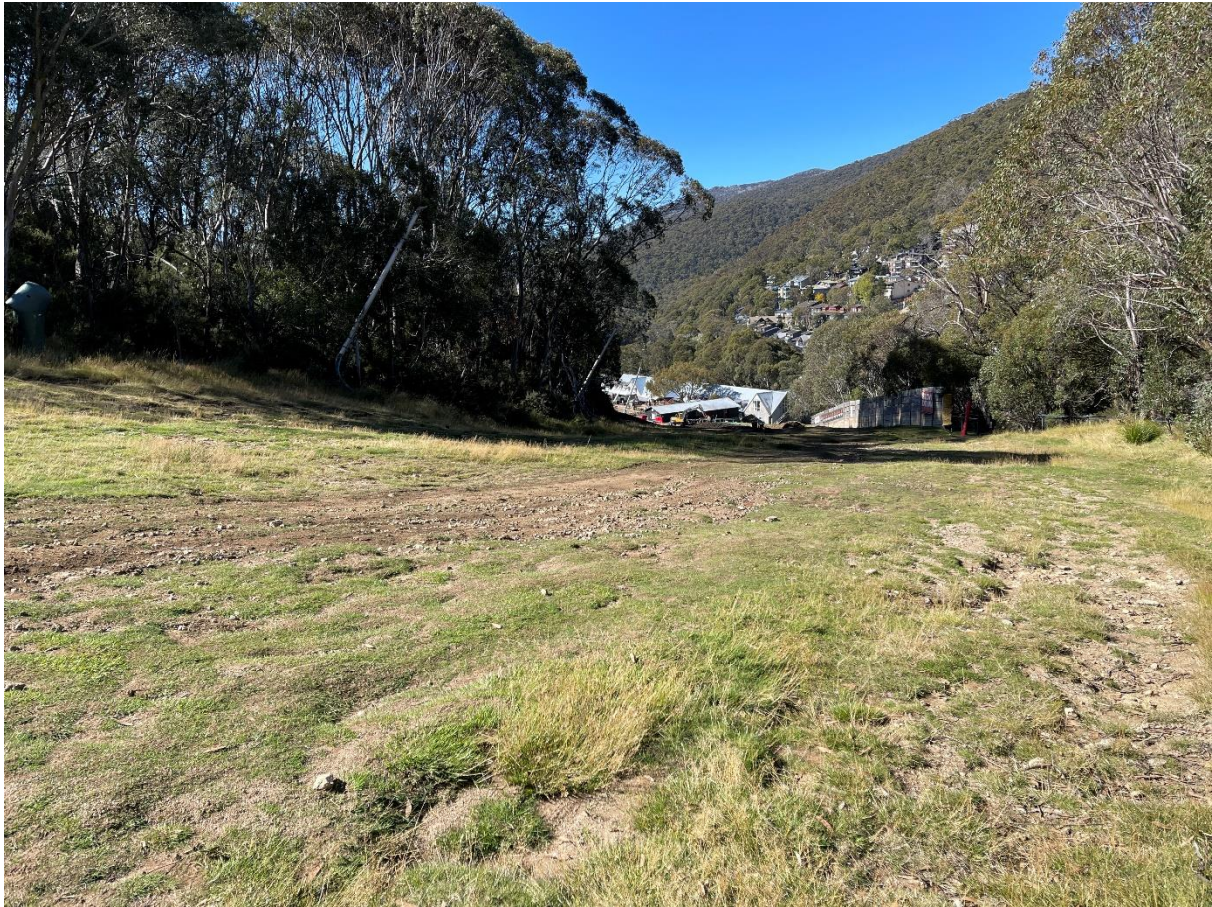
Photo 1 – example of ski slope, Lower Supertrail

Overall ground slopes across the development area are variable and range from about 5° to 20°.

Vegetation comprises short grass over the ski slopes and the terrain in-between is heavily vegetated.

No obvious signs of slope instability were observed during the site inspection. No signs of surface seepage were observed.
