Our ref: 7238-R2  
1 August 2023

Kosciuszko Thredbo Pty Ltd / EVT  
1 Friday Drive  
Thredbo NSW 2625

## Geotechnical Assessment for Snowmaking Upgrades - Lower Supertrail Thredbo NSW

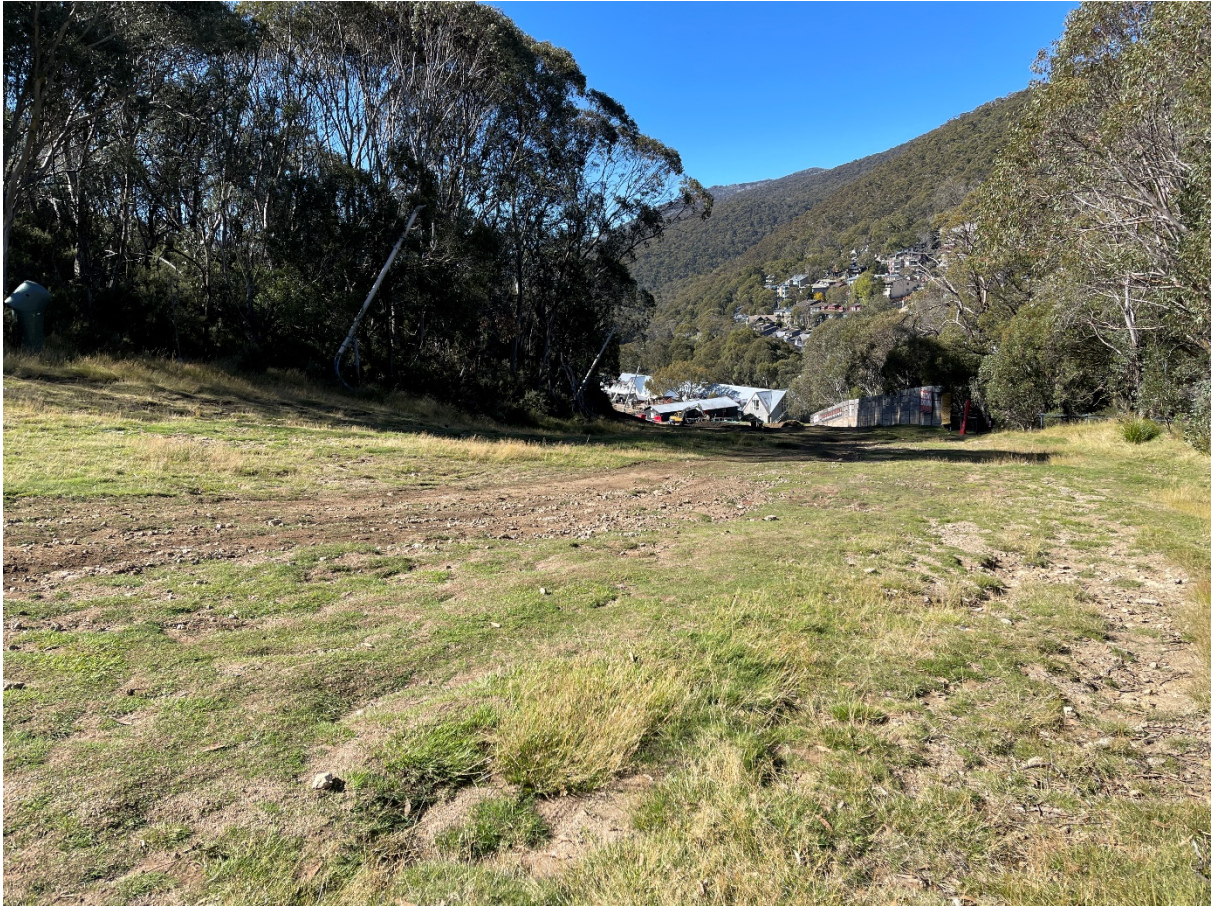
Overall ground slopes across the development area are variable and range from about 5° to 20°.

Vegetation comprises short grass over the ski slopes and the terrain in-between is heavily vegetated.

No obvious signs of slope instability were observed during the site inspection. No signs of surface seepage were observed.

**Photo 1 – example of ski slope, Lower Supertrail**

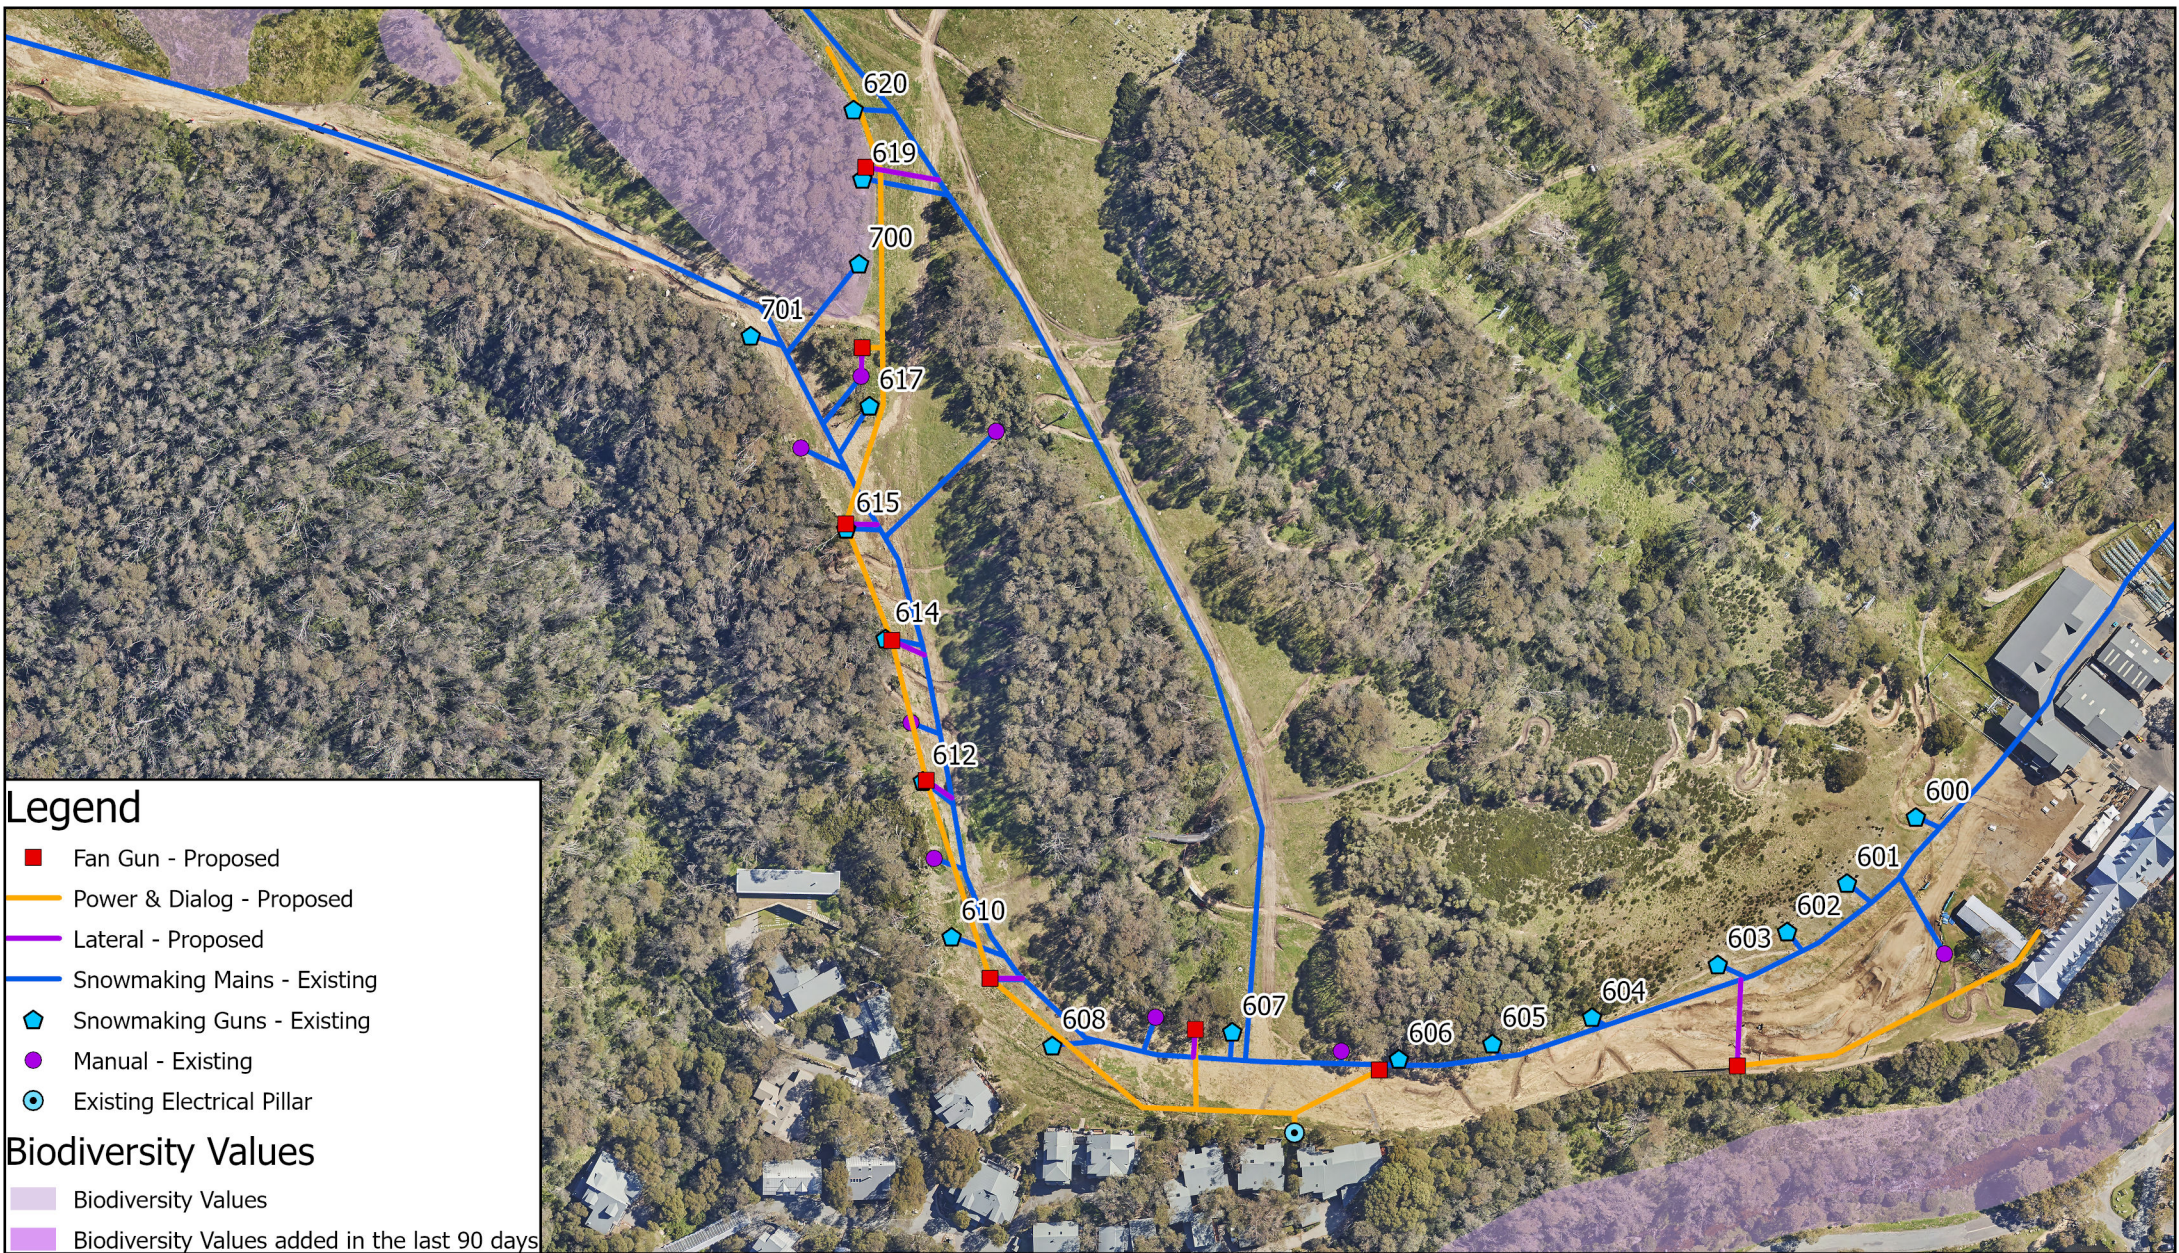
**SITE PLAN**

- trenching for installation of power and data cables adjacent to existing snowmaking mains
- trenching for installation of laterals including water, power, and data to new fan pits
- excavation for installation of fan pits and TT10 fan guns.

The power and data trenches are 1.6 m wide by 0.8 m deep within a construction corridor up to 6 m wide. Lateral trenches are 0.8 m wide by 1 m deep within a construction corridor up to 3 m wide. The fan pits are approximately 1.6 m x 1.6 m wide with a construction footprint approximately 3 m x 3 m wide and 1.6 m deep and the TT10 fan guns are located on top of the fan pits.
