Project Plan

Progressive Rural Solutions Pty Ltd PO Box 74, DENILIQUIN NSW 2710 Ph. 0408577248 ACN: 634 646 825 ABN: 58 634 646 825 Email: admin@prsltd.com.au Web: www.prsltd.com.au		Scale: As shown	Sheet Size: A3	Drawing No.-J322-Plan_site-		
Date:	16/04/2024	Client:	Overport Pty Ltd	Version	Date	Amendment
Property:	140 Louis Hut Rd Moama	Project:	Mooring and BLR Pump	V1R1	05/01/24	Initial Plan
Plan Type:	Site Plan - Proposed	Plan Description:	Proposed Site Plan	V1R2	16/04/24	Draft for client review
				V1R3	14/06/24	Final for lodgement

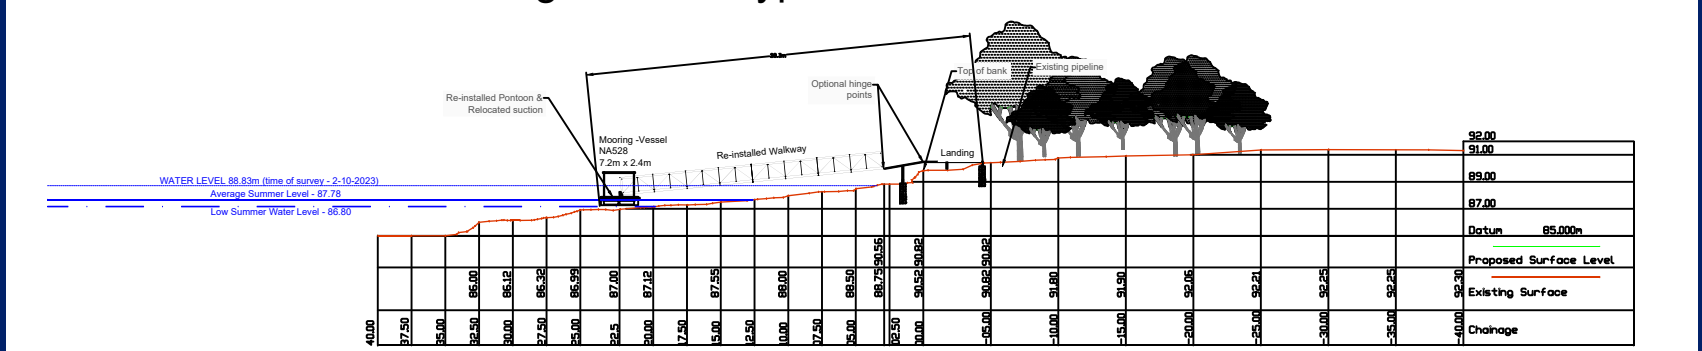
Site configuration in typical summer conditions

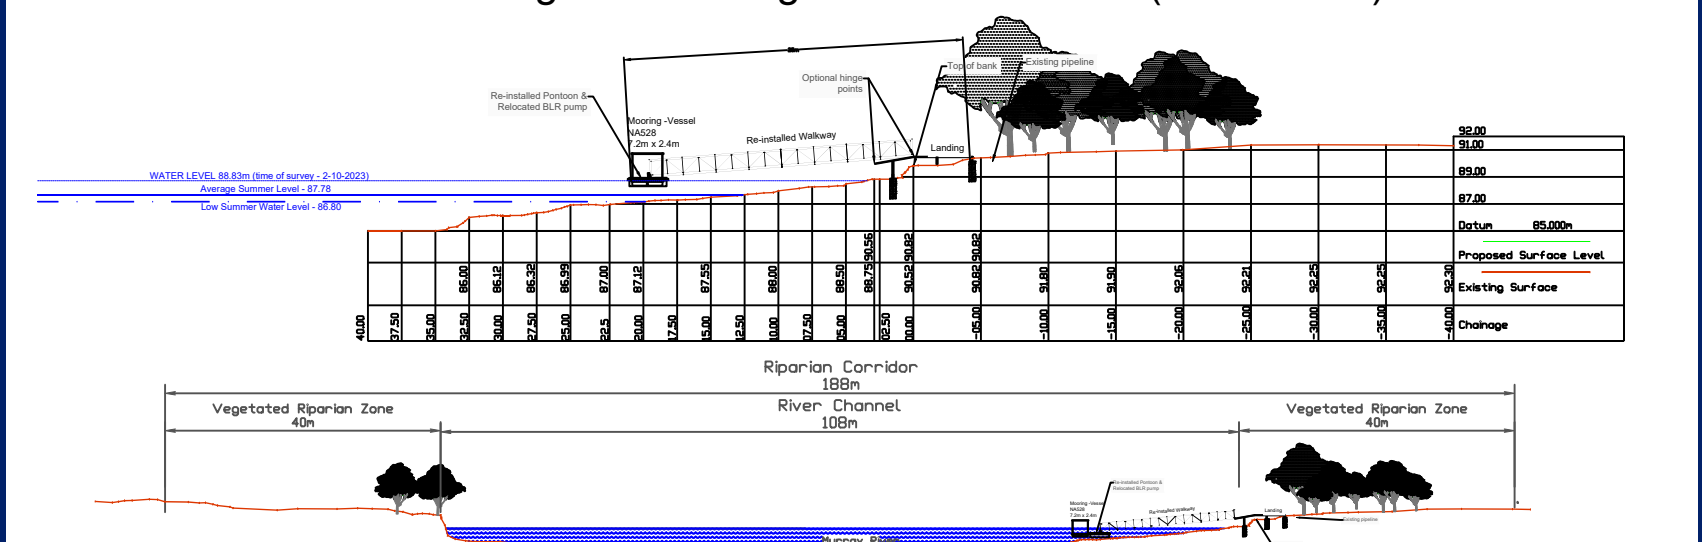
Site configuration in high River conditions (minor flood)
