SOUTH ELEVATION ALPINE HOTEL

CONCEPT

CLADDING REPLACEMENT THREDBO ALPINE HOTEL 17 Friday Dr, Thredbo NSW 2625

DESCRIPTION **ELEVATIONS - SHEET 7**

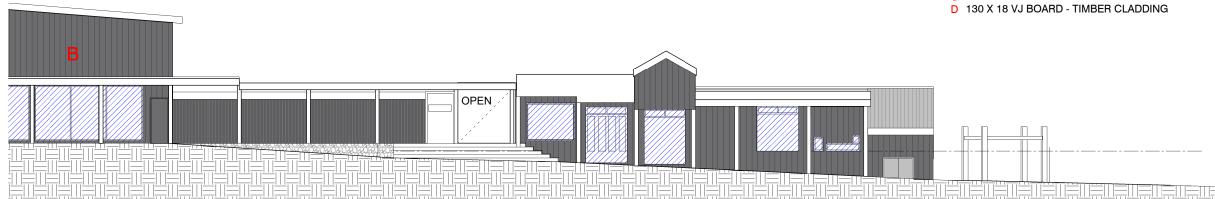
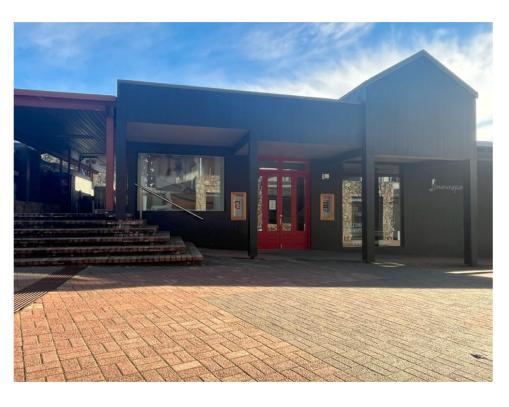
ELEVATION - SOUTH - VIEW 2

EXISTING WALL CLADDING CONDITIONS KEY

- A 145 X 20 HARDWOOD TIMBER (130 COVER) SHIPLAP
- B 145 135 x 20 HARDWOOD TIMBER BOARD ON BOARD
- C CORRUGATED STEEL CLADDING

- REPLACE EXISTING HARDWOOD CLADDING WITH
 NEW COLORBOND V25 PROFILE METAL CLADDING MATERIALITY AND COMPLIANCE TO BE ENSURED PRIOR TO CONSTRUCTION CERTIFICATE.
 EXTERNAL PAINT FINISH TO MATCH EXISTING BASALT COLOUR.

- EXISTING WINDOWS LOCATED IN CLADDING
- WINDOW TO BE REPLACED IF LOCATED WITHIN PROPOSED NEW CLADDING
- NEW WINDOWS WILL COMPLY WITH AUSTRALIAN STANDARDS 3959 CONTRUCTION OF BUILDINGS BUSHFIRE-PRONE AREAS
