# MOD 24/14675 (DA 6877 MOD 2) – Request for Additional Information Response, Village Green Enhancement Project

This document has been prepared in response to the Request for Additional Information, MOD 24/14675 (DA 6877 MOD 2) – Village Green Enhancement Project, Thredbo Village issued by the Department of Planning, Housing and Infrastructure (DPHI) on 20 December 2024.

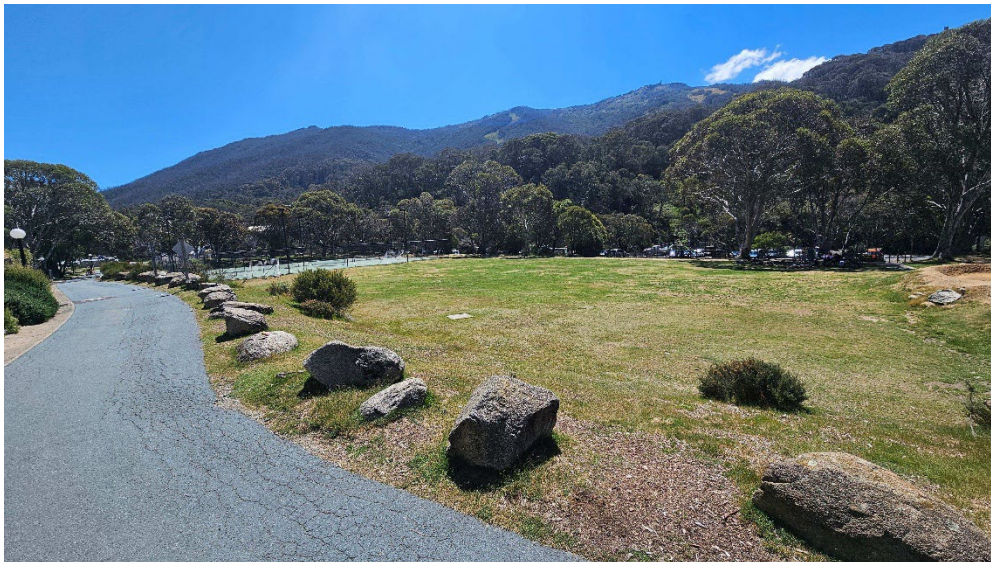
- a) Refer to the updated Geotechnical Assessment (Assetgeoenviro 2025) for detail details.
- b) The track disturbance is detailed in the MOD report (approx. 4m). The Site Plan has marked a slightly larger footprint to allow for construction. No updates to the Site Plan are required. The new access road will operate similar to the existing. No gates or bollards required.
- c) Refer to the update Geotechnical Assessment for details. Boulders will be placed along the edge of the track, similar to those lining/defining the edge of Thyne Reid Drive, see example in Figure 1.

*Figure 1: Example of boulders lining Thyne Reid Drive*
