BUSHFIRE CERTIFICATE

PROPOSED NEW DWELLING

**LOT 11 SEC R DP 8287
243 Warri Street, Pindimar**

NEWCASTLE BUSHFIRE CONSULTING

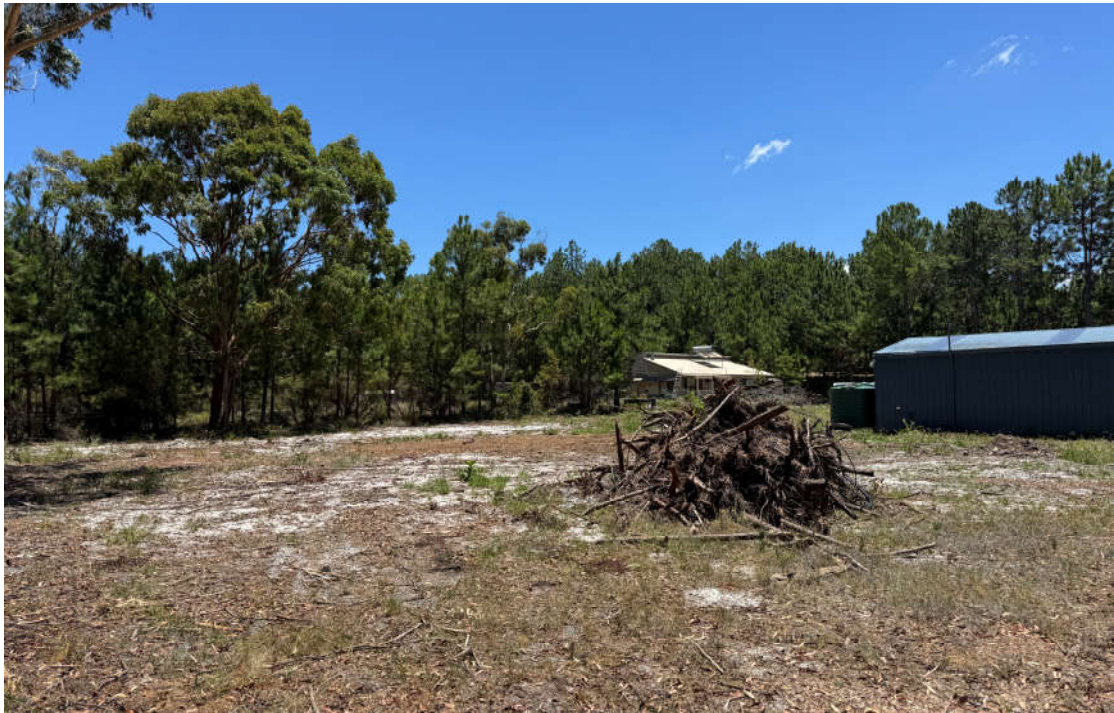
PHOTO 1 - SITE PHOTO LOOKING NORTH

View of the subject site looking north. Existing dwellings surround the site to the north and west. It is noted that the properties to the east and west have poor landscaping management and have been classified as grassland where clearing has occurred in the past.

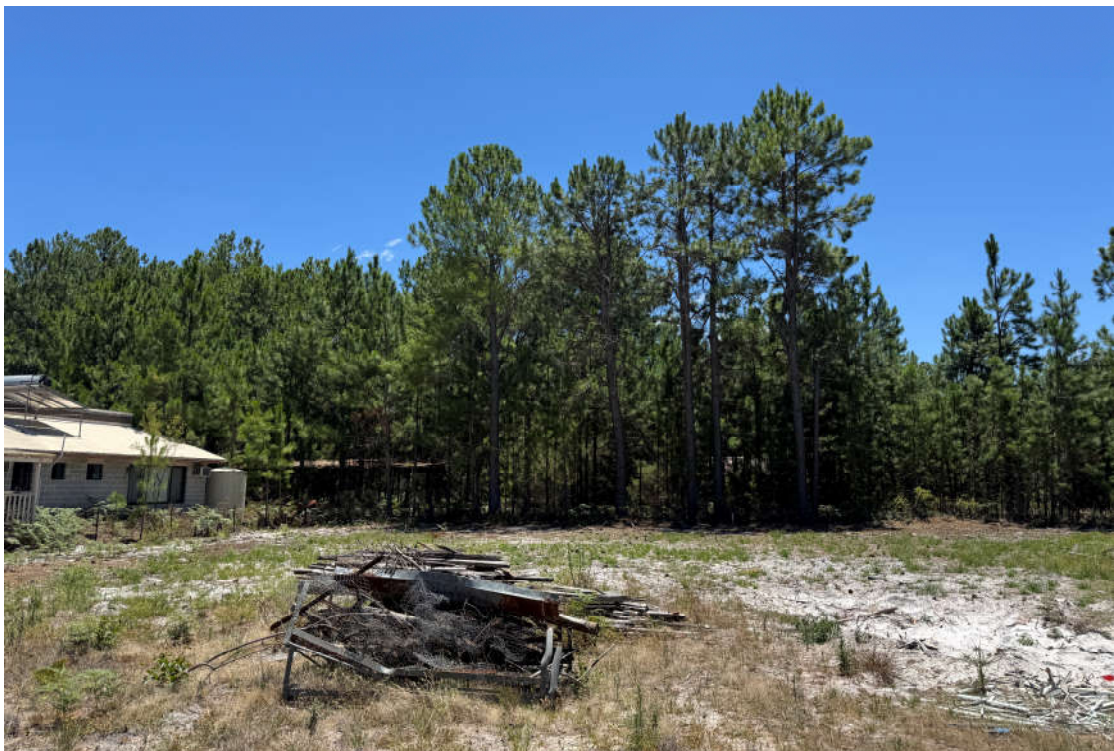
PHOTO 2 - NORTHERN FOREST AND NEIGHBOURING DWELLING

View of forest located and neighbouring dwelling located north of the site. Pine trees dominate the tree canopy with a grassy understorey.

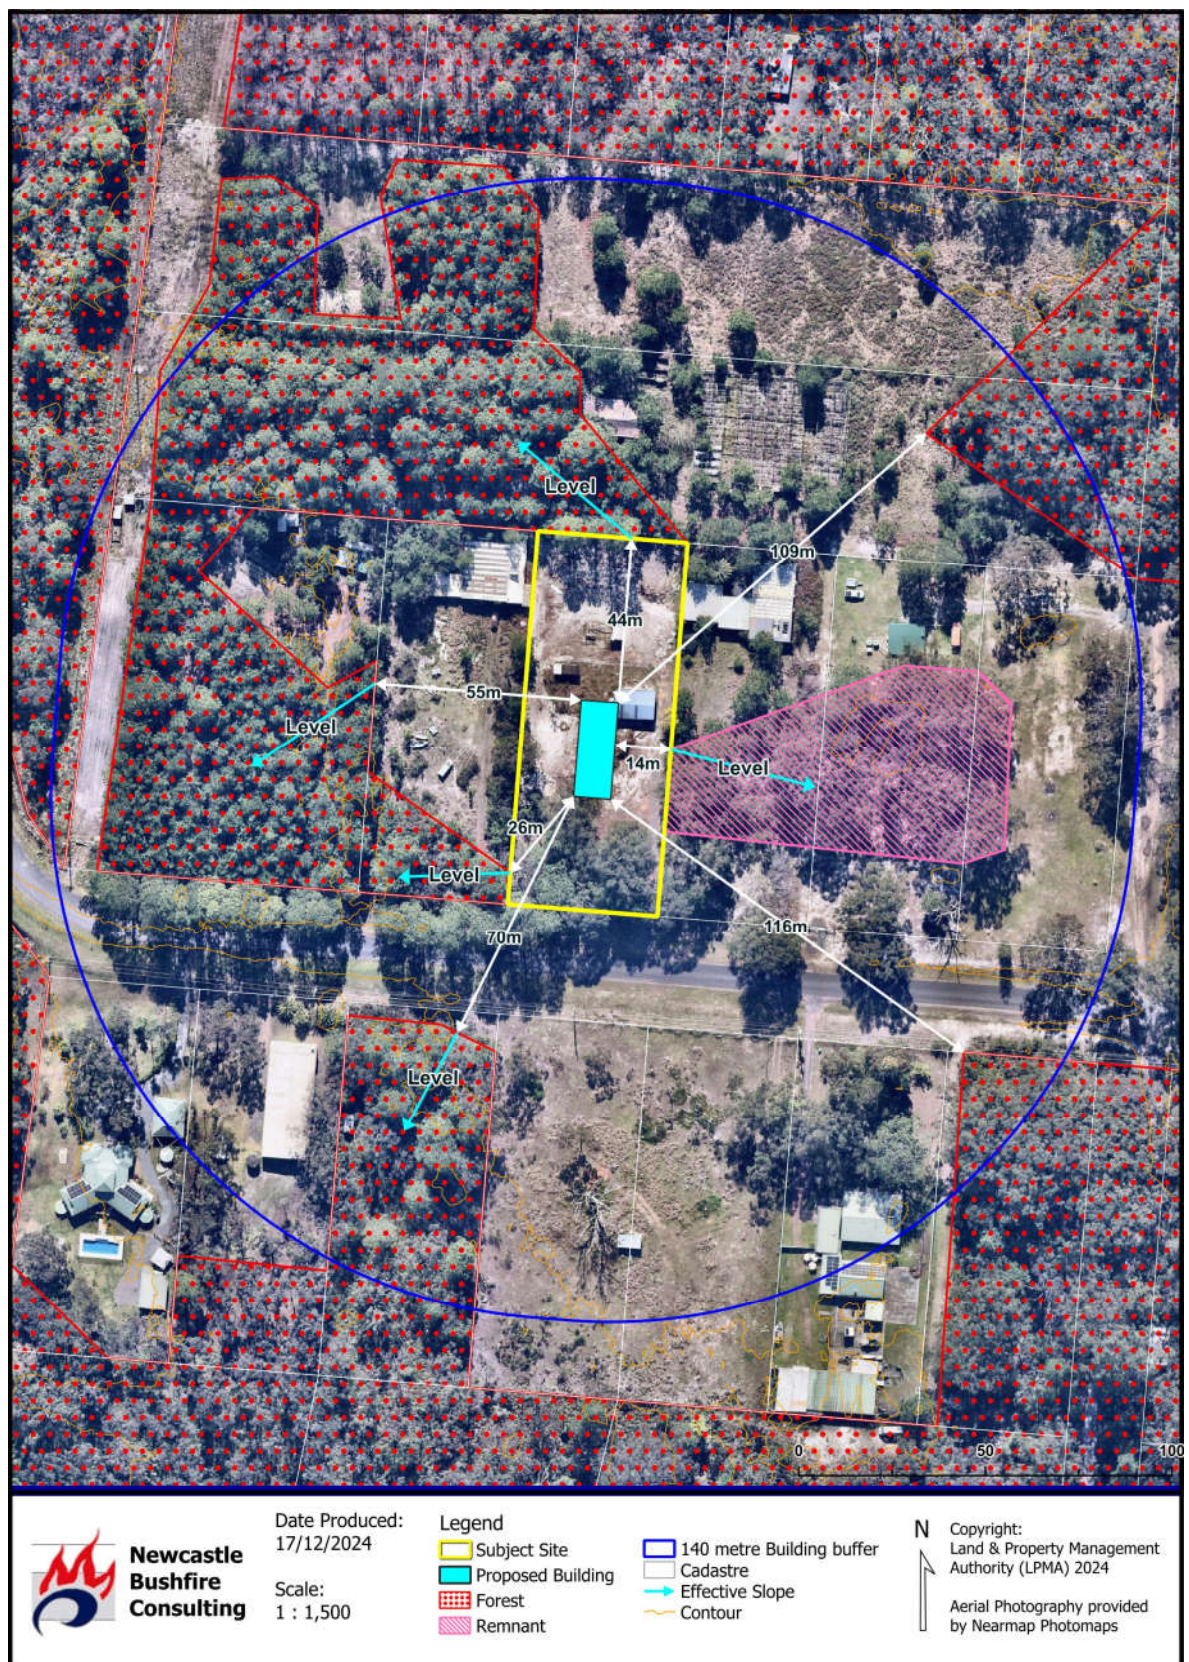
FIGURE 1 – SITE CONSTRAINTS MAP

Primary vegetation structures have been identified in Figure 1 – Site Constraints Map and separation distances shown in Table 2 – Bushfire Attack Assessment.

Effective Slopes have been identified in Figure 1 – Site Constraints Map and slope ranges are shown in Table 2 – Bushfire Threat Assessment.

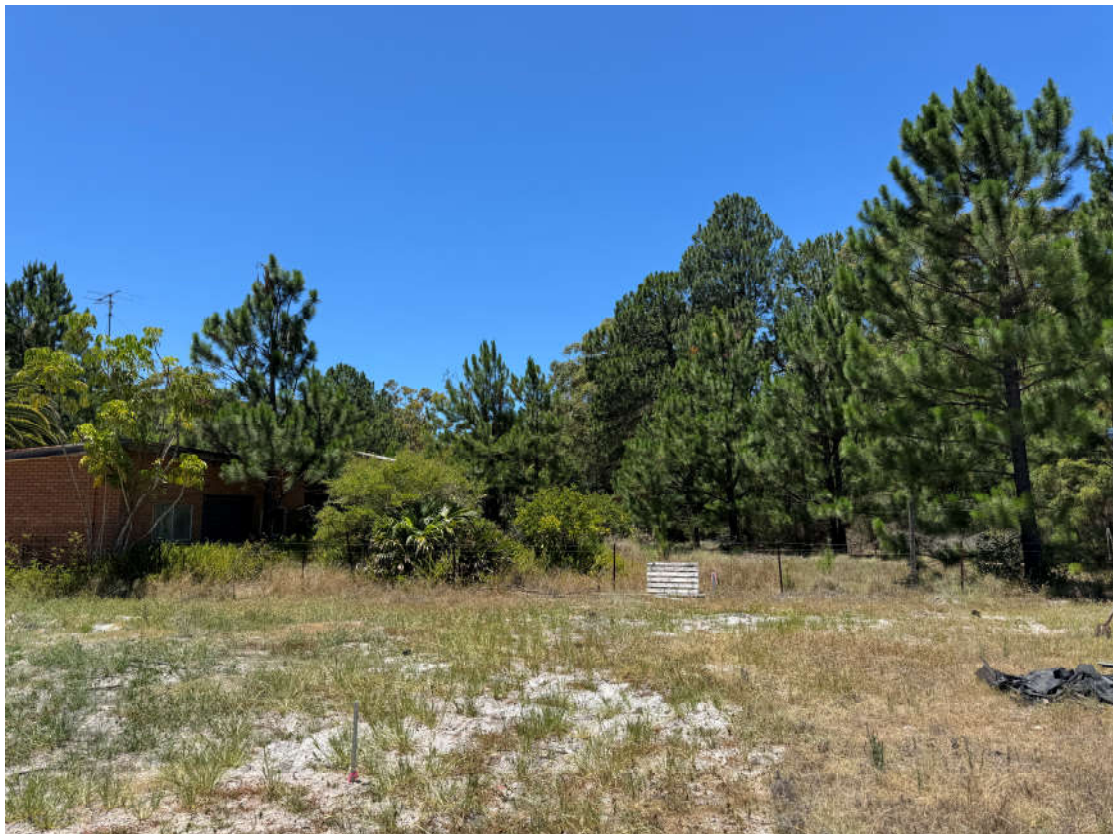
PHOTO 3 - EASTERN NEIGHBOURING DWELLING AND FOREST REMNANT

View of eastern neighbouring dwelling and forest remnant. The remnant is less than 1 hectare in size and has been assessed as equivalent to rainforest BAL.
