BUSHFIRE CERTIFICATE

PROPOSED NEW DWELLING

**LOT 20 DP 1121265
69 Durham Road, East Gresford**

Date: **23/05/2025**

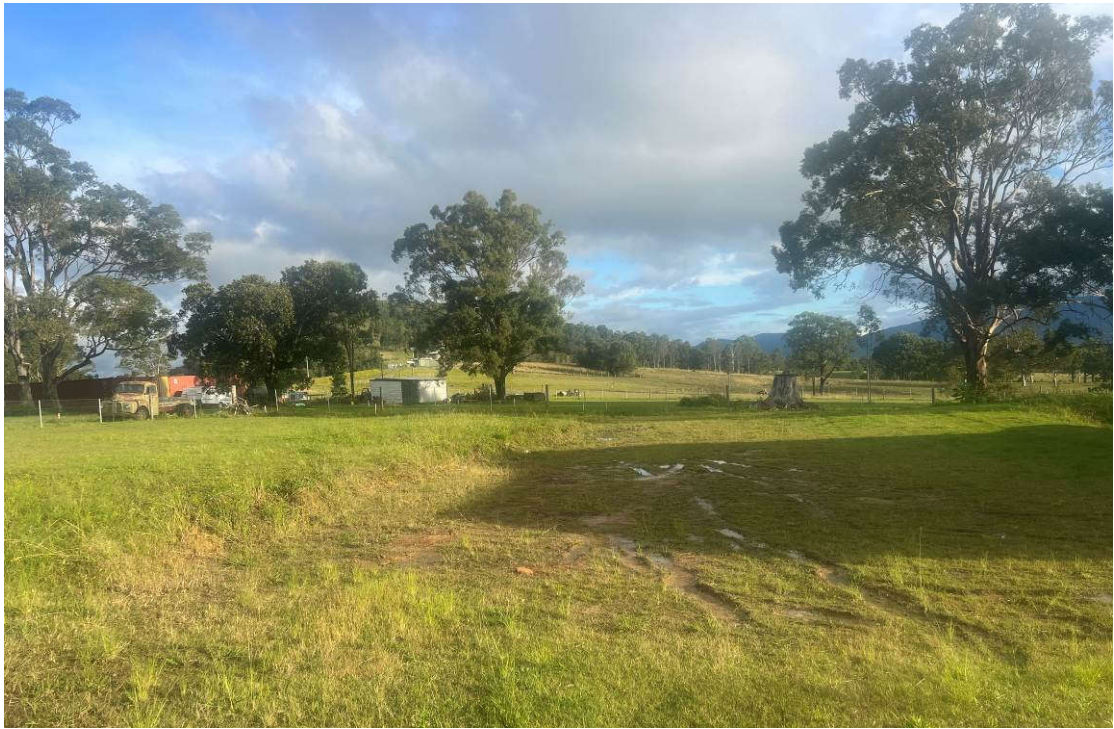
PHOTO 1 - SITE PHOTO LOOKING SOUTH

View of the subject site looking south. A mown fenced paddock can be seen to the south with grazing pasture in the distance.

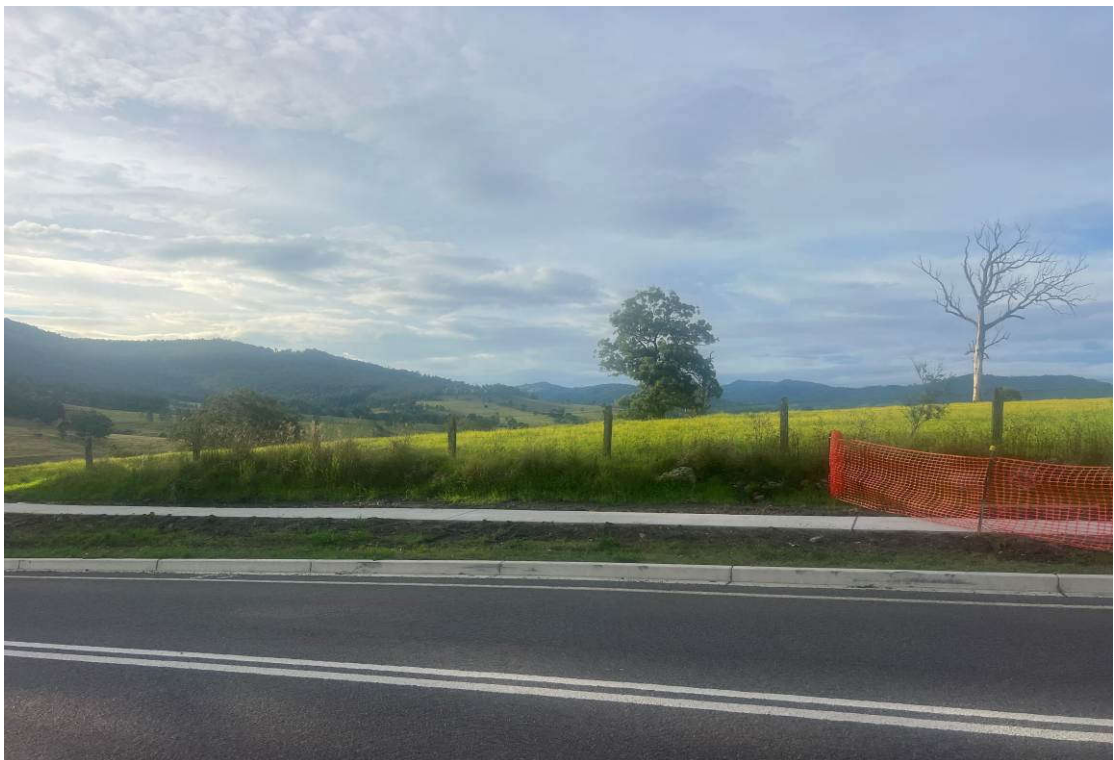
PHOTO 2 - NORTHWESTERN GRASSLAND

View of grazing pasture located northwest of the site. The grass is short-cropped grass less than 30 centimetres in height.

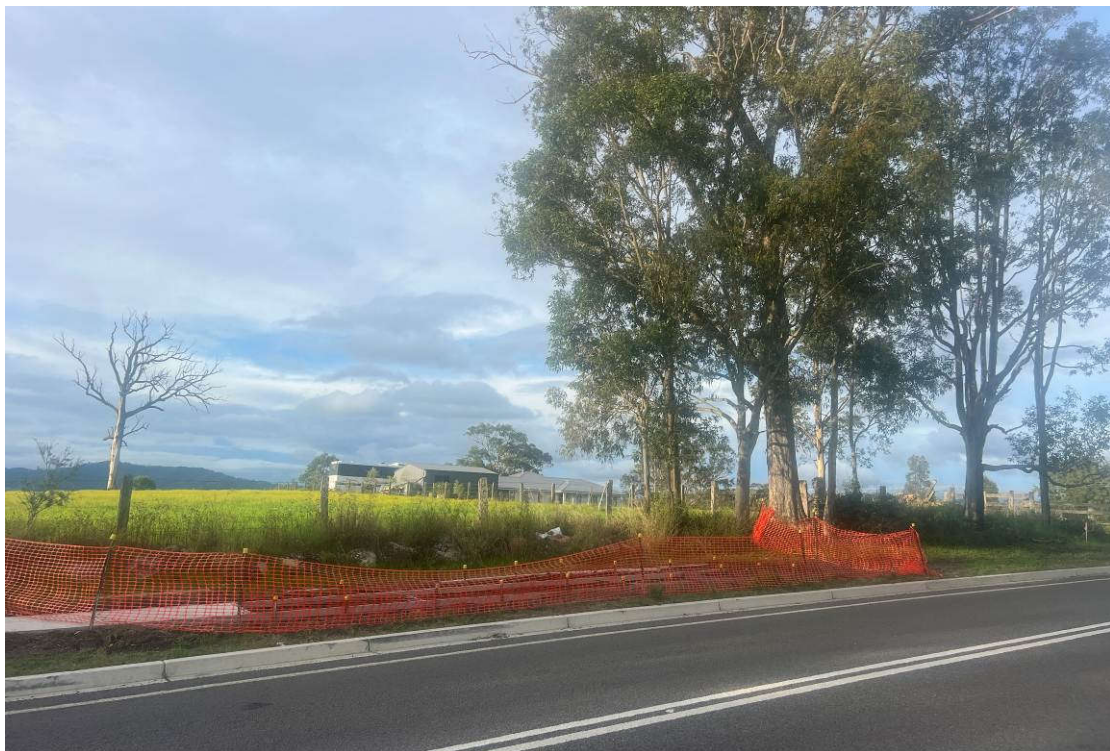
PHOTO 3 - NORTHERN GRASSLAND

View of grassland located north of the site and recently constructed dwelling to the northeast.
