# ***BOREHOLE & LABORATORY TEST REPORT***

LOT 18 91 WINDSOR ROAD PADSTOW

**DATE :** 25/06/2025  
**OUR REFERENCE:** 105216FO  
**YOUR REFERENCE:** LE HOANG  
**LOCATION:** LOT 18 91 WINDSOR ROAD PADSTOW

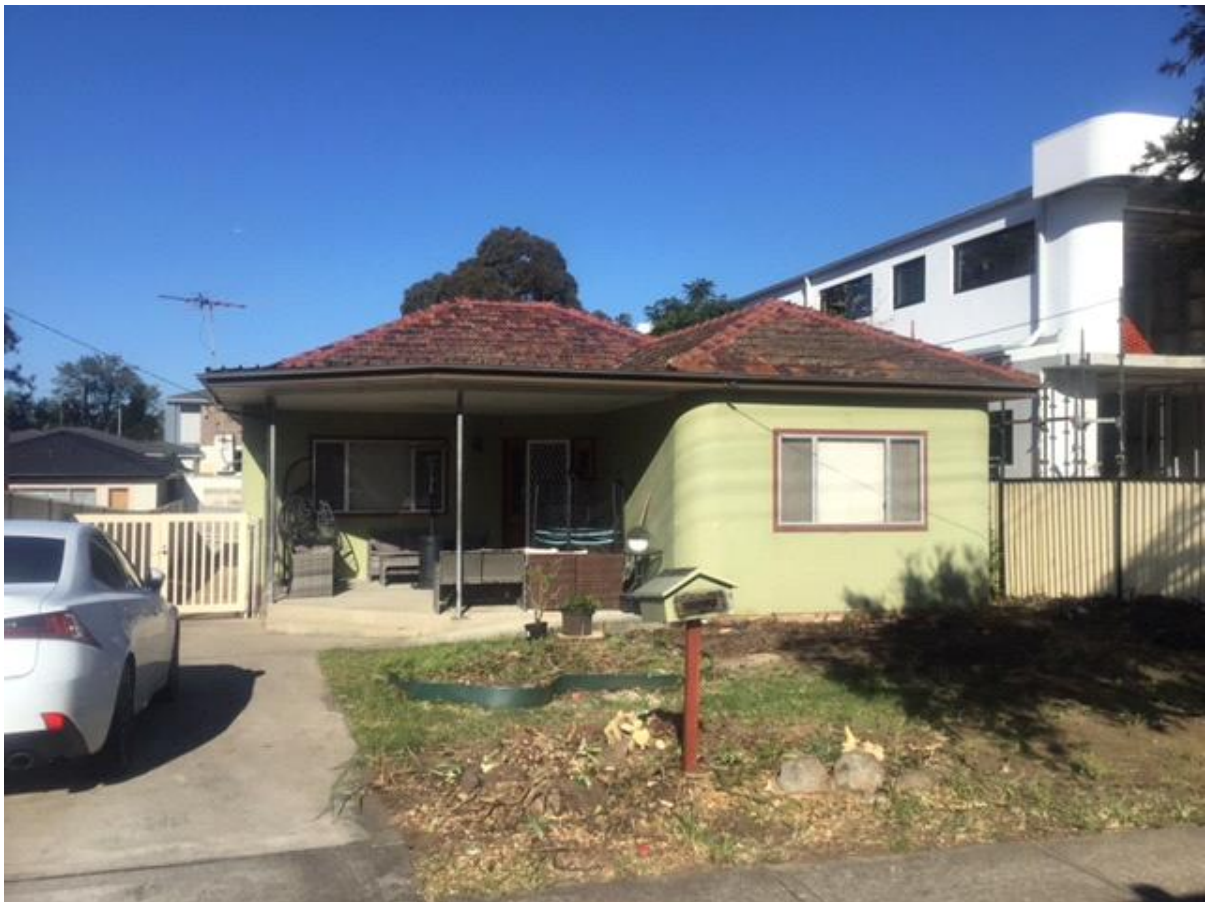
**Taken :** Front of existing residence

**Taken :** Rear of existing residence

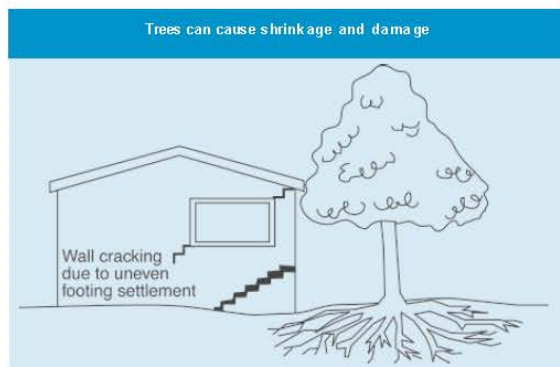
As the moisture absorption process completes its journey to the innermost areas of the building, the internal footings will rise. If the spread of moisture is roughly even, it may be that the symptoms will temporarily disappear, but it is more likely that swelling will be uneven, creating a difference rather than a disappearance in symptoms. In buildings with timber flooring supported by bearers and joists, the isolated piers will rise more easily than the strip footings or piers under walls, creating noticeable doming of flooring.

As the weather pattern changes and the soil begins to dry out, the external footings will be first affected, beginning with the locations where the sun's effect is strongest. This has the effect of lowering the external footings. The doming is accentuated and cracking reduces or disappears where it occurred because of dishing, but other cracks open up. The roof lines may become convex.
