Site Audit Statement

Site audit statement no. **384**

Address	285 Finns Road,		
	Menangle, NSW	Postcode	2568

Remedial Action Plan:
Proposed Depots
285 Finns Road, Menangle, NSW

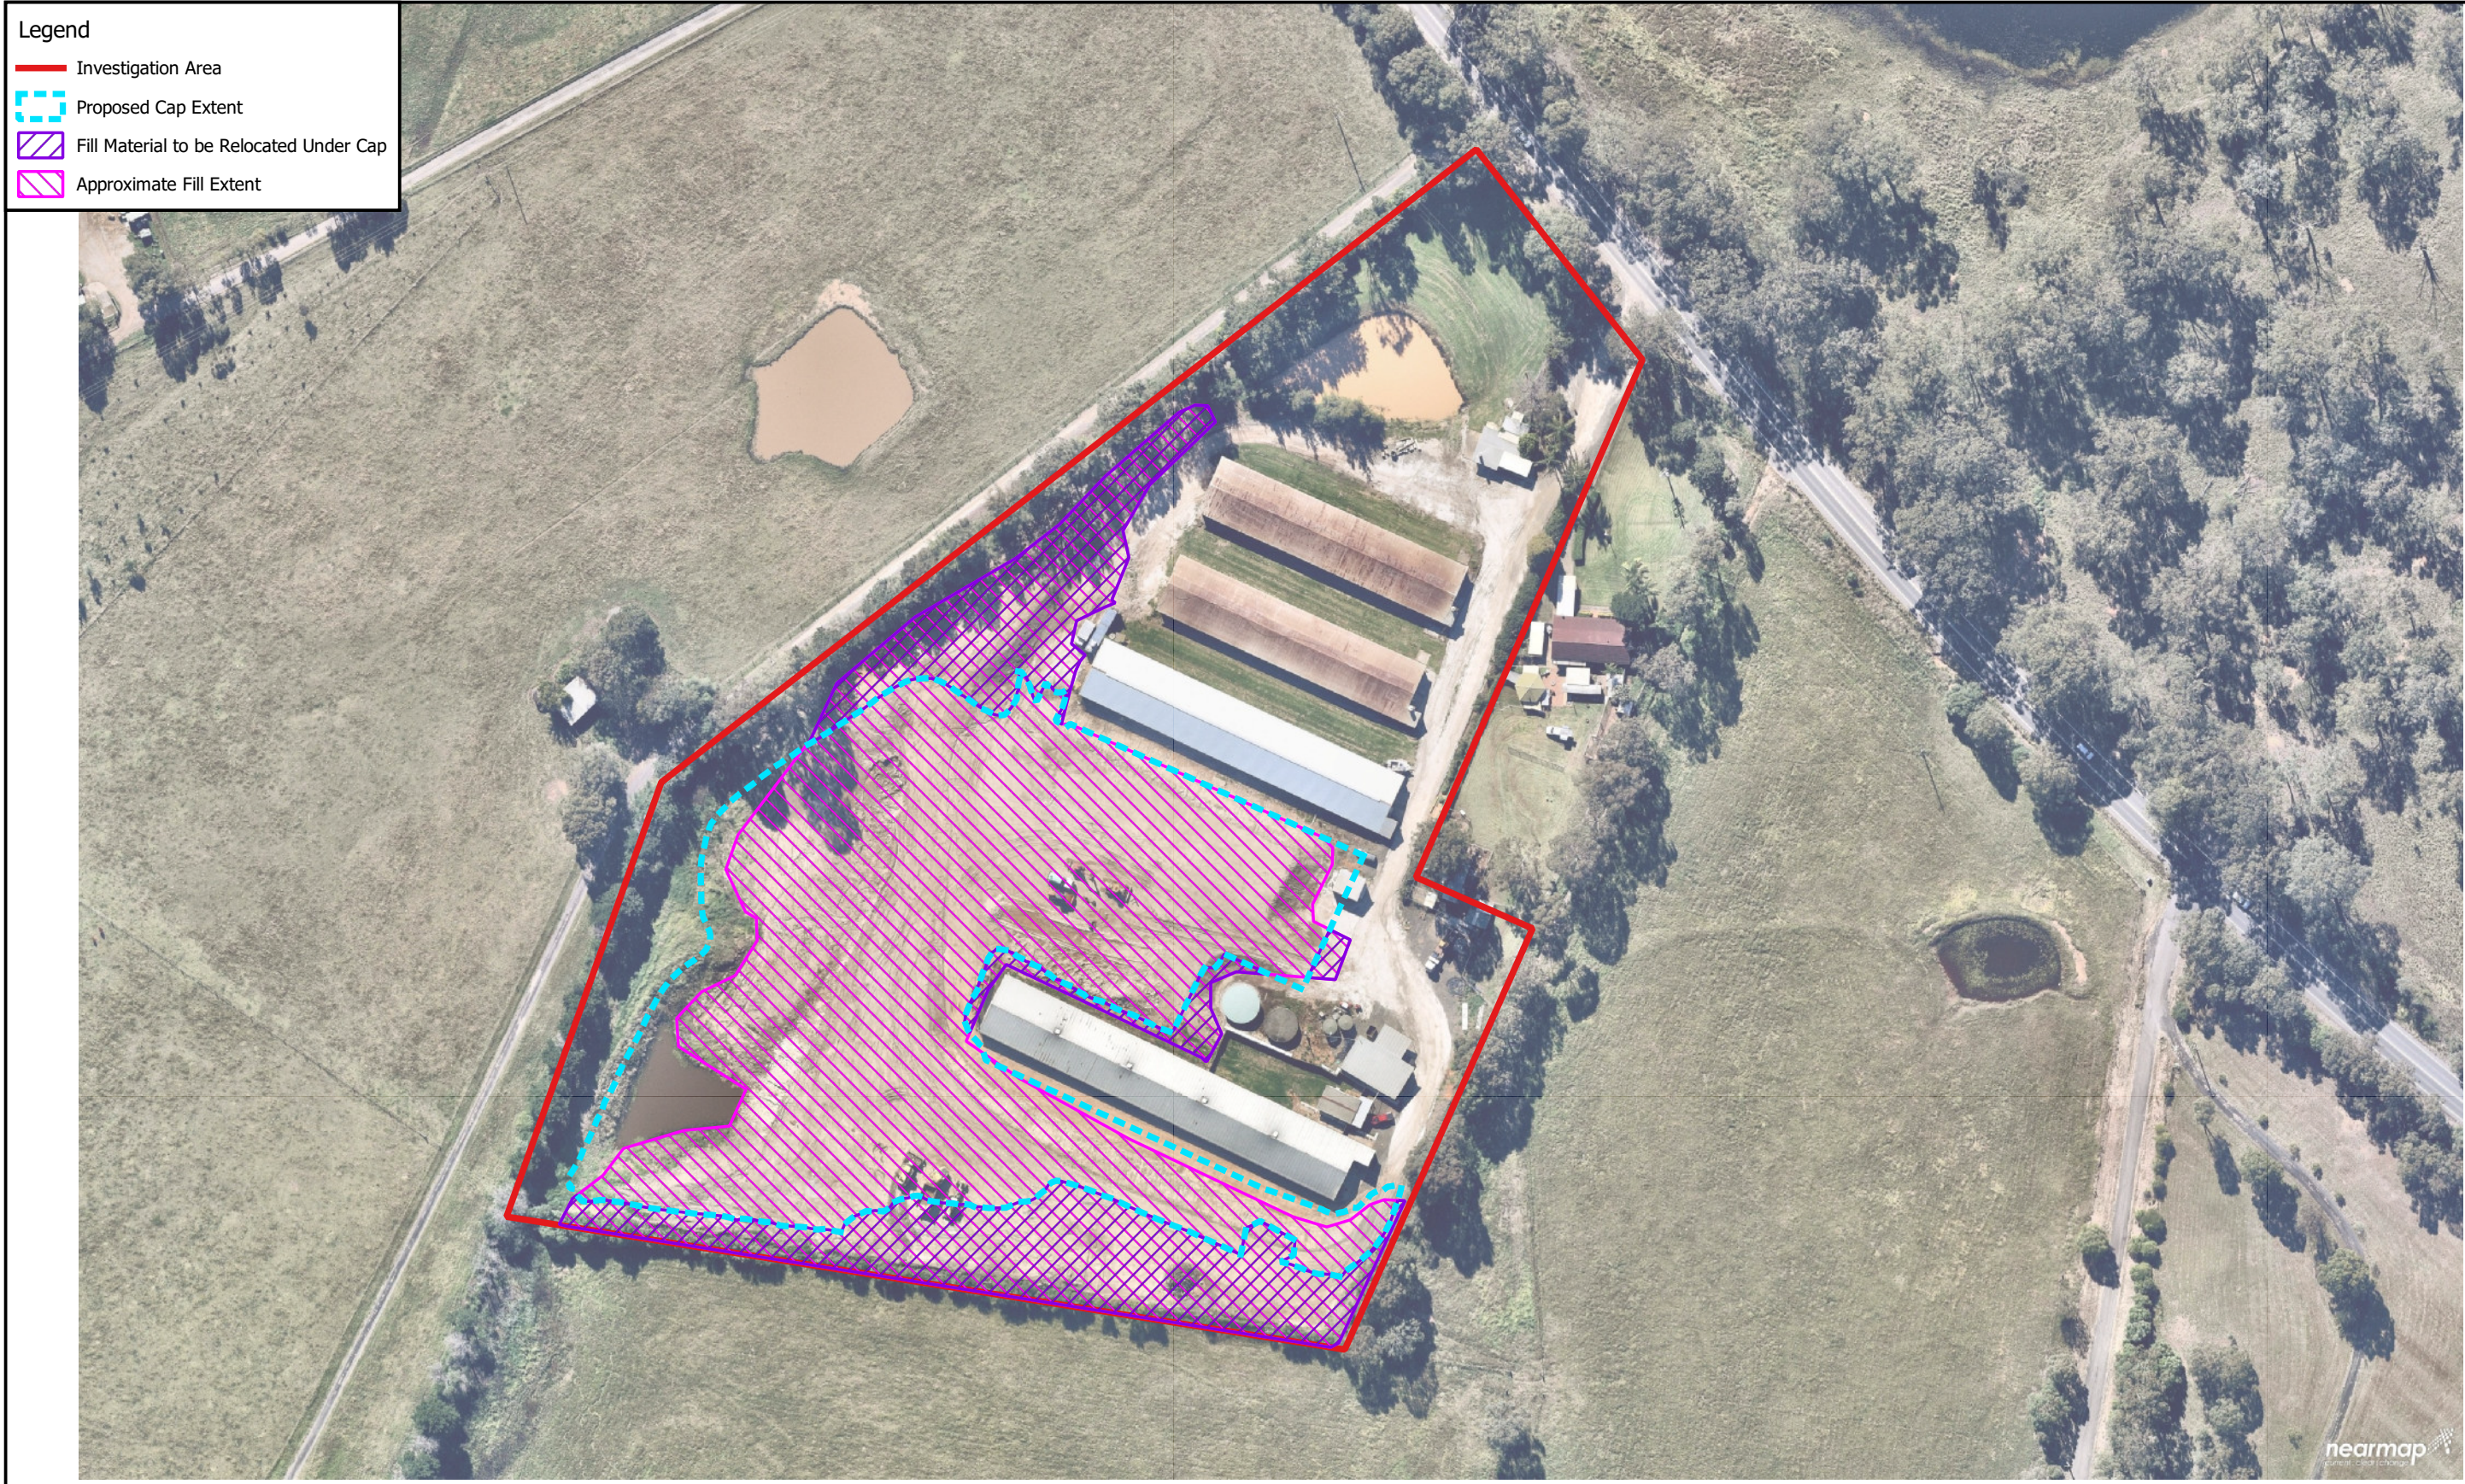
Map Title / Figure:
Approximate Extent of Fill

- Investigation Area
- Proposed Cap Extent
- Fill Material to be Relocated Under Cap
- Approximate Fill Extent
