## Re: Technical Advice Support | Remediation Strategy 44 Wharf Road, 44a Wharf Road and 38-42 Wharf Road, Melrose Park, New South Wales 2114

### 1. Introduction

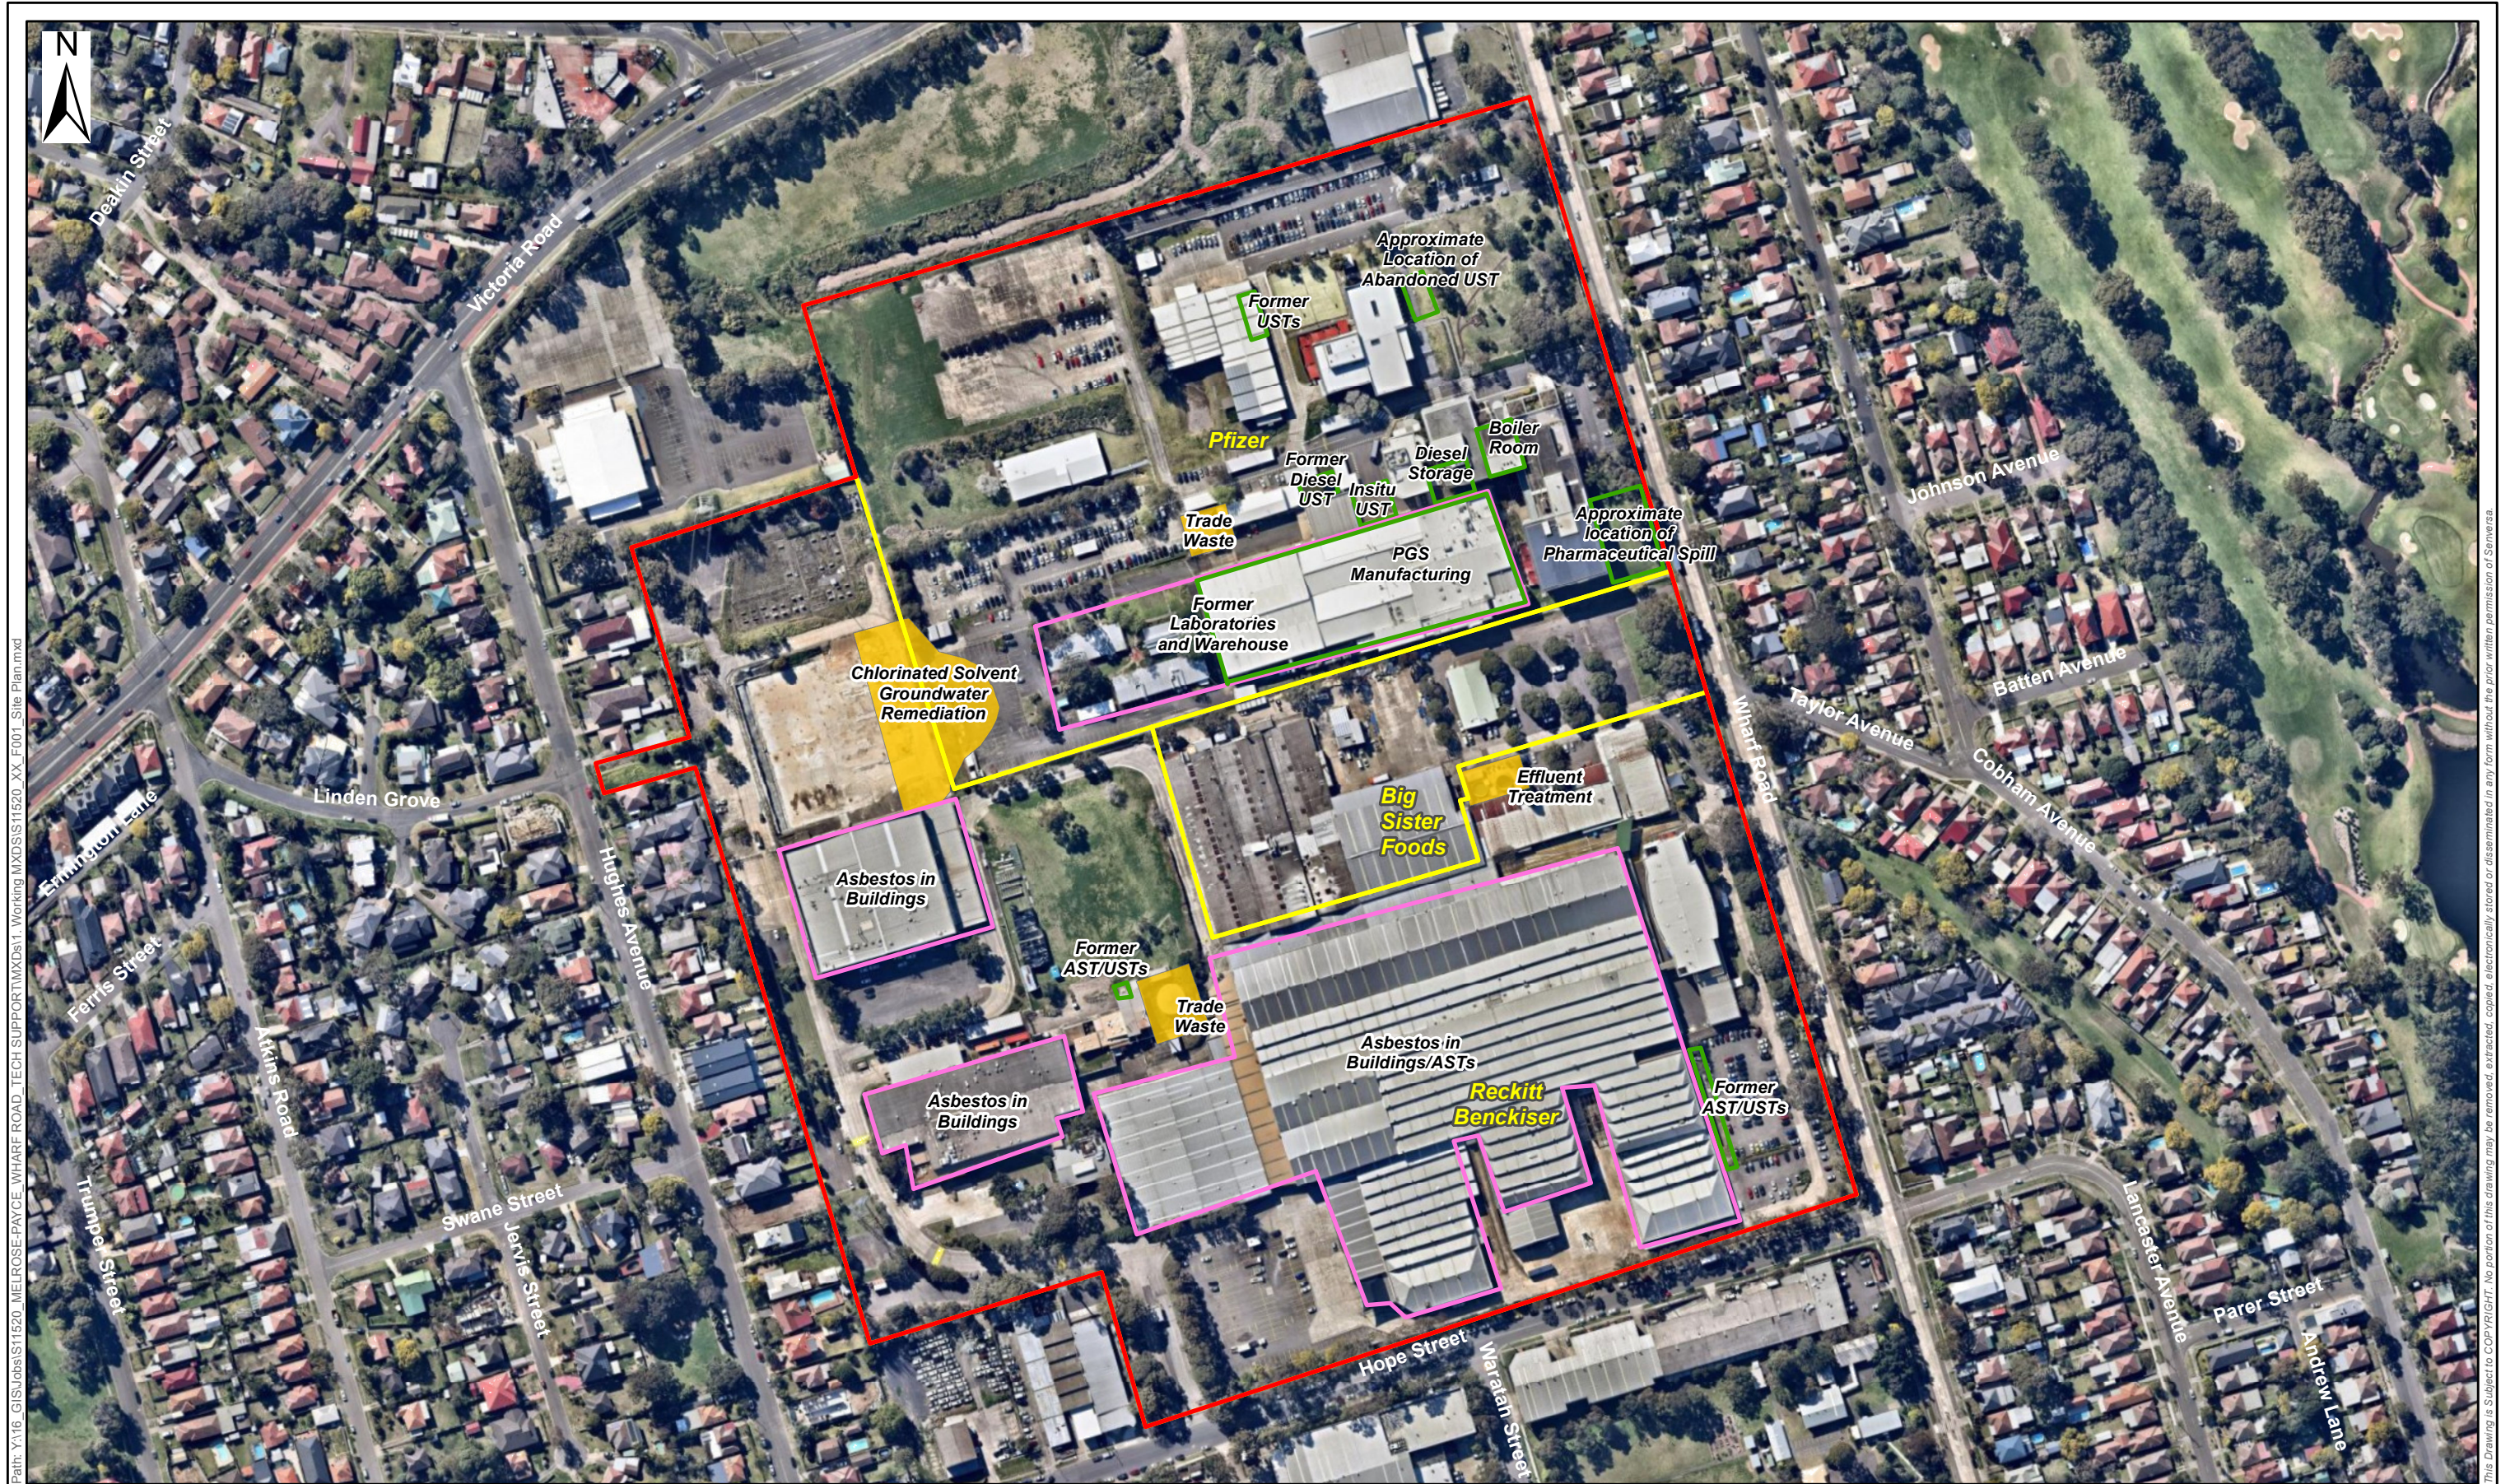
## Figure

**Figure 1** presents the summary of identified contamination and areas of concern across the entire Site.

- Targeted soil bores / groundwater wells targeting point source contamination within the vicinity of the existing and former USTs/ ASTs, trade waste and effluent treatment areas as illustrated within Figure 1.

- Potential dense non-aqueous phase liquid (DNAPL) requires removal at source in order to prevent ongoing contribution to dissolved phase contamination. The likely remediation approach will be as outlined in AECOM (2015) and will involve the excavation of overburden soil material and underlying sandstone within the portion of the Site identified as “the RB former aerosols building and the Pfizer carpark and a combination of off-Site disposal of gross contamination and the on-Site treatment of this material via *ex-situ* remediation within the site boundary. This area is shown on Figure 1.
