***Hornsby Heritage Study Review – Stage 5, 2012 –  
Godden Mackay Logan***

# Hornsby Heritage Study Review Stage 5, 2012

Volume 1—Project Report and Appendices A–F

Report prepared for Hornsby Shire Council  
March 2013

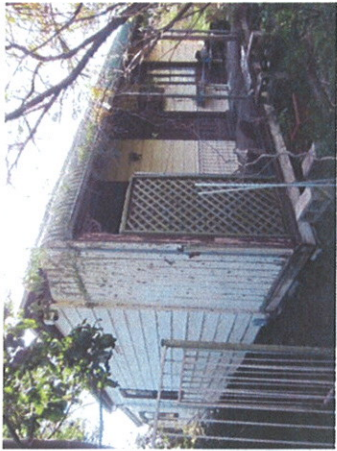
| A | Street Address | Item | Item Image | Issue | Review Recommendations |
|---|---|---|---|---|---|
| 1 | 1015 Pacific Highway,<br>BEROWRA | House | | <p>This cottage is evidence of the turn of the century residential subdivision phase of Berowra's historic development, with aesthetic significance as a representative and now rare example of a late Victorian weatherboard cottage in this location. Its sandstone fence, while later in construction, contributes to its setting.</p> <p>Property is within medium density zoning, on a large allotment sited close to the Highway. Designing for its retention within the context of potentially more intensive surrounding development will conserve its heritage values.</p> | Retain on LEP.<br>(Listing has been updated on inventory form). |

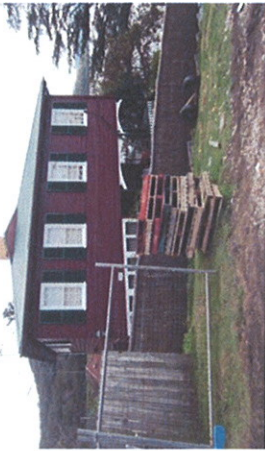
| A | Street Address | Item | Item Image | Issue | Review Recommendations |
|---|---|---|---|---|---|
| 2 | 51 Brooklyn Road,<br>BROOKLYN | House | | <p>One of the first cottages constructed on the subdivided farm of Joseph Gannon, Kingscourt documents the closer, pre WWI residential subdivision along Brooklyn Road. Situated on a bend of the road, the later sympathetic second-storey addition has emphasised the long standing historic presence of the building, and its landmark prominence.</p> | Retain on LEP.<br>(Listing has been updated on inventory form). |

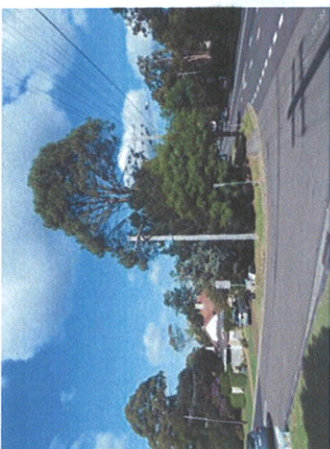
| A | Street Address | Item | Item Image | Issue | Review Recommendations |
|---|---|---|---|---|---|
| 3 | 19C Ethel Street,<br>HORNSBY | House and<br>Garden<br>Trees | | The mature conifers (Bunya Pines) at 19C Ethel Street, across Galston Rd (33-35 Galston Rd) and at 10A Ethel Street are significant remnants of the historic cultural landscape of this part of Hornsby with landmark aesthetic values derived from their majestic scale and horticultural qualities. | Remove listing for 19C Ethel Street from the LEP schedule, (also deleting the 2 Bunya pines that have been removed).<br><br>Include the maritime pine at 19C Ethel Street on Significant Tree Register.<br><br>Include Bunya Pines at 10A Ethel Street and 33-35 Galston Road on Significant Tree Register. |

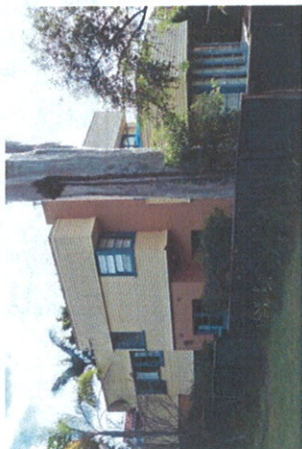
| A | Street Address | Item | Item Image | Issue | Review Recommendations |
|---|---|---|---|---|---|
| 4 | 6 Greycliffe Avenue,<br>PENNANT HILLS | House | | Evidence of the influence of European modernism in Australian domestic architecture, important in demonstrating a new design approach in a suburban context. Associated with local architect Raymond Smith, as his own house. A rare example of 1940s residential modernism in Hornsby Shire. | Retain on LEP.<br><br>(Listing has been updated on inventory form).<br><br>Recommend internal inspection and research with AIA. |

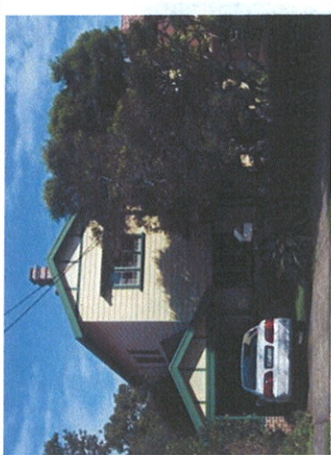
| A | Street Address | Item | Item Image | Issue | Review Recommendations |
|---|---|---|---|---|---|
| 5 | 3 Pritchard Street,<br>THORNLEIGH | House | | Originally a single-storey c1920s weatherboard cottage with a terracotta tiled roof. Now greatly extended and modified with the addition of an upper level, side wing and corrugated steel roofing. No longer a good or intact local example of a representative Federation period cottage.<br>Significance is greatly diminished. | Remove from LEP. |

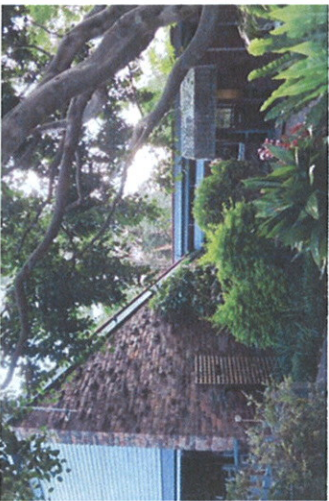
| A | Street Address | Item | Item Image | Issue | Review Recommendations |
|---|---|---|---|---|---|
| 6 | 33 Yaralla Crescent,<br>THORNLEIGH | House | | An architect designed Sydney-School split level compact home, sensitively adapted to its steeply sloping site. House is remarkably intact and well maintained; an excellent example of Hornsby's 1960s fringe development. | Retain on LEP.<br>(Listing has been updated on inventory form). |

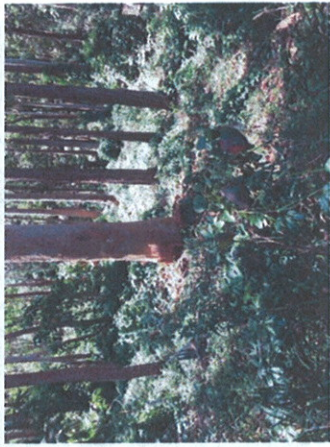
| B | Street Address | Item | Item Image | Issue | Recommendations |
|---|---|---|---|---|---|
| 8 | 50 Sutherland Road,<br>BEECROFT | Log Dragging Rills | | Rare evidence of Beecroft timber getting industry, two parallel ditches/swales in lower area of heavily vegetated Lot. Detailed historic research required to establish comparative significance. | Encourage conservation.<br>Historic research and archival record. |

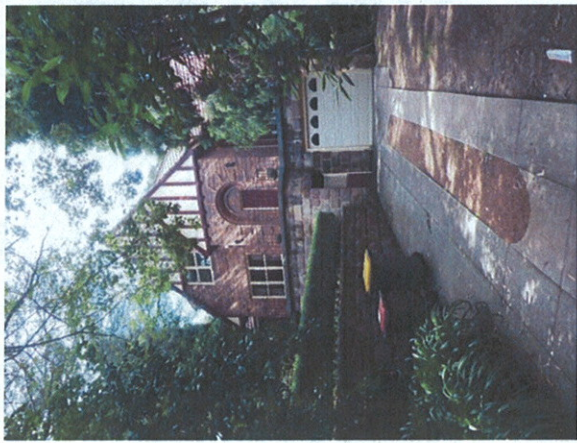
| B | Street Address | Item | Item Image | Issue | Recommendations |
|---|---|---|---|---|---|
| 9 | 86 Sutherland Road, BEECROFT | House and Garden | | <p>A fine example of an Inter-war Old English Revival style residence which demonstrates the investment in substantial housing during the post-war infilling of the older subdivisions in Beecroft. The style and detailing of the house demonstrate accomplished architectural design and trades skills in its execution.</p> <p>The house is representative of an important period of Old English Revival houses in the North Shore area. The front garden, much of it contemporary with the house, has aesthetic values that complement the building and provide an appropriate landscape setting, with species popular in the 1950s.</p> | List in LEP as house and garden.<br>(Listing has been updated on inventory form). |

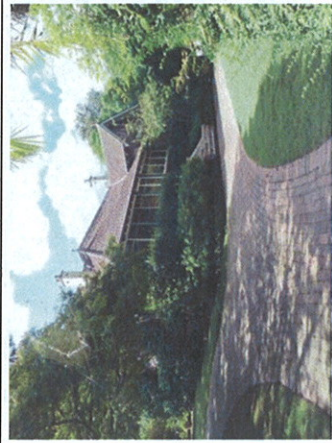
| B | Street Address | Item | Item Image | Issue | Recommendations |
|---|---|---|---|---|---|
| 10 | 88 Sutherland Road, BEECROFT | House and Garden | | <p>A good example of a substantial Federation style bungalow, the house and garden are evidence of the more intensive residential development of Beecroft following the railway. The house is representative of the aesthetic character, form and fabric of the style and era, set in a generous garden which retains mature planting and has sympathetic new features.</p> | List in LEP as house and garden.<br>(Listing has been updated on inventory form). |

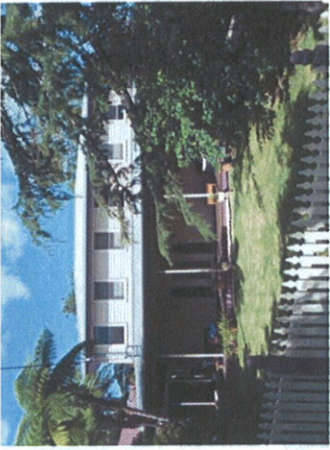
| B | Street Address | Item | Item Image | Issue | Recommendations |
|---|---|---|---|---|---|
| 12 | 77 Chellenham Road, CHELTENHAM | House | | Originally a single-storey weatherboard house with a tile roof built c1948. Second-storey extension c2002/3 in timber has unsympathetically altered the external appearance, extended the footprint to south, widened the verandah and extended the verandah to the northern side. The addition of the second-storey has diminished any previous heritage values. | Do not list in LEP. |

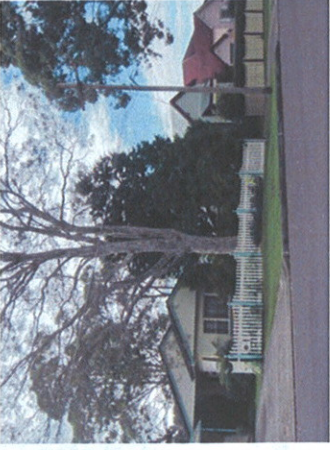
| B | Street Address | Item | Item Image | Issue | Recommendations |
|---|---|---|---|---|---|
| 13 | 3 Dorset Street, EPPING | House | | Said to match the adjacent heritage-listed Federation house at No.5 Dorset Street - but bears little resemblance to its neighbour. No apparent heritage qualities. | Do not list in LEP. |

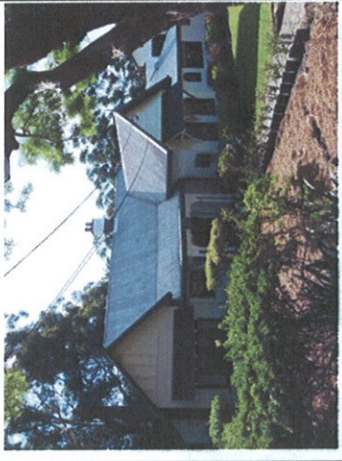
| B | Street Address | Item | Item Image | Issue | Recommendations |
|---|---|---|---|---|---|
| 16 | 52 Dural Street,<br>HORNSBY | 'Birklands' | | The siting and design of 'Birklands' was oriented to enjoy specific views of Hornsby's remarkable bushland valleys on the spurs and ridges to the west. Former home of local architect Louis S Robertson from c1901-1932, whose work in the LGA includes the Hornsby War Memorial and the extension to Beecroft School of Arts. 'Birklands' is representative of the earlier houses in the Hornsby area which sought healthful locations with bushland views on the edge of Sydney suburbia. | List in LEP<br>(Listing has been updated on inventory form). |

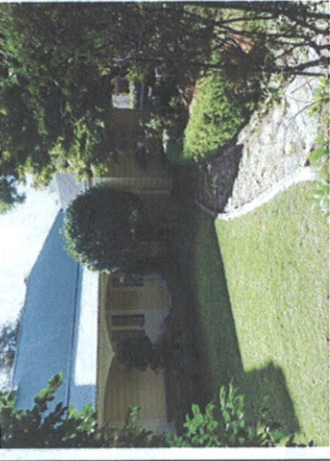
| B | Street Address | Item | Item Image | Issue | Recommendations |
|---|---|---|---|---|---|
| 17 | 6 Rosemead<br>Road,<br>HORNSBY | 'The Haven' | | 'The Haven' is part of the wave of subdivision of the larger estates of Hornsby which occurred in the late nineteenth century to create smaller residential allotments. It was the home of Rev Thomas Watson from 1903-1905, headmaster of Barker College, until he retired and returned to England. An early weatherboard house of the Federation era, its form, fabric and location demonstrates the association of bedrooms with open air verandahs, sited to appreciate the Old Man Valley views. Representative of the small Federation-era bungalows designed for families, sited for bushland enjoyment and healthful open air on Hornsby's outskirts. | List in LEP<br>(Listing has been updated on inventory form). |

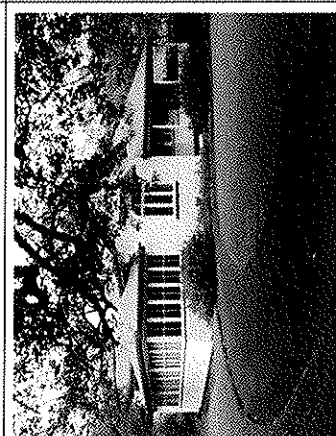
| B | Street Address | Item | Item Image | Issue | Recommendations |
|---|---|---|---|---|---|
| 19 | 41 Pennant Hills Road, NORMANHURST | 'Chislehurst' | | A large, late Federation era house built in 1913, situated in a generous garden setting which demonstrates the subdivision of local farms for residential allotments. A prominent, large house in a corner position surrounded by a mature garden, 'Chislehurst' was associated with the Small family for more than 50 years and is representative of the early residential development along Pennant Hills Road following the decline of orcharding in the area. | List in LEP<br>(Listing has been updated on inventory form). |

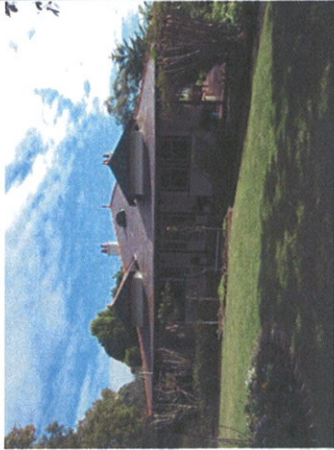
| B | Street Address | Item | Item Image | Issue | Recommendations |
|---|---|---|---|---|---|
| 20 | 311 Mallon Road, NORTH EPPING | House | | The bungalow is a remnant of the orcharding era of the development of North Epping, now on a much subdivided, but still generous curtilage. The building demonstrates careful aesthetic consideration in its detailing and proportions, being designed to maximise its relationship with its garden (and former surrounding orchards), and with principal rooms of formal composition below a fine, sweeping slate roof. The bungalow is representative of the orcharding homes that were once the major residences of the area prior to its residential redevelopment and post-war subdivision. | List in LEP<br>(Listing has been updated on inventory form). |

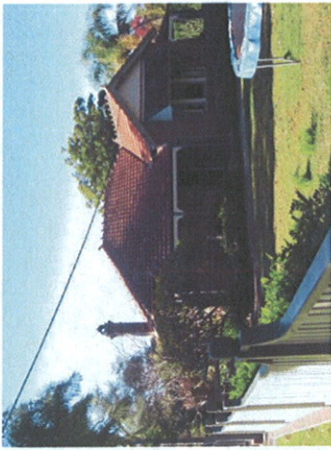
| B | Street Address | Item | Item Image | Issue | Recommendations |
|---|---|---|---|---|---|
| 21 | 80 Norfolk Road, NORTH EPPING | House and Garden | | Demonstrates early large acre residential subdivision of North Epping and closer subdivision as suburban development encroached on the orchards. Successful adjustment of the setting of the house to a diminished curtilage. Representative example of Federation style house and generous front garden with original planting. Historic association with Grigg family who built the house.<br><br>A DA for a second-storey addition has been approved DA/433/2008 dated 30/5/2008. If this proceeds, the heritage value of the property would be severely diminished, to the point of deletion from the list. | List in LEP<br>(Listing has been updated on inventory form). |

In another case (80 Norfolk Avenue, Epping), a DA for substantial changes has been recently approved, which if undertaken, would seriously diminish the heritage significance of the property. In two other cases, recent extensive renovations appear externally to have significantly changed the heritage values (2 Waratah Road, Berowra and 7 Station Street, Thornleigh) and removal from the heritage schedule of the LEP is recommended and no further action is recommended, respectively.

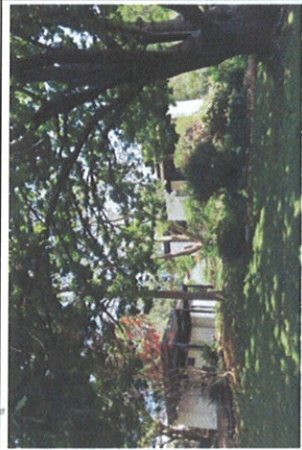
| B | Street Address | Item | Item Image | Issue | Recommendations |
|---|---|---|---|---|---|
| 22 | 108 Bellamy Street,<br>PENNANT HILLS | House and Garden | | A remarkably intact Pettit & Seviitt designed project home, designed c1972, which retains its original form, fabric and features. An excellent example of a contemporary, modest home designed by prominent architects for the project home market and maintained in excellent condition. | List in LEP<br>(Listing has been updated on inventory form). |

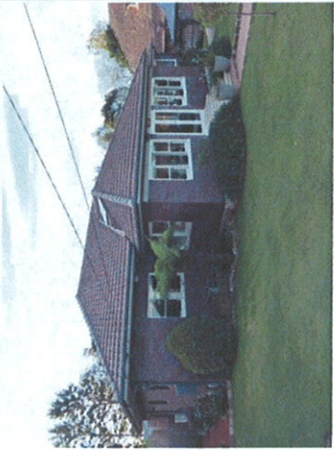
| B | Street Address | Item | Item Image | Issue | Recommendations |
|---|---|---|---|---|---|
| 23 | 10 Harold Avenue,<br>PENNANT HILLS | 'Fairview' | | 'Fairview' is a representative example of the generous Inter-war bungalows built in Pennant Hills as orchards were subdivided, associated with the Yeo family. | List in LEP<br>(Listing has been updated on inventory form). |

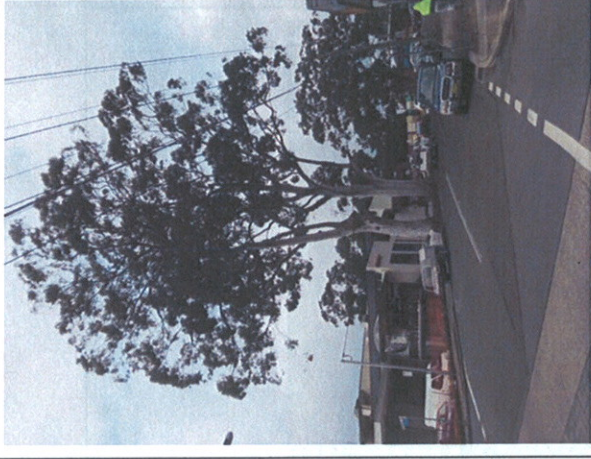
| B | Street Address | Item | Item Image | Issue | Recommendations |
|---|---|---|---|---|---|
| 24 | Hillcrest Road,<br>PENNANT<br>HILLS | Trees in road<br>reserve | | Very large remnant indigenous trees in road reserve with branches overhanging road, footpath and adjacent properties. Need regular arborist assessment for condition, risk assessment and management recommendations. | Protect remnant native trees under Tree Preservation Order. |

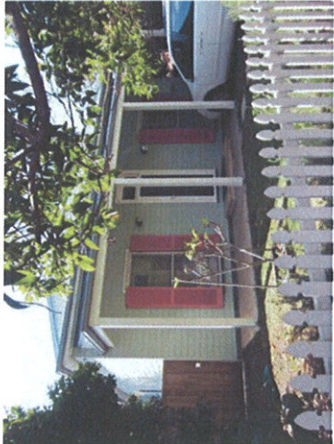
| B | Street Address | Item | Item Image | Issue | Recommendations |
|---|---|---|---|---|---|
| 26 | 7 Station Street,<br>THORNLEIGH | House | | DA and Construction Certificate for residential alterations and additions 2009. | Do not list in LEP |

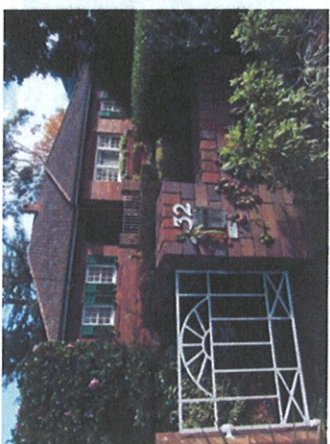
| B | Street Address | Item | Item Image | Issue | Recommendations |
|---|---|---|---|---|---|
| 27 | 32 Ingalara<br>Avenue,<br>WAHROONGA | House and<br>Garden | | The house, its garden, its fittings and contents demonstrate a time capsule of its construction in 1938, a period rarely well recorded in the residential development of Sydney. The house has been associated with the Waterworth family from its construction to today. The house demonstrates the aesthetics of the Art Deco period in a modest cottage form. The house, its associated documentation, furniture and fittings and garden has the potential to yield information that will contribute to an understanding of NSW's cultural history, and that of the Shire. The house is a rare survivor in its present state, uncommon in its intactness and integrity. The garden retains the original gates, sections of the original wall and a number of mature trees characteristic of the period in which the house was built. | List in LEP<br>(Listing has been updated on inventory form).<br>Recommend archival recording of property. |

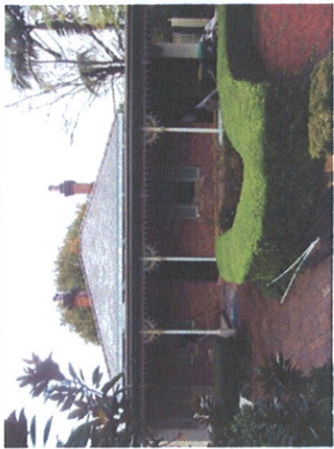
| C | Street Address | Item | Item Image | Issue | Recommendations |
|---|---|---|---|---|---|
| 28 | 59 Beecroft Road,<br>BEECROFT | House | | This late Victorian house is evidence of the spread of settlement along Beecroft Road following the closer subdivision of earlier orcharding properties for residential redevelopment. The house form and fabric are typically Victorian with Federation overlay and extensive modern modifications to rear.<br><br>Front and rear gardens have been extensively modified. No evidence of a well has been sighted or is known of by current owners. | Retain house listing on LEP.<br><br>(Listing has been updated on inventory form). |

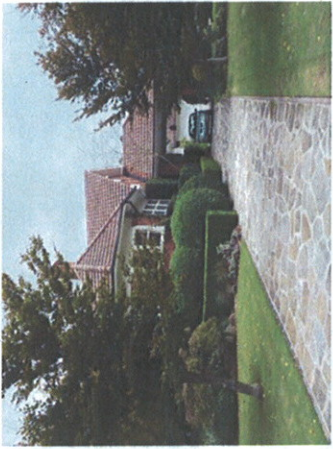
| C | Street Address | Item | Item Image | Issue | Recommendations |
|---|---|---|---|---|---|
| 29 | 48 Bundarra Avenue,<br>WAHROONGA<br>(see also E73) | House | | Landskrona is a substantial Inter-war house and garden (built c1930), demonstrating the subdivision of Wahroonga's early estates for a second generation of significant houses. 'Landskrona' is a finely detailed and executed house and garden design of quality and distinction, an important individual component of a significant streetscape. The house's name is reflective of an association with John Sonnerdale who was the Swedish Vice-Consul. | List house as well as garden in LEP.<br><br>(Listing has been updated on inventory form to cover both house and garden) |

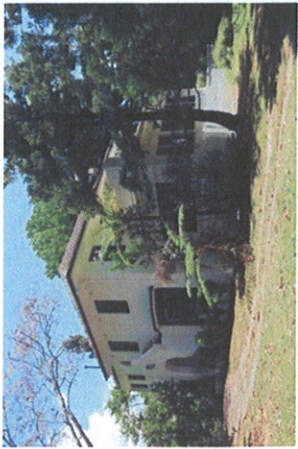
| C | Street Address | Item | Item Image | Issue | Recommendations |
|---|---|---|---|---|---|
| 30 | 54 Bundarra Avenue,<br>WAHROONGA<br>See also E75 | House | | A distinguished, architect designed Inter-war house in remarkably intact condition on its original one acre Lot, set in a mature garden with a wide variety of cultural plantings and mature trees from the period 1930-50, of high Local significance in the Wahroonga North Heritage Conservation Area. | List house as well as garden in LEP.<br>(Listing has been updated on inventory form to cover both house and garden). |

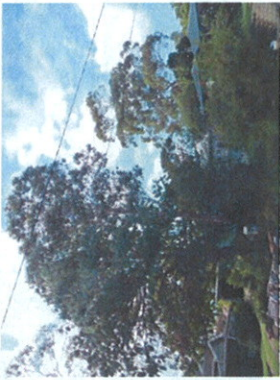
| D | Street Address | Item | Item Image | Issue | Recommendations |
|---|---|---|---|---|---|
| 31 | 22 Hillcrest Road,<br>BEROWRA | Trees associated with 4, 5, 7, 8 and 10 Wanill Place | | Significant trees are actually on properties around cul-de-sac of Wanill Place.<br>Some of these significant trees appear to relate to the re-subdivision of the landscape in the local area, with aesthetic significance and amenity value. | Remove from LEP.<br>Include on Significant Tree Register. |

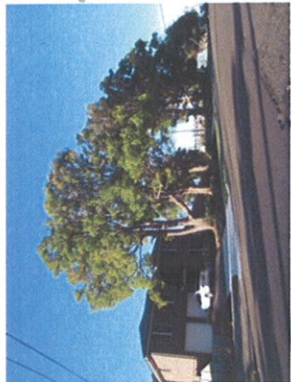
| D | Street Address | Item | Item Image | Issue | Recommendations |
|---|---|---|---|---|---|
| 32 | 2 Waratah Road,<br>BEROWRA | 'The Laurels' and garden | | Delist. Poor maintenance and possible changes to the water table from the new residential development make the future uncertain for the remaining six trees of the former row of eight trees. House to which they related has been demolished and the site subdivided. | Remove from LEP. |

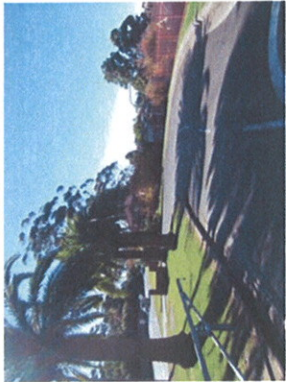
| D | Street Address | Item | Item Image | Issue | Recommendations |
|---|---|---|---|---|---|
| 33 | 423-521 Old Northern Road, CASTLE HILL | Oakhill College, original building, gate house and grounds | | <p>Oakhill College is a significant site in the history of the region, initially as a homestead complex, and now as a major regional educational institution, with associated buildings and landscaping. Institutional buildings, notably the three-storey De La Salle building, illustrate the aesthetic preferences of the brothers of Romanesque architecture. Oakhill has strong associations with the De La Salle brothers and their educational work and with the extensive school and religious communities, as evidenced in its buildings and associated national brothers' cemetery. A rare example of a regional educational and institutional complex.</p> <p>Although the original homestead and gatehouse have been demolished and much of its curtilage redeveloped for housing, the remnant mature cultural tree planting and elements of the homestead garden on the hilltop site remain, dating from about 1910. Archaeological remains of earlier buildings are likely.</p> <p>Proposals for unsympathetic new windows on the De La Salle building and removal of existing grave markers from the cemetery require careful consideration of heritage impacts.</p> | <p>Retain on LEP.</p> <p>Listing updated to remove reference to porter's gatehouse now demolished.</p> |

Discussion with the principal of Oakhill College mentioned several development proposals that will require careful consideration of heritage impacts, such as alterations to the De La Salle Brothers cemetery including removal of existing grave markers and the replacement of the timber windows of the main De La Salle building. A Conservation Management Plan for this regionally important site is recommended to provide guidance for such decisions.

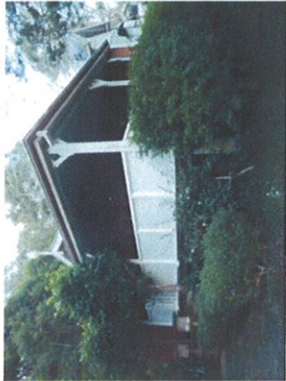
| D | Street Address | Item | Item Image | Issue | Recommendations |
|---|---|---|---|---|---|
| 34 | 36 Grantham Crescent, DANGAR ISLAND | House | | <p>'Joyville' is associated with the 1921 subdivision of the island for residential development, and is evidence of Dangar Island's increasing popularity for residential and weekend recreational use in the 1920s.</p> <p>It is associated with its first owners, the Starrett family, who built and occupied the cottage 1922-1936.</p> <p>The original cottage form is evidence of the Inter-war era in its construction, with sheltering verandahs and hipped roof using materials of fibro, tin and timber that could be readily transported to the island.</p> <p>'Joyville' is representative of the cottages of its era in its original form and fabric. Located on one of the island's first residential subdivisions, its ongoing residential use both as a weekend and as a permanent residence, is evidence of its enduring functionality.</p> | <p>Retain listing in LEP (Listing has been updated on inventory form).</p> <p>No 38 Grantham Crescent should also be investigated – early fibro cottage on 1922 subdivision.</p> |

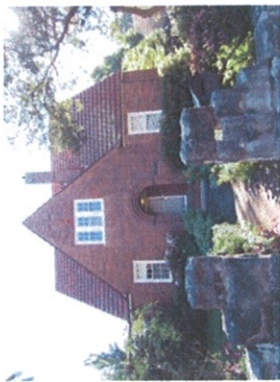
| D | Street Address | Item | Item Image | Issue | Recommendations |
|---|---|---|---|---|---|
| 35 | 3 Pembroke Street<br>(3 - 5 Pembroke Street), EPPING | St Albans Anglican Church and grounds | | <p>The Church site and its buildings have been the focus of Anglican worship since 1896, and it has an enduring association with the Anglican ministry to its congregation and the Epping community more generally, as it continues to play a lively community role today. The existing Church (1922) was designed by Burcham Clapp, the parish hall and rectory (1934) were designed by Professor Leslie Wilkinson, both being Diocesan architects of prominence and accomplishment. Ongoing architectural engagement with local architects has contributed the War Memorial Hall (1957) and completed the second stage of the Church and spire (1961).</p> <p>Together with its mature remnant indigenous trees and landscaping it represents a remarkable enclave in the village area of Epping, notable in the streetscape.</p> <p>The almost complete archive of the parish records of St Alban's provides a remarkable research repository, available to yield information about the history of the site and the area.</p> <p>Rectory recommended for listing in Stage 4 Heritage Review, but not progressed by Council due to concern regarding structural stability.</p> <p>The Church complex is incorrectly called number 3 Pembroke Street in the existing listing, but described as inclusive of the adjacent lot. The listing should encompass numbers 3 - 5.</p> | <p>Heritage significance confirmed, List. The listed address should be amended to 3 - 5 Pembroke Street.</p> <p>Listing has been extensively updated on inventory form.</p> <p>A Conservation Management Plan (CMP) is needed for the site which can build upon the partial analysis of the Church property undertaken by NBSRS in 2005. This will guide future development of this important site.</p> |

Similarly, future planning for the remarkable St Alban's Complex site in Epping requires careful consideration. Analysis of the church complex for this review recommends listing of the whole site (3-7 Pembroke Street) including the Rectory, for its historic, associative, aesthetic, social and research significance. A Heritage Assessment was carried out in 2005 for part of the site (Rectory excluded) which could be updated and used for forward planning. The Rectory was considered in Heritage Review Stage 4 and Council resolved not to progress its listing due to concern regarding possible structural issues.

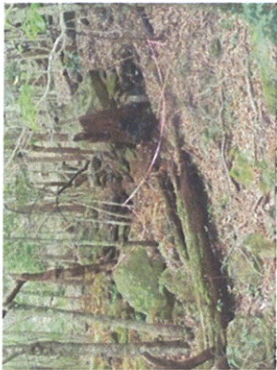
| D | Street Address | Item | Item Image | Issue | Recommendations |
|---|---|---|---|---|---|
| 36 | Crosslands Reserve,<br>441 Sommerville<br>Road, HORNSBY<br>HEIGHTS | Crosslands<br>Reserve<br>House<br>Ruins and<br>Well | | <p>Archaeological remains of former buildings, walls and a well within Crosslands Reserve, identified in a 1911 survey of the area, in a ruinous condition, and likely represent various phases of construction and occupation.</p> <p>Should any disturbance or interpretation of the remains be necessary, this should be archaeologically monitored, consistent with the provisions of the NSW Heritage Act.</p> | <p>Detailed historical research to fully document the occupation and history of the Reserve,</p> <p>In the interim, a curtilage of c. 10m outside the fence indicated in the 1911 survey is recommended for management purposes and identification in the LEP.</p> <p>Inventory form prepared.</p> |

Archaeological remains of former buildings, walls and a well within Crosslands Reserve, identified in a 1911 survey of the area were located and assessed. They may relate to the period of occupation by George Murphy, Matthew Charlton or Burton Crossland. The remains are in a ruinous condition, and likely represent various phases of construction and occupation. Should any disturbance or interpretation of the remains be necessary, this should be archaeologically monitored, as is consistent with the provisions of the NSW Heritage Act. It is recommended that detailed historical research be undertaken by the Hornsby Historical Society to fully document the occupation and history of the Reserve, in order to provide a better context for the management of the remains. In the interim, a curtilage of c.10m outside the fence indicated in the 1911 survey is recommended for management purposes and identification in the HLEP.

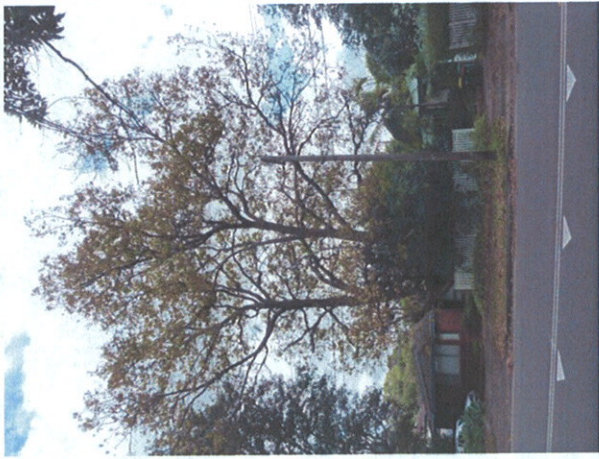
| E | Street Address | Item | Item Image | Issue | Recommendations |
|---|---|---|---|---|---|
| 37 | 27 Royston Parade,<br>ASQUITH | Garden | | Large exotic tree in residential lot, overhanging footpath and adjoining property. Needs arborist report when in leaf for condition and risk assessment.<br><br>Aesthetic significance at a Local level derived from a large mature English Oak, which makes a positive contribution to the streetscape. | Remove from LEP.<br>Include on Significant Tree Register. |

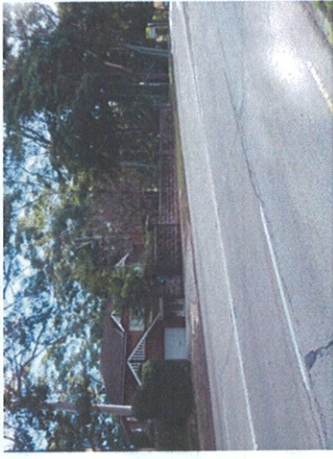
| E | Street Address | Item | Item Image | Issue | Recommendations |
|---|---|---|---|---|---|
| 38 | 2, 2A and 4 Beecroft Road,<br>BEECROFT | Gardens | | Significant items are the sandstone fence, probably relating to Blackwood House (6-8 Beecroft Road) and both exotic and indigenous trees. | Retain on LEP.<br>Amend listing to identify fence as archaeological item or specific built element and include exotic trees on Significant Trees Register .Manage indigenous trees via TPO |

Several properties currently listed as "Gardens" primarily derive their remaining significance from a boundary fence. These are 2,2A and 4 Beecroft Rd, Beecroft and 44 The Crescent and 28 The Promenade, Cheltenham. Rather than continue to list the entire property as a garden, it is recommended that the fences be listed as archaeological items, or as specific built elements.

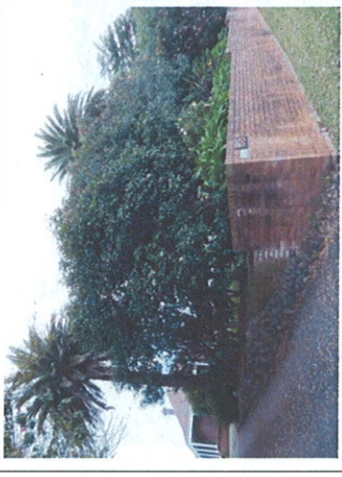
| E | Street Address | Item | Item Image | Issue | Recommendations |
|---|---|---|---|---|---|
| 39 | 68 Beecroft Road,<br>BEECROFT | Garden | | Garden has significantly altered since the 1993 Heritage Study but retains prominent Canary Island Date palms. | Remove from LEP<br>Include mature palms on Significant Tree Register. |

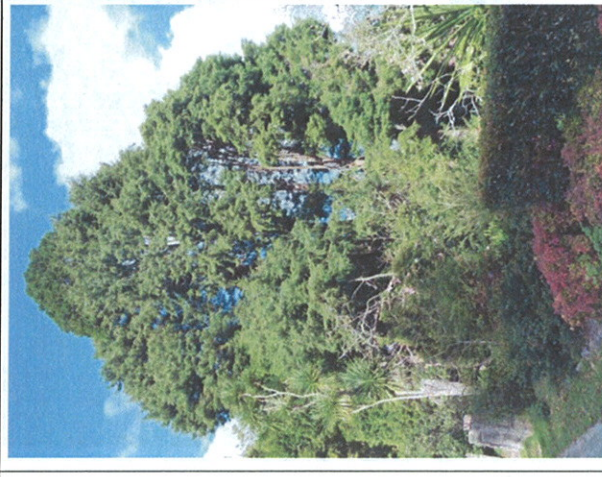
| E | Street Address | Item | Item Image | Issue | Recommendations |
|---|---|---|---|---|---|
| 40 | 128 Beecroft Road,<br>BEECROFT | Garden | | Garden has been significantly altered since 1993 Heritage Study. | Remove from LEP. |

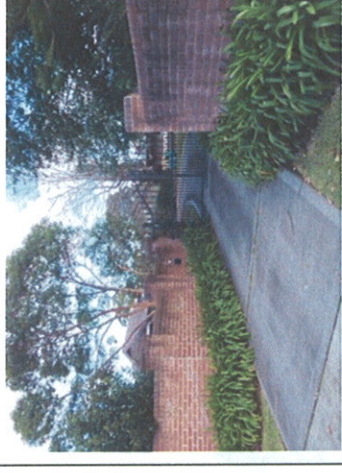
| E | Street Address | Item | Item Image | Issue | Recommendations |
|---|---|---|---|---|---|
| 41 | 136 Beecroft Road,<br>BEECROFT | Garden | | Garden has altered since 1993 Heritage Study but retains significant specimen of Norfolk Island Pine. | Remove from LEP.<br>Include Norfolk Island Pine on Significant Tree Register. |

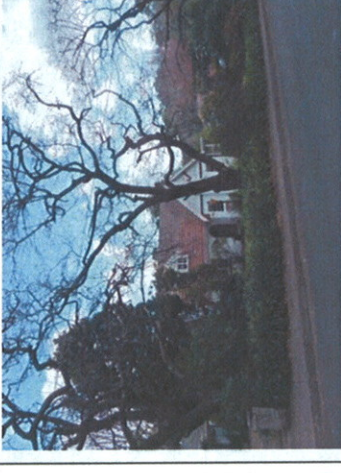
| E | Street Address | Item | Item Image | Issue | Recommendations |
|---|---|---|---|---|---|
| 42 | 2-4 Boronia Avenue,<br>BEECROFT | Gardens | | No 2 appears to have had a new fence constructed since the 1993 Heritage Study. Gardens have also been altered since the 1993 Heritage Study but retain significant elements. | Retain on LEP.<br>(Listing has been updated on inventory form). |

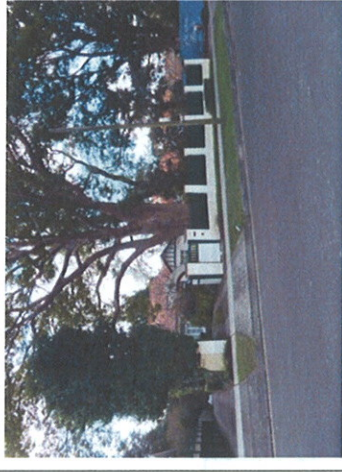
| E | Street Address | Item | Item Image | Issue | Recommendations |
|---|---|---|---|---|---|
| 43 | 149 Copeland Road,<br>BEECROFT | Garden | | New front fence since 1993 Heritage Study but garden retains significant elements. | Retain on LEP.<br>Investigate house in stage 6 Heritage Study Review.<br>(Listing has been updated on inventory form). |

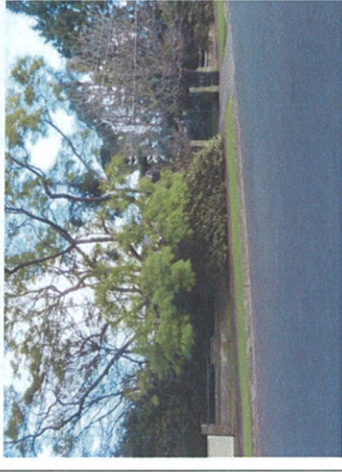
| E | Street Address | Item | Item Image | Issue | Recommendations |
|---|---|---|---|---|---|
| 44 | 156A Copeland Road,<br>BEECROFT | Garden | | Garden has altered since 1993 Heritage Study but retains significant elements. | Retain on LEP.<br>(Listing has been updated on inventory form). |

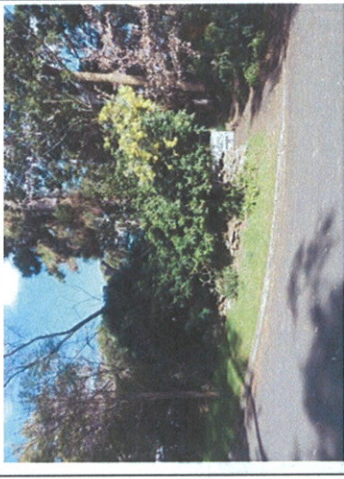
| E | Street Address | Item | Item Image | Issue | Recommendations |
|---|---|---|---|---|---|
| 45 | 15 Kirkham Street/ 6 Parker Close, BEECROFT | Garden | | Address is now known as 6 Parker Close. Most of trees in listing have gone. Garden has association with the late Mary Duigan, a prominent local gardener. | Retain on LEP with updated address. (Listing has been updated on inventory form). |

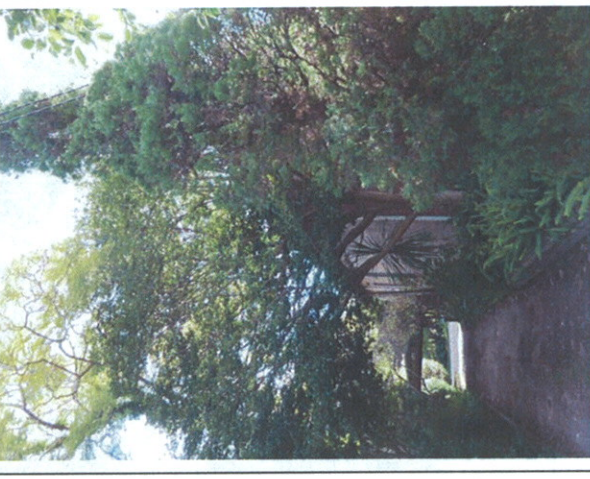
| E | Street Address | Item | Item Image | Issue | Recommendations |
|---|---|---|---|---|---|
| 46 | 25 Wongala Crescent, BEECROFT | Garden | | Surviving front fence, curvilinear bride path and plantings typical of the Federation period, including a magnificent specimen of <i>Camellia sasanqua</i> . Local historic and aesthetic significance as representative of a particular garden style. | Retain on LEP. (Listing has been updated on inventory form). |

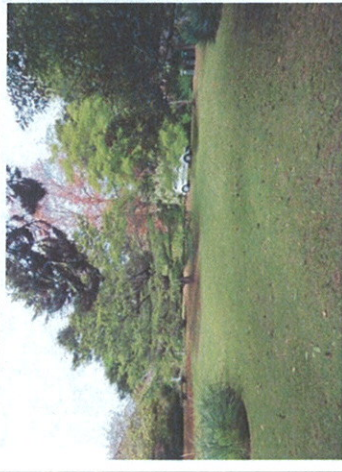
| E | Street Address | Item | Item Image | Issue | Recommendations |
|---|---|---|---|---|---|
| 47 | 2-4 Hillcrest Road, BEROWRA | Garden | | Gardens retain original layout and plantings and the house is largely original. Investigate house for possible listing as representative of late 1940s/early 1950s style. | Retain on LEP. Archival record of garden recommended. Investigate house in stage 6 of Heritage Study Review. Listing updated. |

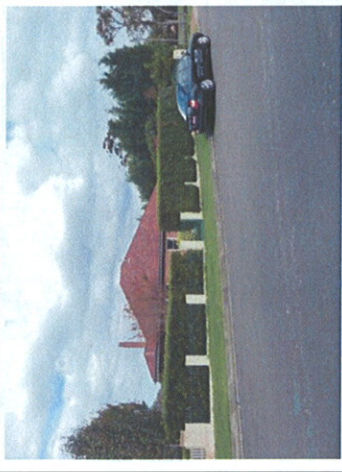
| E | Street Address | Item | Item Image | Issue | Recommendations |
|---|---|---|---|---|---|
| 48 | 15 Yallambee Road, BEROWRA | Garden | | Site subdivided and garden significantly modified since 1993 Heritage Study. Remaining house requires investigation. | Remove garden from LEP. Investigate surviving building in Stage 6 of Heritage Study Review. |

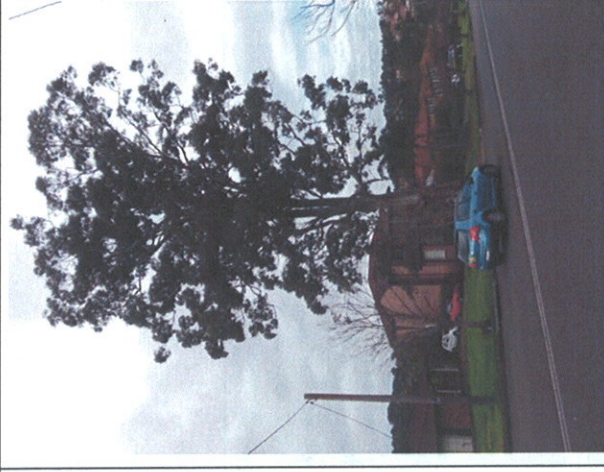
| E | Street Address | Item | Item Image | Issue | Recommendations |
|---|---|---|---|---|---|
| 49 | 121-123 David Road, CASTLE HILL | Garden | | Remnant indigenous tree demonstrating an element of the pre-European settlement plant community. Historical and aesthetic significance locally. | Remove from LEP.<br>Protect remnant native trees under TPO. |

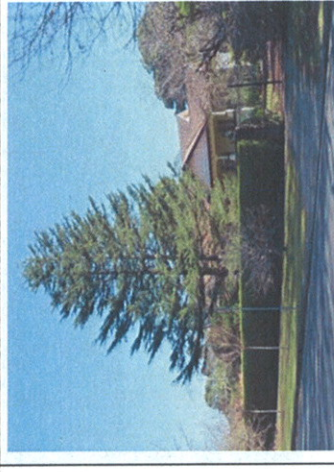
| E | Street Address | Item | Item Image | Issue | Recommendations |
|---|---|---|---|---|---|
| 50 | 183 Beecroft Road, CHELTENHAM | Garden | | A largely intact period garden on a prominent corner, conserving fine original or early features including a curved gravel drive, twin entries with stone gale pillars and wrought iron gates, garden beds and a garden of trees and shrubs of the late Federation/Inter-war era. Of historical and aesthetic significance. | Retain on LEP.<br>Recommend archival recording. |

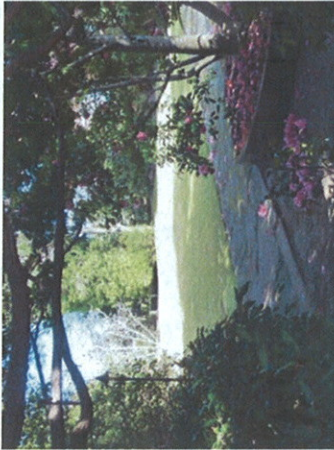
| E | Street Address | Item | Item Image | Issue | Recommendations |
|---|---|---|---|---|---|
| 51 | 22 Cheltenham Road,<br>CHELTENHAM | Garden | | Garden retains many original features including the boundary fence, pedestrian gate and plantings. White pool fence for pedestrian safety on nature strip is visually intrusive. | Retain on LEP.<br>(Listing has been updated on inventory form). |

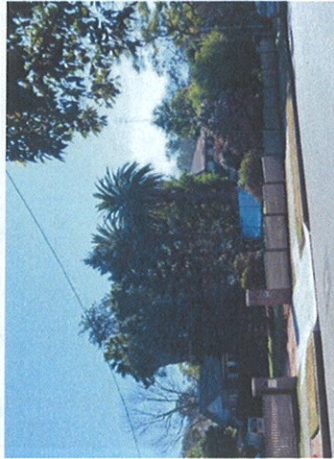
| E | Street Address | Item | Item Image | Issue | Recommendations |
|---|---|---|---|---|---|
| 52 | 10-12 The Boulevard,<br>CHELTENHAM | Garden | | New front fence since 1993 Heritage Study but garden retains many original features. Despite alteration since the 1993 Heritage Study, this garden retains considerable original fabric representative of its period and has Local aesthetic significance derived from mature tree and shrub plantings. | Retain on LEP.<br>(Listing has been updated on inventory form). |

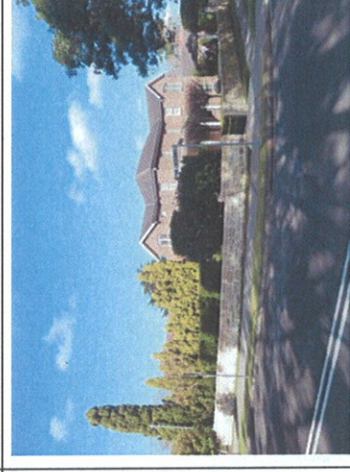
| E | Street Address | Item | Item Image | Issue | Recommendations |
|---|---|---|---|---|---|
| 53 | 44 The Crescent,<br>CHELTENHAM | Garden | | <p>The fine sandstone boundary fence is a prominent element in the streetscape of both The Crescent and The Promenade, with Local aesthetic significance and interpreting the former garden on the site.</p> <p>The previous garden has been largely replaced and should no longer be listed as such</p> | <p>Modify listing to delete garden and only include fence, which relates to pre-subdivision boundary and extends along street boundary of 28 The Promenade, Cheltenham.</p> <p>Alternatively, list fence of 44 The Crescent and 28 The Promenade as an archaeological item. (Listing has been updated on inventory form).</p> |

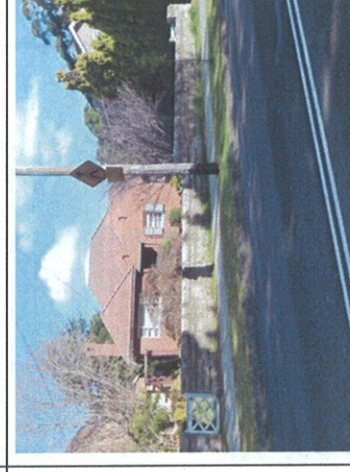
| E | Street Address | Item | Item Image | Issue | Recommendations |
|---|---|---|---|---|---|
| 54 | 46 The Crescent,<br>CHELTENHAM | Garden | | <p>Garden dilapidated but retains original features including timber arbour, row of cypress, original sandstone front fence and timber vehicle and pedestrian gates.</p> | <p>Retain on LEP.</p> <p>(Listing has been updated on inventory form).</p> |

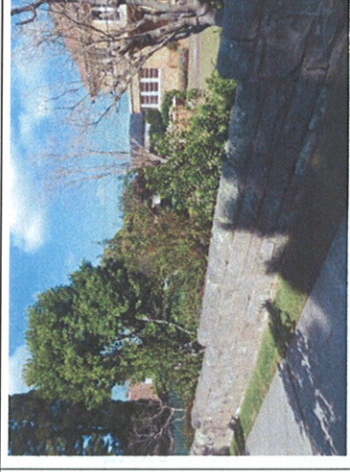
| E | Street Address | Item | Item Image | Issue | Recommendations |
|---|---|---|---|---|---|
| 55 | 48 The Crescent,<br>CHELTENHAM | Garden | | Several garden features have been removed since the 1993 Heritage Study (including the gravel drive and some plantings) but garden retains early significant plantings and sandstone front fence retains continuity with adjoining properties at 44 and 46 The Crescent. | Retain on LEP.<br>(Listing has been updated on inventory form). |

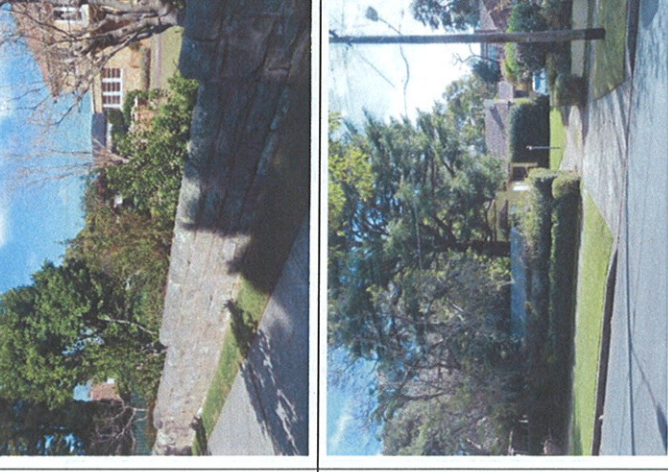
| E | Street Address | Item | Item Image | Issue | Recommendations |
|---|---|---|---|---|---|
| 56 | 7 The Promenade,<br>CHELTENHAM | Garden | | Garden has altered since 1993 Heritage Study and is now mainly significant for the large Deodar. | Remove from LEP but include Deodar on Significant Tree Register. |

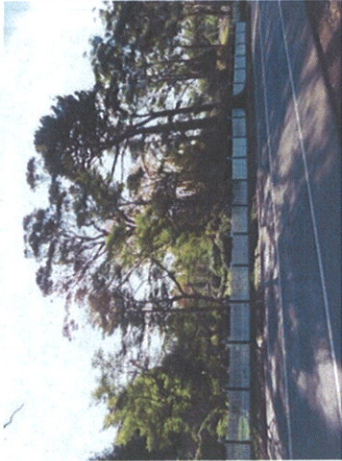
| E | Street Address | Item | Item Image | Issue | Recommendations |
|---|---|---|---|---|---|
| 57 | 452 Galston Road, DURAL | Garden | | Garden – Pukekara Park.<br>Although of more recent date than suggested in the 1993 Heritage Study, this garden has considerable aesthetic significance as a “plantsman’s garden” featuring a wide variety of ornamental trees and flowering shrubs. | Retain on LEP<br>Information on listing has been updated on inventory form. |

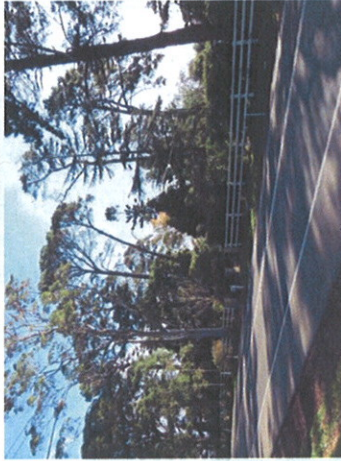
| E | Street Address | Item | Item Image | Issue | Recommendations |
|---|---|---|---|---|---|
| 58 | 454 Galston Road, DURAL | Garden – Kelvin Park | | Garden—Kelvin Park<br>Representative of large 1960-70s rural gardens with ornamental shrubs massed blow canopy trees. Plantings have declined since 1993 Study.. | Retain on LEP.<br>(Listing has been updated on inventory form). |

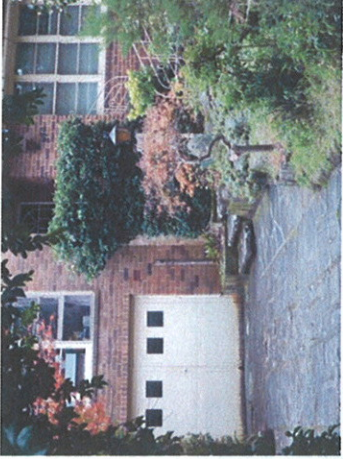
| E | Street Address | Item | Item Image | Issue | Recommendations |
|---|---|---|---|---|---|
| 59 | 27A Chester Street, EPPING | Garden | | Some plants have gone from garden since 1993 Heritage Study but it retains many original features including the landmark Deodar. | Retain on LEP.<br>(Listing has been updated on inventory form).<br>Investigate house in Stage 6 Heritage Study Review. |

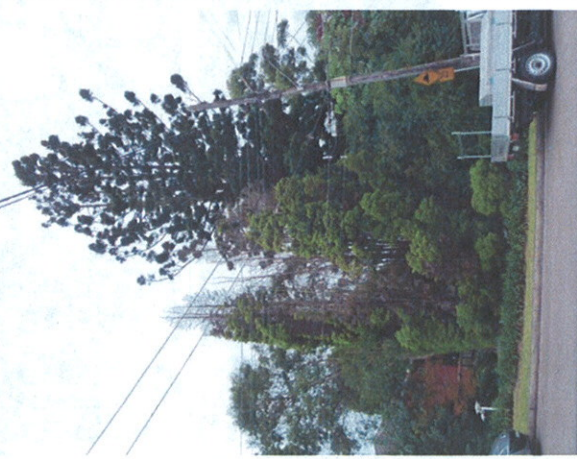
| E | Street Address | Item | Item Image | Issue | Recommendations |
|---|---|---|---|---|---|
| 60 | 132 Midson Road, EPPING | Garden | | Garden has changed since 1993 Heritage Study but large Hoop Pine still warrants listing. | Remove from LEP.<br>Include Hoop Pine on Significant Tree Register. |

These trees require more detailed arboricultural assessment to determine their condition, public risk and management recommendations. Examples include large specimens of *Eucalyptus saligna* (Sydney Blue Gum) and/or other remnant indigenous trees in Hillcrest Road, Pennant Hills; 121–123 David Road, Castle Hill; 17–23A Trelawney Street, Thornleigh; 7–17 Capella Place, Normanhurst; 2–7 Bluegum Street, Normanhurst; *Quercus robur* (English Oak), 27 Royston Parade, Asquith; *Araucaria heterophylla* (Norfolk Island Pine), 547 Pacific Highway, Mount Colah; *Araucaria cunninghamii* (Hoop Pine), 132 Midson Road, Epping.

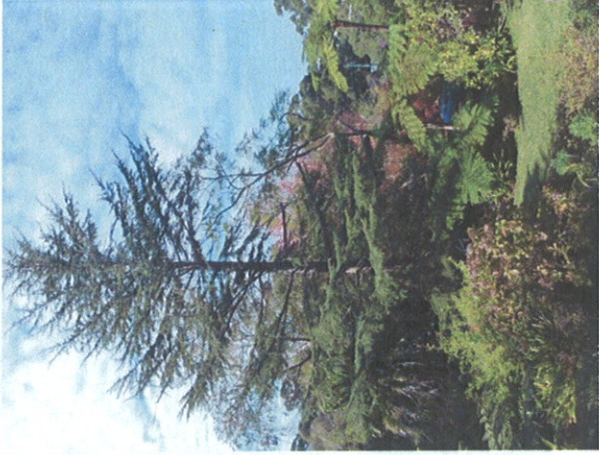
| E | Street Address | Item | Item Image | Issue | Recommendations |
|---|---|---|---|---|---|
| 62 | 4 Lisgar Road, HORNSBY | Garden | | A locally significant hillside garden for its aesthetic values derived from trees, terraced garden beds and mature plantings, particularly cycads, azaleas and tree ferns. Also significant is the ornamental sandstone lily pond with a central fountain. | Retain on LEP.<br>Description updated.<br>(Listing has been updated on inventory form) |

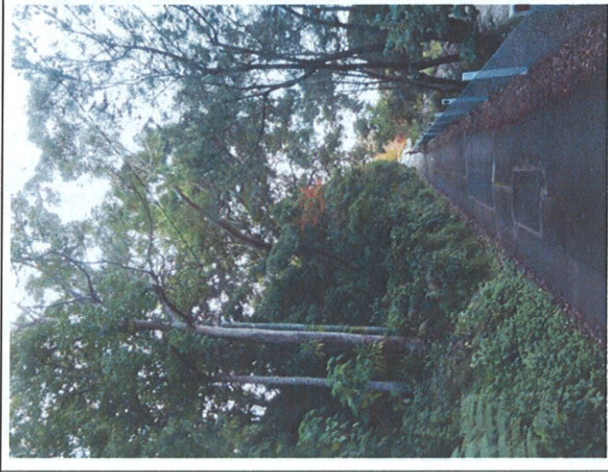
| E | Street Address | Item | Item Image | Issue | Recommendations |
|---|---|---|---|---|---|
| 63 | 6 Lisgar Road,<br>HORNSBY | Garden | | Bushland remnant with Local significance and positive streetscape contributions. Primarily significant for remnant native trees and sandstone outcrops, but also with some exotic orientals, making major contribution to streetscape in conjunction with 4 and 8 Lisgar Road. | Retain on LEP.<br>(Listing has been updated on inventory form). |

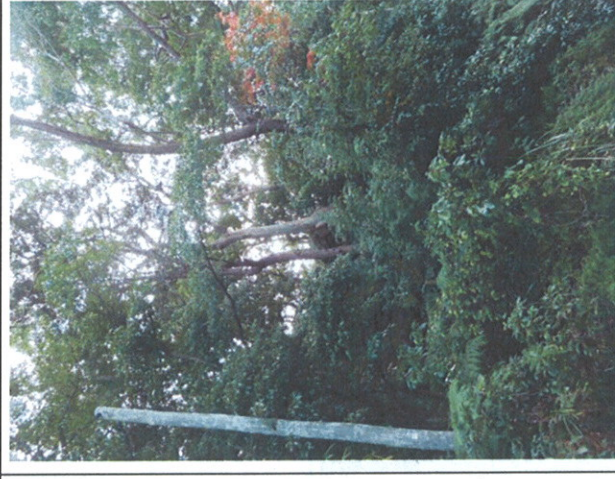
| E | Street Address | Item | Item Image | Issue | Recommendations |
|---|---|---|---|---|---|
| 64 | 8 Lisgar Road,<br>HORNSBY | Garden | | Primarily significant for remnant native trees and sandstone outcrops, making major contribution to streetscape in conjunction with 4 and 6 Lisgar Road. | Retain on LEP.<br>(Listing has been updated on inventory form). |

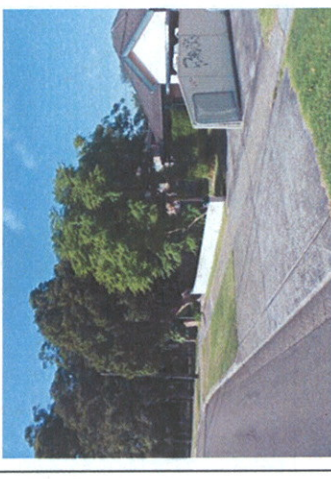
| E | Street Address | Item | Item Image | Issue | Recommendations |
|---|---|---|---|---|---|
| 65 | 61-63 Pretoria<br>Parade,<br>HORNSBY | Garden | | All but one heavily lopped Camphor Laurel have been removed. | Remove from LEP. |

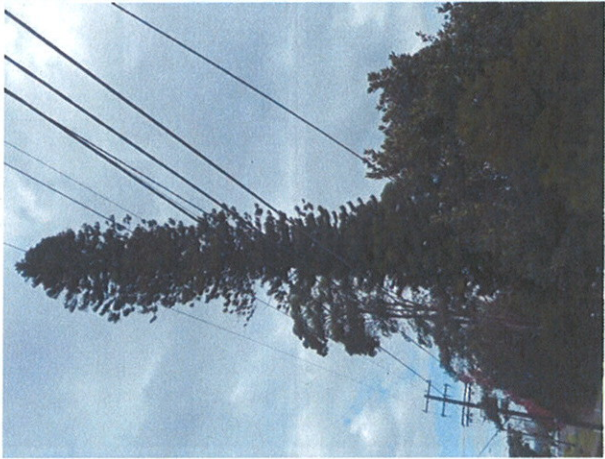
| E | Street Address | Item | Item Image | Issue | Recommendations |
|---|---|---|---|---|---|
| 66 | 547 Pacific Highway, MOUNT COLAH | Garden | | Very tall Norfolk Island Pine is a landmark tree. | Remove from LEP.<br>Include Norfolk Island Pine on Significant Tree Register.<br>(Listing has been updated on inventory form). |

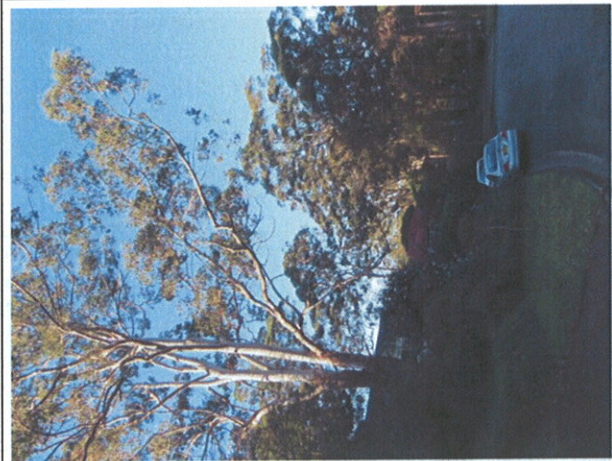
| E | Street Address | Item | Item Image | Issue | Recommendations |
|---|---|---|---|---|---|
| 67 | 2, 3, 5, 6 and 7<br>Bluegum Street,<br>NORMANHURST | Gardens | | Group of remnant indigenous trees in residential gardens reflect canopy species of original vegetation community.<br>Through their majestic scale and aesthetic qualities these trees make a positive contribution to the streetscape and bushland identity of the area, as well as contributing to biodiversity, conservation and habitat protection. | Remove from LEP.<br>Protect remnant native trees under TPO. |

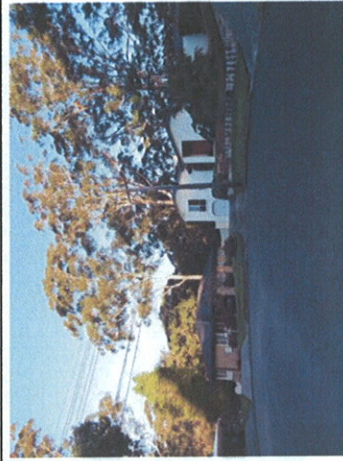
| E | Street Address | Item | Item Image | Issue | Recommendations |
|---|---|---|---|---|---|
| 68 | 7, 9, 11, 15 and<br>17 Capella Place,<br>NORMANHURST | Rear Gardens | | Group of remnant indigenous trees in residential gardens reflect canopy species of original vegetation community. | Remove from LEP.<br>Protect remnant native trees under TPO. |

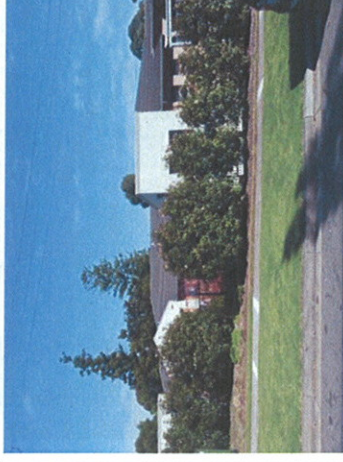
| E | Street Address | Item | Item Image | Issue | Recommendations |
|---|---|---|---|---|---|
| 69 | 1-7 Frith Avenue,<br>NORMANHURST | Garden | | House and most of garden removed since 1993 Heritage Study. The remnant garden and trees of a 1920s house, its significance has been reduced by the loss of the house, and much of its plantings, but a number of significant trees remain on the site. They interpret its original use and contribute to the aesthetic values of the site. | Remove from LEP.<br>Include the surviving non-indigenous trees on Significant Tree Register. |

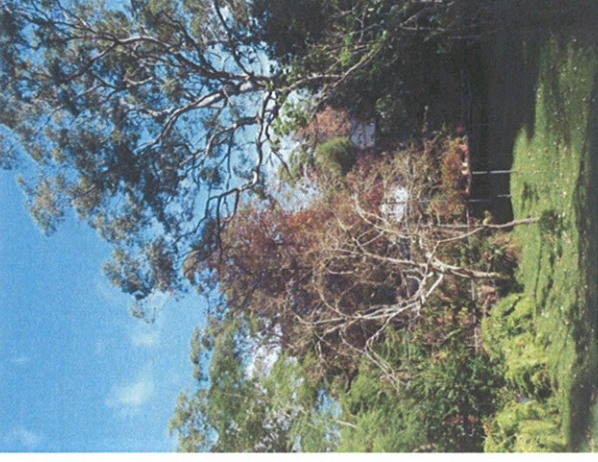
| E | Street Address | Item | Item Image | Issue | Recommendations |
|---|---|---|---|---|---|
| 70 | 17, 19, 21, 21A, 23 and 23A<br>Trelawney Street,<br>THORNLEIGH | Gardens | | Group of remnant indigenous trees in residential gardens reflect canopy species of original vegetation community. | Remove from LEP.<br>Protect remnant native trees under TPO. |
