***Hornsby Heritage Study Review – Stage 5, 2012 –  
Godden Mackay Logan***

# Hornsby Heritage Study Review Stage 5, 2012

Volume 1—Project Report and Appendices A–F

Report prepared for Hornsby Shire Council  
March 2013

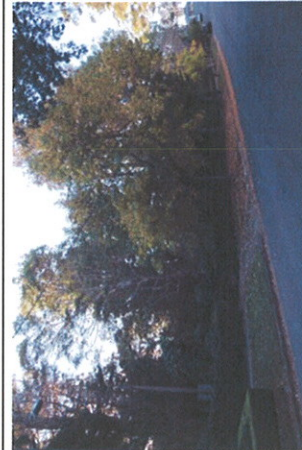
| E | Street Address | Item | Item Image | Issue | Recommendations |
|---|---|---|---|---|---|
| 71 | 43 Bundarra Avenue,<br>WAHROONGA | Garden | | Large Pin Oak remains but rest of garden significantly altered. | Remove from LEP.<br>Include Pin Oak on Significant Tree Register. |

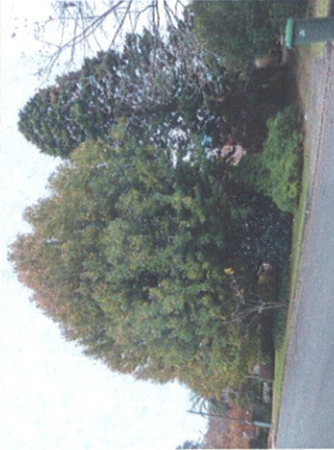
| E | Street Address | Item | Item Image | Issue | Recommendations |
|---|---|---|---|---|---|
| 72 | 45 Bundarra Avenue,<br>WAHROONGA | Garden | | The horticultural qualities of the mature trees give the garden aesthetic significance at a Local level and contribute greatly to the streetscape of Bundarra Avenue and the Wahroonga North Heritage Conservation Area. | Retain on LEP.<br>(Listing has been updated on inventory form). |

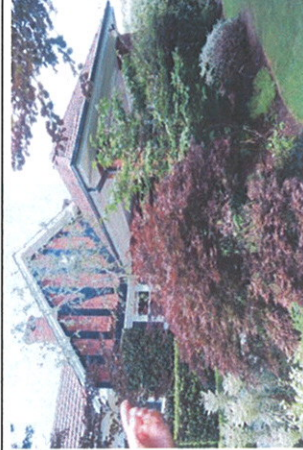
| E | Street Address | Item | Item Image | Issue | Recommendations |
|---|---|---|---|---|---|
| 73 | 48 Bundarra Avenue,<br>WAHROONGA<br>See also C29 | Garden –<br>'Landskrona' | | Landskrona is a substantial inter-war house and garden demonstrating the subdivision of Wahroonga's early estates for a second generation of significant houses. 'Landskrona' is a finely detailed and executed house and garden of quality and distinction. | Retain on LEP and extend to include house.<br>(Listing has been updated on inventory form). |

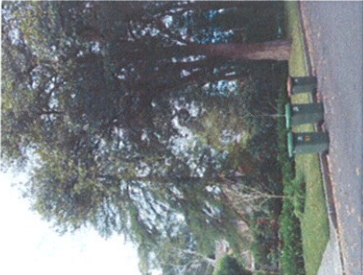
| E | Street Address | Item | Item Image | Issue | Recommendations |
|---|---|---|---|---|---|
| 74 | 51 Bundarra Avenue,<br>WAHROONGA | Garden | | Exotic trees and shrubs and indigenous remnant trees have aesthetic significance at a Local level as evidence of the tree layer of pre-European settlement vegetation or regrowth thereof. | Retain on LEP.<br>(Listing has been updated on inventory form). |

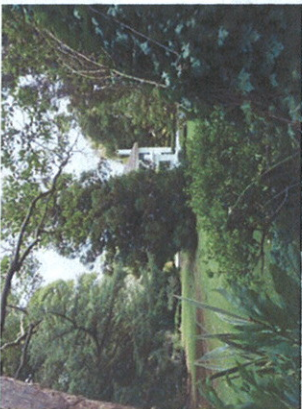
| E | Street Address | Item | Item Image | Issue | Recommendations |
|---|---|---|---|---|---|
| 75 | 54 Bundarra Avenue,<br>WAHROONGA<br><br>See also C30. | Garden<br>(and House) | | Garden has been altered since 1993 Heritage Study but retains many significant features. | Retain garden on LEP.<br>House recommended for individual listing. |

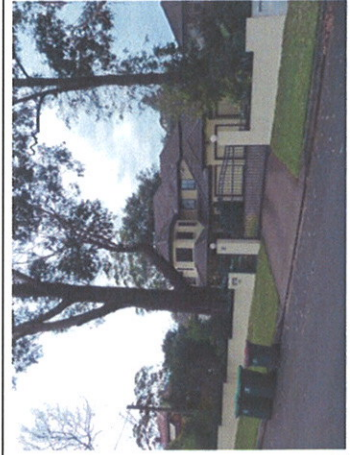
| E | Street Address | Item | Item Image | Issue | Recommendations |
|---|---|---|---|---|---|
| 76 | 55, 57 and 57A<br>Bundarra Avenue,<br>WAHROONGA | Garden | | Subdivisions since 1993 Heritage Study.<br>No.57 has two remnant eucalypts in garden of new house; No.57A—two remnant eucalypts in garden of new house. Now significant only for remnant indigenous trees | Remove from LEP.<br>Protect remnant native trees under TPO. |

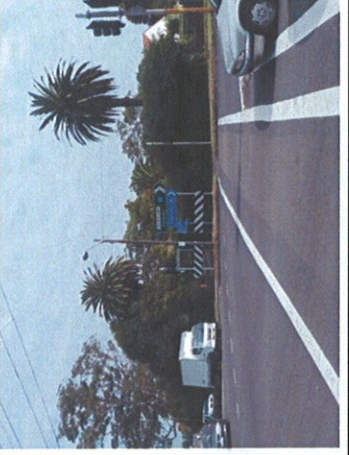
| E | Street Address | Item | Item Image | Issue | Recommendations |
|---|---|---|---|---|---|
| 77 | 1 Pacific Highway,<br>WAHROONGA | Garden | | Garden retains landmark palms and an earlier garden with Local historical and aesthetic significance derived from their species and horticultural qualities at a major intersection. | Retain on LEP.<br>(Listing has been updated on inventory form). |

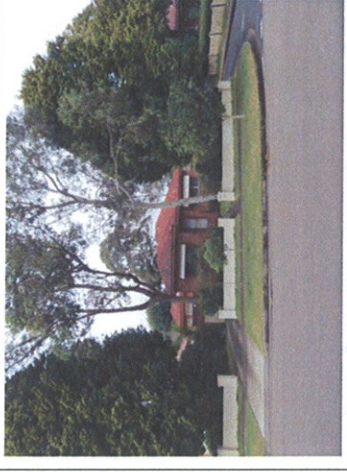
| E | Street Address | Item | Item Image | Issue | Recommendations |
|---|---|---|---|---|---|
| 78 | 28-36 Balmoral Street, WAITARA | Gardens | | Gardens have been altered since last Heritage Study and several lots have been subdivided, removing rear gardens. The Cypress Pines at No. 34 are significant elements in the streetscape | Remove from LEP.<br>Include mature Cypress at No.34 on Significant Tree Register.<br>Protect remnant native trees under TPO. |
