## PLANNING PROPOSAL

Inclusion of Scots Presbyterian Church, 13-19 Denison Street, Finley 2713 as a Heritage Item in Berrigan Local Environmental Plan 2013.

## Building Condition Report

MARCH 11, 2015  
REALM BUILDING DESIGN  
531 High Street, Echuca VIC 3564

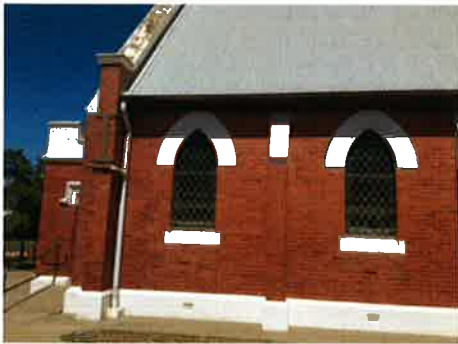
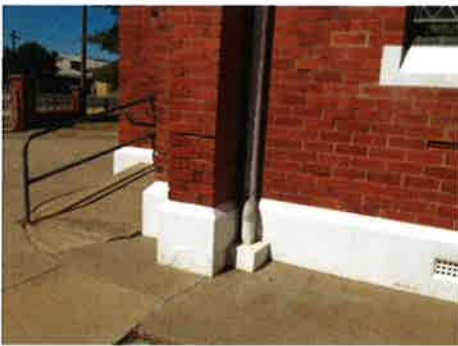
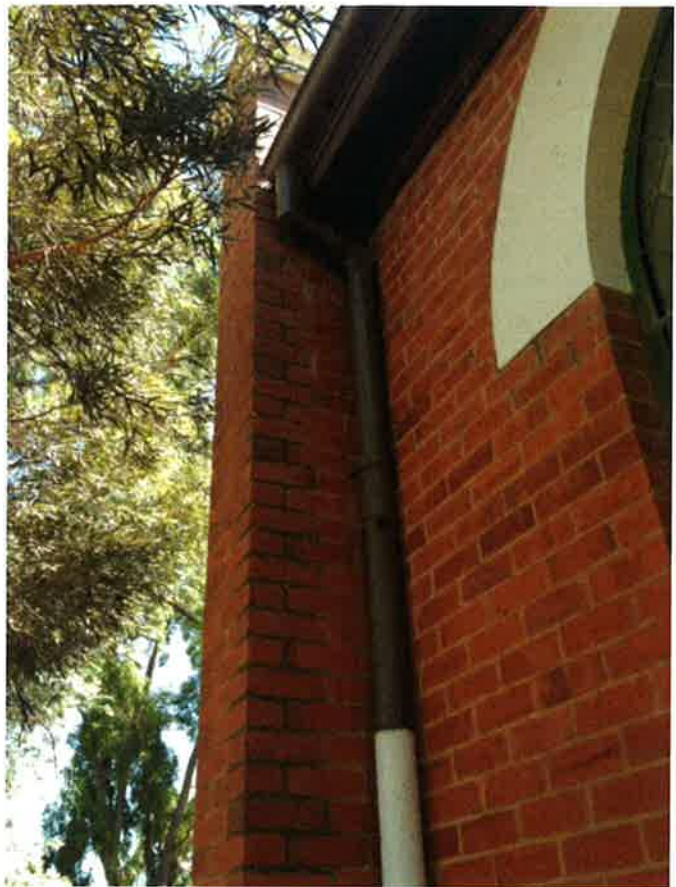
A recent corrugated roof is present on the building which appears to be well fixed and flashed. Overall the flashings and gutters are present and intact, however there are signs of water damage to the brickwork due to deterioration of the down pipes, inadequate downpipe capacity, inadequate number of downpipes and concentration of water run off.at the roof – parapet junctions.

Some downpipes have been replaced or partly replaced with pvc pipes, with all down pipes presently set into a concrete surround at the base of the wall.

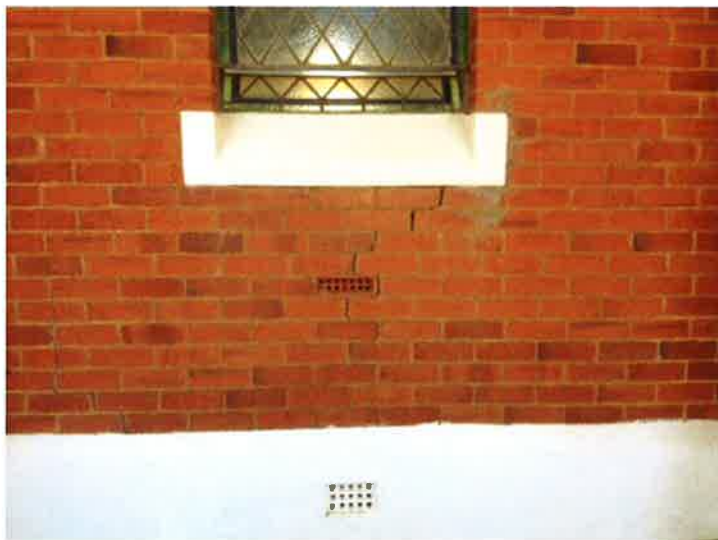
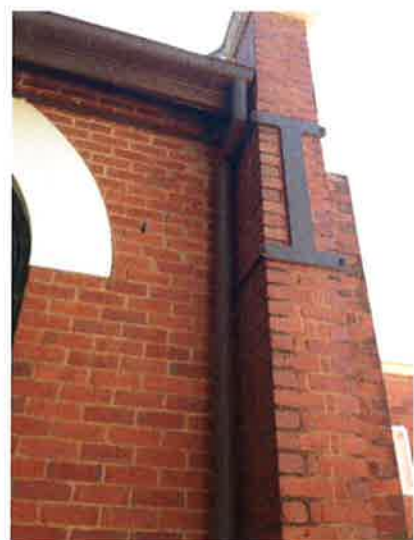
Some minor cracking is present in the wall faces which is consistent with a solid masonry structure of this age. The cracking generally occurs around the window and door openings which can be areas of concentrated stresses in the brickwork or at the interface of two differing materials or changes in configuration of the building elements. In this case, at the window sills and where the window arches meet the walls.

There is a consistent pattern of cracking within each wall 'bay' on the south elevation of the building. Cracking emanates from the apex of the Gothic arch and from the external sill through the centre of the panel beneath the window. The cracking observed here is minor and no deflection in the wall face was detected. Cracking is confined to the mortar joints with no damage occurring to the brickwork in these locations.

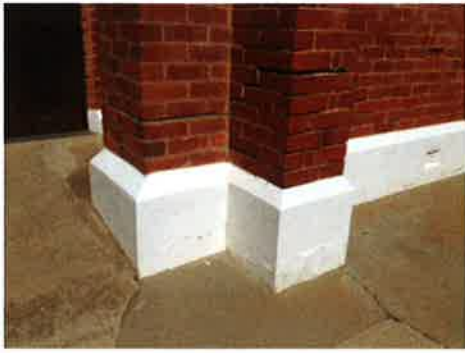
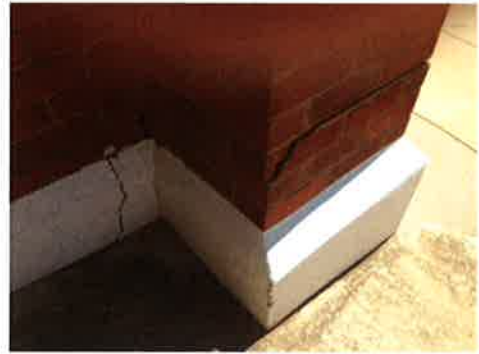
More severe cracking is present in the brickwork where it is exacerbated by the presence of water and failure in the footing beneath. The two locations where this occurs would also have a concentration of load at each of the extremities of the front parapet wall on the north east and south east corners of the main part of the building.

At these points there are 2 additional supporting buttresses in place to support the front wall of the building. While these buttresses support the wall they may also contribute to additional weight and stress on the footing system in these locations. As the brickwork of the buttresses is tied to the original wall and no articulation is present, stresses are likely to occur at these points.

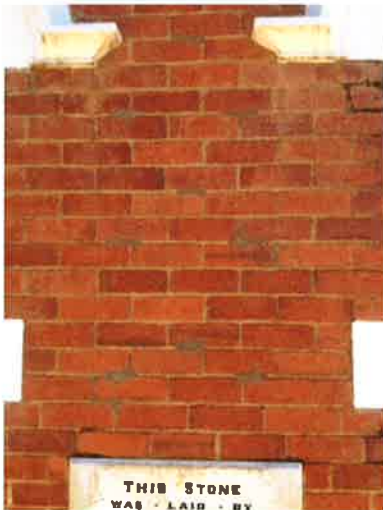
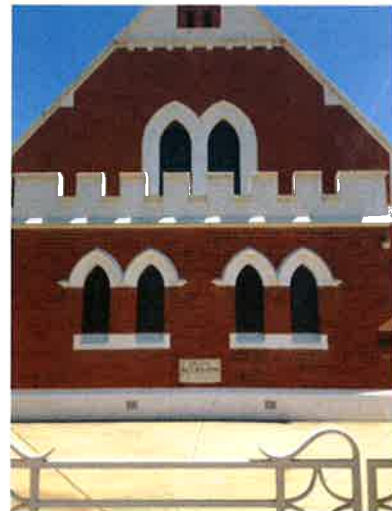
Some cracking is present in the front wall of the entry and the main building. Minor repair has been undertaken to the pointing using an unsuitable cement based mortar.

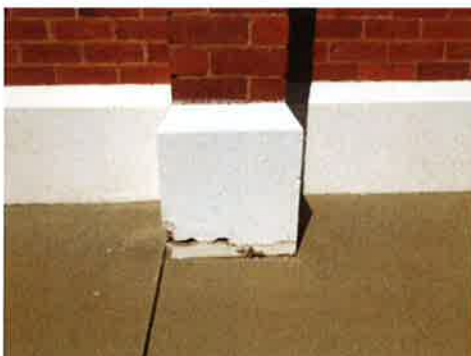
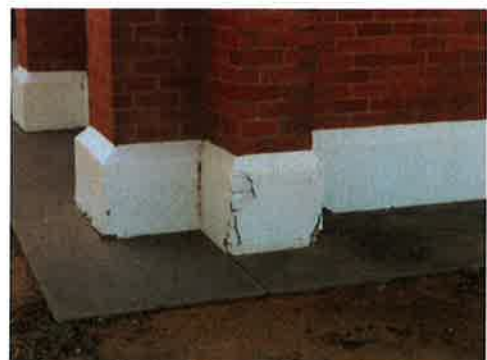
Minor cracking and delamination of the render to the plinth at the base of the building occurs in some locations. This varies from very minor cracking to more severe cracking and loss of render at the rear of the building on the south west corner.

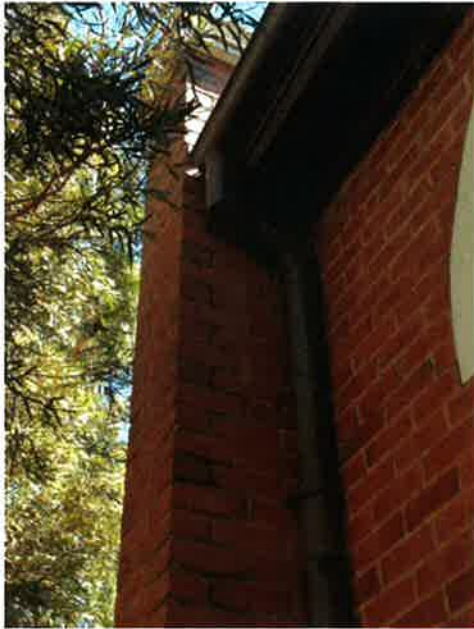
The southwest corner of the building shows evidence of damage which could be attributed to the damp conditions present here due to overflow from the gutter above.

Evidence of damp and mould on the brickwork suggests that this has been a problem for some time and would manifest in deterioration of the render below.
