**REPORT**  
**TO**  
**JANPEC PTY LTD**  
**ON**  
**GEOTECHNICAL INVESTIGATION**  
**FOR**  
**PROPOSED MIXED USED DEVELOPMENT**  
**AT**  
**171-189 PARRAMATTA ROAD, GRANVILLE**

**24 September 2014**  
**Ref: 24711PYrpt**

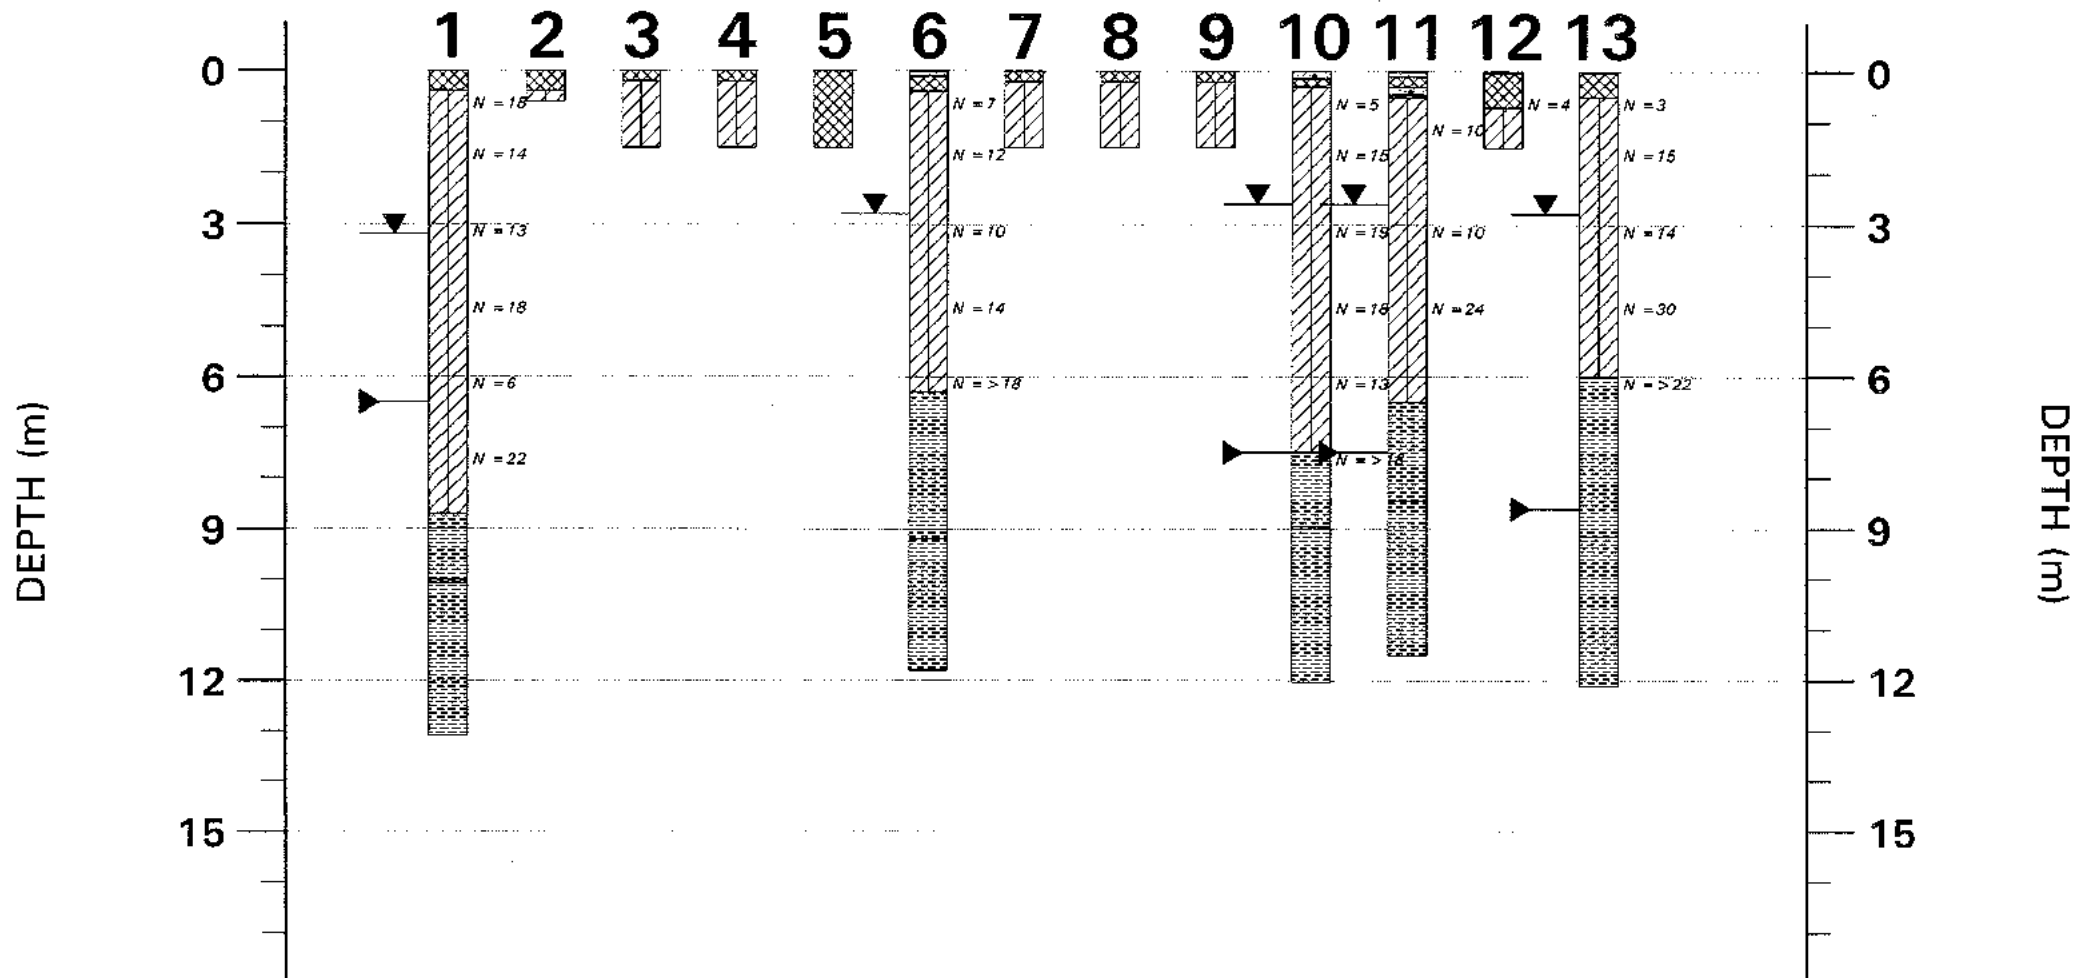
# GRAPHICAL BOREHOLE SUMMARY

NOTE: REFER TO BOREHOLE LOGS

Scale: 1 : 150 (vert) ; NTS (horiz)

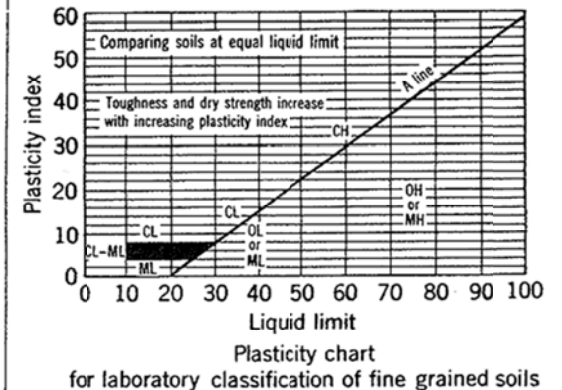
- Note: 1 Soils possessing characteristics of two groups are designated by combinations of group symbols (eg. GW-GC, well graded gravel-sand mixture with clay fines).  
2 Soils with liquid limits of the order of 35 to 50 may be visually classified as being of medium plasticity.
