Upjohn House c1885
Formerly known as Netherlands
Kirby Street Planning Proposal
55-59 Kirby Street, Rydalmere, NSW

Conservation Management Strategy

August 2018
REF: 1641: CMS
Issue 03
FINAL

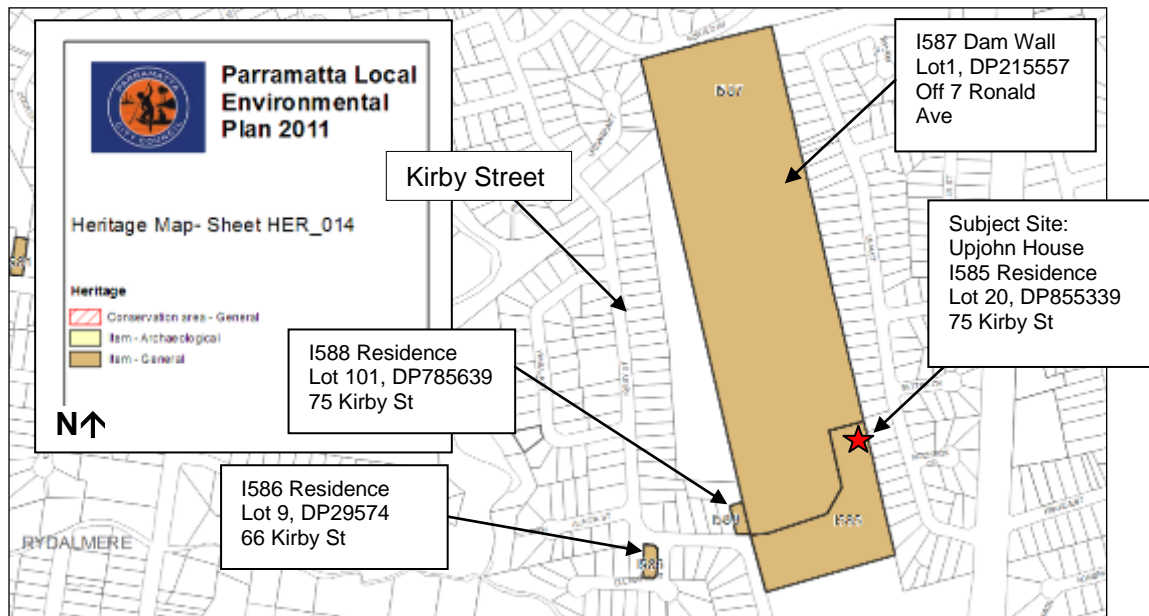
Figure 5a: Parramatta Local Environment Plan 2011, Heritage Map Sheet HER_014: 55-59 Kirby St.

The subject property, Upjohn House is listed as a Heritage Item on the Parramatta LEP 2011 Heritage Register as a local item (I585) at 59 Kirby Street, Rydalmere. Refer to Appendices A and B for NSW Heritage Inventory Sheets. Other neighboring Heritage Items, as identified by Parramatta LEP, include 'Upjohn Park' stone dam wall, 66 & 75 Kirby Street, being early residences – refer to Figure 5a. Refer to Figures 5a & 5b.

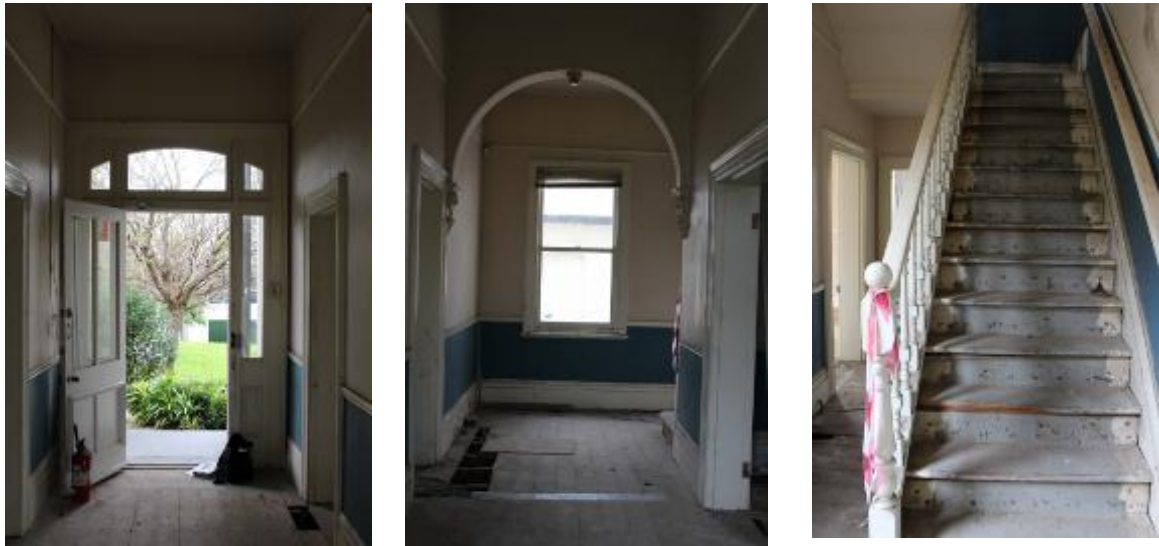
Figure 19: Main Entry space **G.1** indicating pressed metal ceiling

ITEM	ELEMENT	DESCRIPTION	CONDITION	SIGNIFICANCE
1.0	ENTRY HALL G.1			
1.1	Floor	Early T&G pine flooring (160mmx20mm)	Fair	S
1.2	Skirting	Profiled timber 240mm high	Good	S?
1.3	Walls	Early plastered brick walls Recent timber dado and picture rails	Good Good	S NS
1.4	Cornice	Early decorative plaster	Good	S
1.5	Ceiling	Later pressed metal Early plaster under ?	Fair+Good ?	S S
1.6	Special Archway	Decorative plaster archway with corbels	Good	S
1.7	Windows	Early timber double hung	Good	S
1.8	Doors	Timber framed and panelled with highlight and sidelights	Good to poor	S

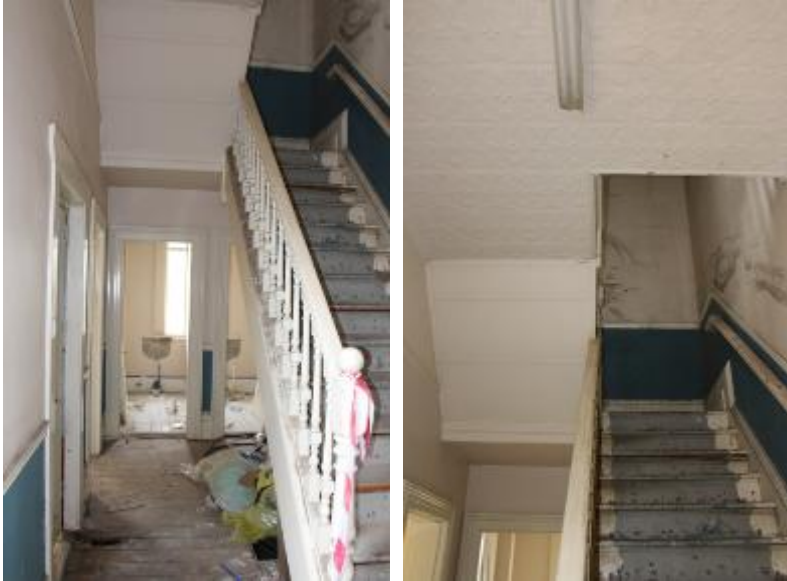
Figure 20: Main Hall space **G.2** with stair & pressed metal ceiling looking towards **G.6 & G.7**

ITEM	ELEMENT	DESCRIPTION	CONDITION	SIGNIFICANCE
2.0	STAIR HALL G.2			
2.1	Floor	Early T&G pine flooring (160mmx20mm) Recent particle board	Poor/Fair Fair	S NS
2.2	Skirting	Profiled timber 240mm high	Fair/Good	S?
2.3	Walls	Early plastered brick walls Recent timber dado and picture rails	Good Good	S NS
2.4	Cornice	Early plaster	Fair	S
2.5	Ceiling	Later pressed metal Early plasterboard	Fair Good	S NS
2.6	Special Staircase	Early closed timber stairs with decorative newel and balusters. Recent modifications.	Good/Fair	S
2.7	Windows	Early timber double hung	Good/Fair	S
2.8	Doors	Timber framed and panelled (4)	Good	S

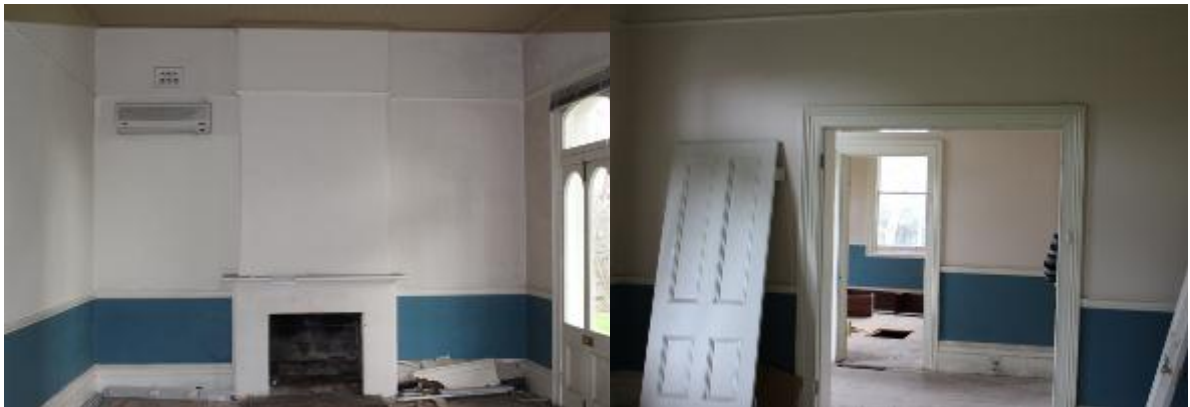
Figure 21: Space **G.3** - Drawing (with pressed metal ceiling. French doors to verandah & double doors to Space G1)

ITEM	ELEMENT	DESCRIPTION	CONDITION	SIGNIFICANCE
3.0	DRAWING G.3			
3.1	Floor	Early T&G pine flooring (160mmx20mm) Recent particle board	Poor Fair	S NS
3.2	Skirting	Profiled timber 240mm high Recent MDF (termite damage)	Good Poor	S? NS
3.3	Walls	Early plastered brick walls Recent timber dado and picture rails	Good Good	S NS
3.4	Cornice	Early decorative plaster	Good/Fair	S
3.5	Ceiling	Recent pressed metal	Good	NS

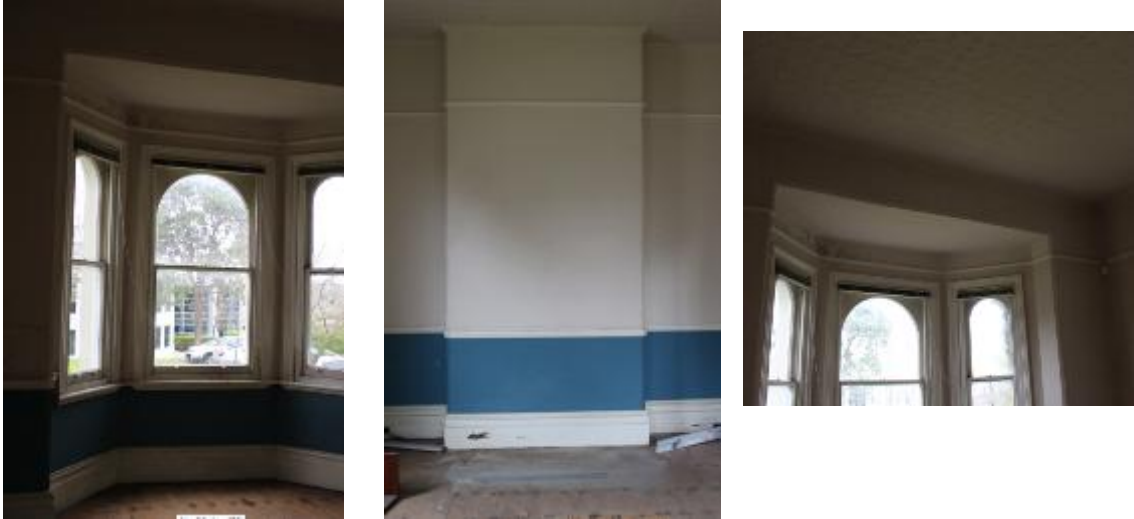
Figure 22: Space **G.4** – Sitting (with bay window & pressed metal ceiling)

ITEM	ELEMENT	DESCRIPTION	CONDITION	SIGNIFICANCE
4.0	SITTING G.4			
4.1	Floor	Early T&G pine boards, possibly Kauri*	Good to Fair	S
4.2	Skirting	Profiled timber 240mm high	Good	S?
4.3	Walls	Early plastered brick walls Recent timber dado and picture rails	Good Good	S NS
4.4	Cornice	Later pressed metal	Good	S
4.5	Ceiling	Later pressed metal	Good	S
4.6	Special Fireplace	Early fireplace bricked in	Poor	S/NS
4.7	Windows	Early timber double hung	Good/Fair	S
4.8	Doors	Early timber framed and panelled	Good	S

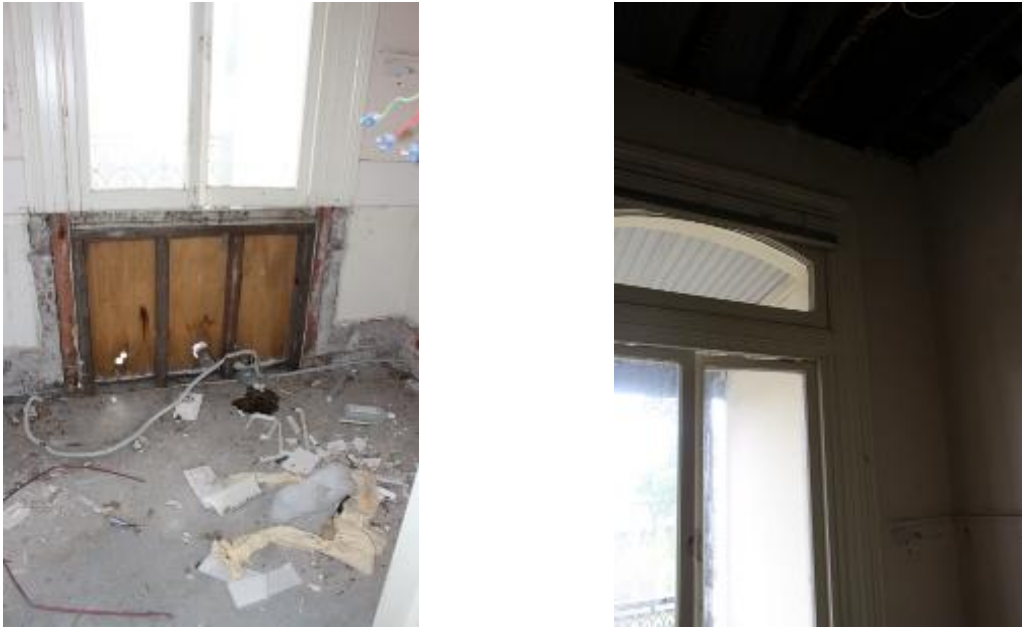
Figure 33: Part of Space F1 – recent enclosure & door converted to window

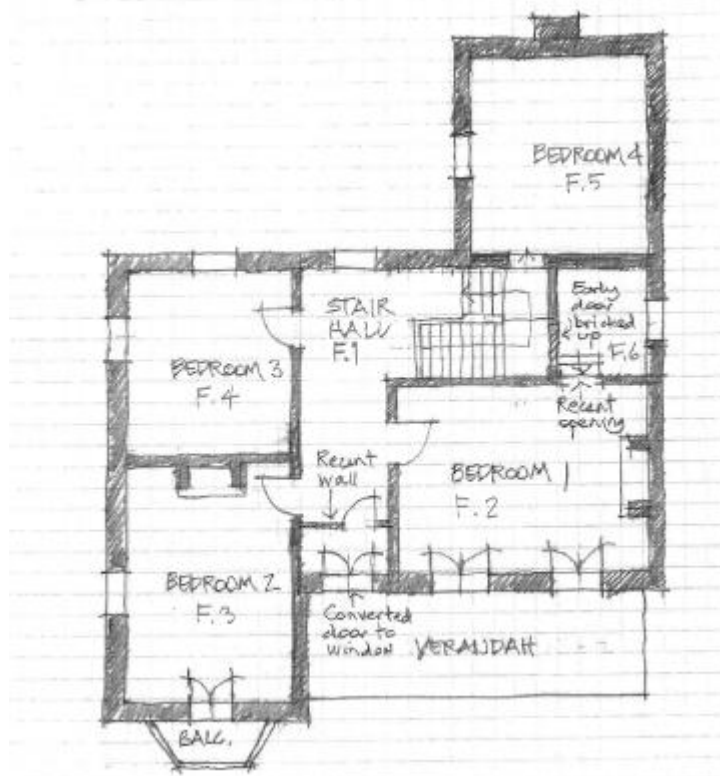
Figure 39: First Floor Plan
(Note: Internal rooms are identified as probable early residential uses).

The following figures are the Upjohn House Site, Ground, First and Roof Plan sketches with its probable early residential uses to the internal spaces of the Ground and First Floors - refer to Figures 38a, 38b, 39 and 40. At present the building is vacant with the remnants of a recent office fitout - refer to Figures 19 - 37.

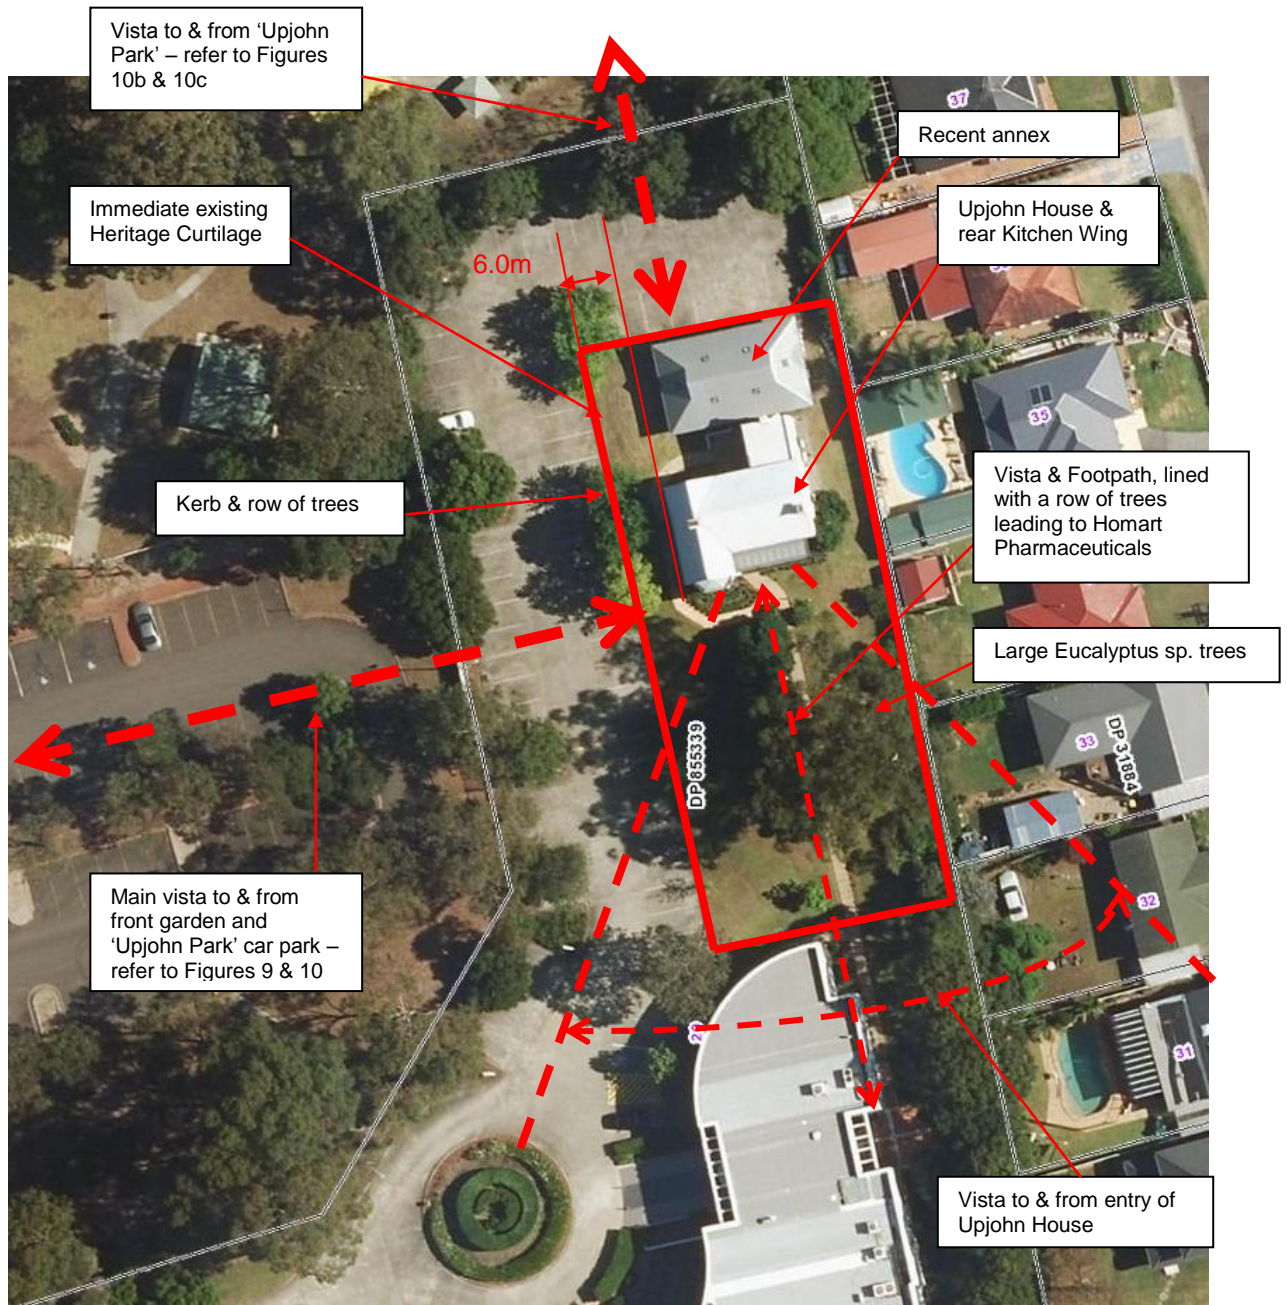
Figure 41: Existing Immediate Curtilage

The existing immediate curtilage for Upjohn House extends from the east boundary paling fence, running along the car park kerb behind the annex building, returning along the western car park kerb and row of deciduous trees— refer to Figure 41. The southern curtilage boundary terminates at the edge of the Homart Pharmaceuticals building.

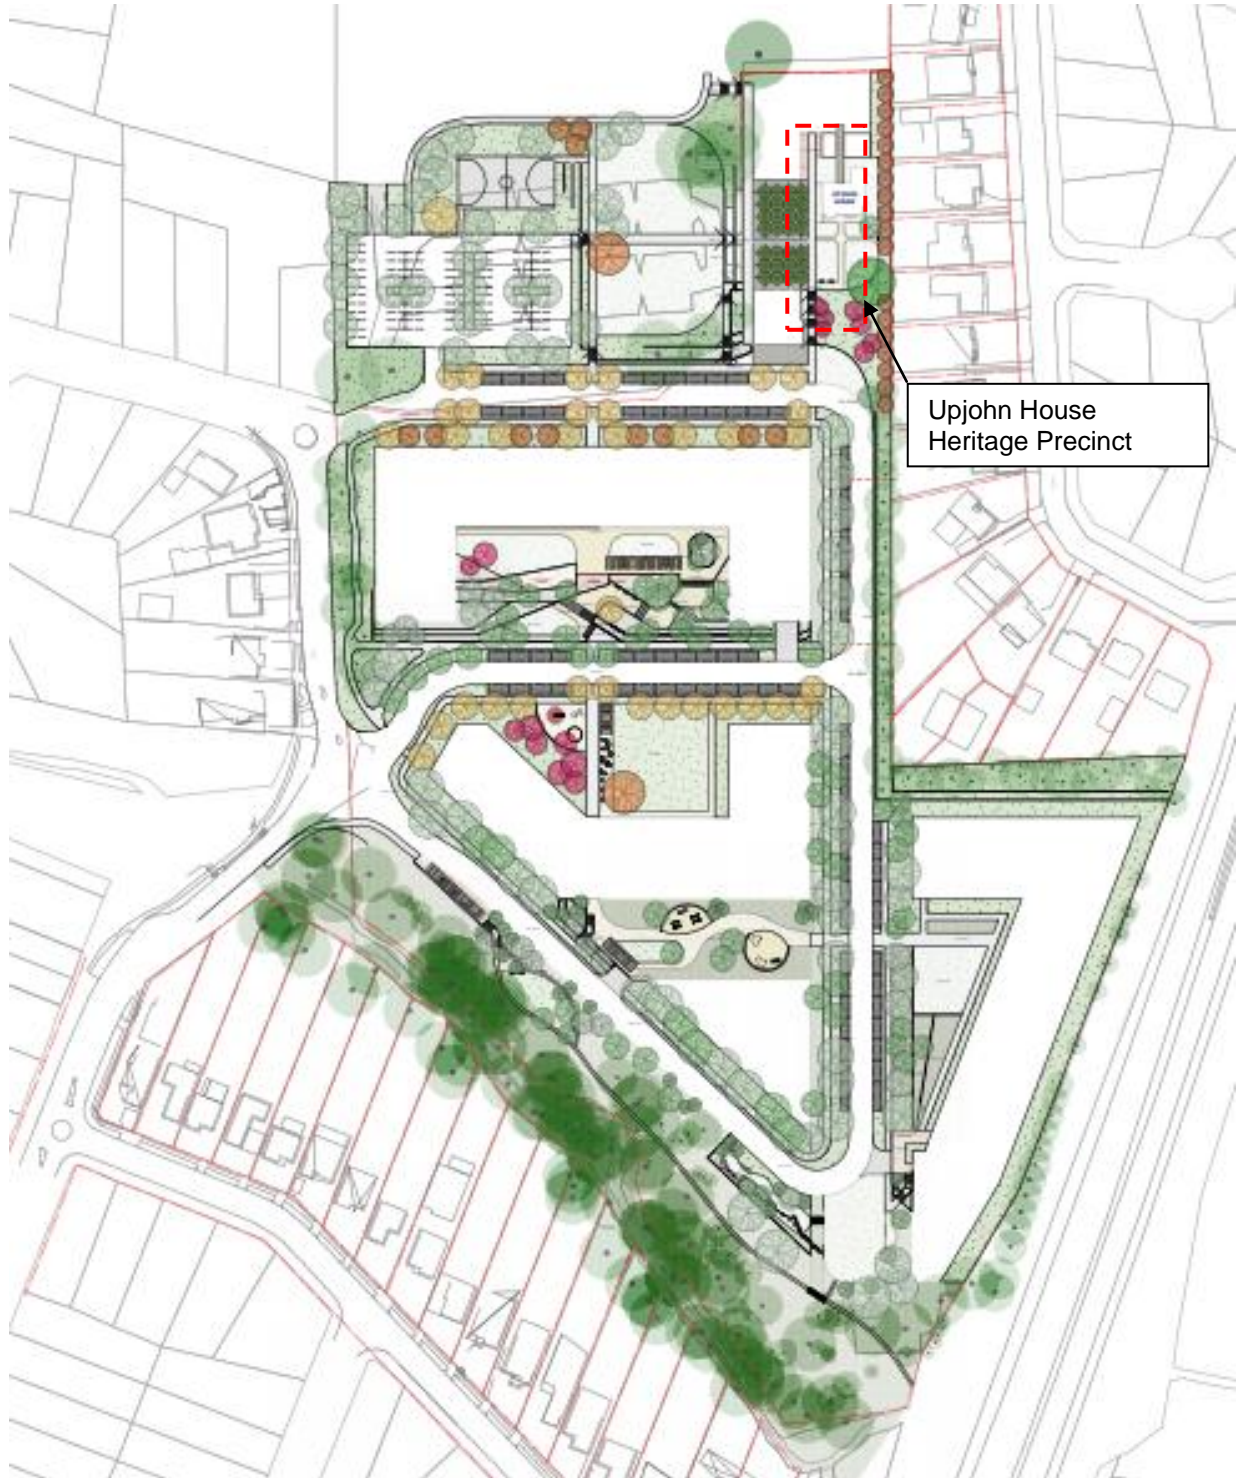
Figure 44: Kirby Street – Landscape Plan

- 6.2.1 The proposed redevelopment, indicated in Figures 44 – 50, has the potential to satisfy many of the Conservation Management Strategies recommendations. The chief design principals of the redevelopment adjacent to the Upjohn House and Garden and Upjohn Park are concerned with the providing a good quality curtilage to Upjohn House and Garden whilst ensuring an improved physical and visual connection with Upjohn Park.
- 6.2.2 The curtilage and setting of Upjohn House and garden would be enhanced with a much improved front garden expanse and design. This improved setting would allow Upjohn House to be clearly and prominently identifiable.
- 6.2.3 The relationship between Upjohn House and Upjohn Park would be enhanced with a dynamic physical and visual connection that strongly links Upjohn House and Garden with the Park.
