# ELECTRICAL FRICTION CONE PENETROMETER TEST RESULTS

**Client:** HELM PTY LTD  
**Project:** PROPOSED RESIDENTIAL DEVELOPMENT  
**Location:** 177 RUSSELL AVENUE, DOLLS POINT, NSW

**Job No.:** 29353S

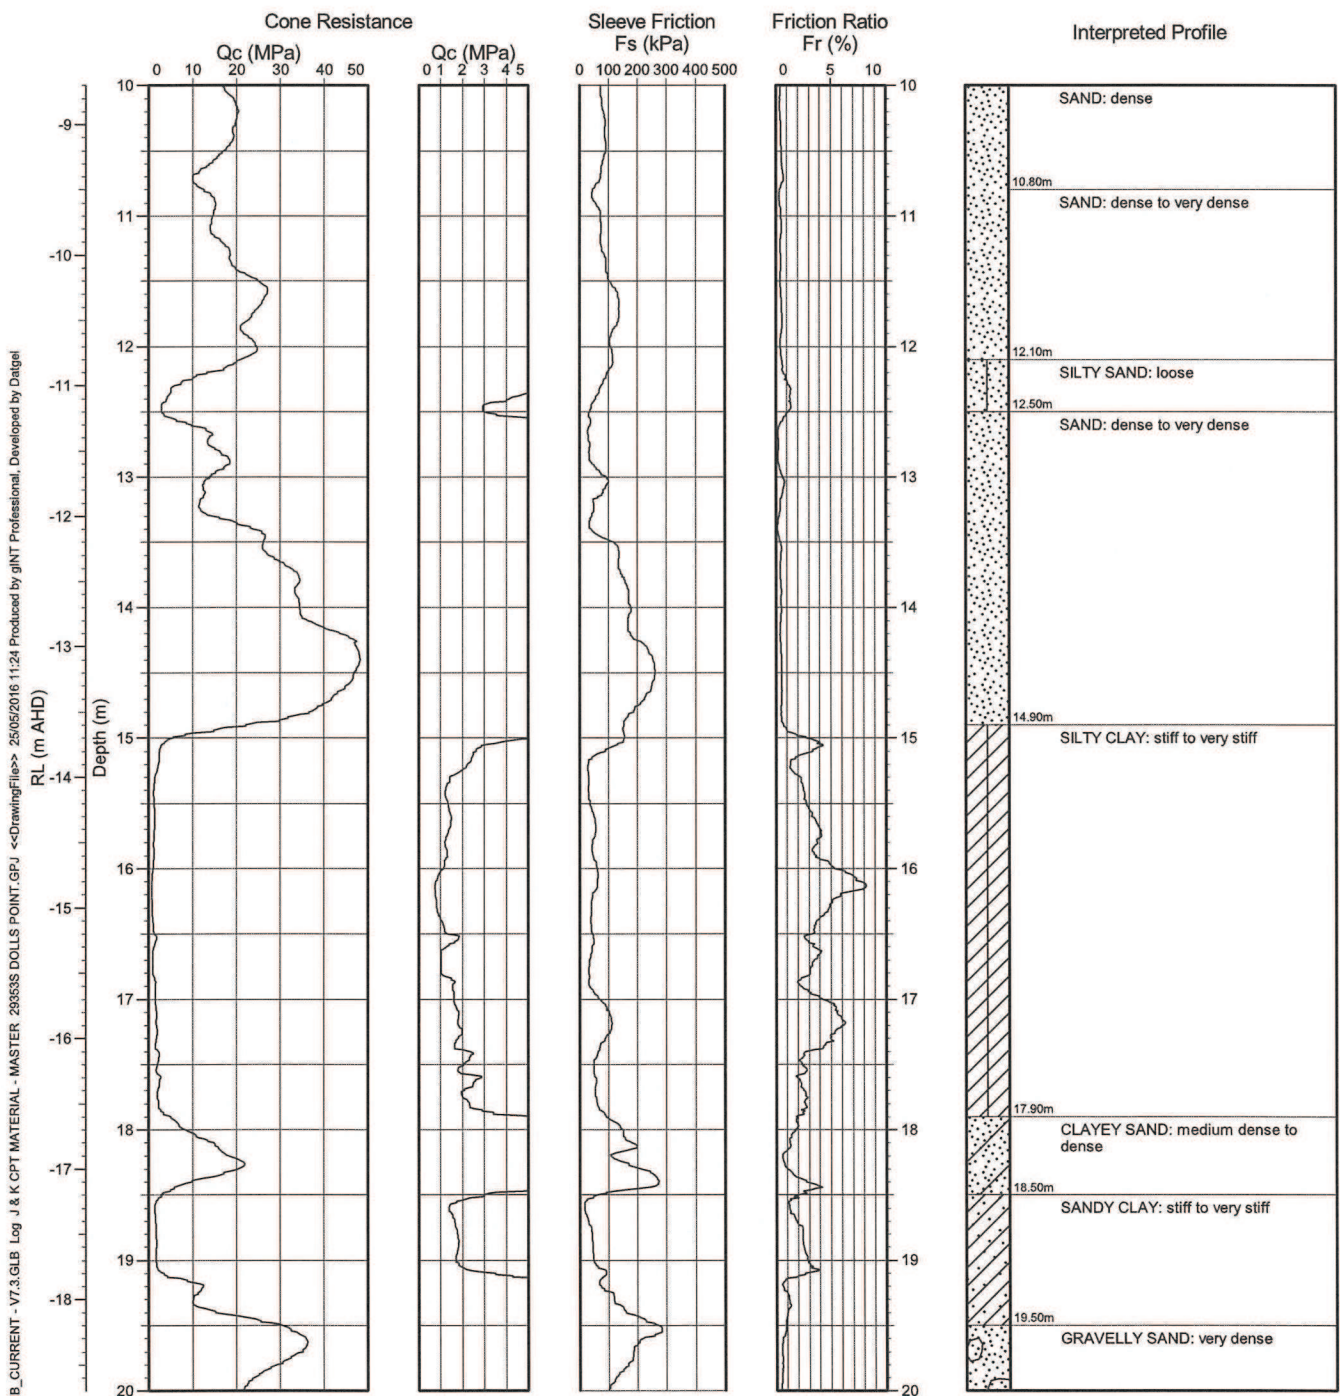
**R.L. Surface:** ~1.3 m

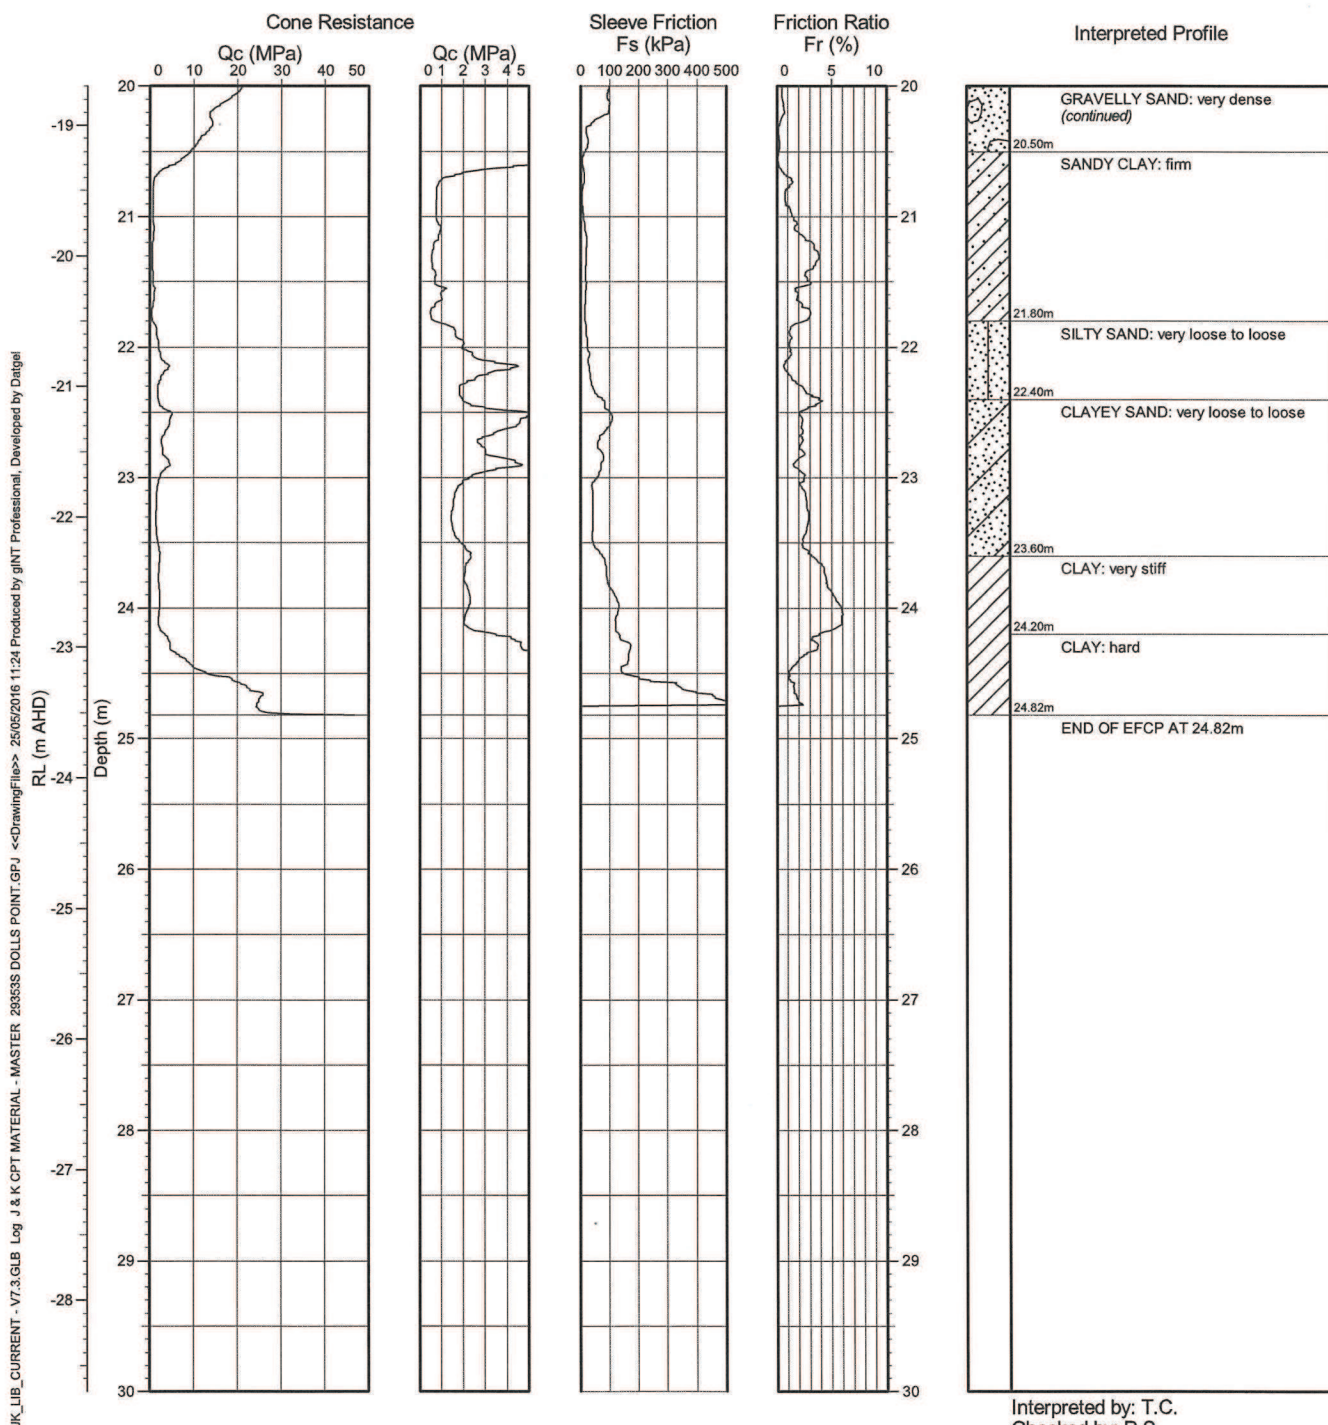
# ELECTRICAL FRICTION CONE PENETROMETER TEST RESULTS

**R.L. Surface:** ~1.3 m

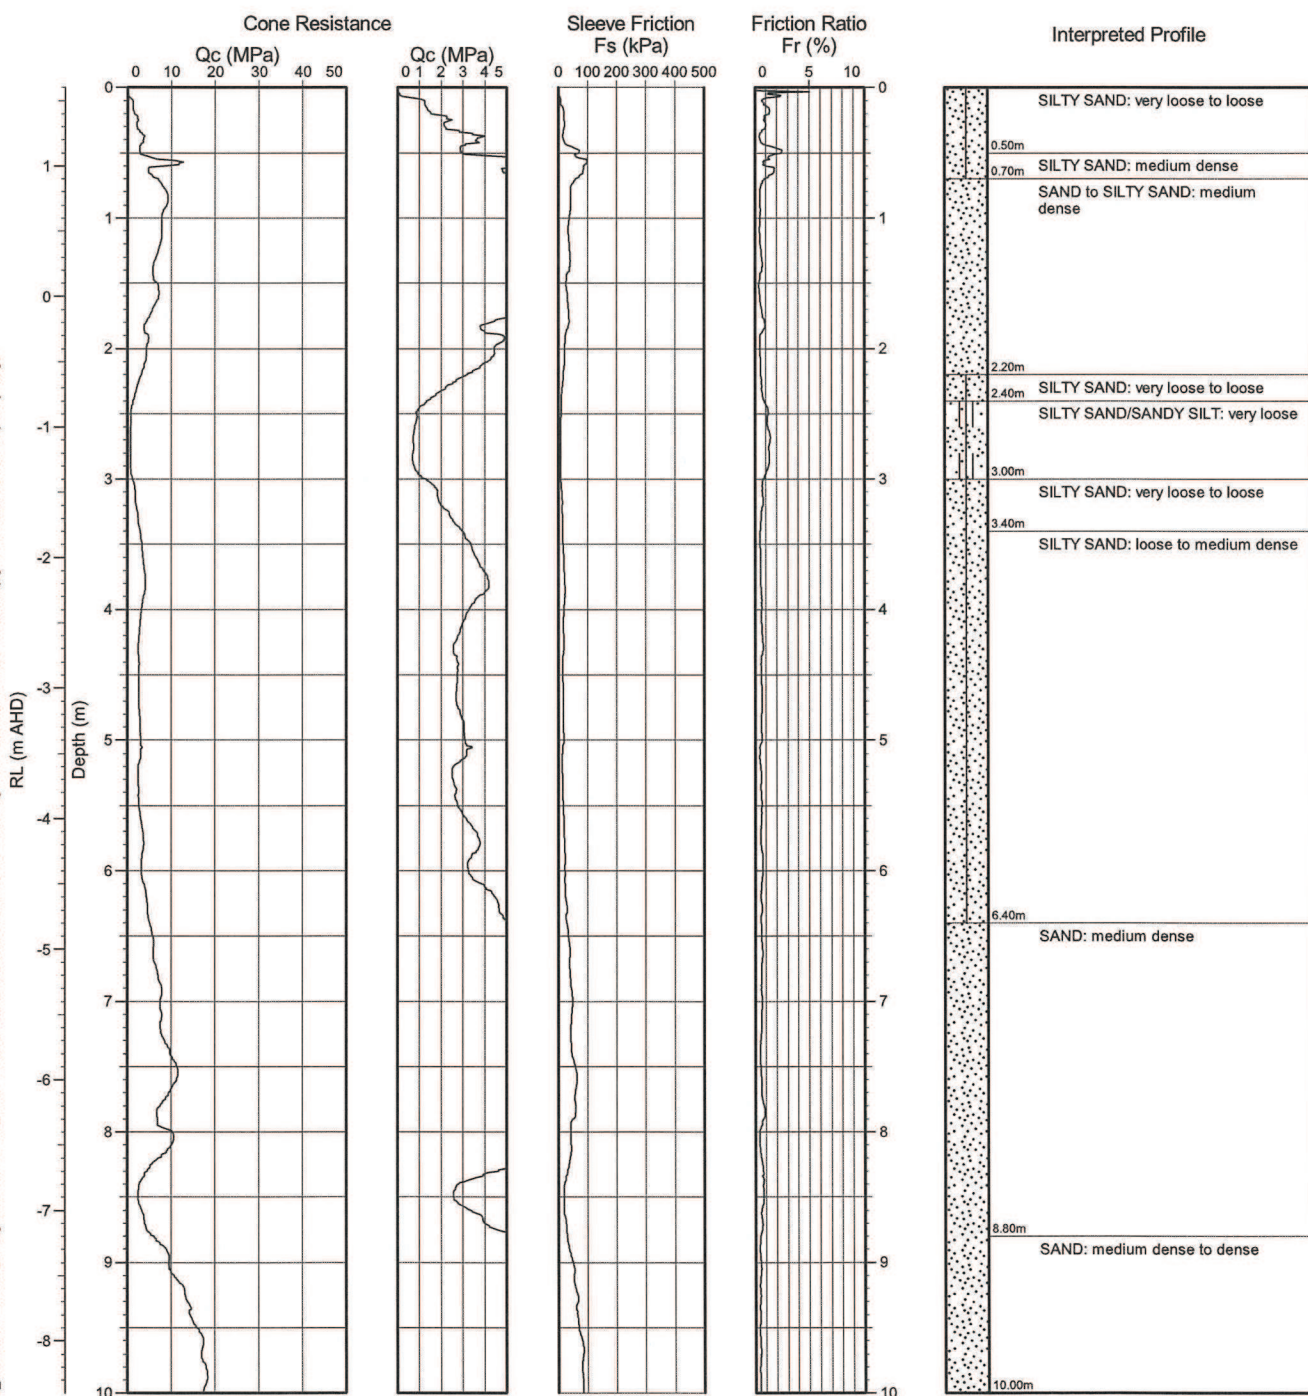
# ELECTRICAL FRICTION CONE PENETROMETER TEST RESULTS

**R.L. Surface:** ~1.6 m

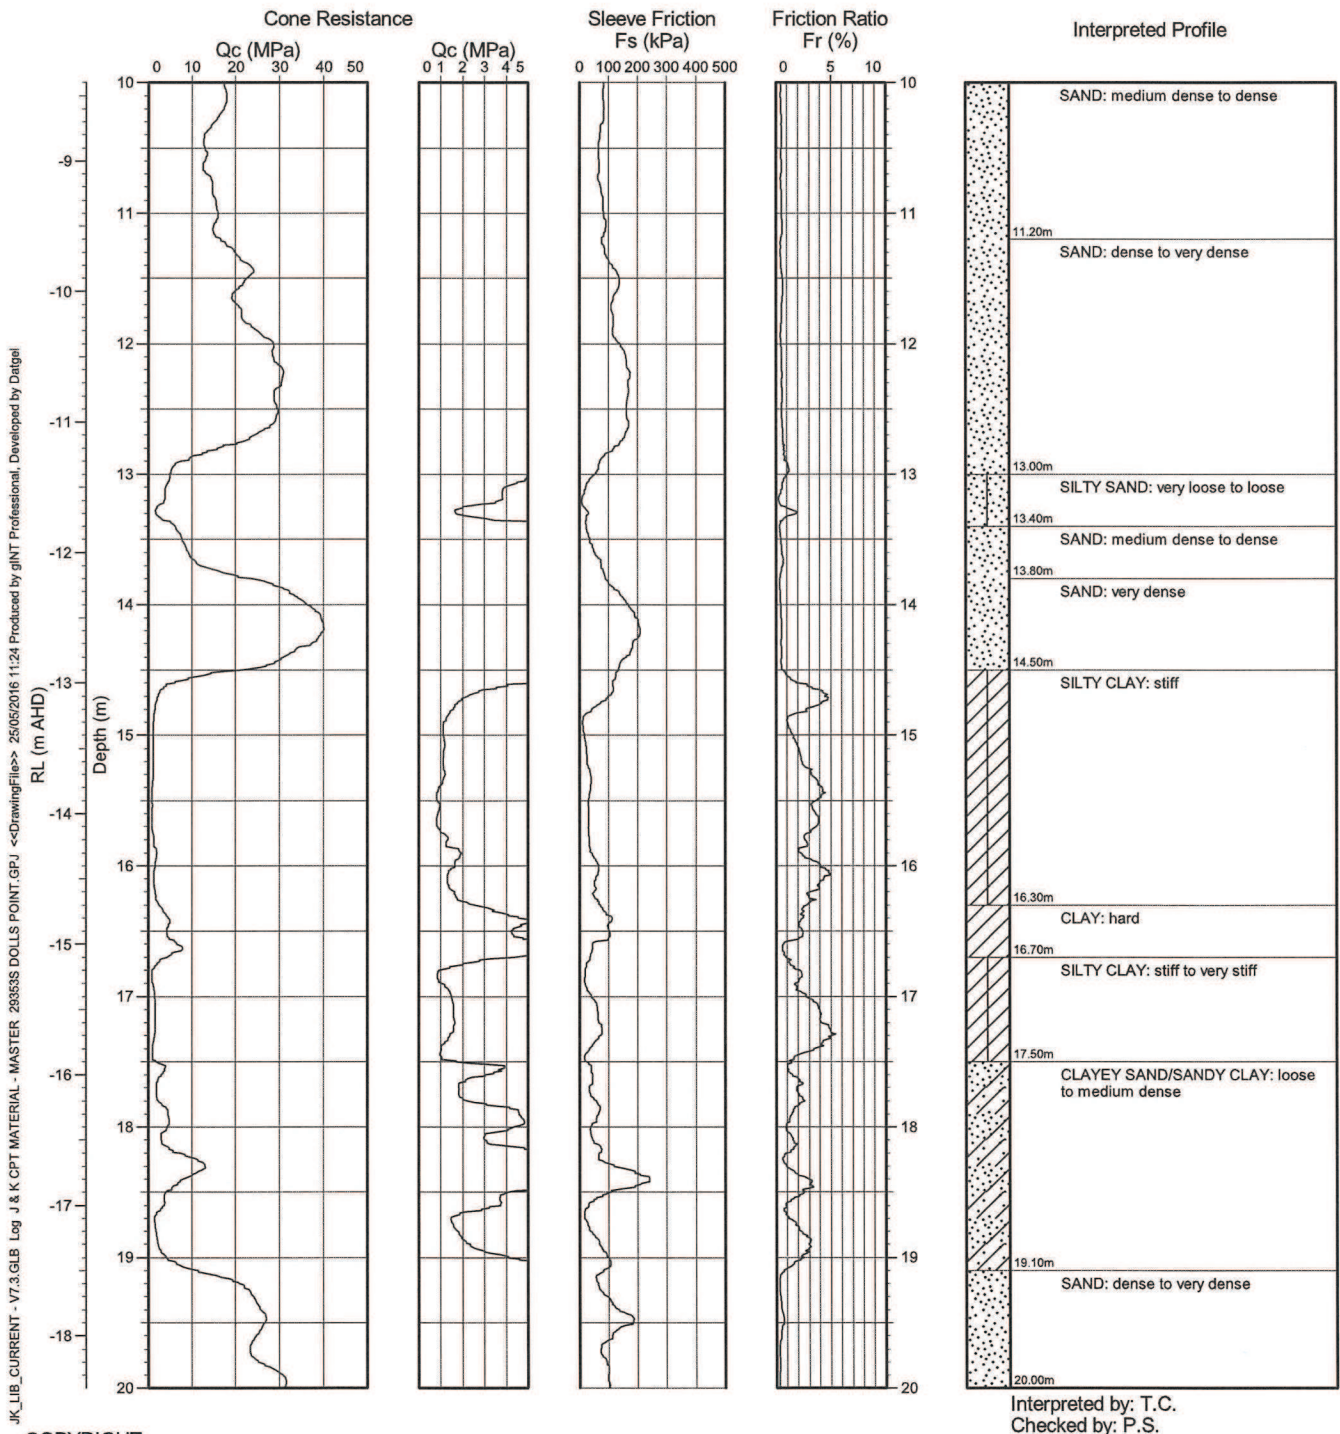
# ELECTRICAL FRICTION CONE PENETROMETER TEST RESULTS

**R.L. Surface:** ~1.6 m

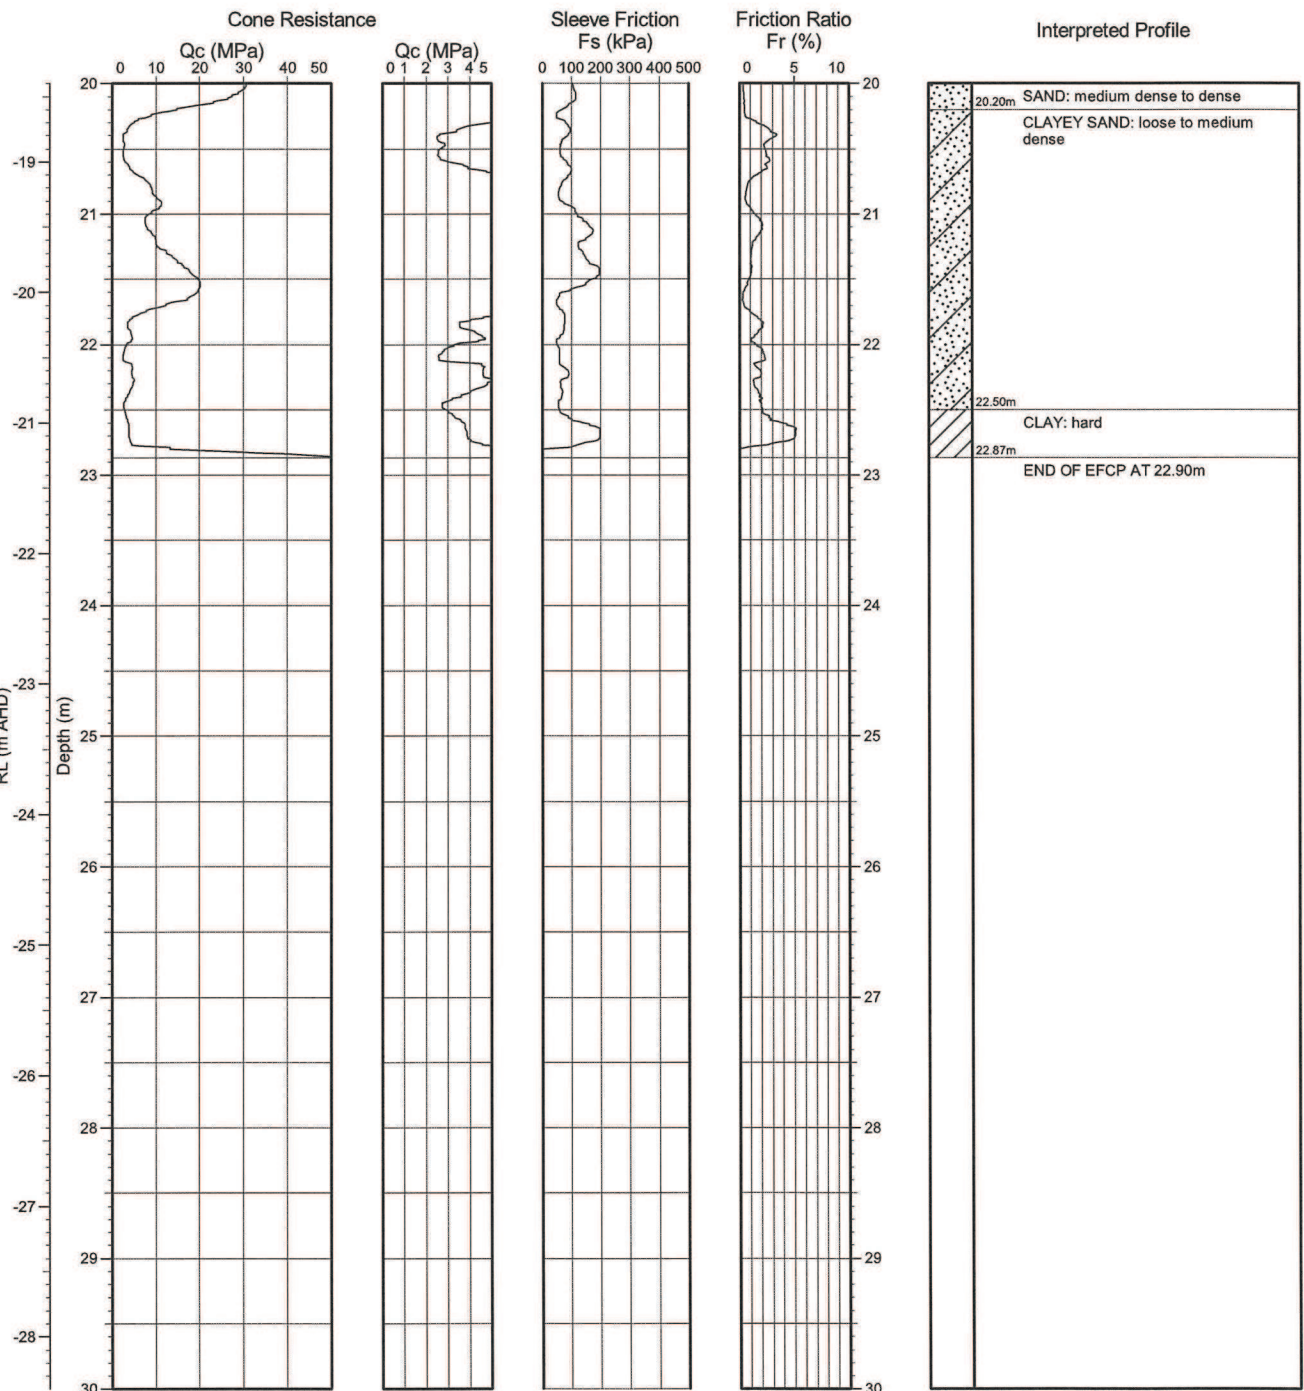
# ELECTRICAL FRICTION CONE PENETROMETER TEST RESULTS

**R.L. Surface:** ~1.6 m

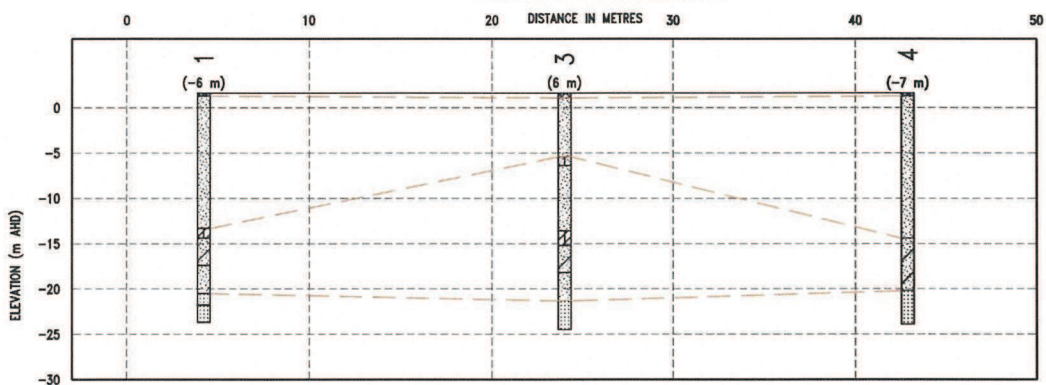
### CROSS SECTION AA

| CLAYEY SAND | SILTY CLAY | SANDSTONE |
| CORE LOSS | SILTY SAND | |
| SAND | FILL | |

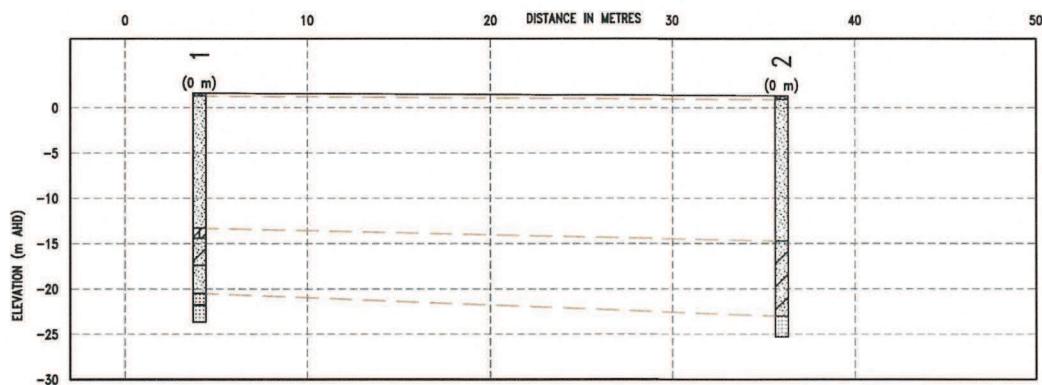
### CROSS SECTION BB

| CLAYEY SAND | SILTY CLAY |
| CORE LOSS | FILL |
| SAND | SANDSTONE |
