# **PROPOSED REZONING**

**87 BAY STREET  
GLEBE**

## **HERITAGE IMPACT STATEMENT**

March 2011

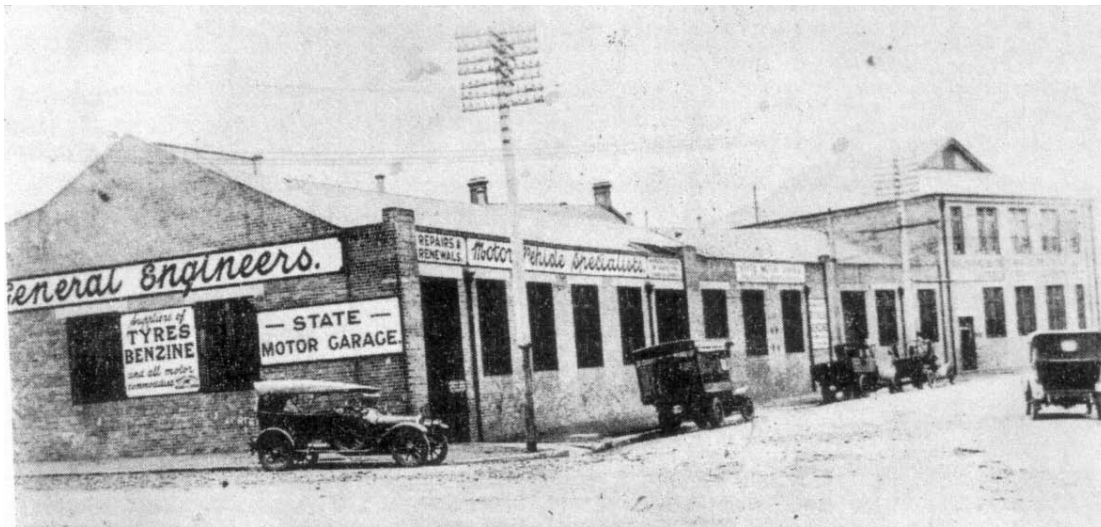
Figure 2.14 The Wentworth Park Road frontage of the State Motor Garage. The photograph shows the building as completed in 1914. Photograph dated 1919

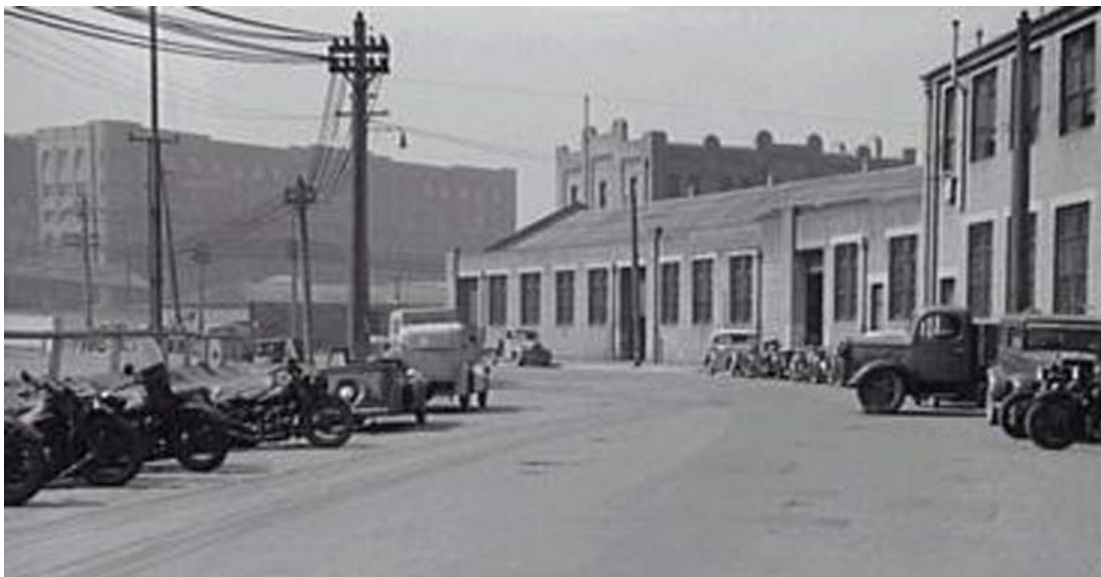
Figure 2.15 The Wentworth Park Road frontage of the State Motor Garage. The photograph shows alterations to the openings of the western section of the garage. Undated, 1930s

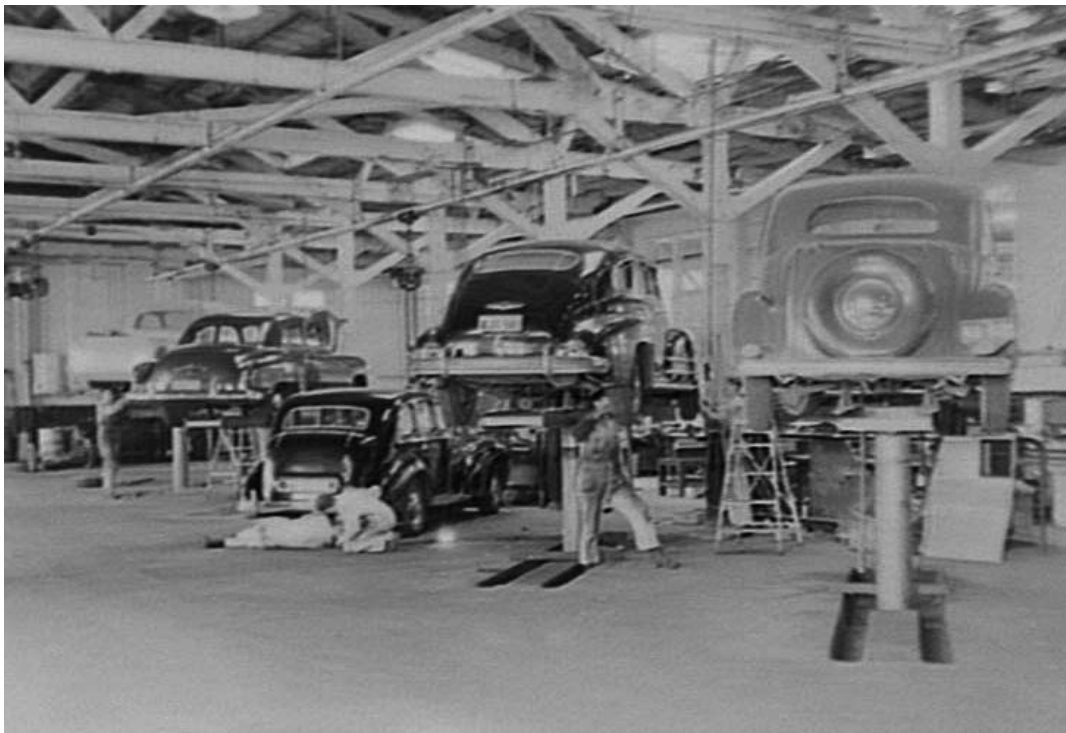
Figure 2.19The hardwood structural frame of the 1913 garage. Photograph is dated October 1953

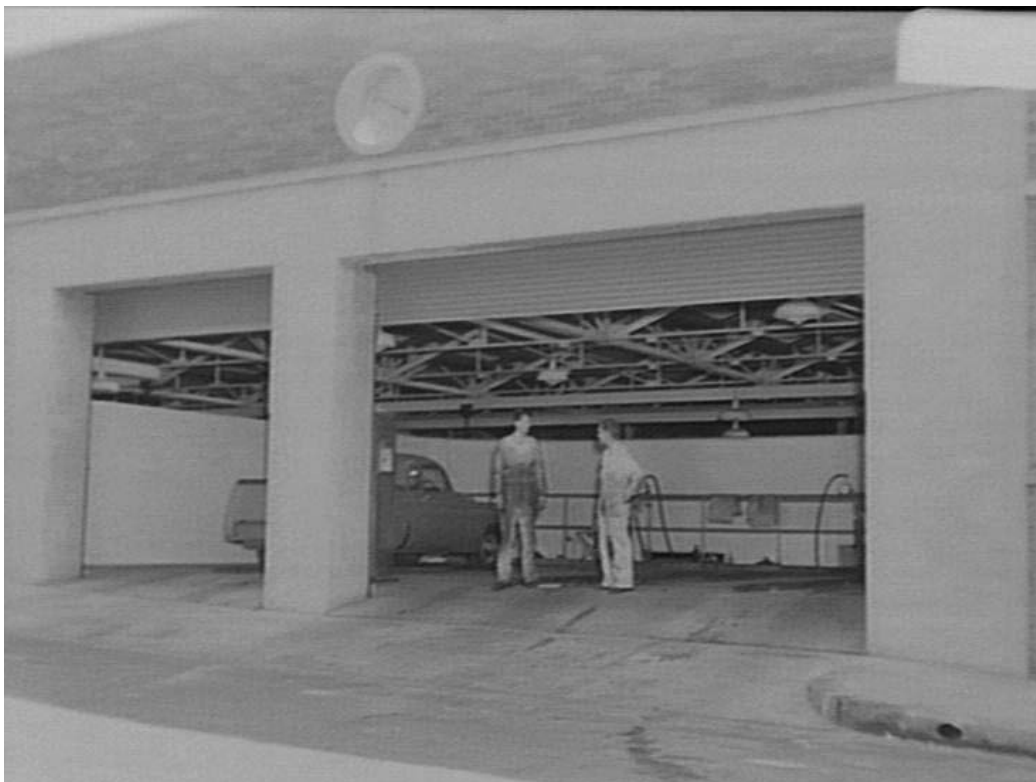
Figure 2.30 The Greasing Bay of the 1947 extension; this facility was accessible from Wentworth Street. Photograph is dated 1953

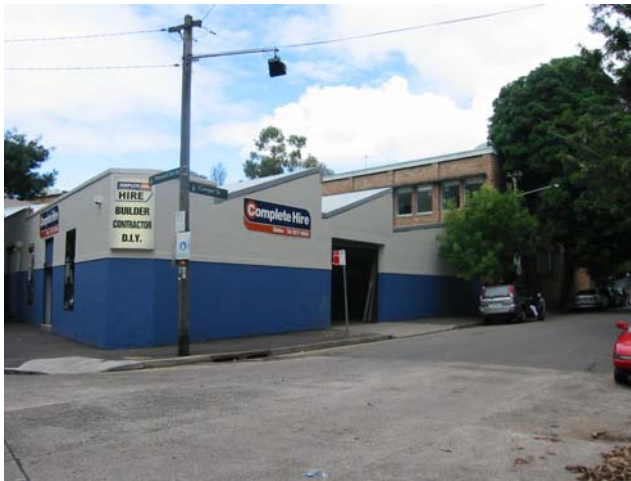
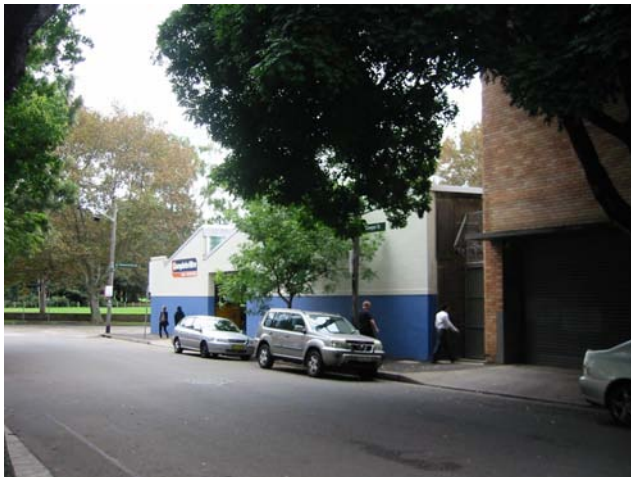
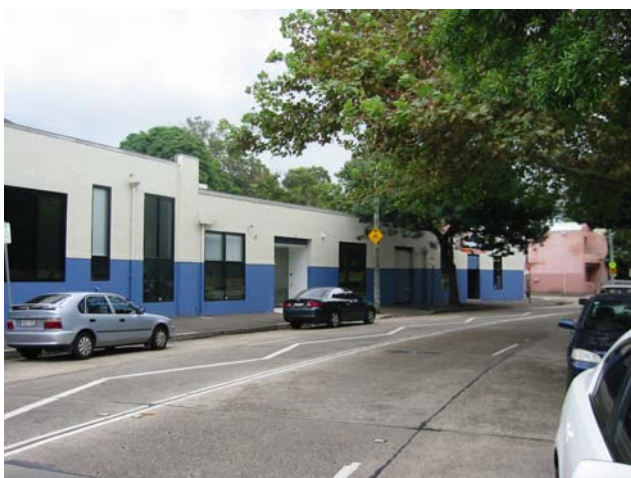
Single storey, rendered masonry building with a saw tooth, corrugated metal roof with south facing alsonite highlights over earlier timber framed highlights. The building has a stepped parapet to Wentworth Park Road and a saw tooth wall to Cowper Street. The building is divided into several commercial units including a car repair shop to the corner of Cowper Street and offices to Wentworth Park Road. The building has been fitted with modern aluminium windows and doors and there are roller shutter doors to both street elevations.

Figure 3.2 87 Bay Street, Glebe  
Building A looking east from Wentworth Park Road

Figure 3.3 87 Bay Street, Glebe  
Building A looking north from Cowper Street

Figure 3.4 87 Bay Street, Glebe  
Building A looking west from Wentworth Park Road

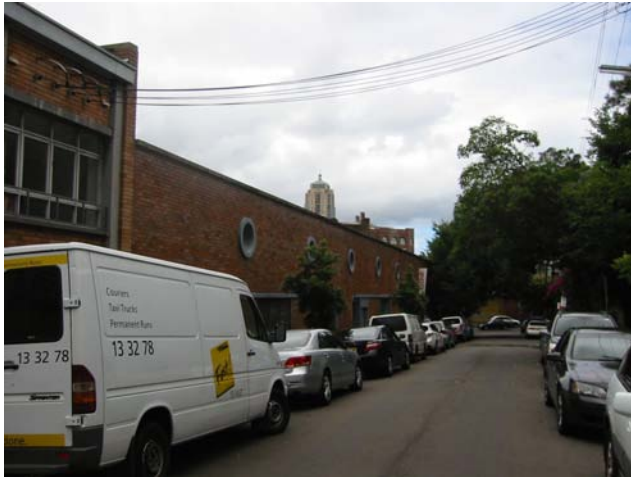
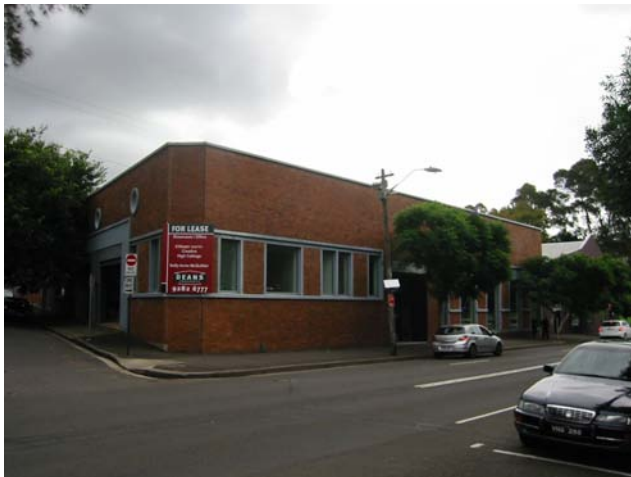
One and a half storey, face brick building fronting Bay Street and Wentworth Street with a parapet to the street and a saw metal roof behind with circular openings to the street between the roof slopes. The building has been fitted with some full height, replacement, aluminium windows and doors set between rendered horizontal banding. The building has a chamfer to the street corner and there are new openings to Bay Street and a goods entrance to Wentworth Street. The building is currently used for offices and car parking.

Figure 3.8 87 Bay Street, Glebe

Building E looking east along Wentworth Street

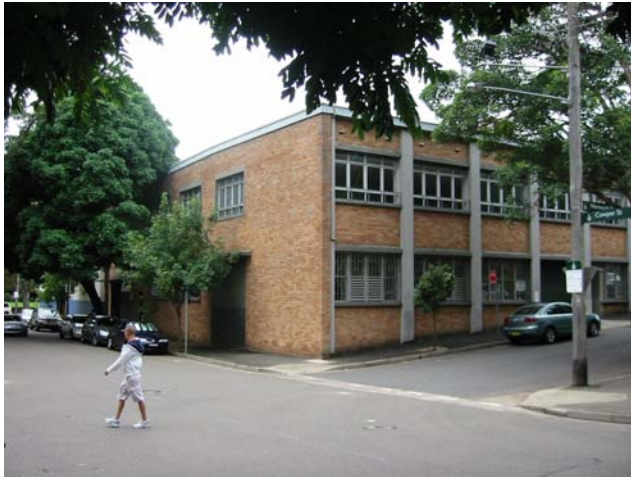
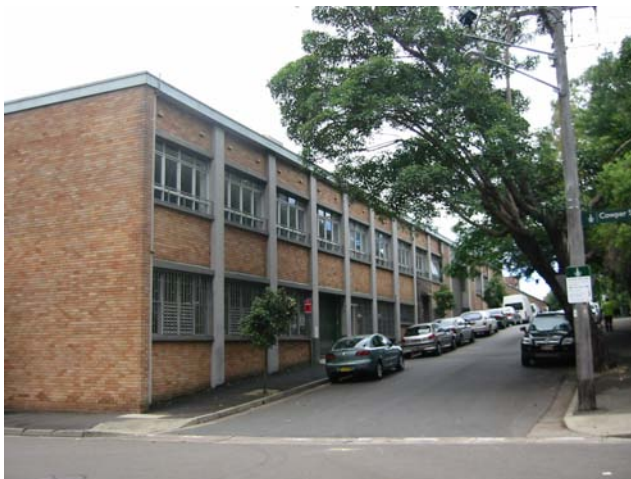
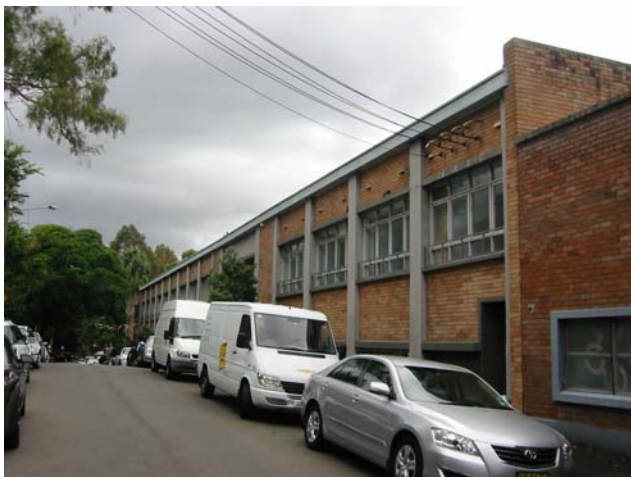
Two storey, flat roof, concrete framed building with a parapet to the street and face brick infill. The building has multi-paned, aluminium windows set between expressed, horizontal render bands. Some of the windows have been fitted with security grilles and louvres. There is an entrance on Wentworth Street with a dark brick surround with a concrete hood over a concertina door. Wentworth Street rises to the west and the building is partly below ground level. A large opening to Cowper Street has been infilled and there are goods openings to Wentworth Street.

Figure 3.11 87 Bay Street, Glebe  
Building F looking north from Cowper Street

Figure 3.12 87 Bay Street, Glebe  
Building F looking east along Wentworth Street

Figure 3.13 87 Bay Street, Glebe  
Building F looking west along Wentworth Street
