Heritage Significance Assessment, Cooper Park, Bellevue Hill

Prepared by
Chris Betteridge, Betteridge Consulting Pty Ltd
t/a Betteridge Heritage
for
Woollahra Municipal Council

3 November 2019

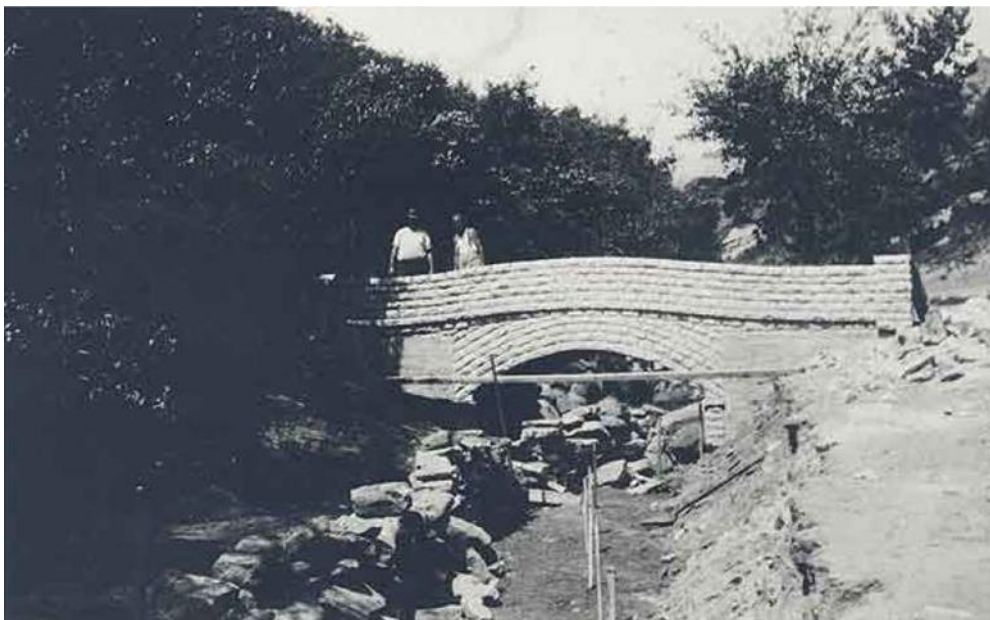
Figure 8 Two workers on the Moon Bridge, Cooper Park, during construction, 1930s. (Source: Woollahra Local Studies Collection)

Ernest Miles, (head of a gang of fifty) taught workers to cut and lay stone. He led the team of stoneworkers to construct the Moon Bridge in the centre of the park. They were so proud of the finished product that they placed a time capsule containing the names of the men who worked on the job inside one of the bridge corners. This time capsule was apparently resumed circa 2001.⁴⁶ The sandstone wall along the frontage of Victoria and Bellevue Roads was constructed in 1937. Clean fill supplied from the Metropolitan Water Sewerage and Drainage Board (MWSDB) quarry in Waverley was used to solve problems in Cooper Park including the construction of filter beds to deal with the runoff from the Council's incinerator site.⁴⁷

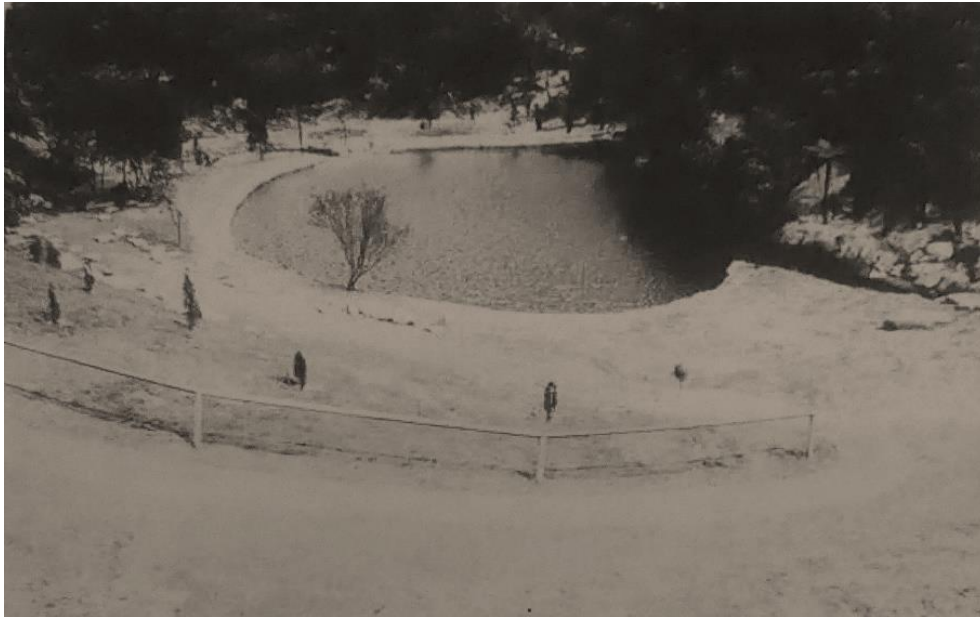
Figure 9 Ornamental pond, Cooper Park, 1930s (Source: Woollahra Library PFF000255)

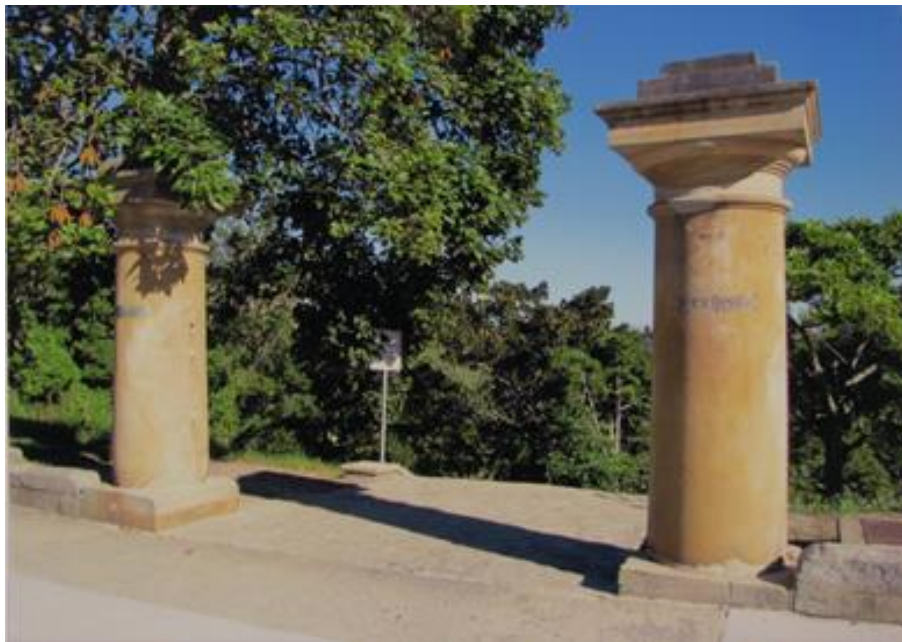
Figure 13 The pair of Doric pillars, originally from Sydney Post Office, installed at the top of the stairs down to the amphitheatre, Cooper Park. (Source: Woollahra Local Studies Collection)

In 1994 two sandstone Doric columns which once graced the old 1847 Sydney Post Office were installed at the Victoria Road entrance to Cooper Park, at the top of the stone steps down into the Amphitheatre. For a time after the demolition of the old post office, the columns were moved to Elizabeth Bay House, then to Vacluse House where they stood for many years. With the restoration of the latter house to its former glory, the columns were declared surplus and given to Woollahra Council.⁷⁷

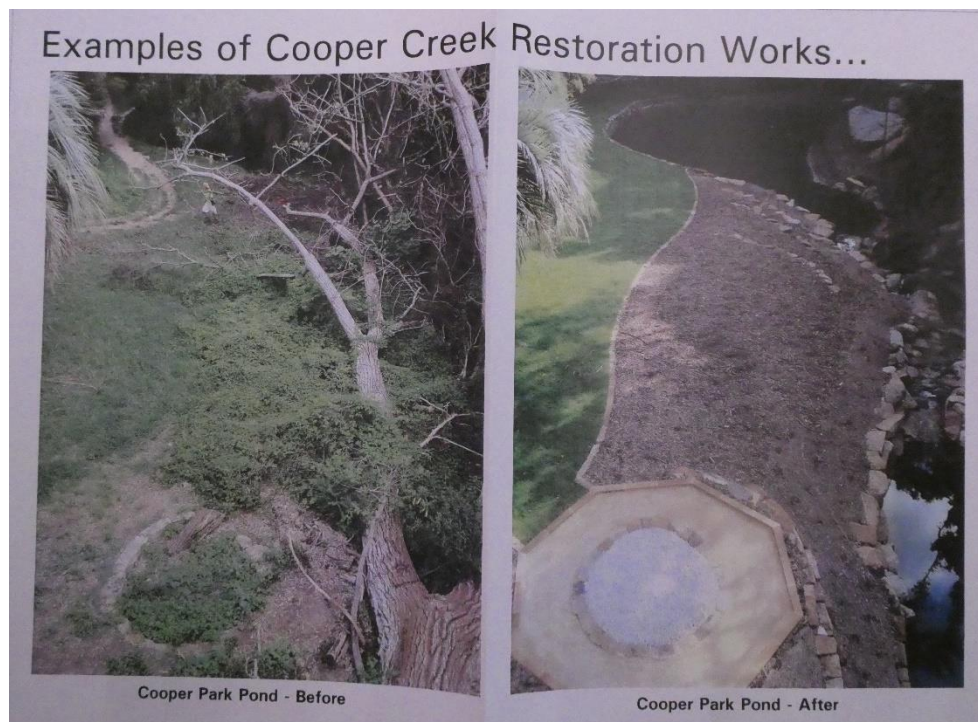
Figure 14 Results of Cooper Creek Restoration Works after the removal of weeds and sediment, revealing one of the landscape features. (Source: Woollahra Local Studies Collection)

In 2009 a burst water main caused a section of Bellevue Road to collapse, resulting in a landslide down the amphitheatre embankment and significant damage to Cooper Park. Repair works were primarily completed by September 2009. Siltation of the creeks in Cooper Park from developments upstream remains an ongoing problem for Park management but sediment removal has produced some spectacular results as shown in Figure 14.

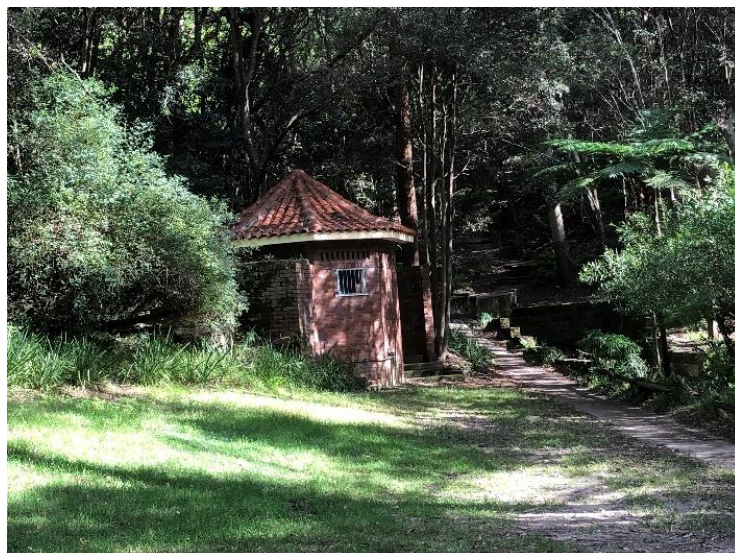
Figure 17 Former toilet block, now used for storage of maintenance equipment for staff and volunteers. (Photo: Chris Betteridge, 29 March 2019)

Built elements in Cooper Park include the tennis courts and associated pavilion, Cooper Park Community Hall (former Scout Hall), artificial stone shelters, octagonal public toilet block (now a storage facility for park staff and volunteers).

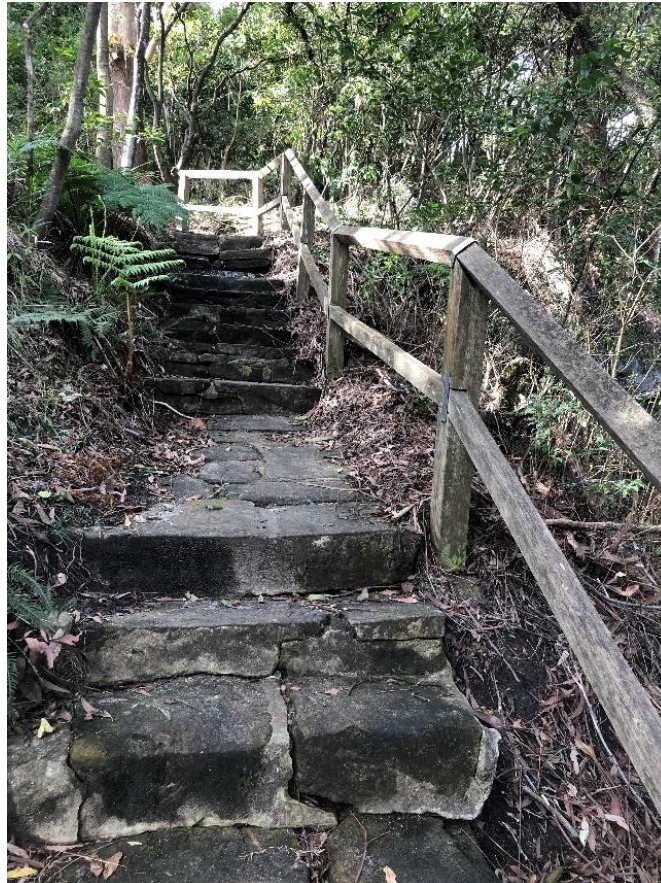
Figure 18 Sandstone steps and timber arris rail balustrade. Cooper Park. (Photo: Chris Betteridge, 29 March 2019)

Paths and walking tracks in the park include original and reconstructed sandstone flagged paths, stencilled, brushed and exposed aggregate concrete paths, compacted gravel paths and beaten earth bushwalking tracks.

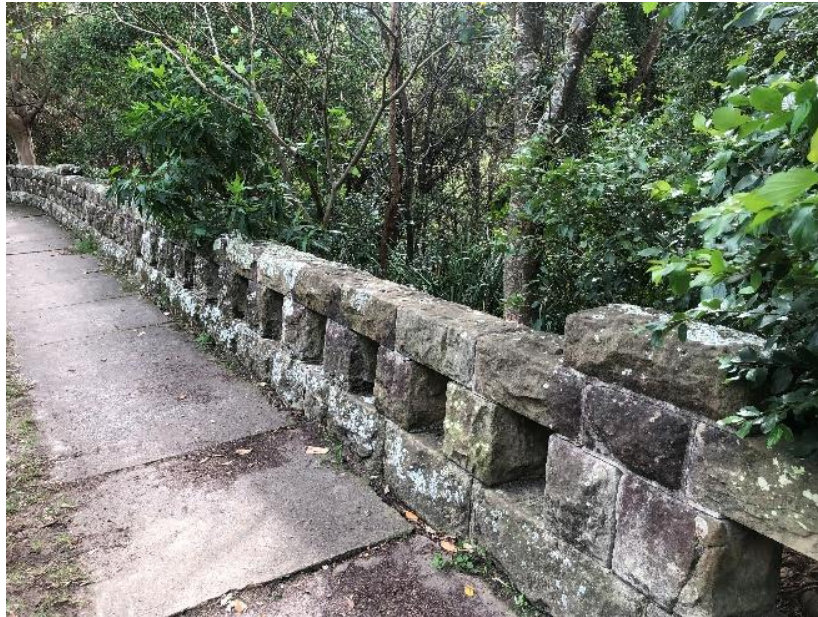
Figure 19 Sandstone balustrade, Cooper Park. (Photo: Chris Betteridge, 29 March 2019)

Some original or early fences and balustrades survive including timber arris rail fencing and galvanized steel handrails but many of the fences and balustrades have been replaced with newer types.

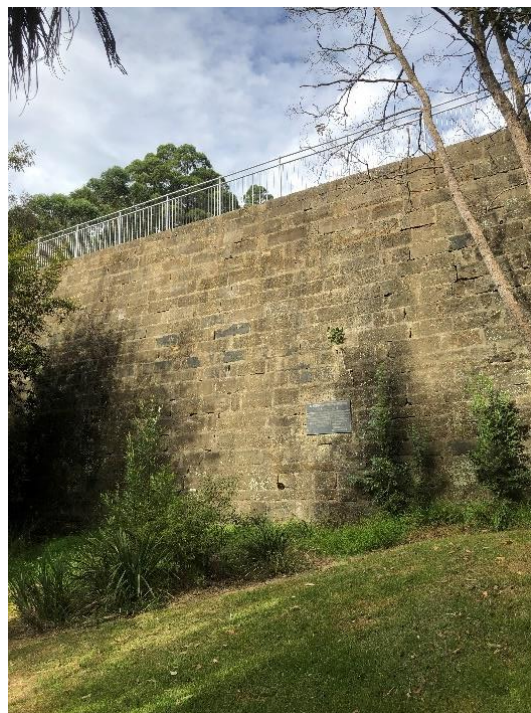
Figure 20 The major sandstone retaining wall at the western end of the Amphitheatre, with a plaque commemorating the unemployment relief works carried out during the Depression. (Photo: Chris Betteridge, 29 March 2019)

The major walls in the park are the sandstone Amphitheatre Retaining Wall and the sandstone Fletchers Gully Retaining Wall but there are other minor walls, including at the top of the Amphitheatre, north of the base of the Amphitheatre banks and at Bellevue Gardens and Adelaide Parade. There are also two Koppers log retaining walls that are inconsistent with the historic sandstone walls in the park. Several paths are also edged with sandstone dwarf walls.

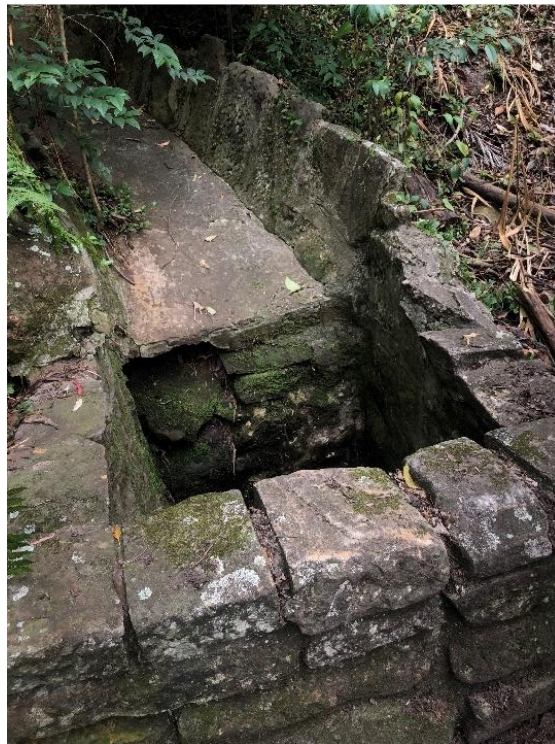
Figure 21 Original or early sandstone drainage channel and pit, Cooper Park. (Photo: Chris Betteridge, 29 March 2019)

The constructed Cooper Creek is the major drainage feature within the park but there are numerous sandstone pits and channels constructed to handle stormwater flows.

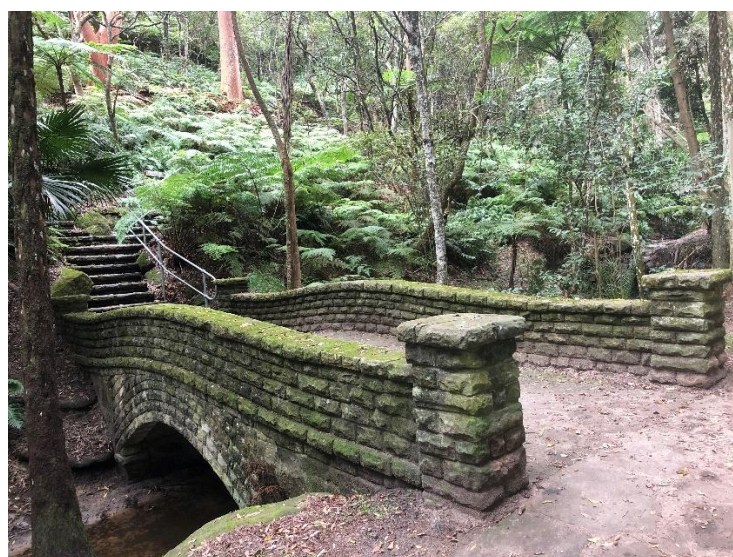
Figure 22 View northeast of Moon Bridge, Cooper Park. (Photo: Chris Betteridge, 29 March 2019)

The masonry bridges constructed during the 1930s are a major feature of the park and include concrete, brick, steel and timber examples but the most significant is the sandstone Moon Bridge.

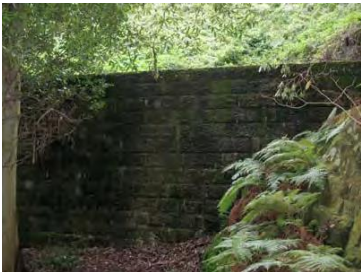
Major Depression-era landscape and built elements in the park, providing a large open space and pedestrian access from Victoria Road into the Amphitheatre.
Fletchers Gully Sandstone Retaining Wall

Constructed in the early 1950s and assessed in the 2011 CMP as having no heritage significance. Fulfils useful purpose.

Fletchers Foundry closed in 1950 and by 1955 the land was filled, levelled and grassed, with a sandstone retaining wall to the base of Fletchers Gully.⁶³

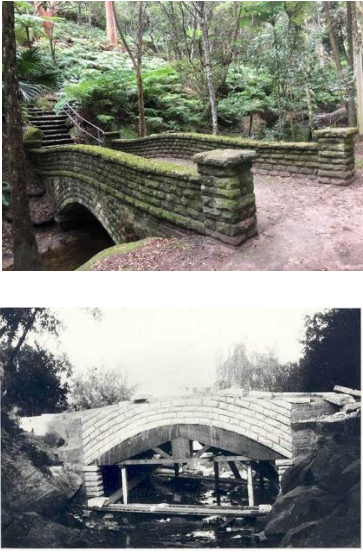
<p>Major built element constructed in 1936 by Ernest Miles and a team of 50 stoneworkers. The location of the bridge is assumed to be from the winning Masterplan design by architects S E Coleman and R G C Coulter.⁸⁰ A high quality, central feature in Cooper Park, making a major contribution to the aesthetic character of the bushland pleasure ground style of open space. Assessed in the 2011 CMP as having historic and aesthetic significance at a local level.</p>
Tennis Courts and Pavilion

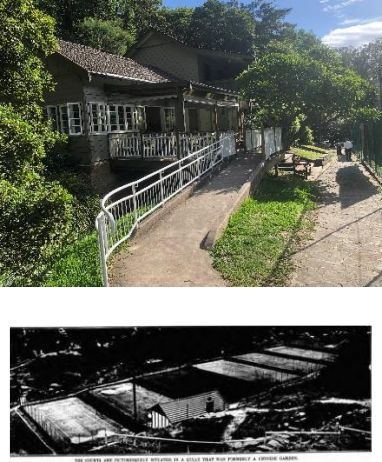
<p>The original courts and pavilion were among the earliest visitor facilities in Cooper Park, in the 1920s. While the building has been altered extensively and the courts have been increased in number and resurfaced, this facility remains a major visitor amenity. Assessed in the 2011 CMP as having no significance but this assessment is challenged, the courts and pavilion considered likely to have high social significance at a local level.</p>

In January 1923, Council agreed to proceed with the construction of a tennis pavilion and 'necessary sanitary accommodation' in the park opened for use at the end of that year.²⁶ In May Council called tenders for the erection at Cooper Park of (a) Club House Building, and (b) Club House Building with Caretaker's quarters²⁷. Council also advertised, in August 1923, for a Caretaker and Green Keeper for the tennis courts at Cooper Park. "Applicants must be capable of keeping courts, lawns and playing areas in first class condition and be excellent green keepers. Capable men only need apply".²⁸ The grass courts and club-house were opened by the end of that year.²⁹

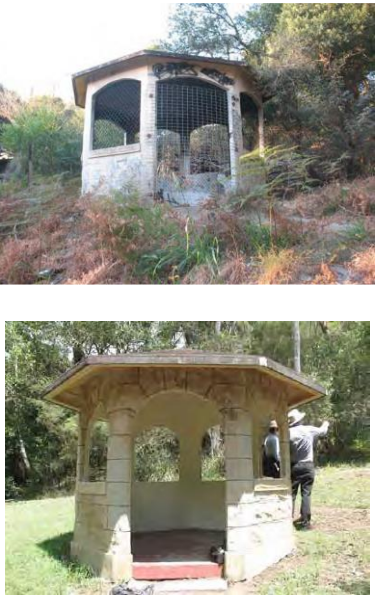
<p>The three 1930s rustic formal shelters were assessed in the 2011 CMP as having local historical, aesthetic and social significance due to their contribution to the bushland pleasure ground style of Cooper Park.in conjunction with the naturalistic shelters. They also demonstrate the investigation of construction methods and use of materials, particularly testing the versatility of concrete to look natural. The symmetrical regular physical form of the formal shelters contrasts with the freeform shapes of the nine naturalistic synthetic stone shelters.</p>
Naturalistic synthetic stone shelters

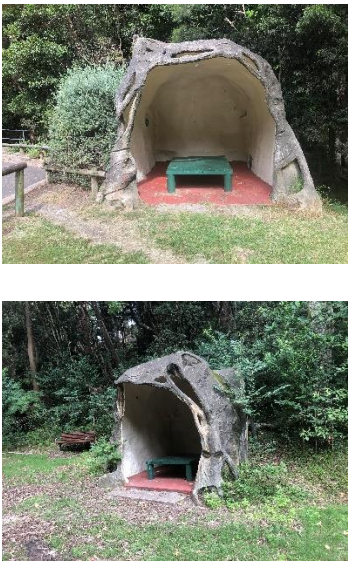
<p>Assessed in the 2011 CMP as having local historic and aesthetic significance due to their contribution to the unique bushland pleasure ground style of Cooper Park. The CMP found that 'the presence of these nine shelters, particularly their freeform naturalistic construction method is unique to Cooper Park, with the only other evidence of this style of construction being at Taronga Zoo'.⁸¹ Research for this assessment indicates that these structures are rare at a State level, with only a few other examples in the Blue Mountains. Considered to</p>

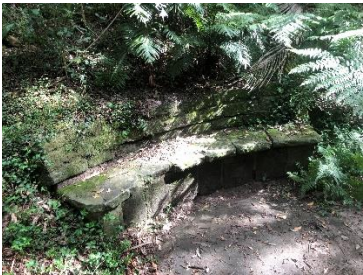
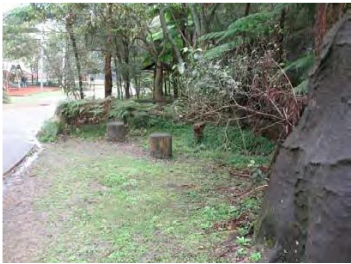
<p>Constructed in the 1920s, the Seating Grottoes were assessed in the 2011 CMP as having local historical and aesthetic significance for their contribution to the bushland pleasure ground style of Cooper Park.</p>
Constructed Creek

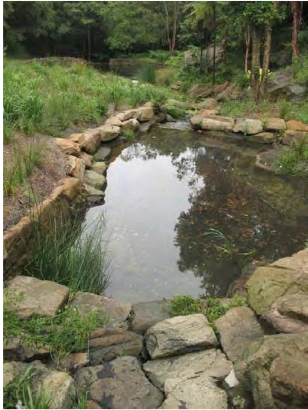
The three ponds constructed as part of the Depression-era works in Cooper Park were assessed in the 2011 CMP as having local historic and aesthetic significance. ⁸³

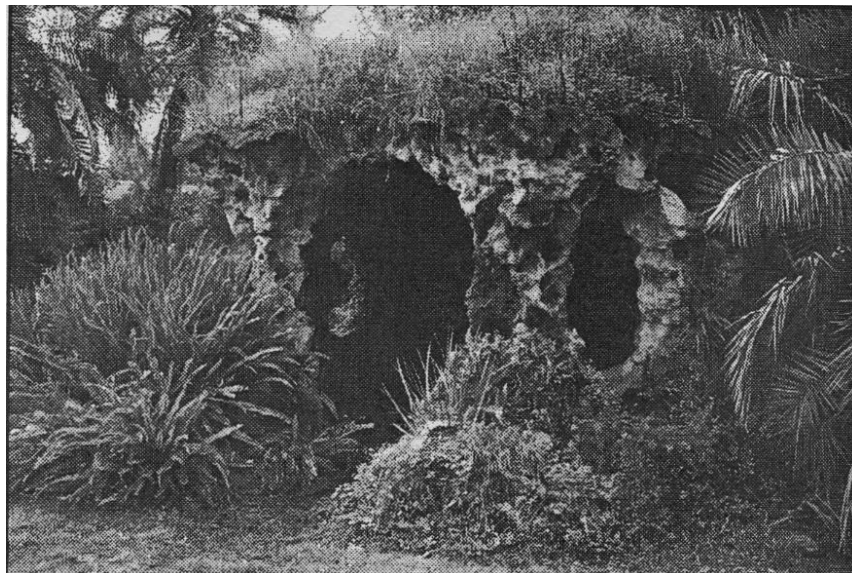
Figure 26 Part of the extensive Edwardian period grotto constructed of artificial rockwork at Yaralla, Concord. (Photo: Lois Michel in Skehan 2000, p. 218)

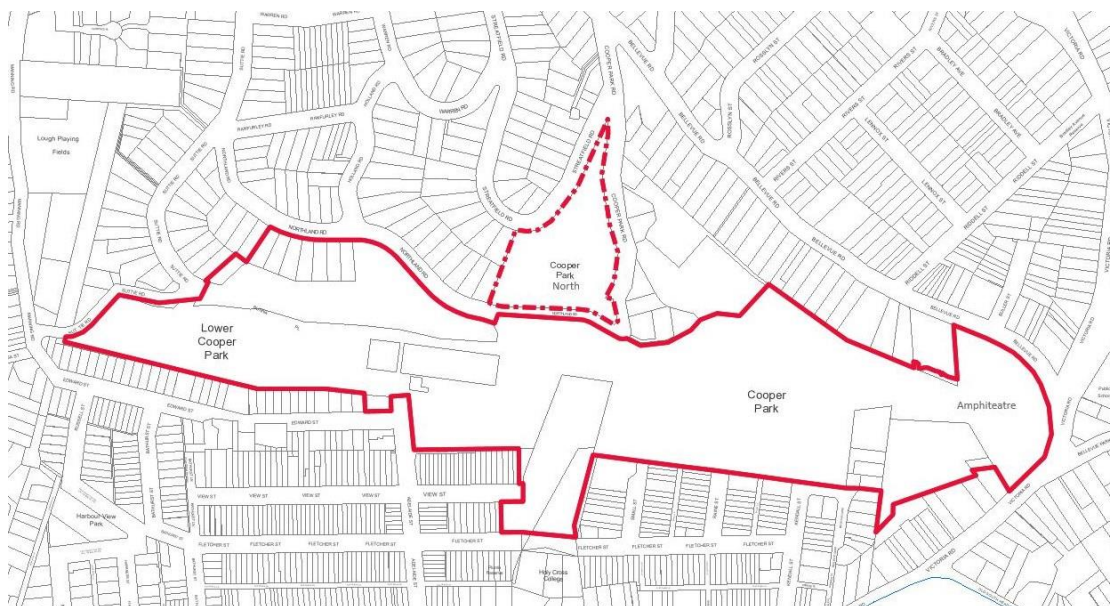
Figure 27 Recommended SHR (State significant) curtilage shown solid red. The dashed area is Cooper Park North which is not recommended for SHR or LEP listing. All boundaries subject to detailed survey. (Source: Woollahra Municipal Council 2019)

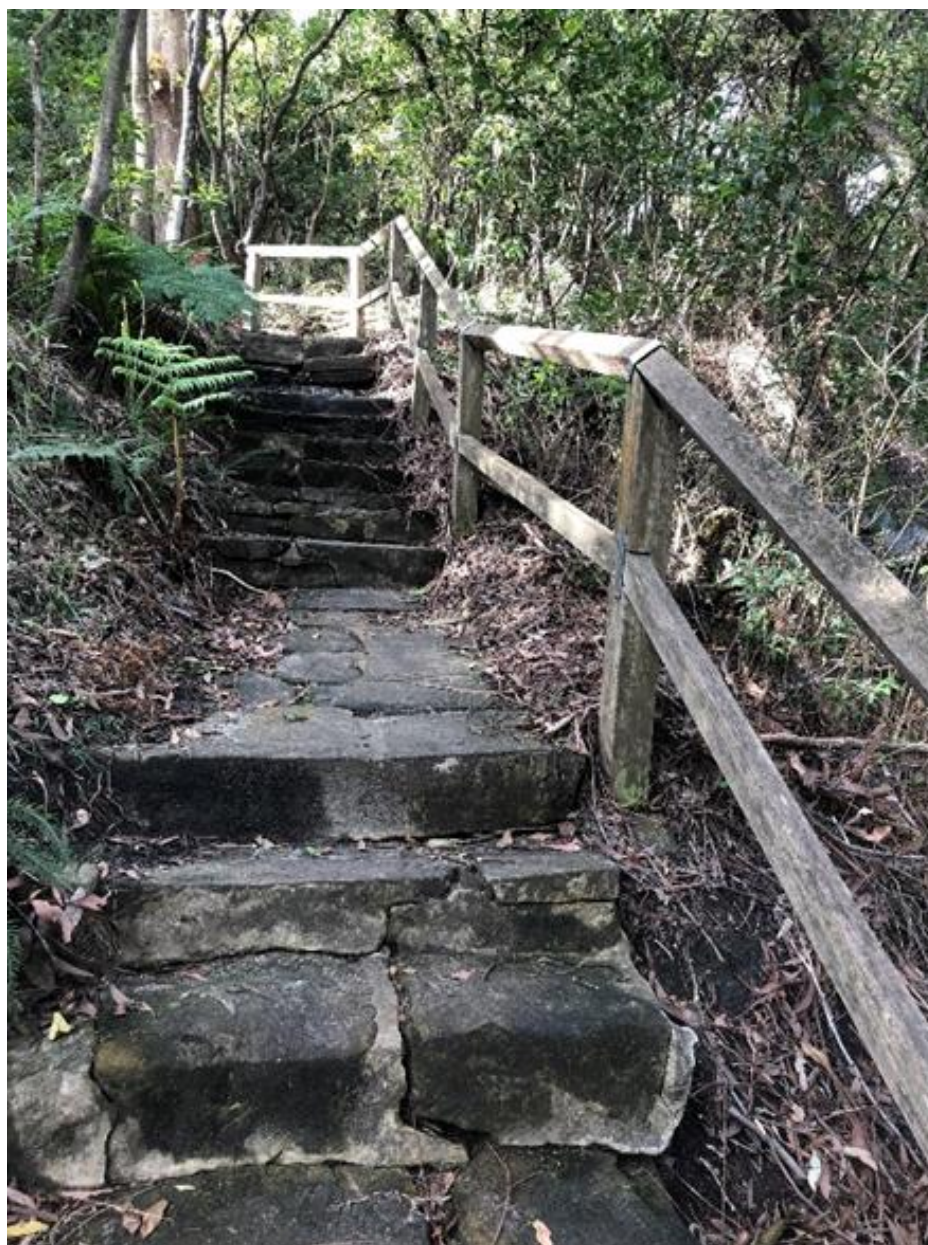
Image caption	Sandstone steps and timber arris rail balustrade, Cooper Park.				
Image year	2019	Image by	Chris Betteridge	Image copyright holder	Chris Betteridge

Stairs and steps include original or early sandstone examples but in recent years several sandstone steps have been replaced by concrete or timber as cost-saving measures.

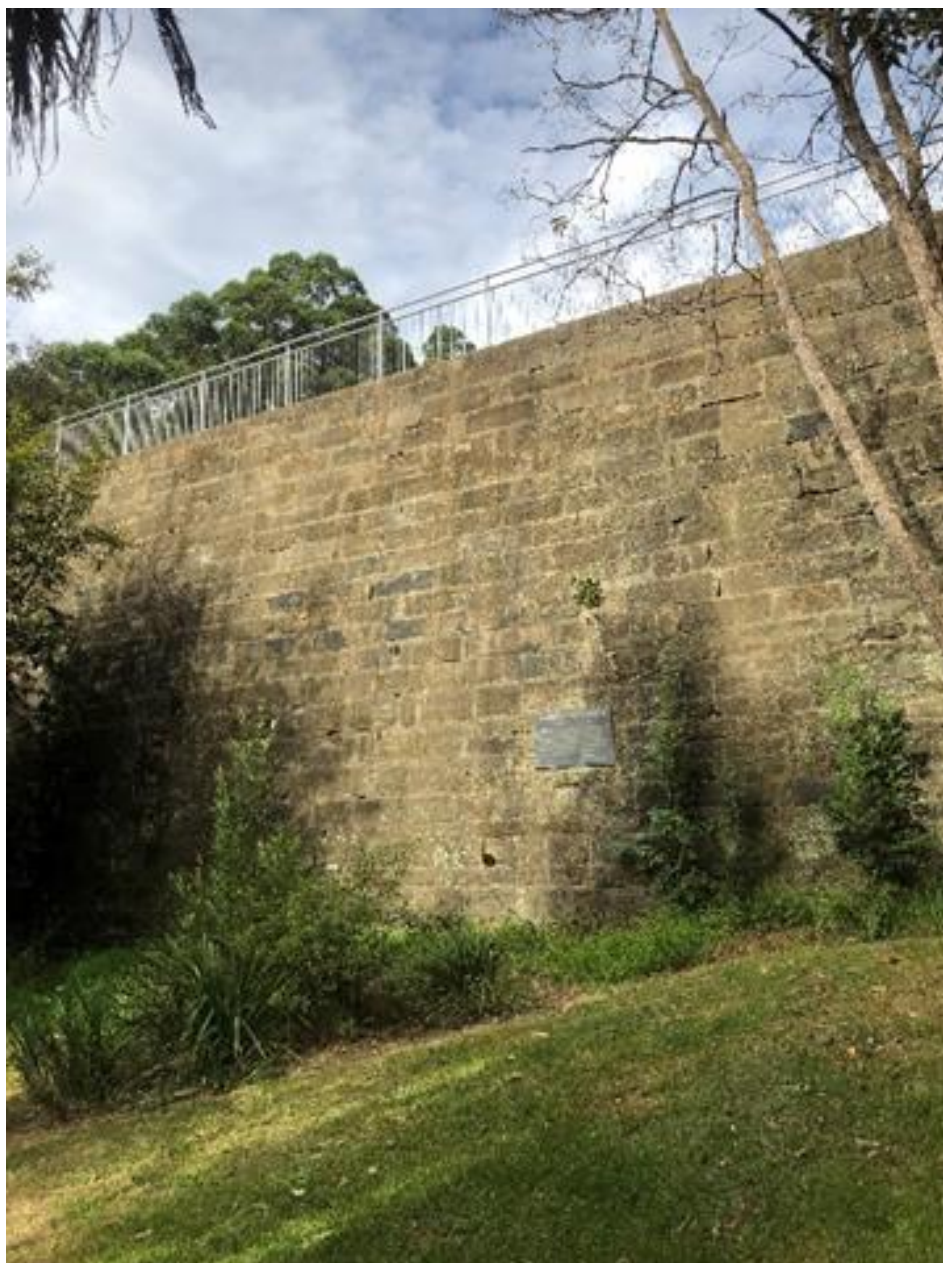
Image caption	The major sandstone retaining wall at the western end of the Amphitheatre, with a plaque commemorating the unemployment relief works carried out during the Depression.				
Image year	2019	Image by	Chris Betteridge	Image copyright holder	Chris Betteridge

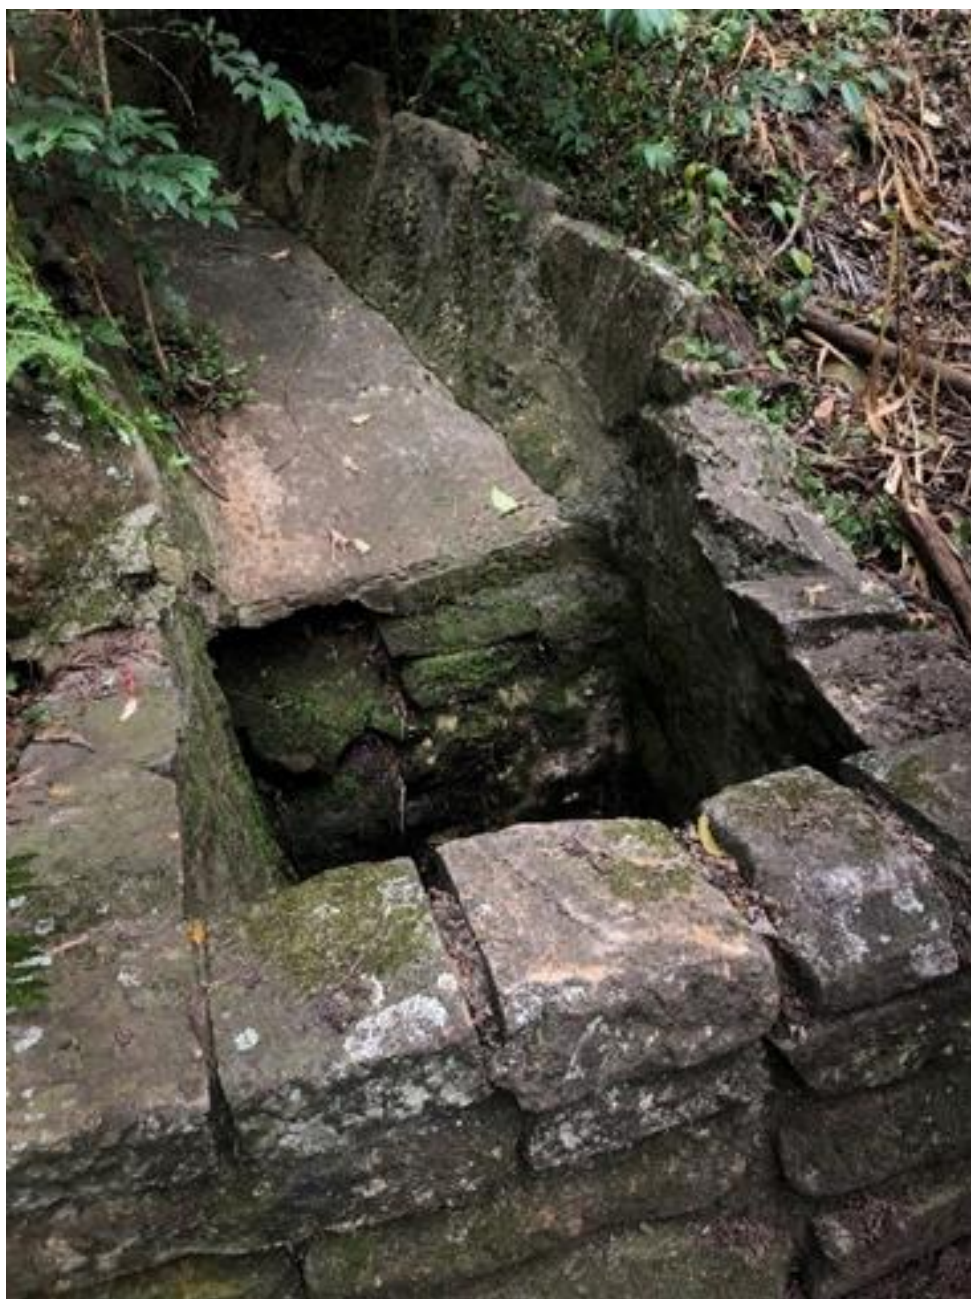
Image caption	Original or early sandstone drainage channel and pit, Cooper Park.				
Image year	2019	Image by	Chris Betteridge	Image copyright holder	Chris Betteridge

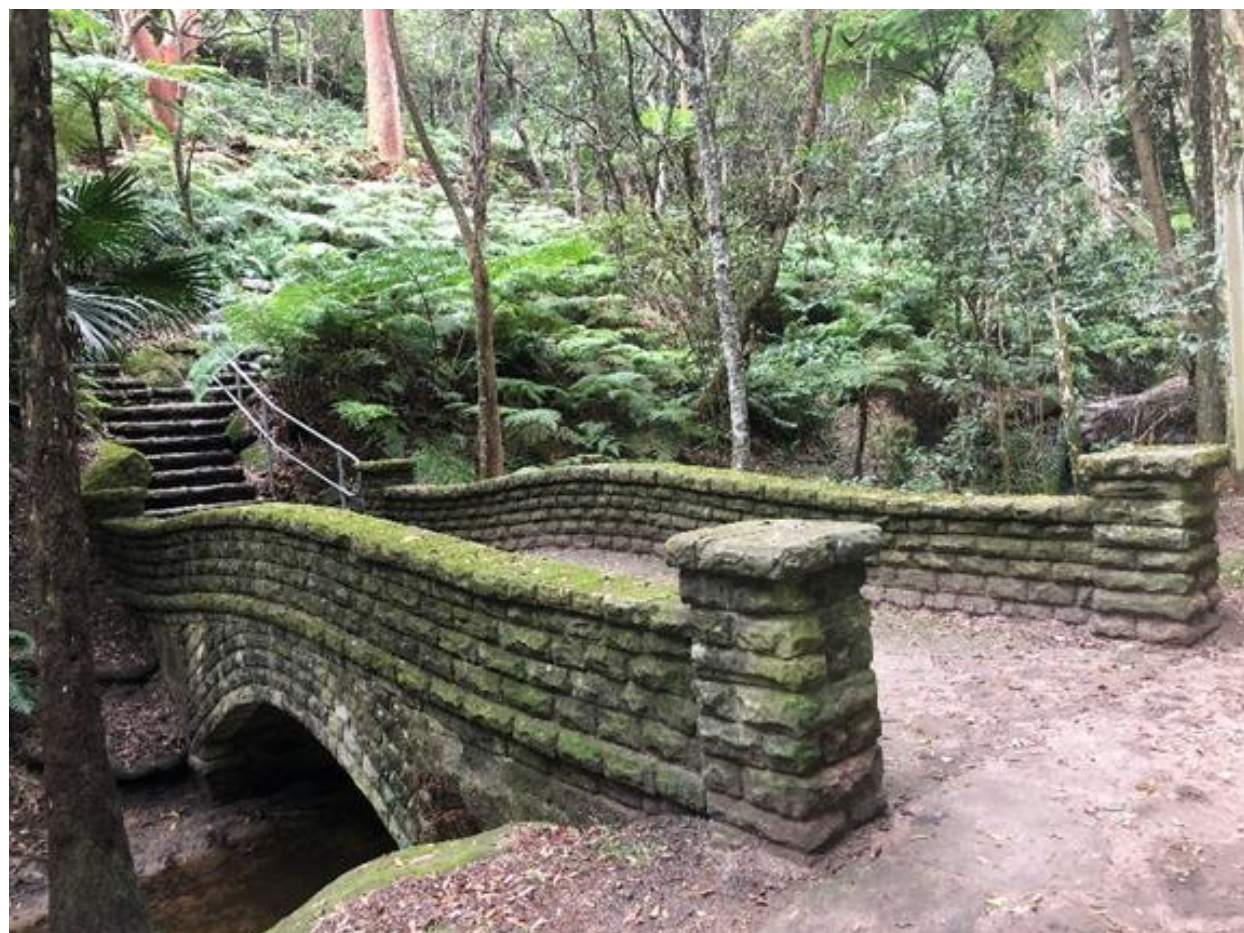
Image caption	View northeast of Moon Bridge, Cooper Park.				
Image year	2019	Image by	Chris Betteridge	Image copyright holder	Chris Betteridge

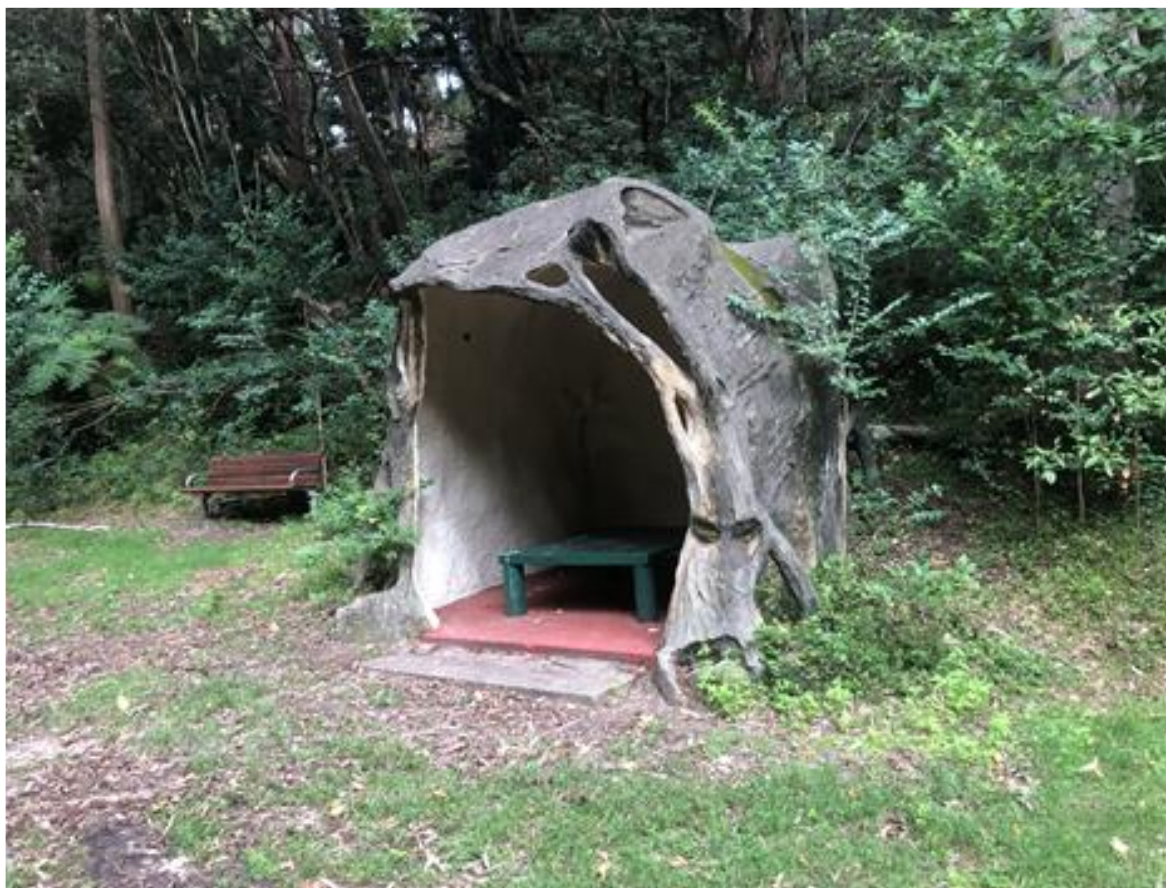
Image caption	One of the artificial rock shelters constructed by H Arnold at Cooper Park during the 1930s				
Image year	2019	Image by	Chris Betteridge	Image copyright holder	Chris Betteridge

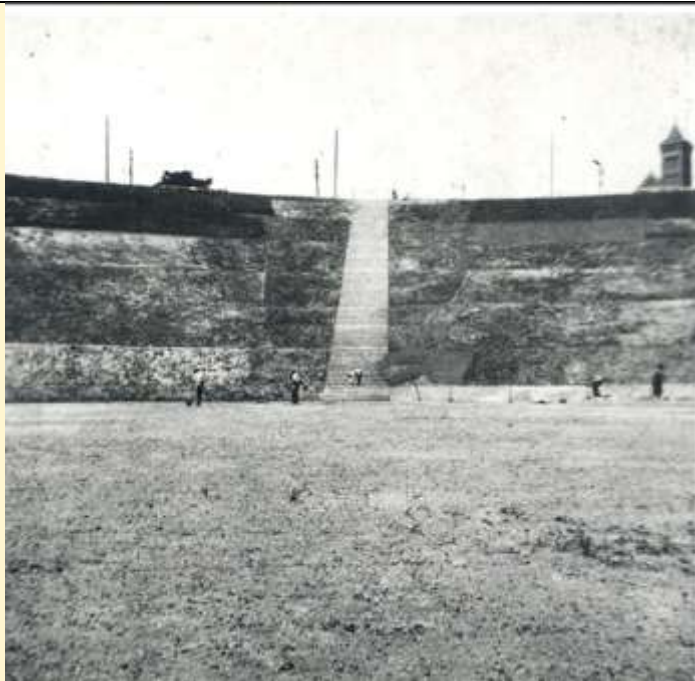
11. Image 1

Subject of photo:	The stone steps and amphitheatre at Cooper Park during construction, 1930s.
Date of photo:	1930s
Photographer:	Unknown
Copyright holder:	Unknown

Figure 6 The stone steps and amphitheatre at Cooper Park during construction, 1930s. (Source: Woollahra Local Studies Collection)

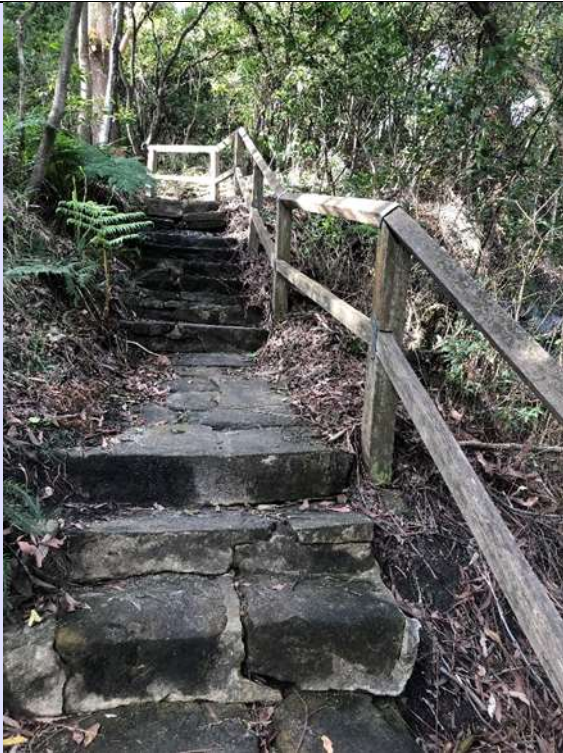
Image 4

<table><tr> <td style="width: 25%;">Subject of image:</td> <td>Sandstone steps and timber arris rail balustrade, Cooper Park</td> </tr></table>

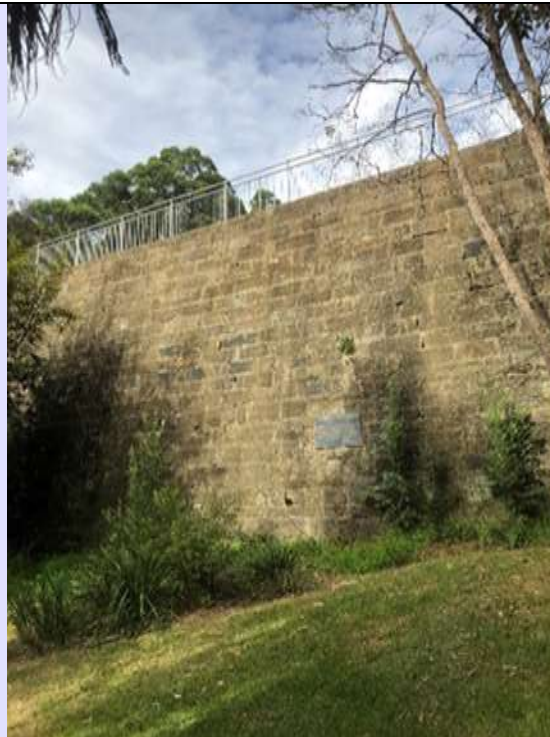
The major sandstone retaining wall at the western end of the Amphitheatre, with a plaque commemorating the unemployment relief works carried out during the Depression.

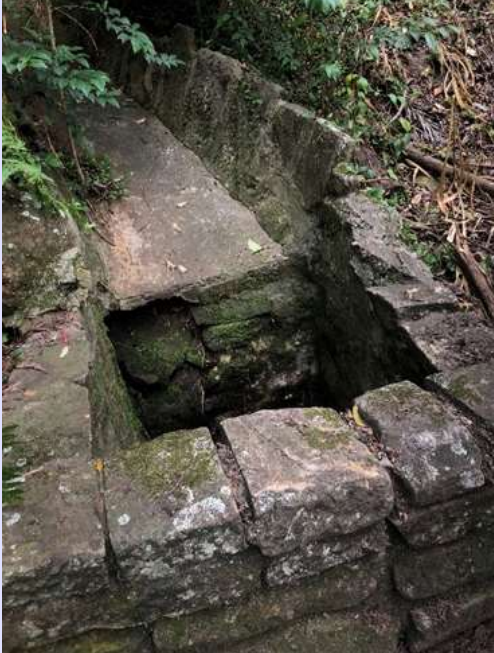
Image 6

Subject of image:	Original or early sandstone drainage channel and pit, Cooper Park.	
Date of image:	29 March 2019	
Photographer or author:	Chris Betteridge	
Copyright holder:	Chris Betteridge

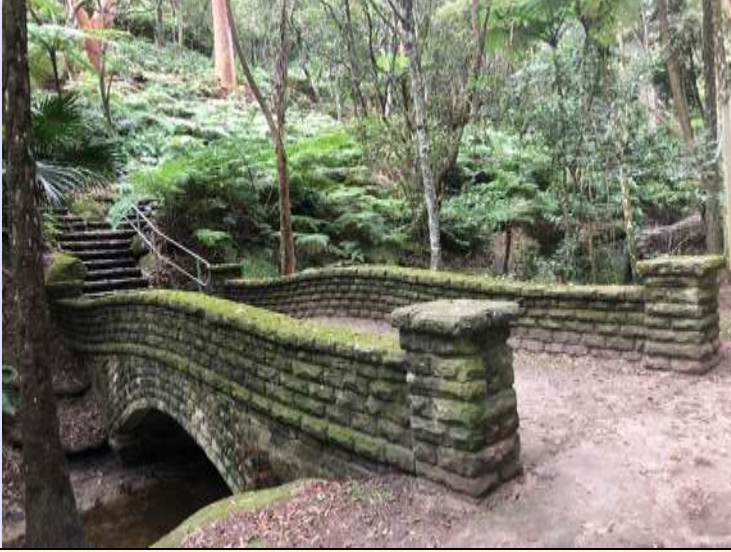
Image 7

Subject of image:	View northeast of Moon Bridge, Cooper Park.	
Date of image:	29 March 2019	
Photographer or author:	Chris Betteridge	
Copyright holder:	Chris Betteridge

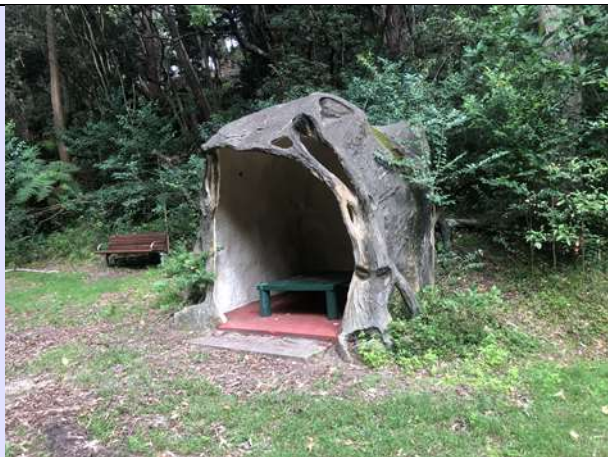
Subject of image:	One of the artificial rock shelters constructed by H Arnold at Cooper Park during the 1930s	
Date of image:	29 March 2019	
Photographer or author:	Chris Betteridge	
Copyright holder:	Chris Betteridge

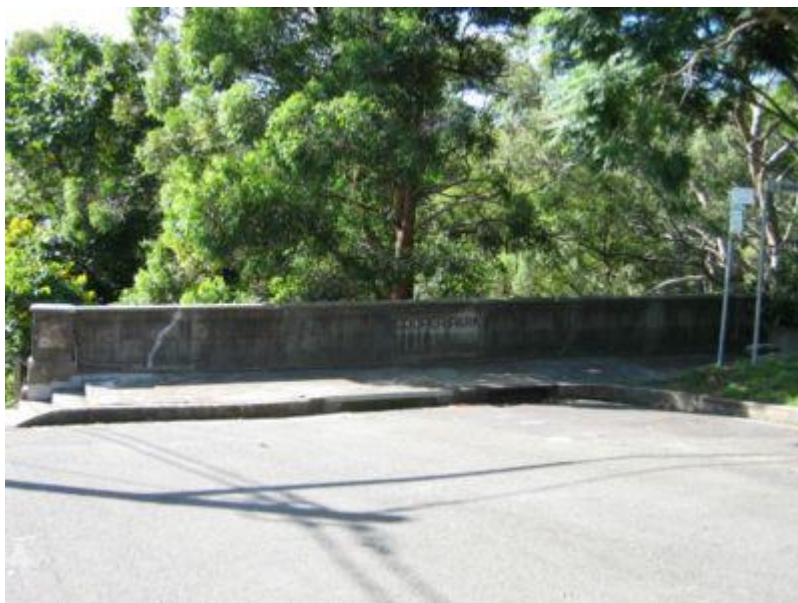
Adelaide Parade, sandstone wall western end showing rendered street level retaining wall
Image copyright owner: Woollahra Council

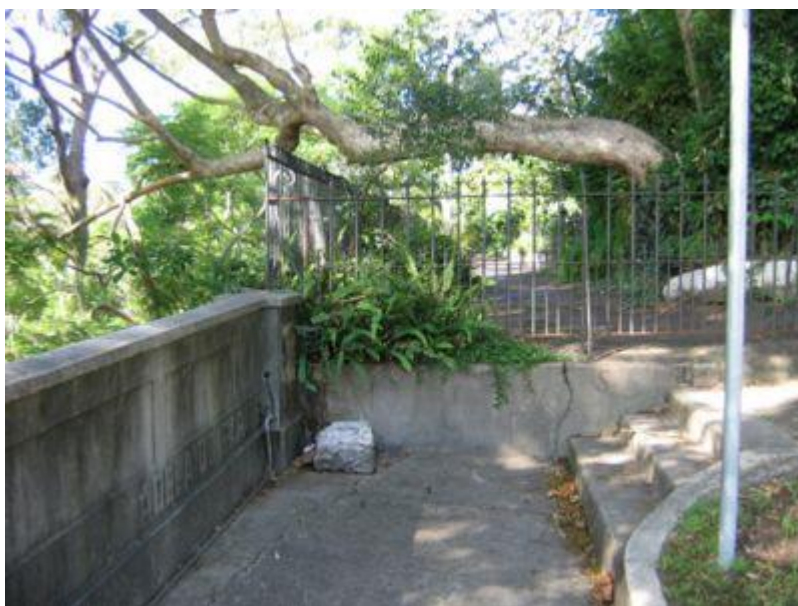
Adelaide Parade pathway between Cooper Park and row of terraces
Image copyright owner: Woollahra Council

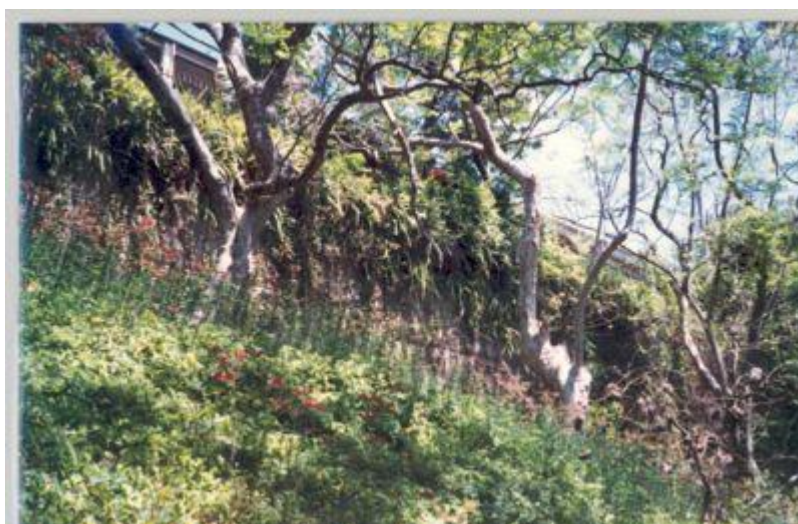
Adelaide Parade, sandstone retaining wall to Adelaide Parade as viewed from Cooper Park
Image copyright owner: Woollahra Council

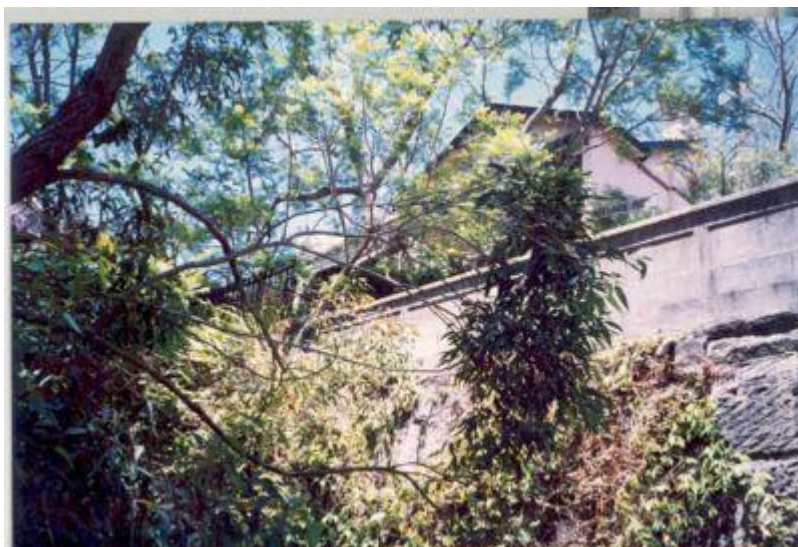
Adelaide Parade, Sandstone wall western end of retaining wall viewed from Cooper Park
Image copyright owner: Woollahra Council
