Project 84979.01  
10 August 2016  
84979.01.R.001.Rev1  
PMM:jljb

**Report on Groundwater Testing**  
**4-10 Northwood Road, Longueville.**

TITLE: **Bore Locations**  
**4-10 Northwood Road, Longueville**

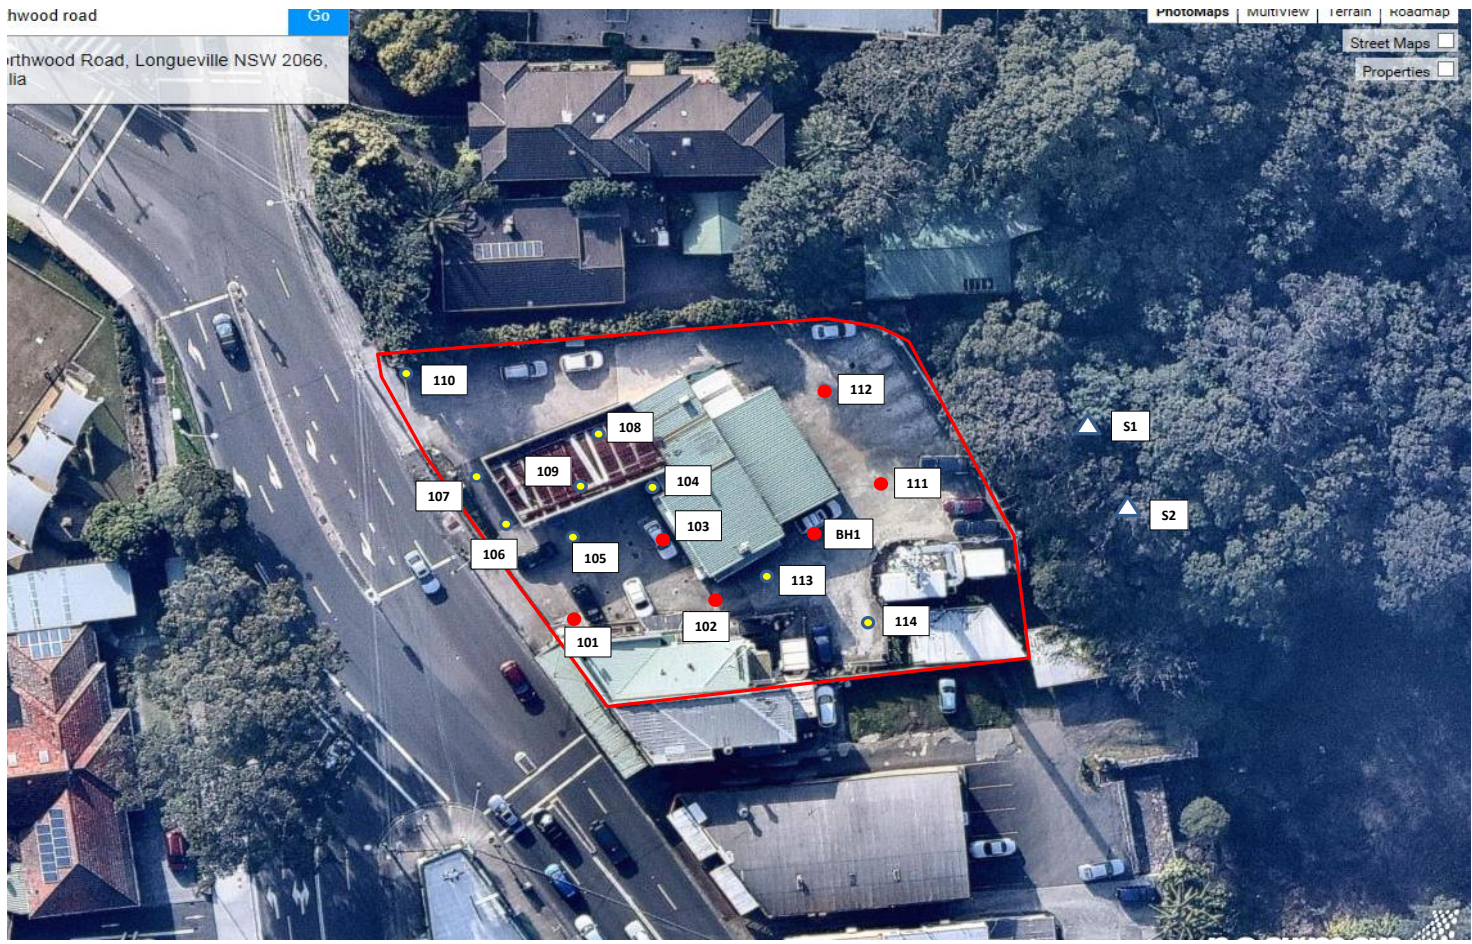
| DRAWING No: | 1 |

Three of the previously installed groundwater monitoring wells, identified as BH102, BH111 and BH112 (refer Drawing 1, attached) were developed, purged and sampled.

The initial plan was to install an additional three groundwater monitoring wells, particularly targeting the rear boundary. Due to issues with underground services, the scope was amended to include the installation of one additional groundwater monitoring well (BH1, Drawing 1 attached), which was subsequently developed, purged and sampled.
