# HERITAGE ASSESSMENT REPORT

## “Ashley Villa”

34 BELMORE STREET, ENMORE NSW

MARRICKVILLE COUNCIL

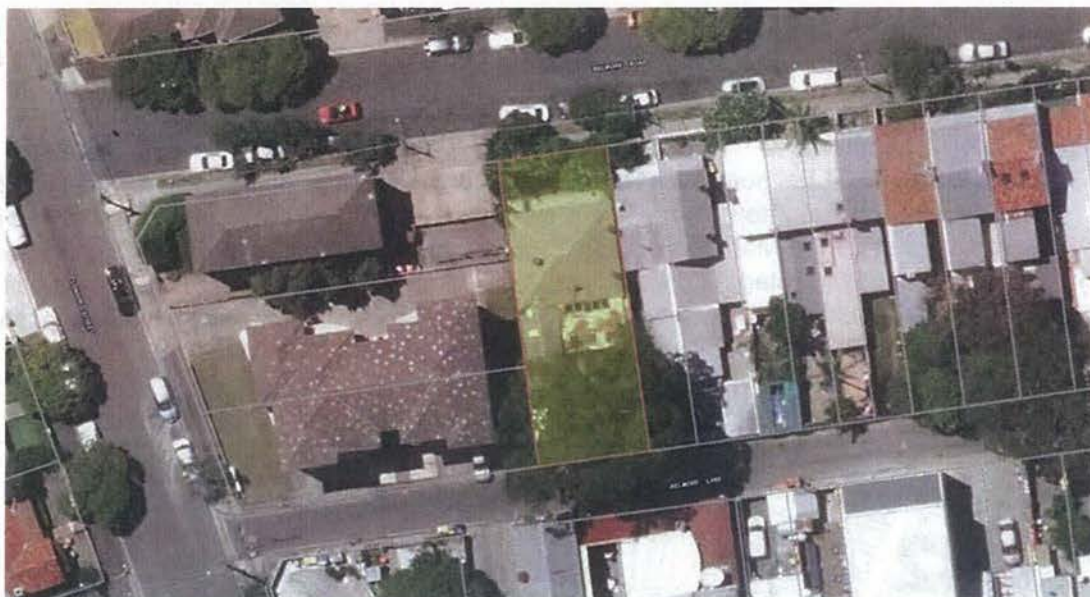
Figure 2: Recent satellite view of 34 Belmore Street, Enmore (shaded yellow, outlined in red) Source: NSW Land & Property Information Six Maps

The 1943 and 1949 aerial photos (see Figures 3 and 14 above) reveal that the gable roofed rear western wing of the house originally had a rear verandah beside it to the east. It is clear from comparison of the 1943 and 1949 aerial photo and a modern satellite view (see Figure 2 above) that there are post-1943 rear extensions to the east of this gable roofed wing.

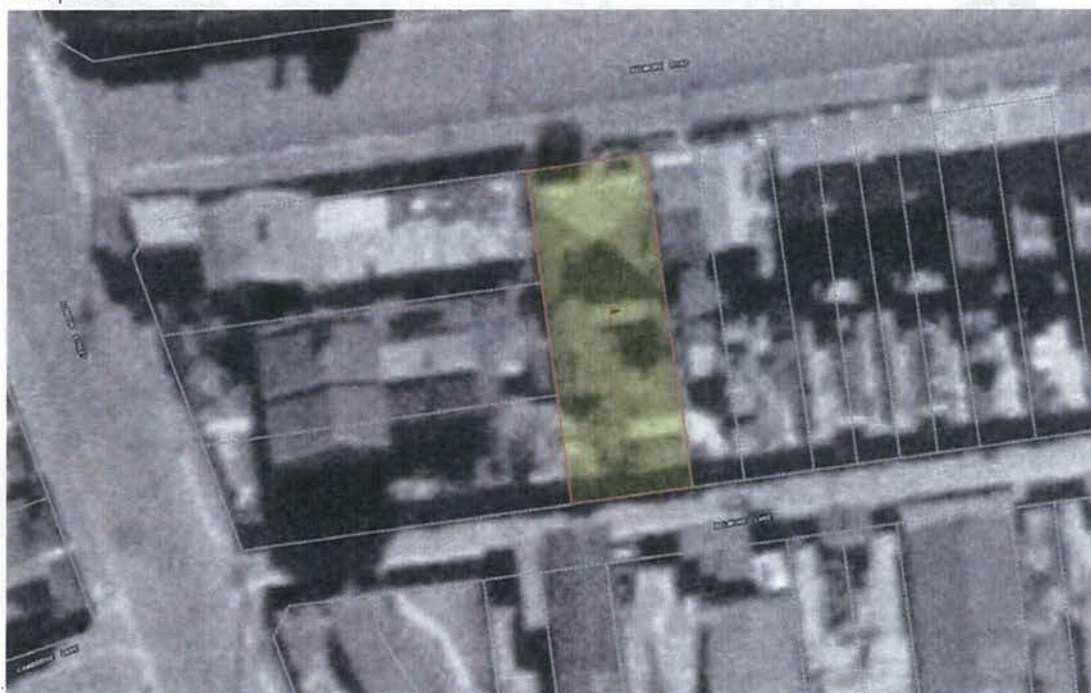
Figure 3: 1943 aerial photo of 34 Belmore Street, Enmore (shaded yellow, outlined in red), showing the current house on the site at this time. Source: NSW Land & Property Information Six Maps

Rear outbuildings on the site evident in the 1896 Lands Department detail survey (Figure 13 above) and in the 1940s aerial photos (Figures 3 and 14 above) have evidently been demolished.

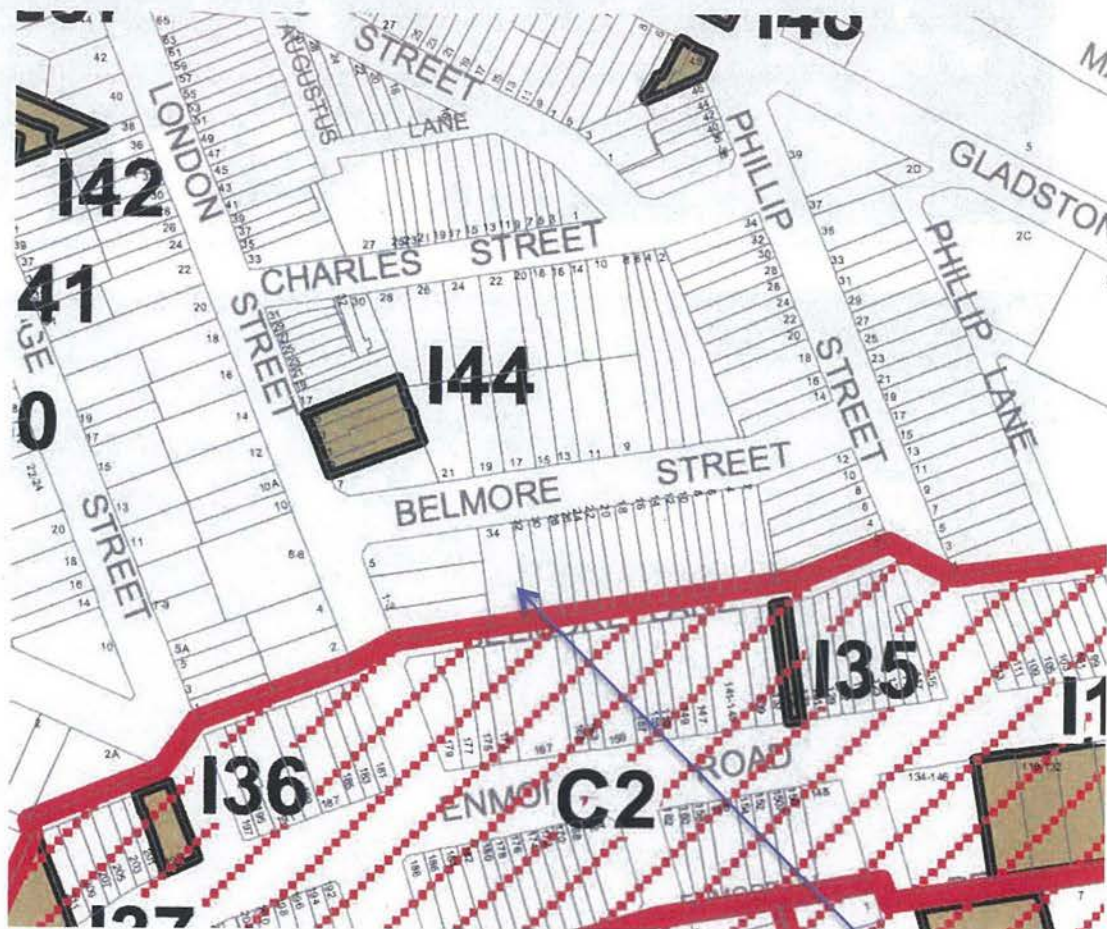
Figure 4: Extract of Marrickville LEP 2011 Heritage Map 003, showing the location of No. 34 Belmore Street (indicated with blue arrow) adjacent to Heritage Conservation Area C2 and not in the vicinity of any heritage items.

The property at 34 Belmore Street Enmore is not heritage listed in the Marrickville LEP 2011. The property backs onto Belmore Lane, which forms a boundary to Heritage Conservation Area C2 listed in the Marrickville LEP 2011, so the property is adjacent to but outside the boundary of this Heritage Conservation Area. The property is not in the vicinity of any heritage items listed in the Marrickville LEP 2011. Figure 4 below shows the relationship of the property to Heritage Conservation Area C2 and LEP listed heritage items in the area.

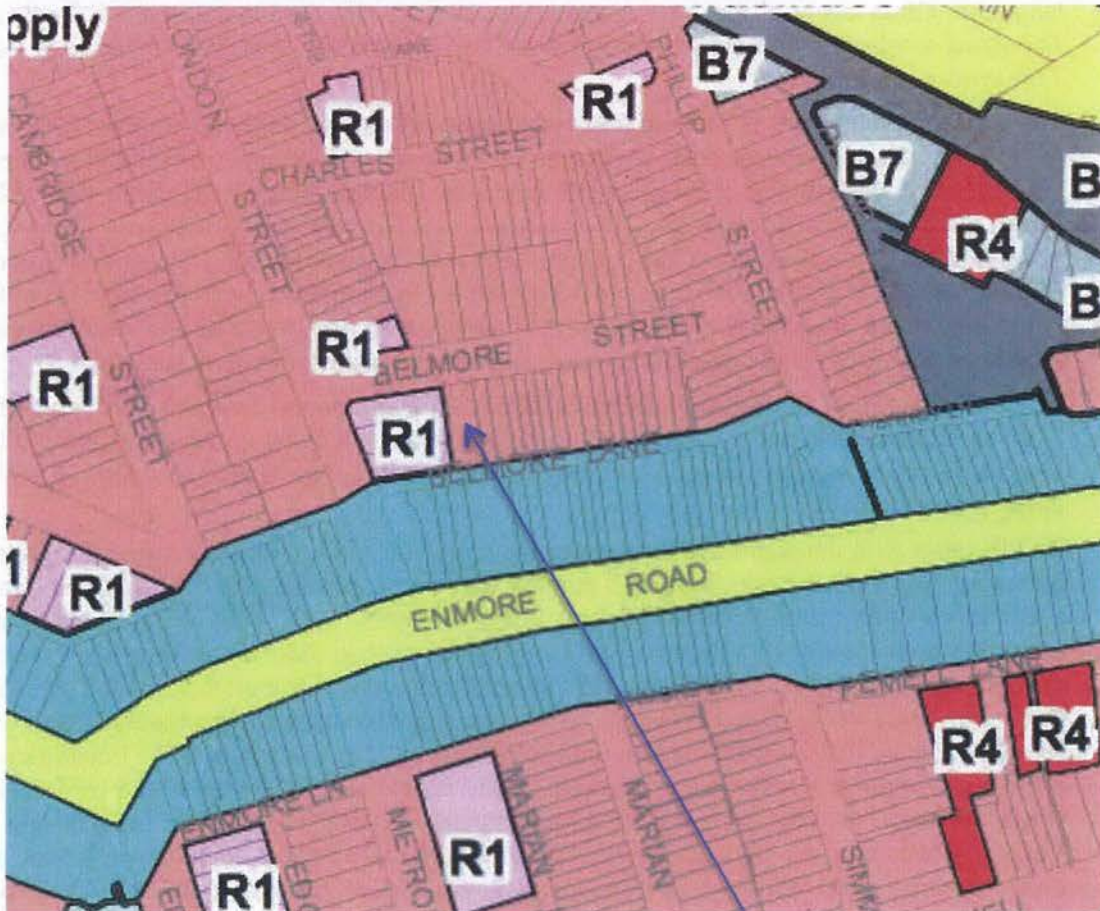
Figure 5: Extract of Marrickville LEP 2011 Zoning Map 003 showing the site at 34 Belmore Street Enmore zoned R2 Low Density Residential

Under the Marrickville LEP 2011 the site at 34 Belmore Street Enmore (indicated with blue arrow) is zoned R2 Low Density Residential, however adjacent sites to the west fronting London Street are zoned R1 General Residential, as shown on the map in Figure 5 below. Sites to the south along Enmore Road are zoned B2 Local Centre (coloured blue).

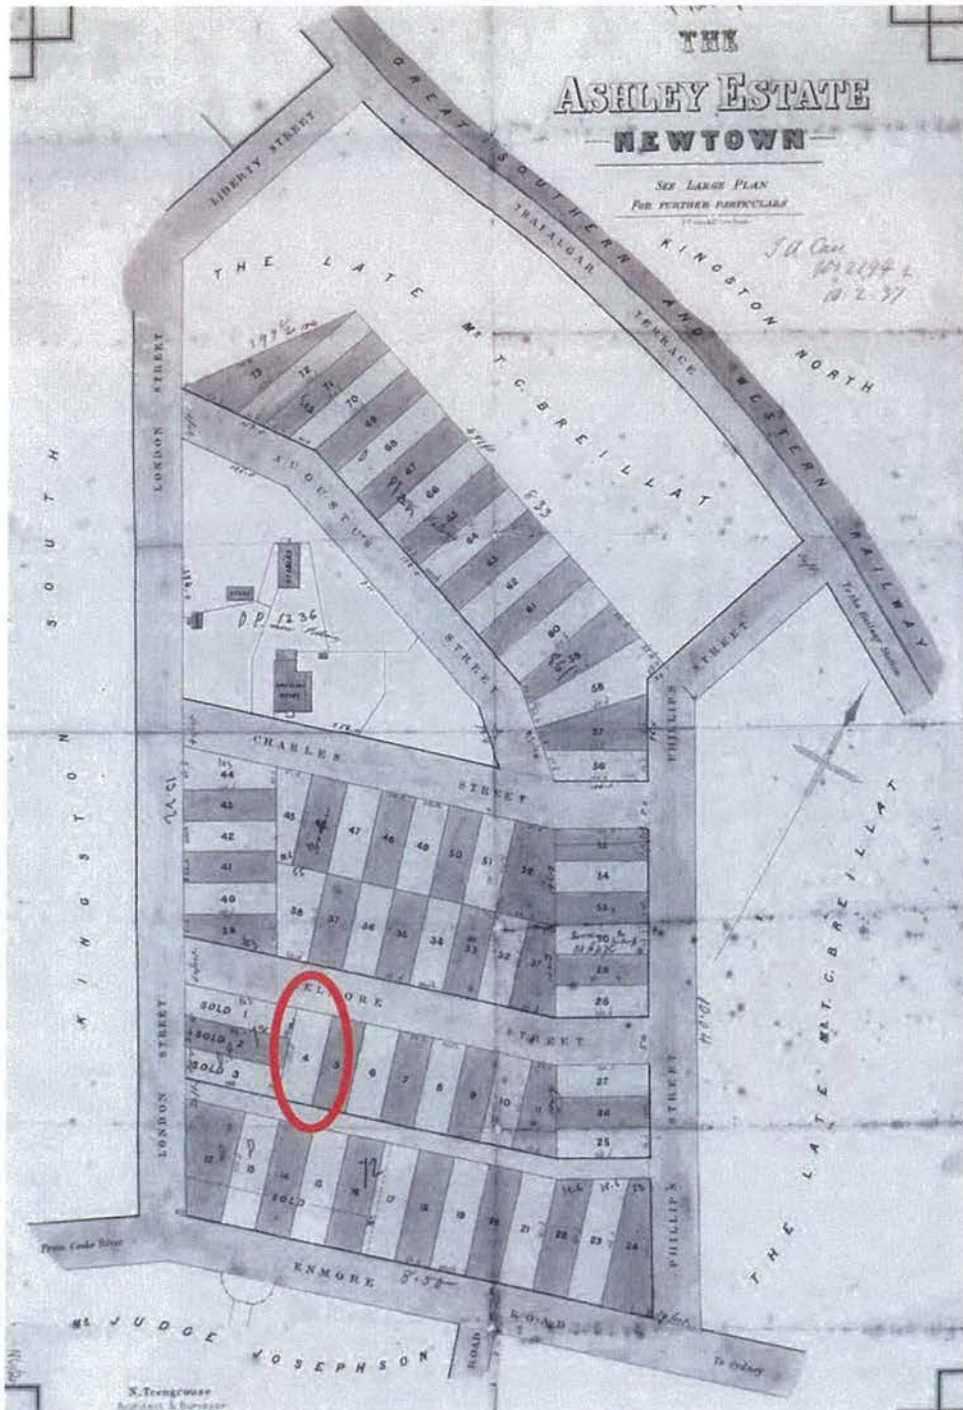
Figure 10: Plan of subdivision of the Ashley Estate. Circled is Lot 4 (No. 34 Belmore Street). Not dated, but 1876.  
Source: State Library of New South Wales (N6/2)

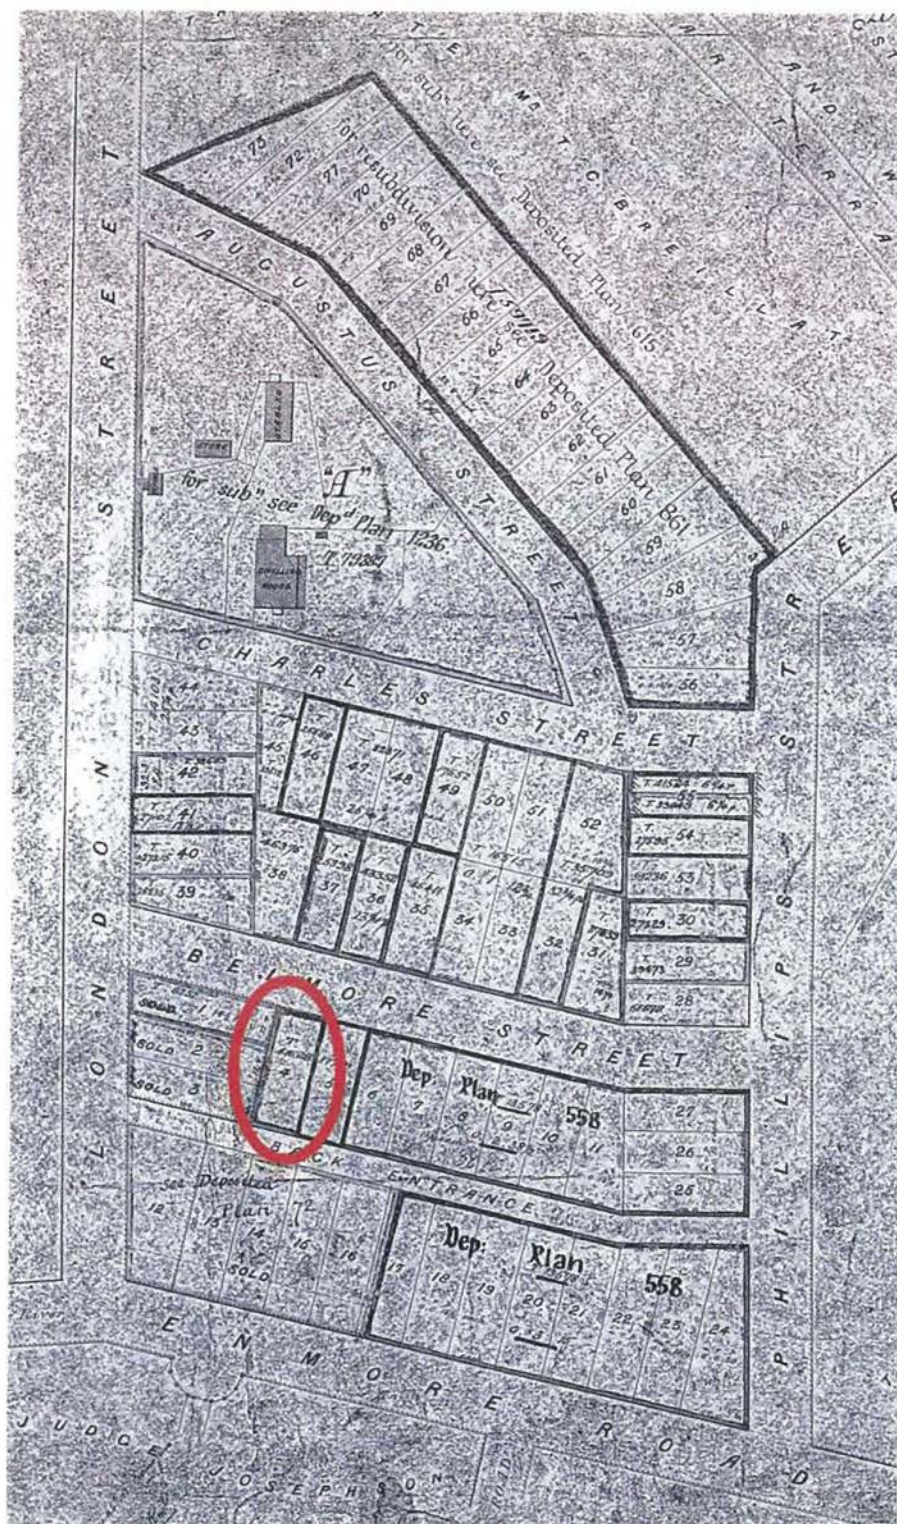
Figure 11: The registered plan of subdivision (Deposited Plan 136) of the Ashley Estate dated 1876. Circled is Lot 4 (No. 34 Belmore Street), and noted are the locations of later re-subdivisions (DP558, DP861, and DP 1236)  
Source: NSW Land and Property Information

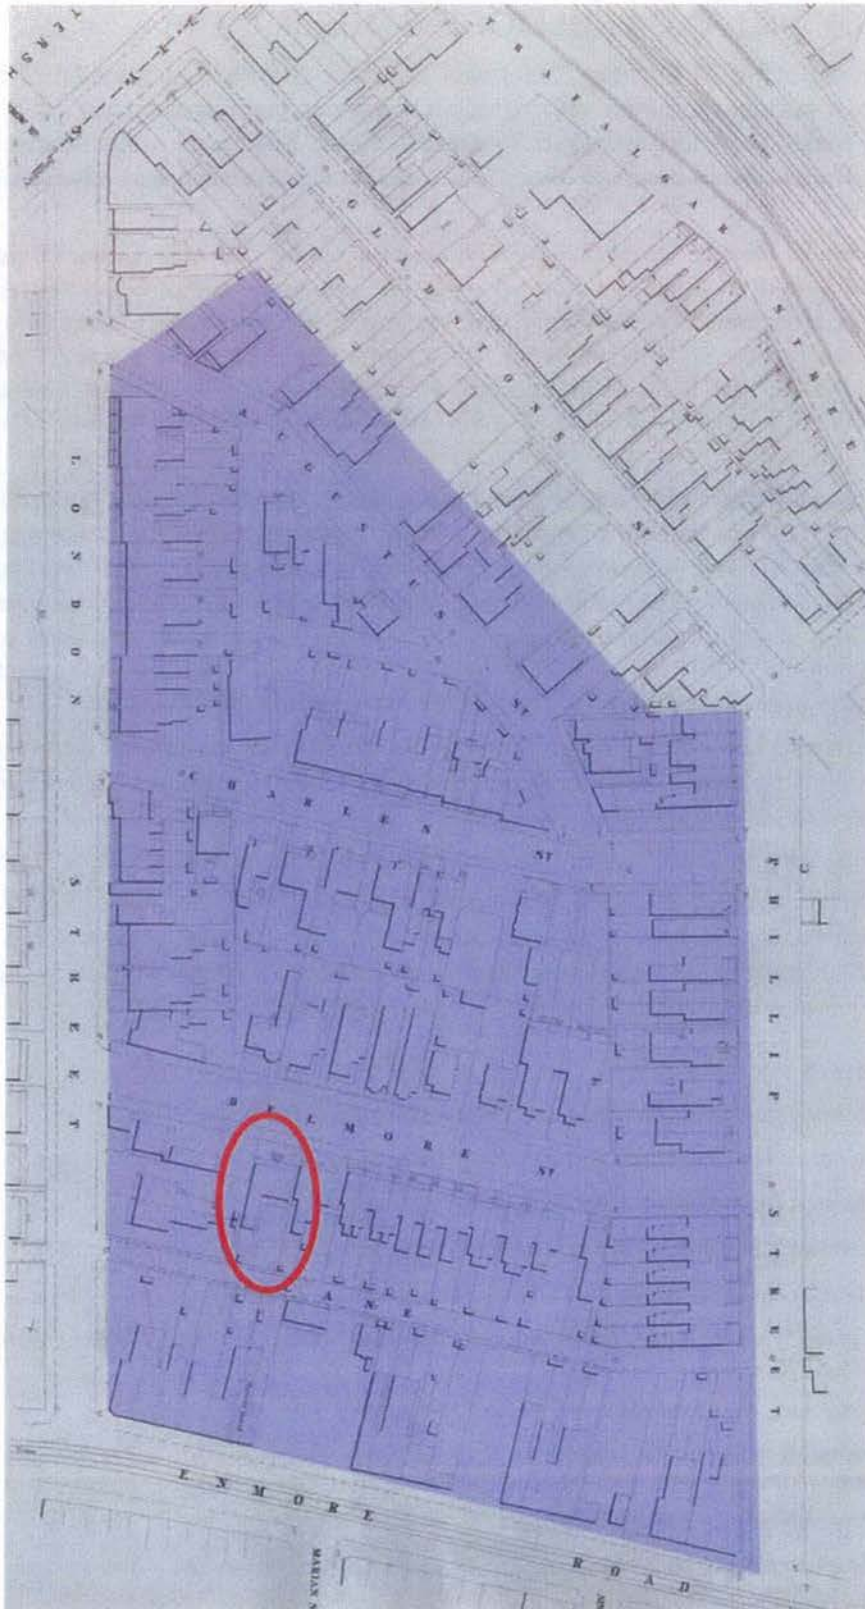
Figure 12: Newtown Sheet No. 8 of the Lands Department's detail series of surveys of metropolitan Sydney, dated 1896. The development within the Ashley Estate is shaded blue, and circled is No. 34 Belmore Street.  
Source: State Library of New South Wales (Z M Series 4 811.17/1)

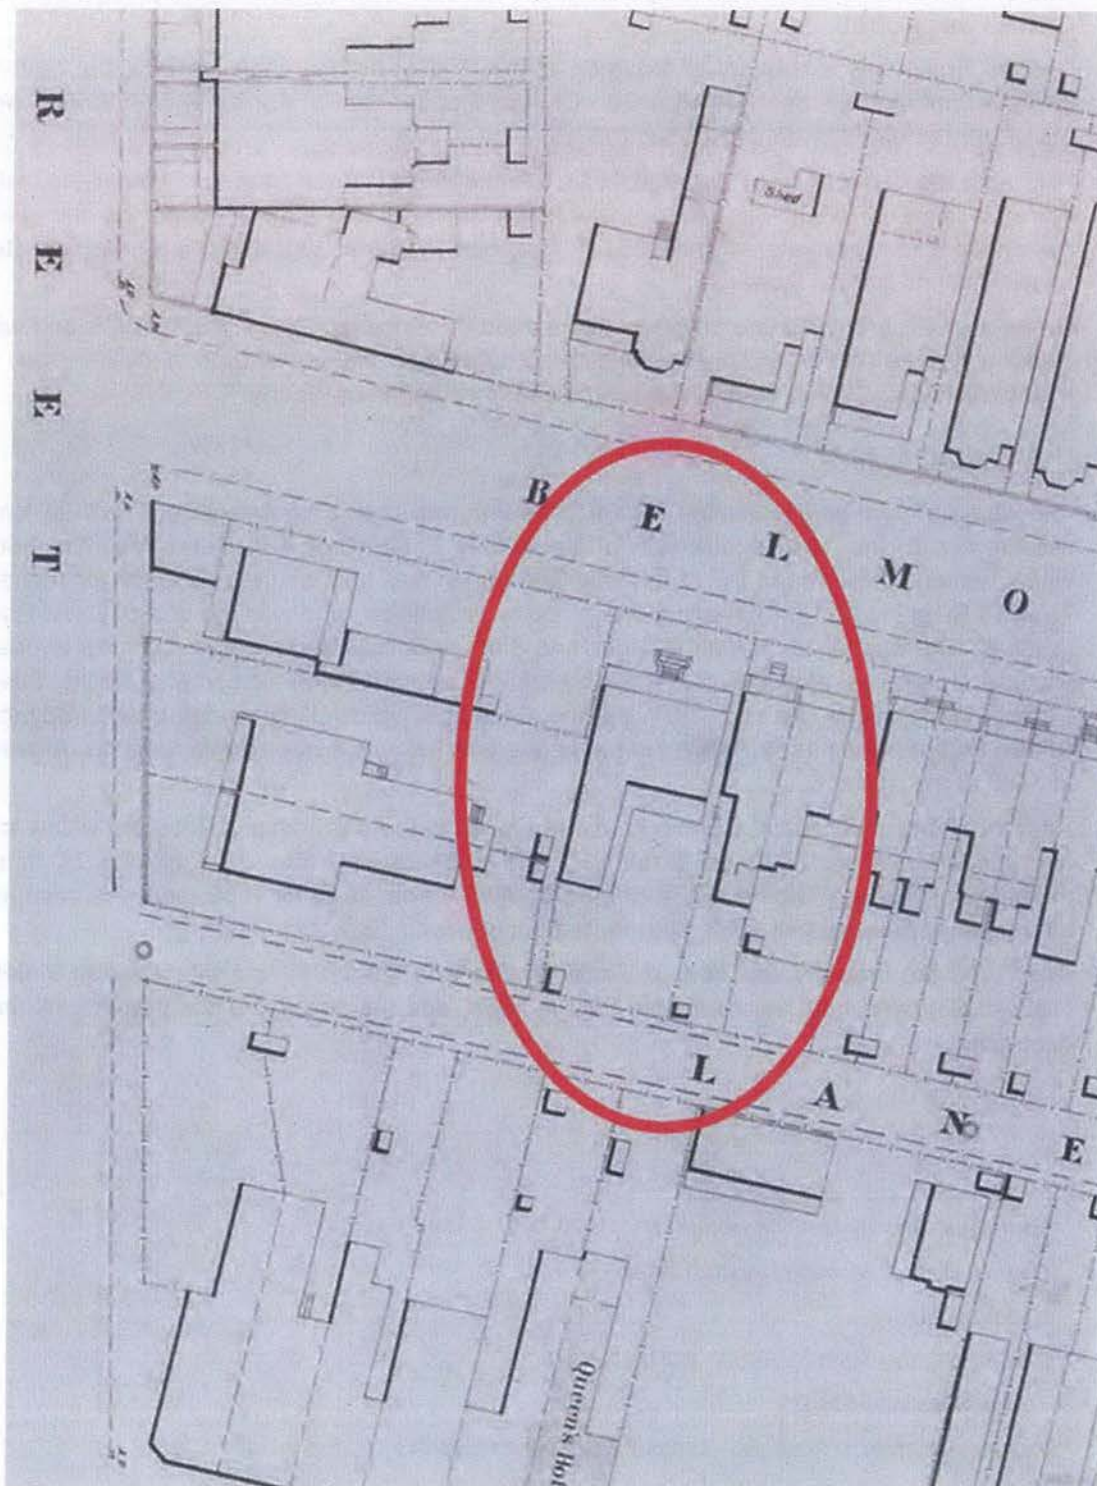
Figure 13: Detail from Newtown Sheet No. 8 of the Lands Department's detail series of surveys of metropolitan Sydney, dated 1896. Circled is No. 34 Belmore Street with the original footprint of the house with its rear service wing, front and rear verandahs, flight of steps at front, and brick WC beside the rear laneway.

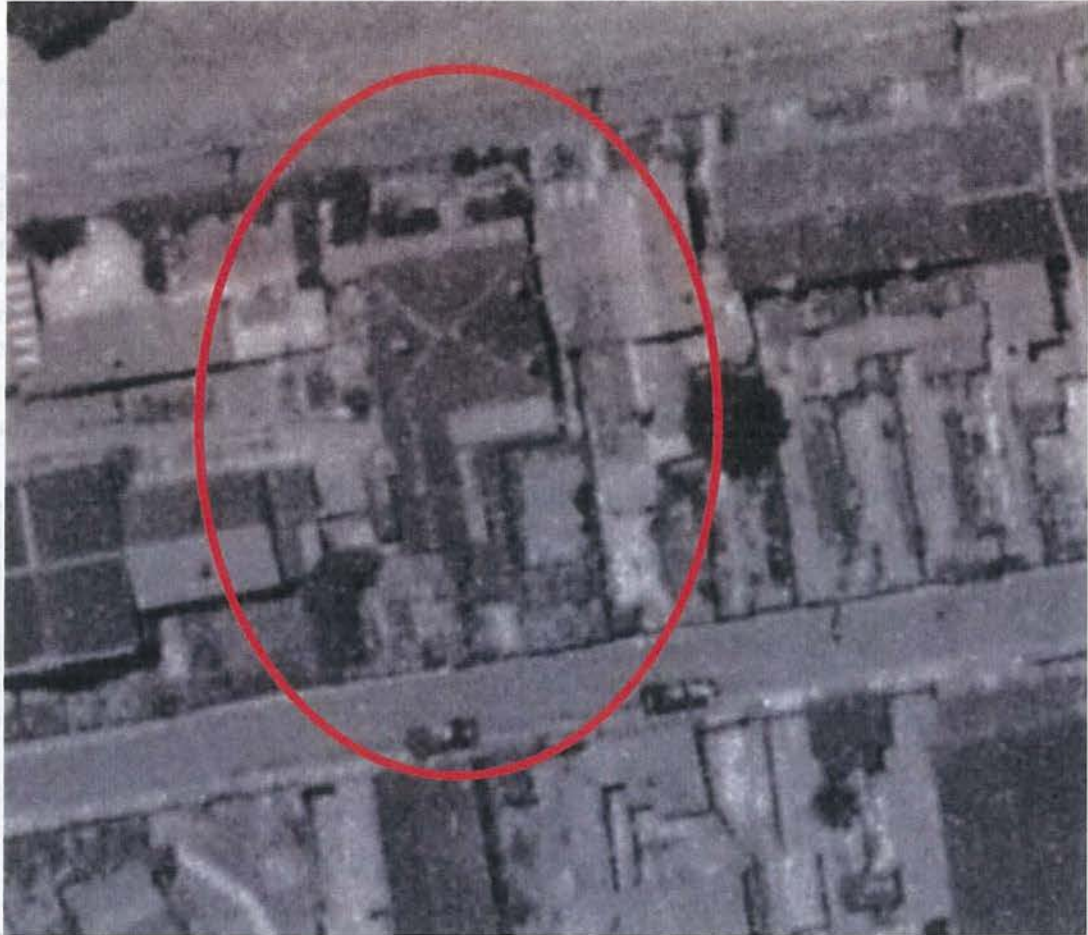
Figure 14: Detail from the City of Sydney series of aerial photographs of inner Sydney, dated 1948. Circled is No. 34 Belmore Street with the footprint of the house with its rear service wing, verandahs, chimneys, defunct brick WC, and possibly rear garage.  
Source: NSW Land and Property Information

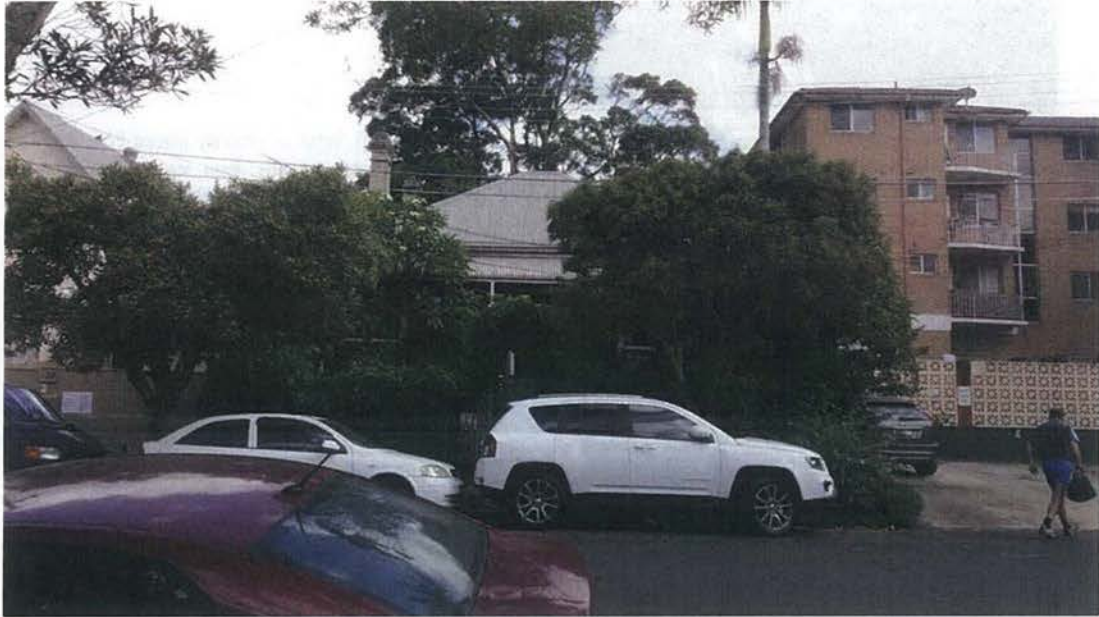
Figure 15: The front (north elevation) of the house at 34 Belmore Street, Enmore, as seen from the opposite side Belmore Street.

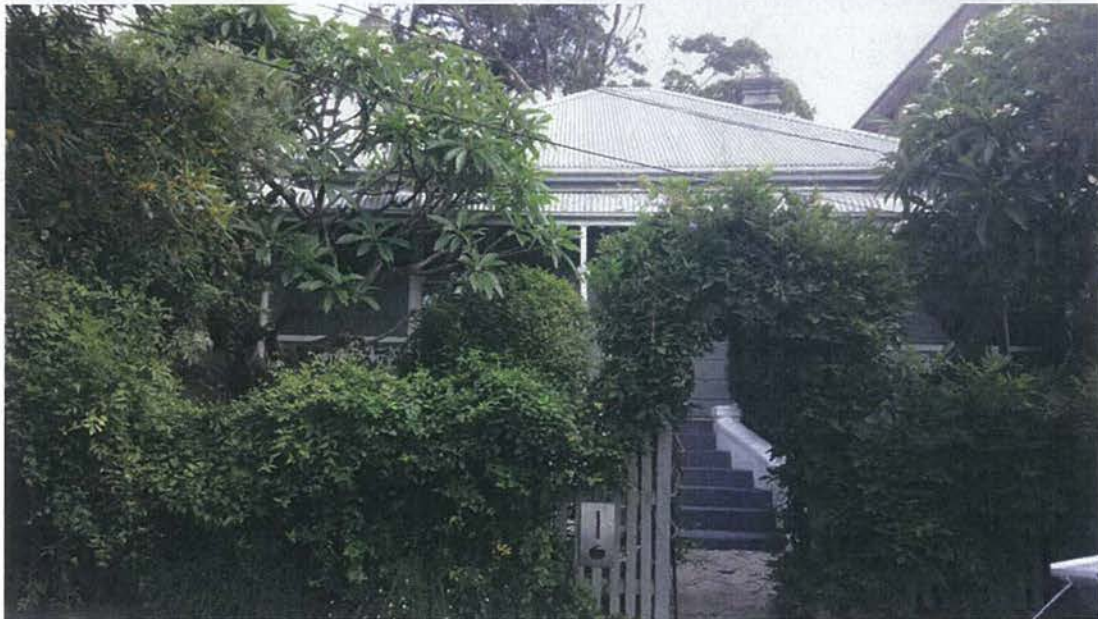
Figure 16: Detail of the front (north) elevation of the house at 34 Belmore Street, Enmore, as seen from Belmore Street. Cast iron verandah posts and balustrade and verandah roof can be seen.

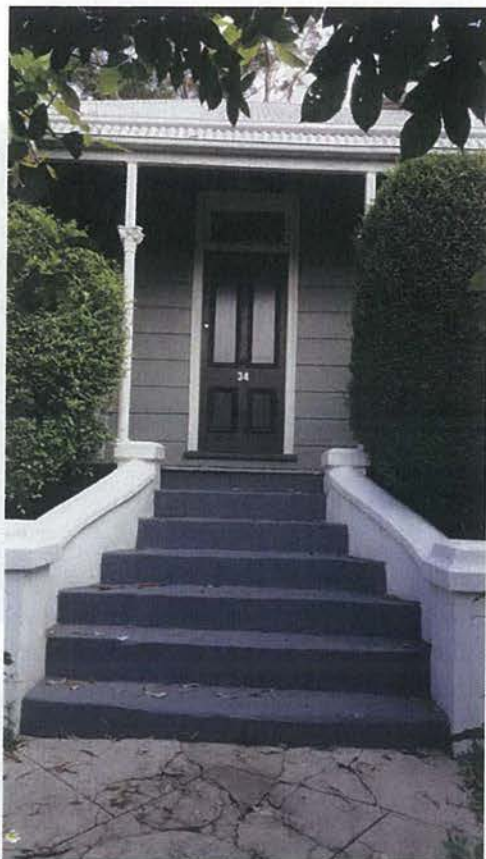
Figure 17: (Left) Detail of centrally placed front door, fanlight, cast iron verandah columns, front steps, taken from Belmore Street

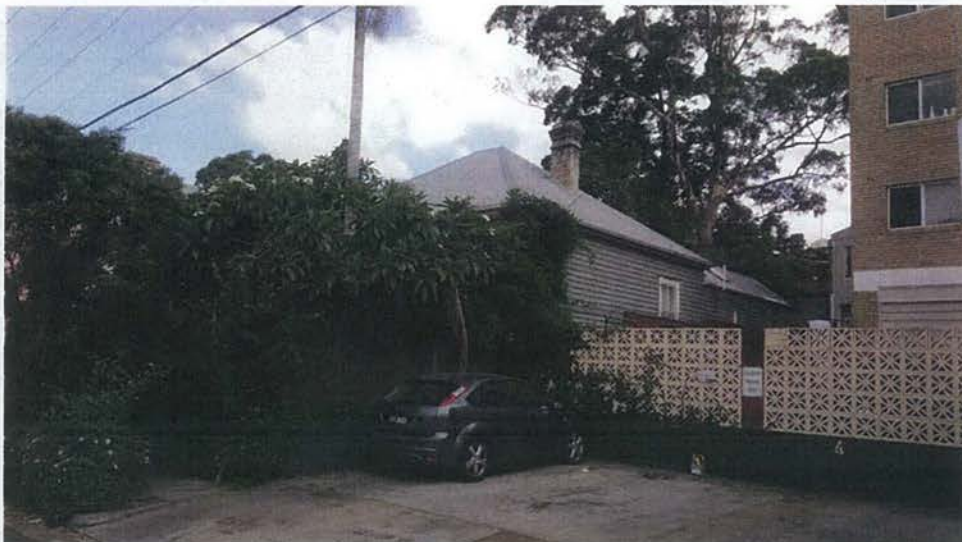
Figure 19: Western elevation of the house from Belmore Street. One of the chimneys, and the gable roofed rear wing, and eucalyptus tree in the rear garden are seen in this view

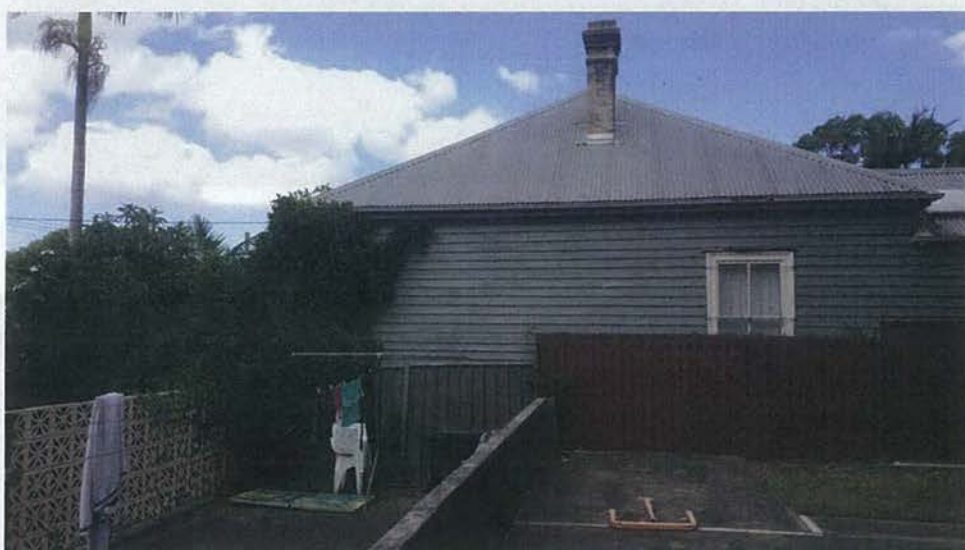
Figure 20: Detail of western elevation of the main hipped roofed section of the house, with chimney. Note timber-framed double hung window with vertical glazing bar to each sash.

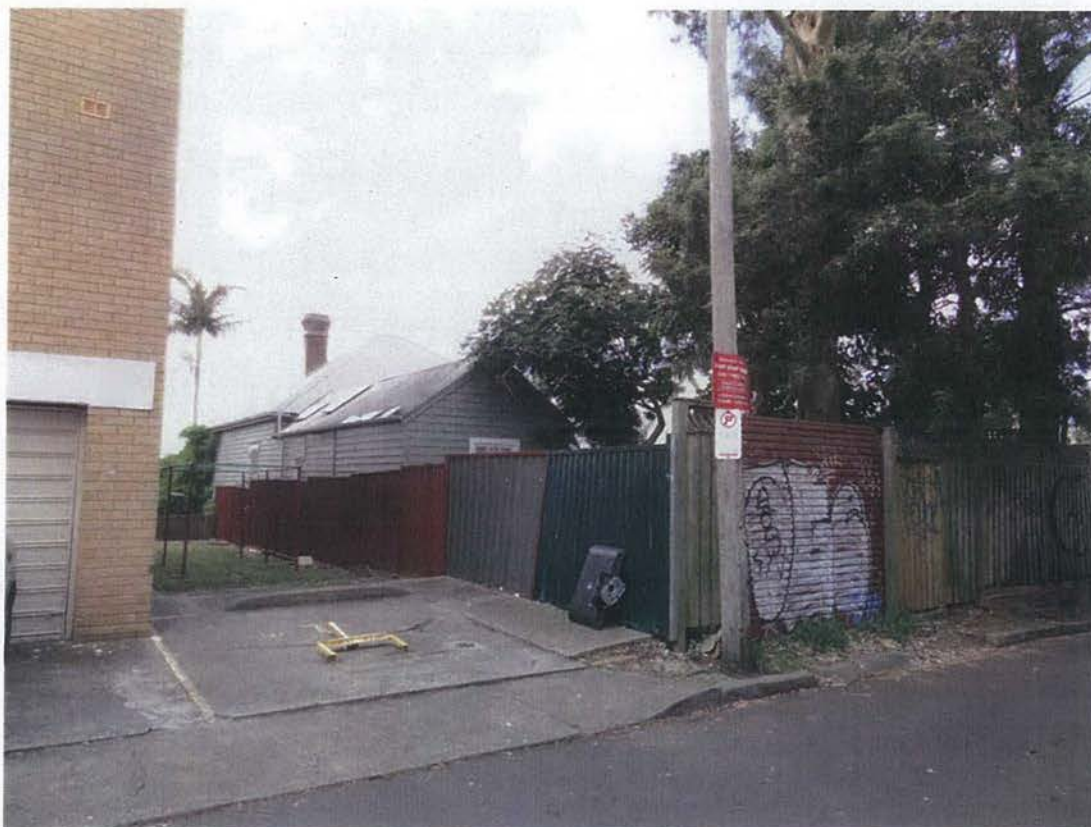
Figure 21: View of the western elevation of the house and the gable roofed rear wing from Belmore Lane at the rear. The tall bangalow palm tree in the front garden can be seen in this view.

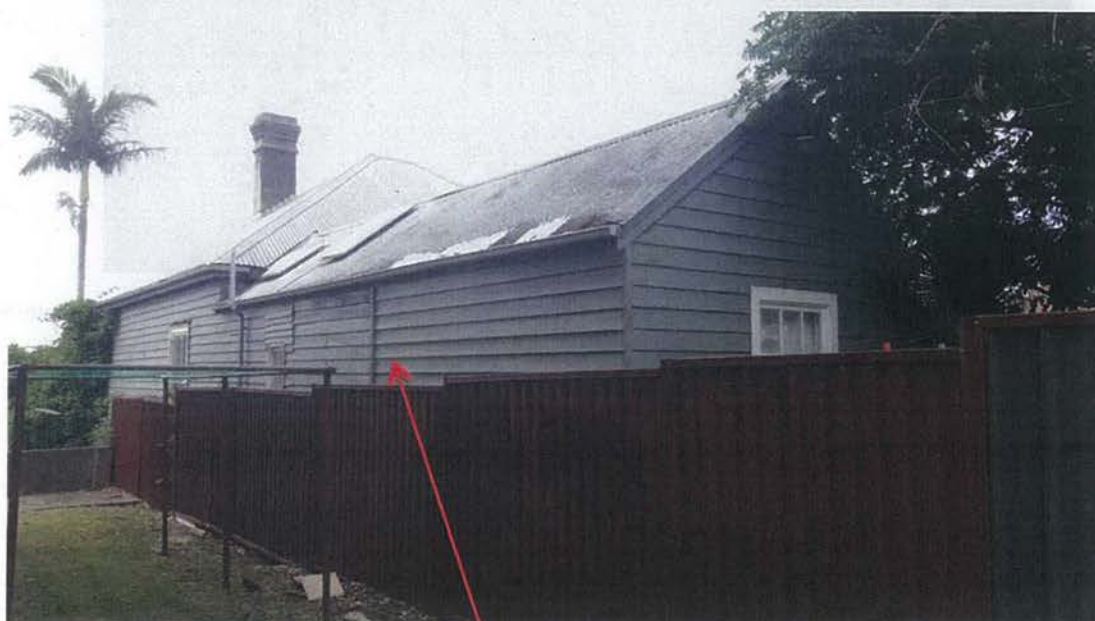
Figure 22: Detail of the western elevation of the house and the gable roofed rear wing from Belmore Lane at the rear. The point at which the pre-1949 extension of this wing starts is arrowed.

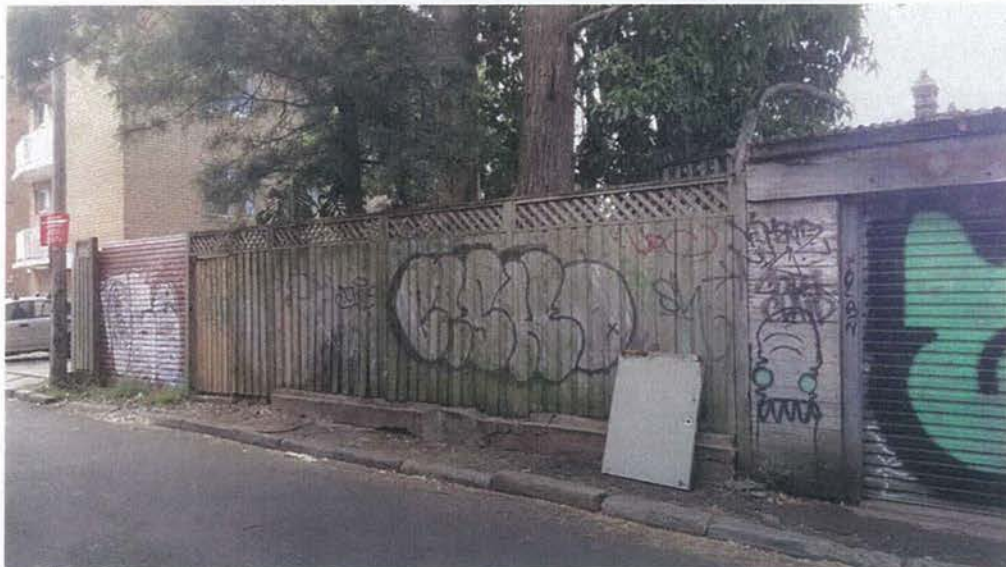
Figure 23: View of the rear garden from the Belmore Lane to the east of the site. The eastern chimney to the main roof is just visible at right.

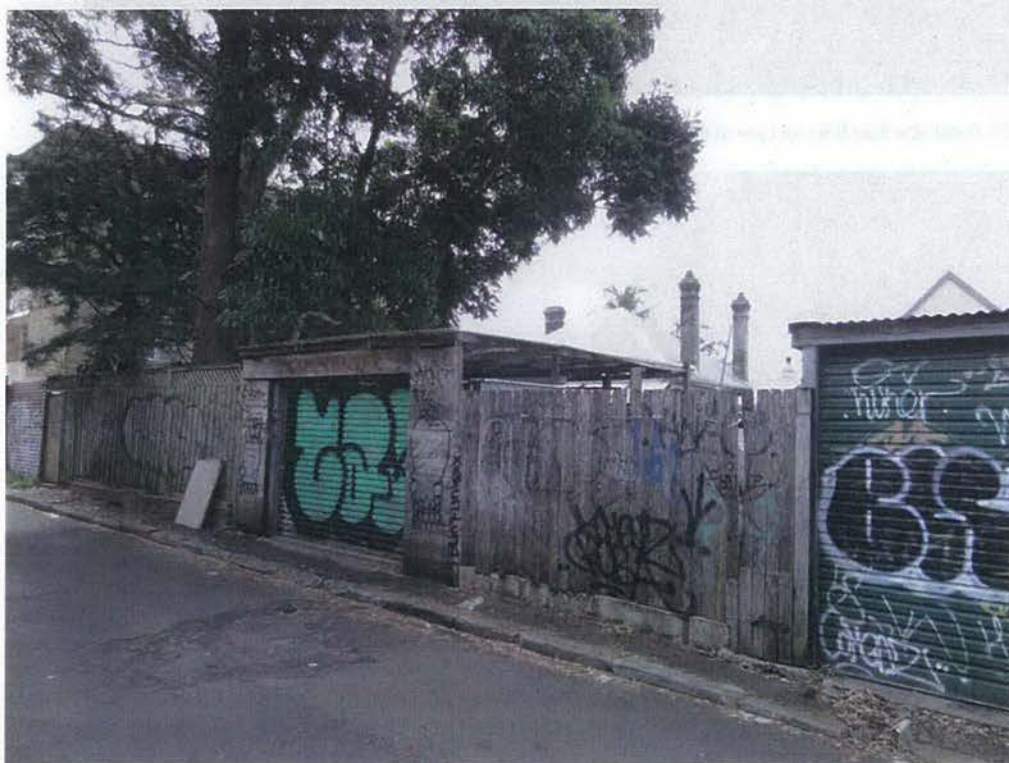
Figure 24: View from Belmore Lane to the east. All three tall rendered brick chimneys to the main hipped roofed section of the house can be seen in this view. The garages (centre and right) belong respectively to properties at Nos. 32 and 30 Belmore Street. The roller door at far left is the vehicle access to No. 34 Belmore Street.

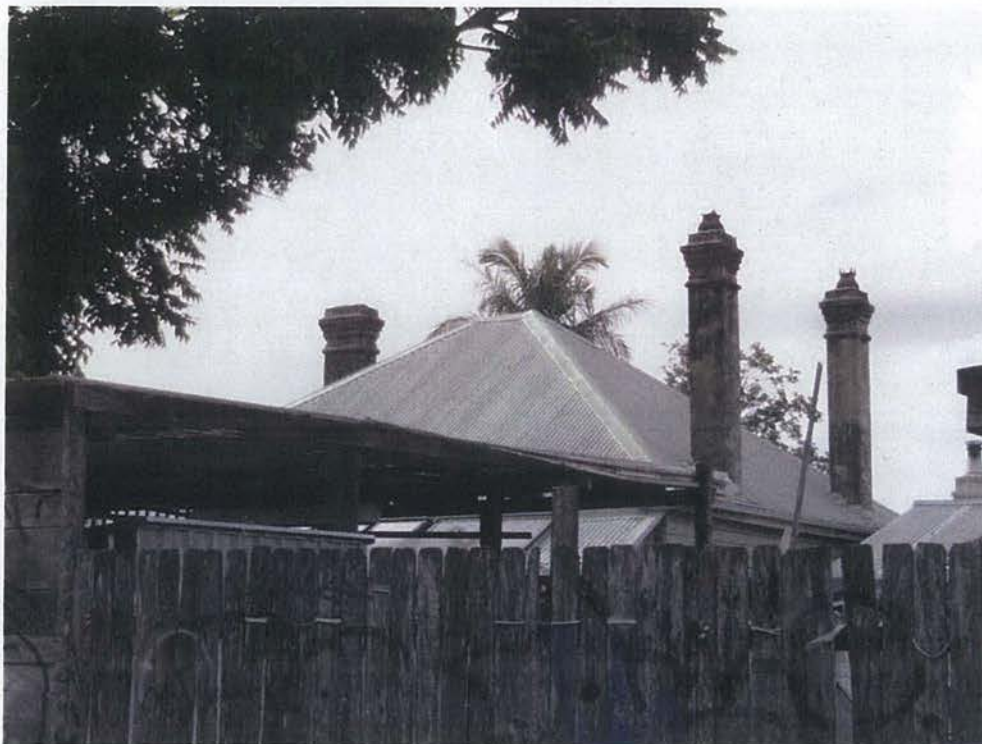
Figure 25: Detail view from Belmore Lane to the east, showing the main roof with all three chimneys, and rear shed structure.

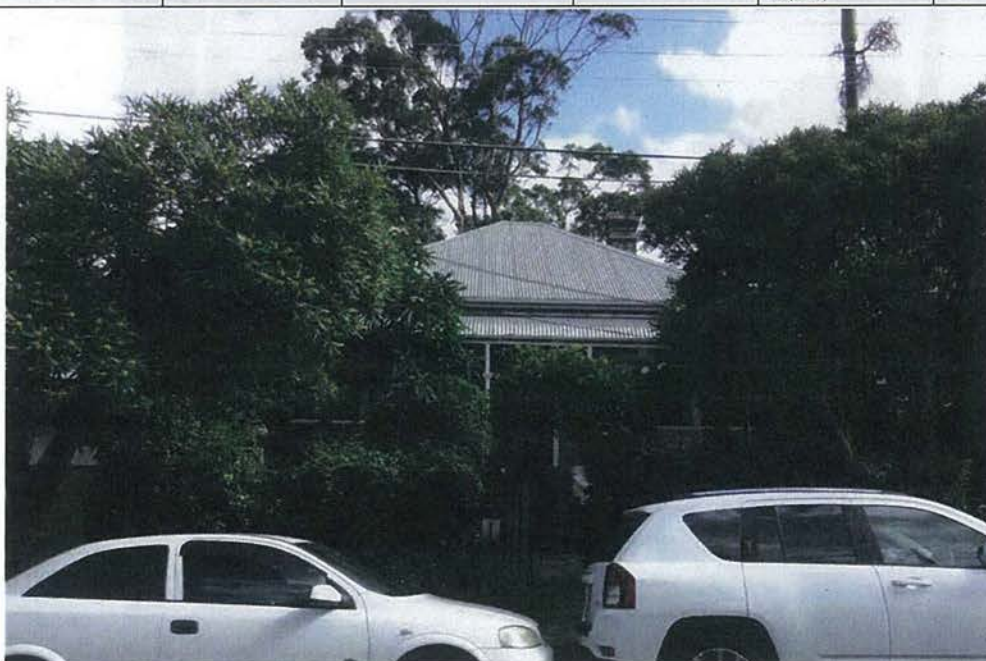
Figure 27: North (Front) elevation of 1880 Victorian Filigree style weatherboard cottage at 34 Belmore Street, Enmore

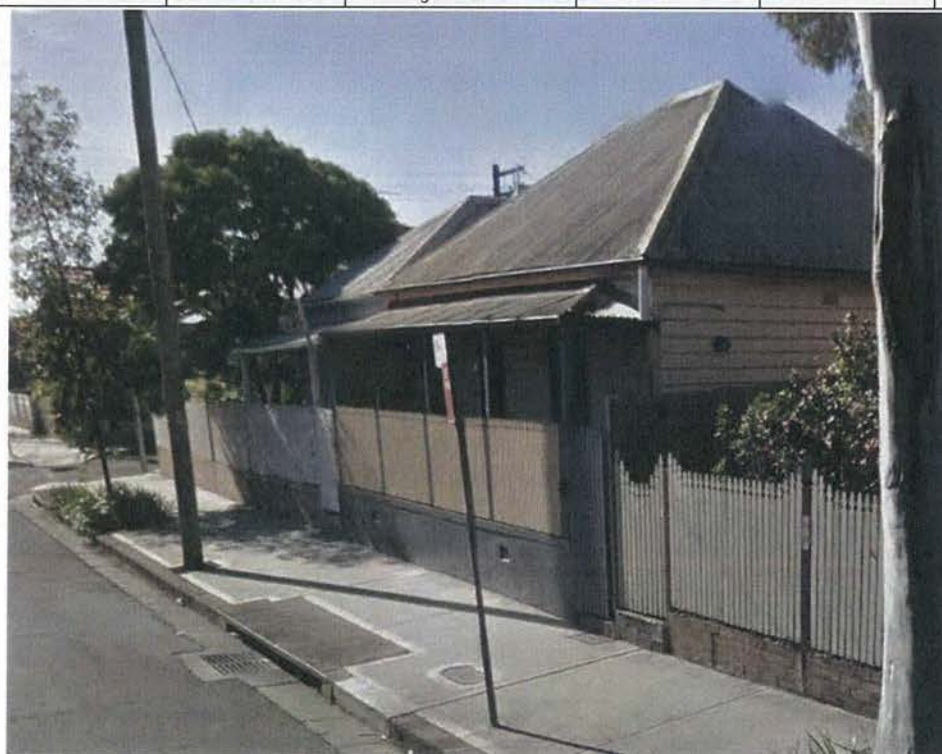
| Lewisham | 11 & 13 Old Canterbury Road | Pair of Victorian weatherboard cottages including interiors | Circa 1860 | Local | I58 |

Figure 29: Circa 1860 Weatherboard cottages at 11 & 13 Old Canterbury Road, Lewisham Source: Google Streetview

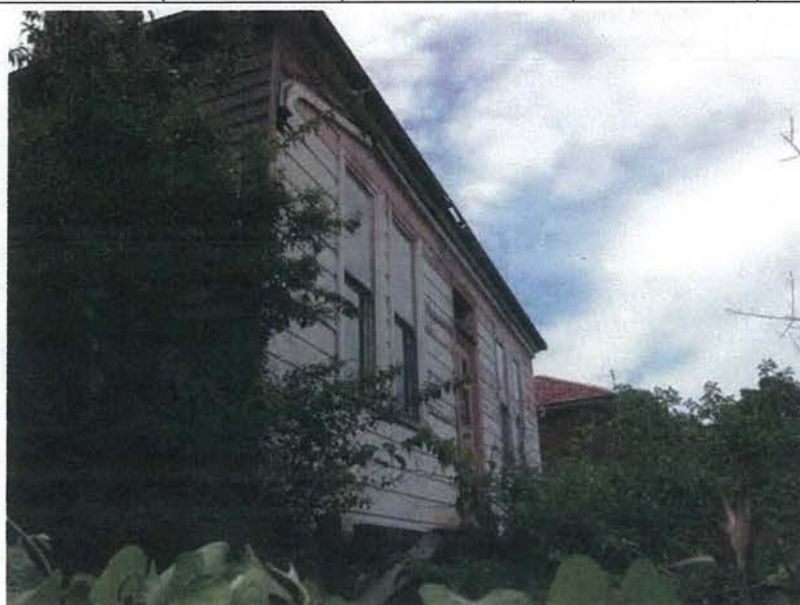
Figure 30: West (Front) of the 1896 weatherboard Benson's Quarry cottage, with evidence of it's missing front verandah.  
Source: State Heritage Inventory form

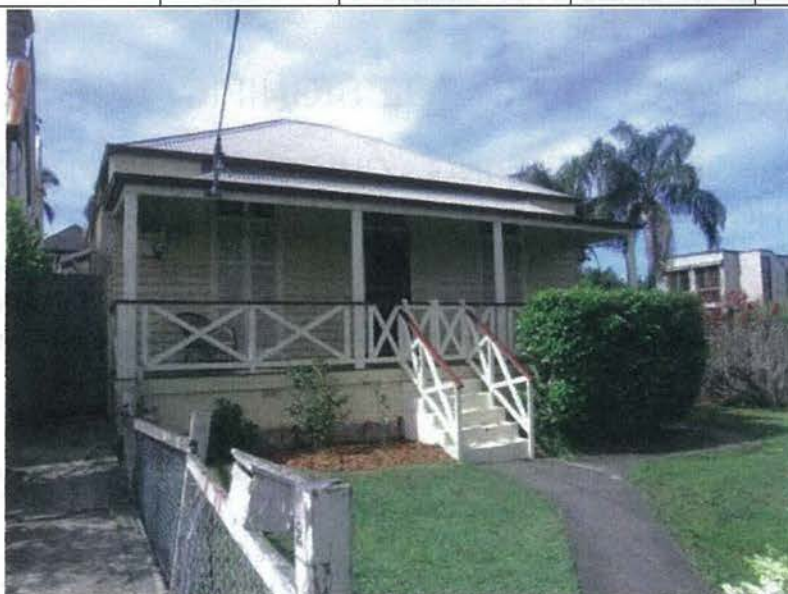
| Petersham | 2 York Crescent | Victorian Georgian weatherboard cottage on a sandstone base, evidence of development of circa 1857 "Wardellville Estate". | 1868 | Local | 1232 |

Figure 31: 1868 weatherboard cottage at 2 York Crescent, Petersham Source: State Heritage Inventory form

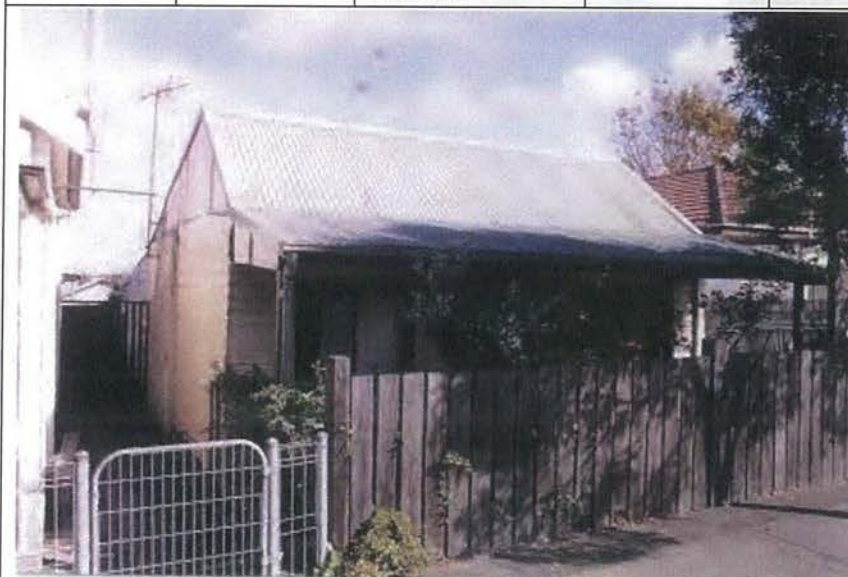
| Suburb | Address | Description of item | Date of construction | Significance | Heritage Item No. in the LEP |
|---|---|---|---|---|---|
| Tempe | 44 Barden Street | Split timber slab cottage with she oak shingles beneath corrugated steel roof. May relate to A.B.Sparke's 1940s "Village of Tempe" subdivision. | Circa 1840 | State | SHR No. 01412<br>LEP Heritage Item No. 1294 |

Figure 32: Circa 1940 Timber slab cottage at 44 Barden Street, Tempe. Source: State heritage inventory form
