# Hurstville Heritage Inventory

Item Name: **Weatherboard Cottages & Peppercorn Tree**

Location: **20 & 22 Botany Street, Carlton [Hurstville]**

### Full Report with Images

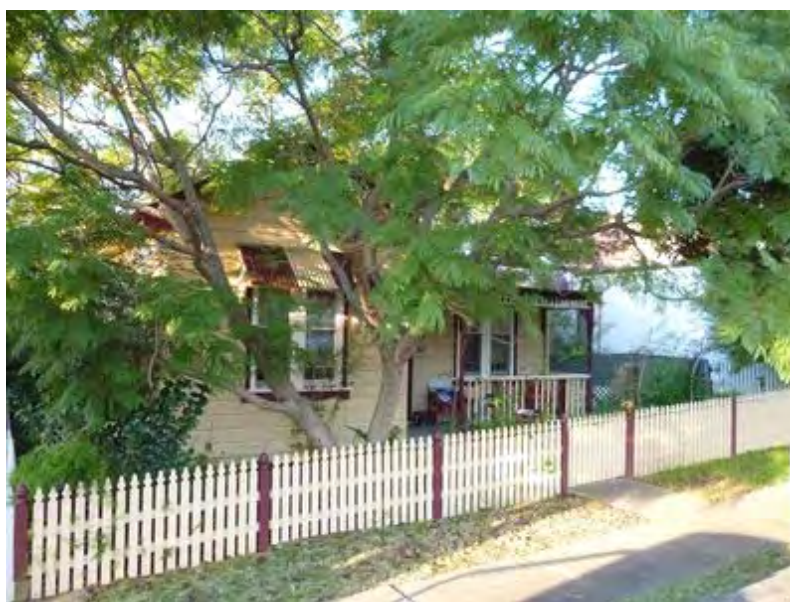
**Physical Description:** These Federation period weatherboard cottages feature similar form and asymmetrical facades with a projecting bay and veranda supported on turned timber posts with decorative frieze and simple balustrade. Number 20 is more intact than its neighbour number 22 and maintains its stripped corrugated metal bullnose veranda roofing and window awning with decorative brackets, decorative bargeboards and timber picket fence in matching colours. The windows are timber framed double hung windows with coloured glazing panels to the bottom sash and decorative skirting. The house is largely obscured from the street by the existing street trees. The site of number 20 also has considerable landscaping to the side and rear yard, which enhances its streetscape presentation to both Botany Street and to Xenia Avenue where both allotments have rear frontages. Number 22 has similar detailing in a different colour scheme with shingled awning to the window and tiles to the roof. Its boundary fence is replaced with rendered dwarf fence that would be more suitable for a later period masonry house rather than a weatherboard cottage. However, this change in the fence does not reduce its overall architectural presentation. A double garage is located at the rear of the site fronting Xenia Avenue. The Peppercorn tree was planted c100+ year ago on a land that was part of the original farm on the John Townsend grant of Crown land in 1810. It is approximately 40 metres high and is in good condition. Hurstville City Council approved pruning of 5 lower branches about 5 years ago with a condition that "not one leaf from the top" was allowed for removal.

Caption: Weatherboard Cottage at 20 Botany Street, Carlton

**Recommended Management:** Continue the ongoing maintenance. When opportunity arises replacement of the existing masonry fence of number 22 should be replaced with a timber picket fence similar to the number 20's fence to further enhance its streetscape presentation and architectural quality. Maintain the Peppercorn tree and continue to undertake regular tree maintenance as appropriate.

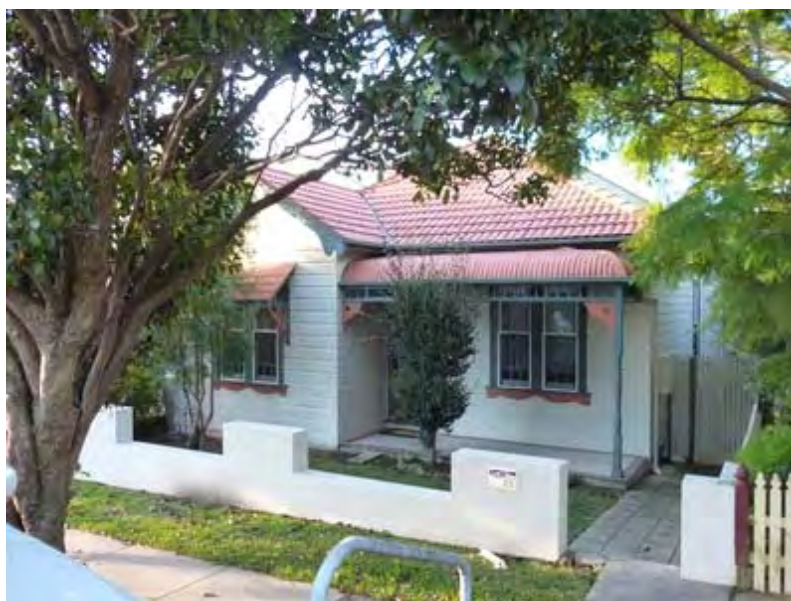
Caption: Weatherboard Cottage at 22 Botany Street, Carlton
