**Addendum to planning proposal 15-23 Homer Street, Earlwood.**

### **ILLAWARRA ROAD TREE ASSESSMENT**

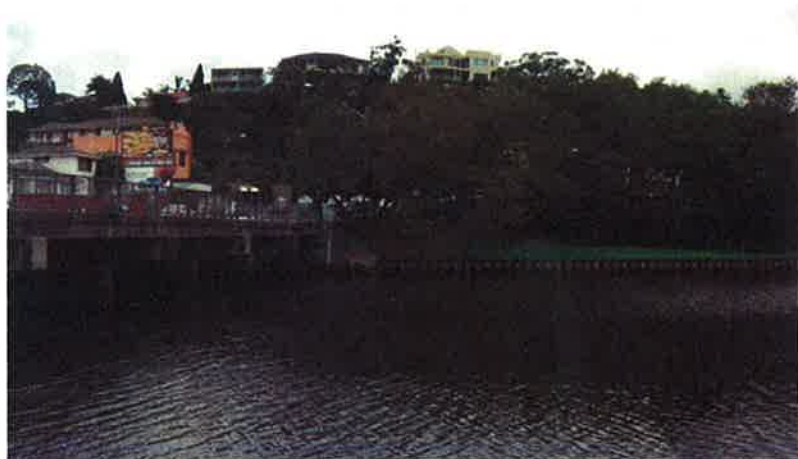
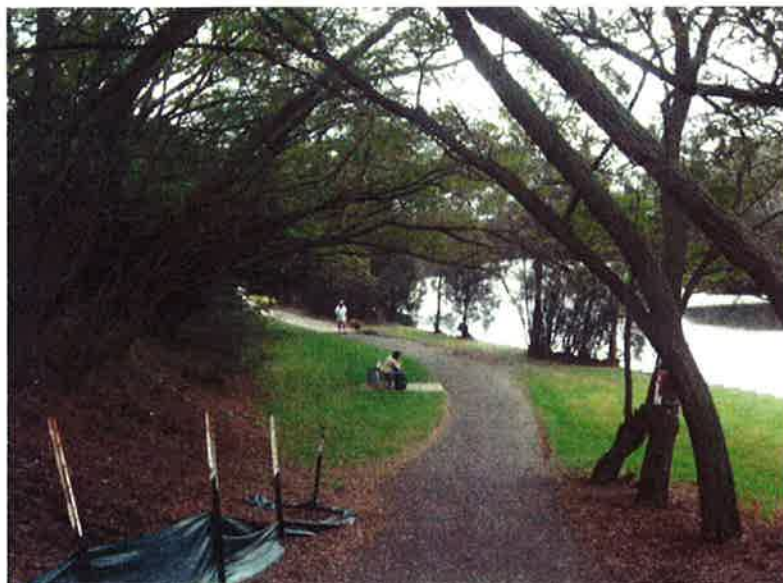
In addition, Clouston and Associates was engaged (as part of the DCP study for the site) to assess the likely impact of the trees on the subject site. The report identified a group of trees situated along the western side of Illawarra Road on the Stafford Walk path (see photos below). The report identified the group of trees are '*Robinia pseudoacacia*' commonly known as 'Black locust', an introduced species from the USA. They found the trees were in poor condition and could even be considered a 'potential hazard' due to thorns and propensity to sucker, creating a trip hazard. A copy of the tree report is attached.

Both groups of trees are in poor condition with many suckers. These suckers, thrown up from the species rootstock are armed with sharp thorns. The trees are growing at steep angles to the land showing evidence of land slippage which has also exposed many roots causing more suckering. The species is propagated by seed and will eventually overtake the original cultivar planted.
