# Pells Sullivan Meynink

Our Ref: PSM2497-003L

26 June 2014

**RE: PRELIMINARY GEOTECHNICAL ADVICE FOR PLANNING AND REZONING  
PURPOSES, RECLAIMED AREAS OF PEAT ISLAND AND FORESHORE**

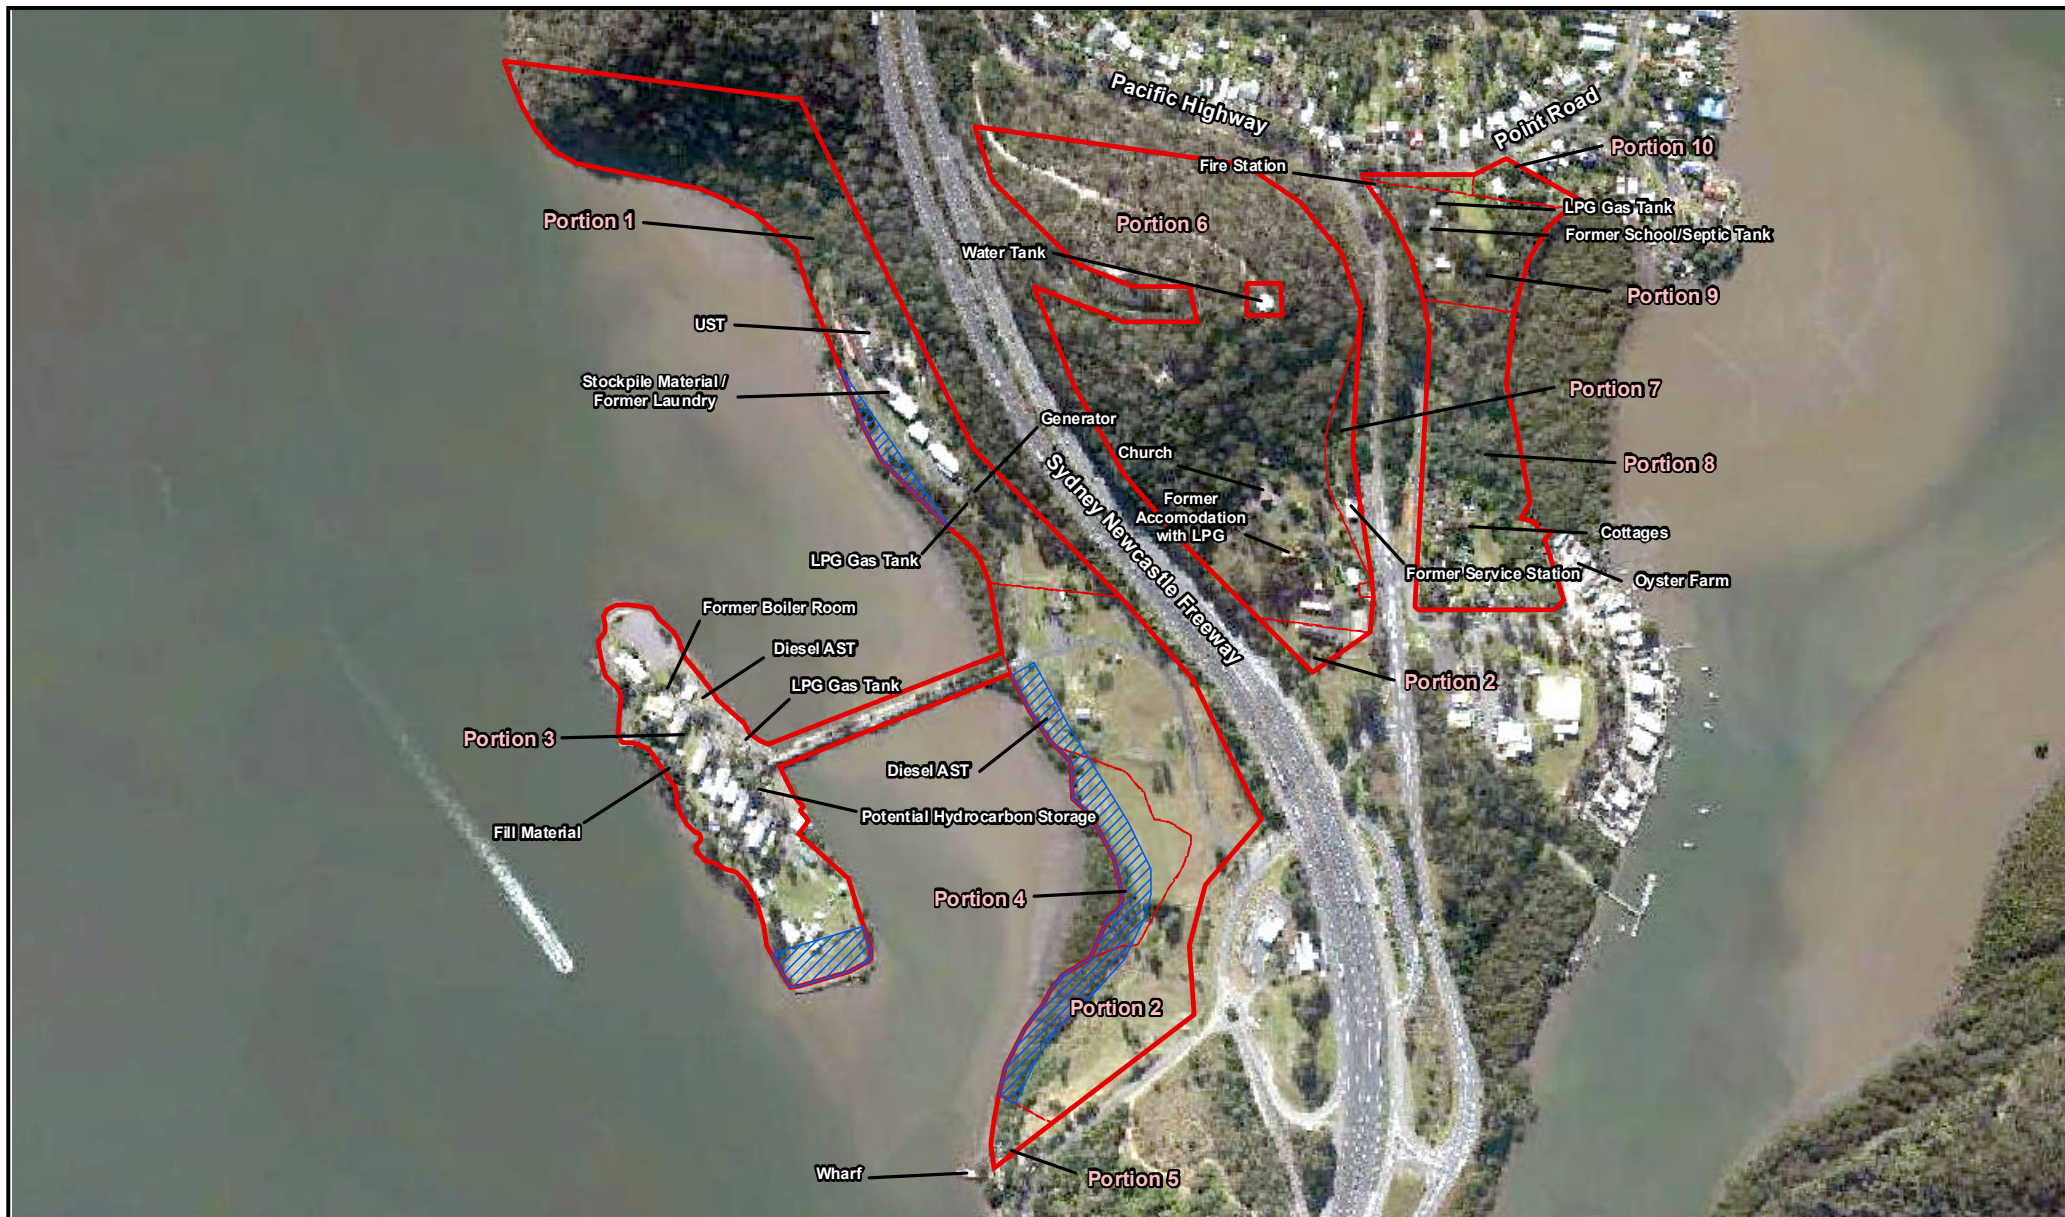
**Figure 3: Site Details**

The areas hatched in light blue on the JBS Figure 3: Site Details, Job No: 42532 attached to this letter have been assessed as comprising reclaimed land. The advice in this letter refers to these areas in particular.

At the request of Norelle Jones, PSM has undertaken a desktop study and site visit of Peat Island for the purpose of preliminary geotechnical advice for rezoning purposes of the area of Peat Island and the foreshore identified as comprising reclaimed land on Drawing No CMP03, Rev 4, dated 2 June 2014
