Report on  
Conceptual Remediation Action Plan

Proposed Rezoning  
Lot 1 Military Road, Port Kembla

REV 1  
Project 78564.01  
September 2016

PHASE II - ENVIRONMENTAL  
SITE ASSESSMENT - FORMER  
PORT KEMBLA PRIMARY SCHOOL

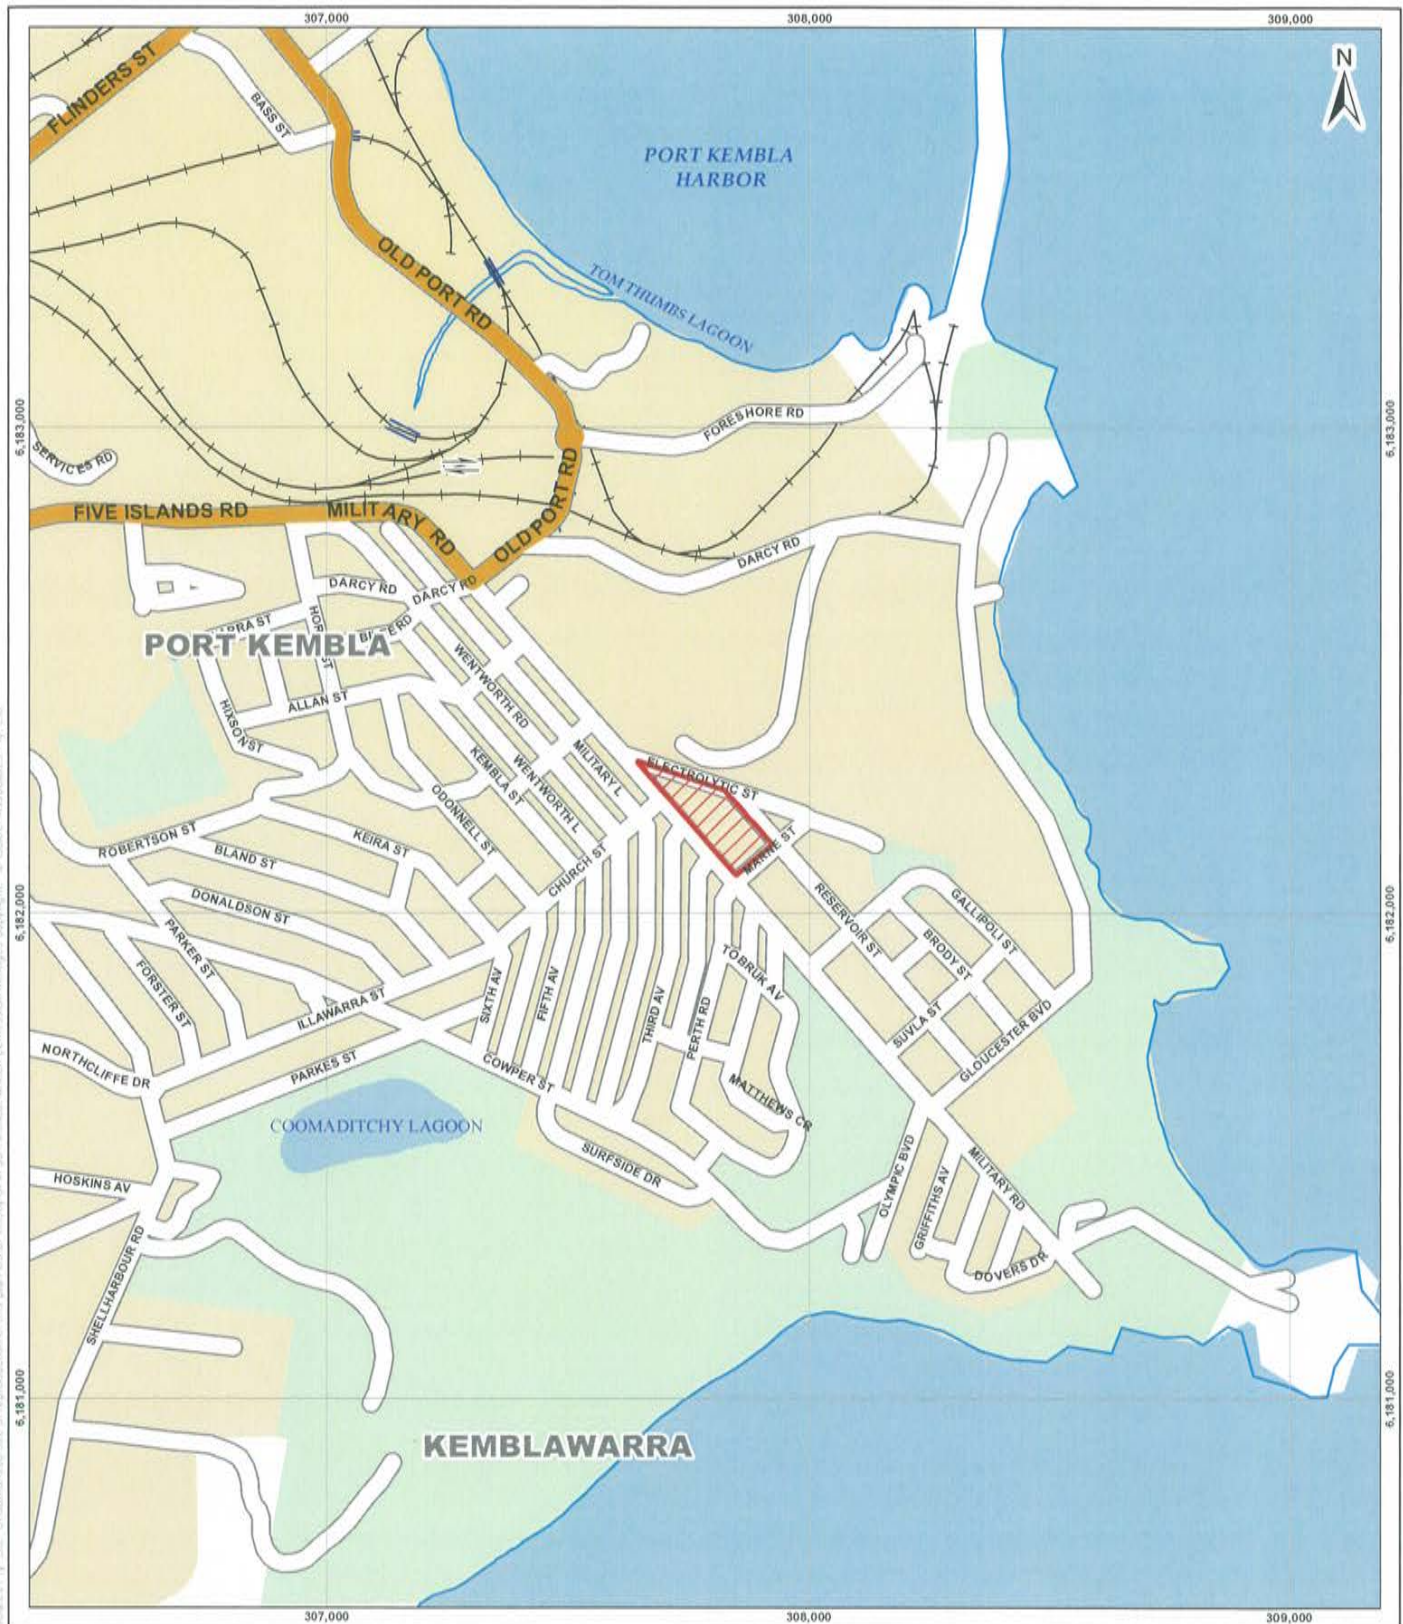
FIGURE 1

The site location is shown on the Golder (2013) Figures, Appendix B. Table 1 presents a summary of the site identification details.

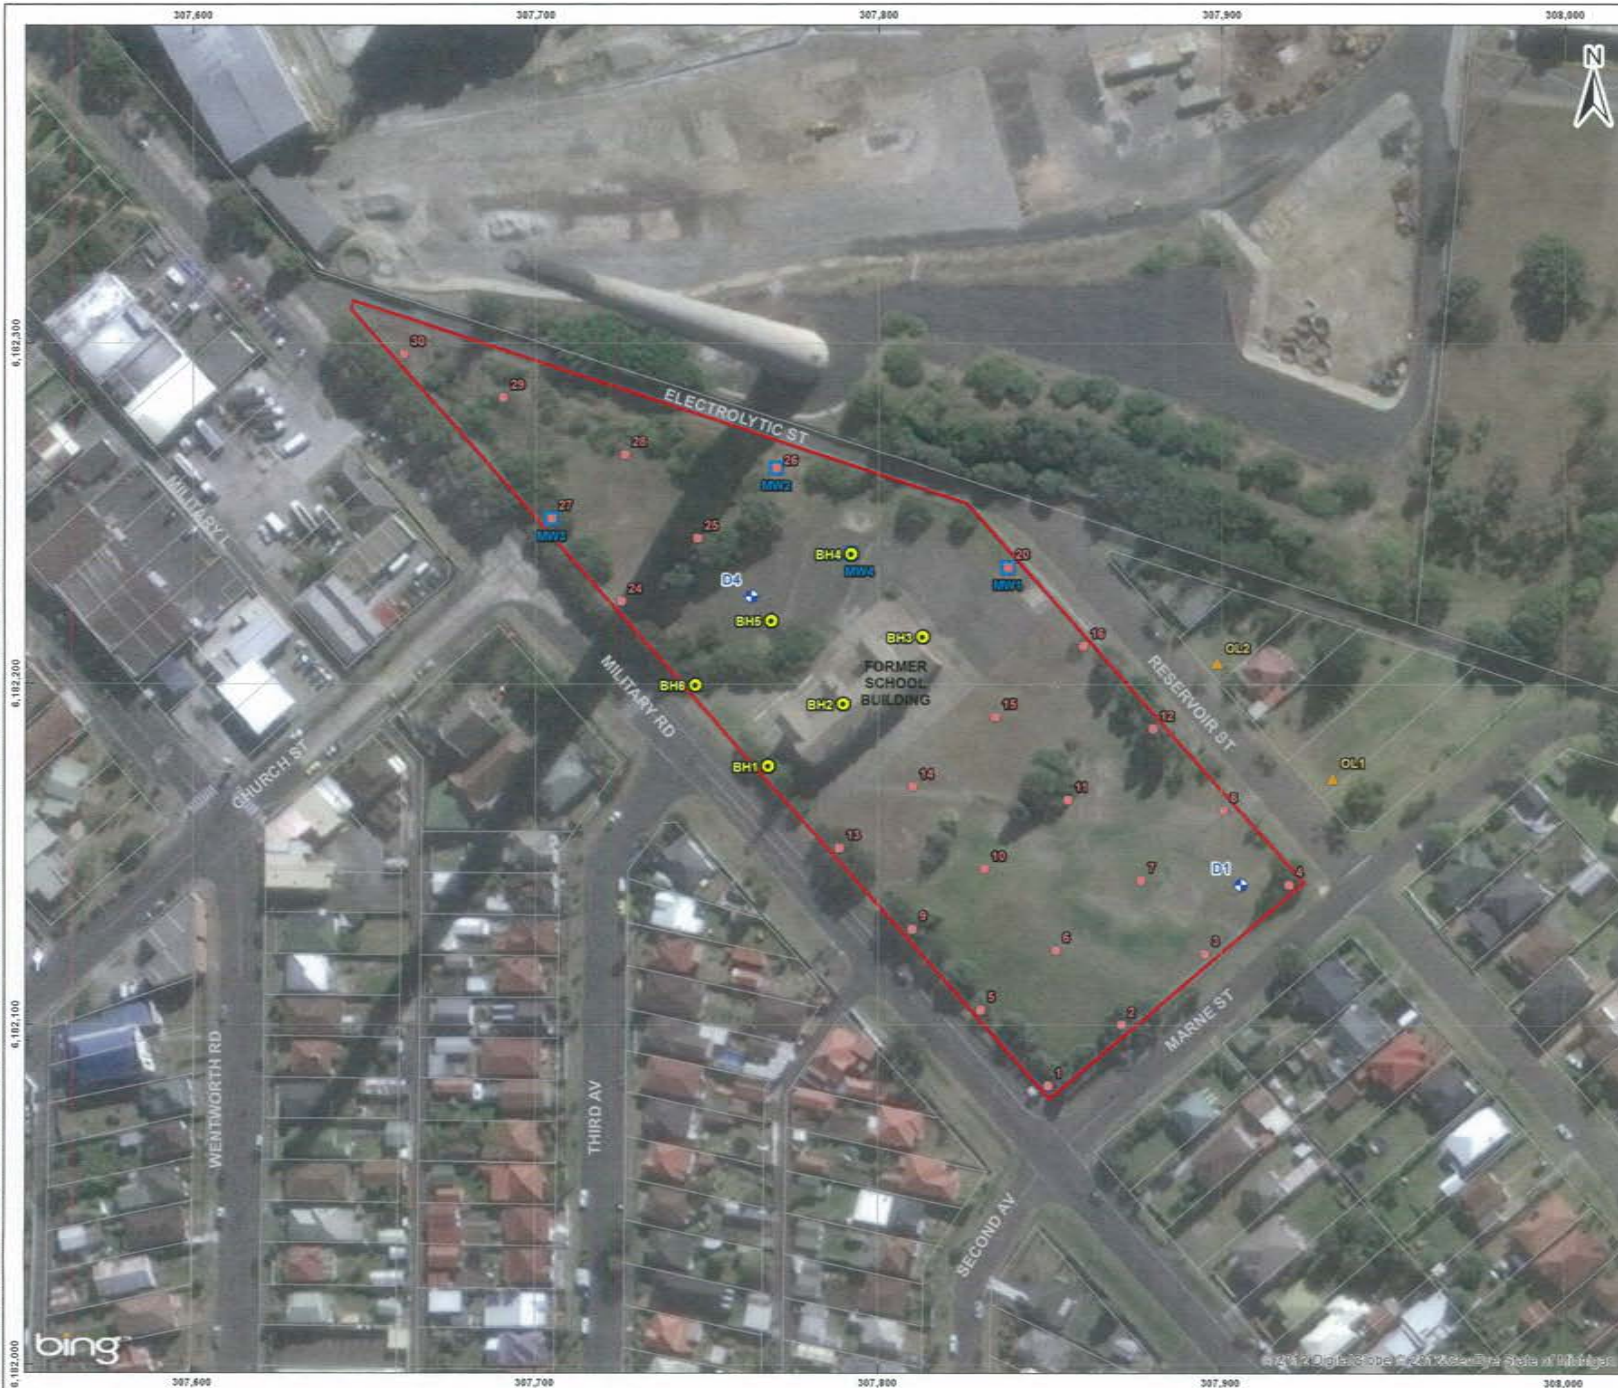
FIGURE 2

boreholes, which were located on an approximate 30 m grid across the site (Golder Figure 2, Appendix B). Soil samples were collected from the test pits and boreholes at surface, 0.5 m below ground level (bgl), 1 m bgl, at every metre thereafter and/or at signs of contamination. Four shallow monitoring wells were installed, either converted from a borehole (BH4 converted into MW4) or installed near the locations where water seepages had been observed in the test pits. Following installation all newly installed shallow groundwater monitoring wells were dry and were not sampled. Two pre-existing deep groundwater monitoring wells were sampled as part of Golder (2103).

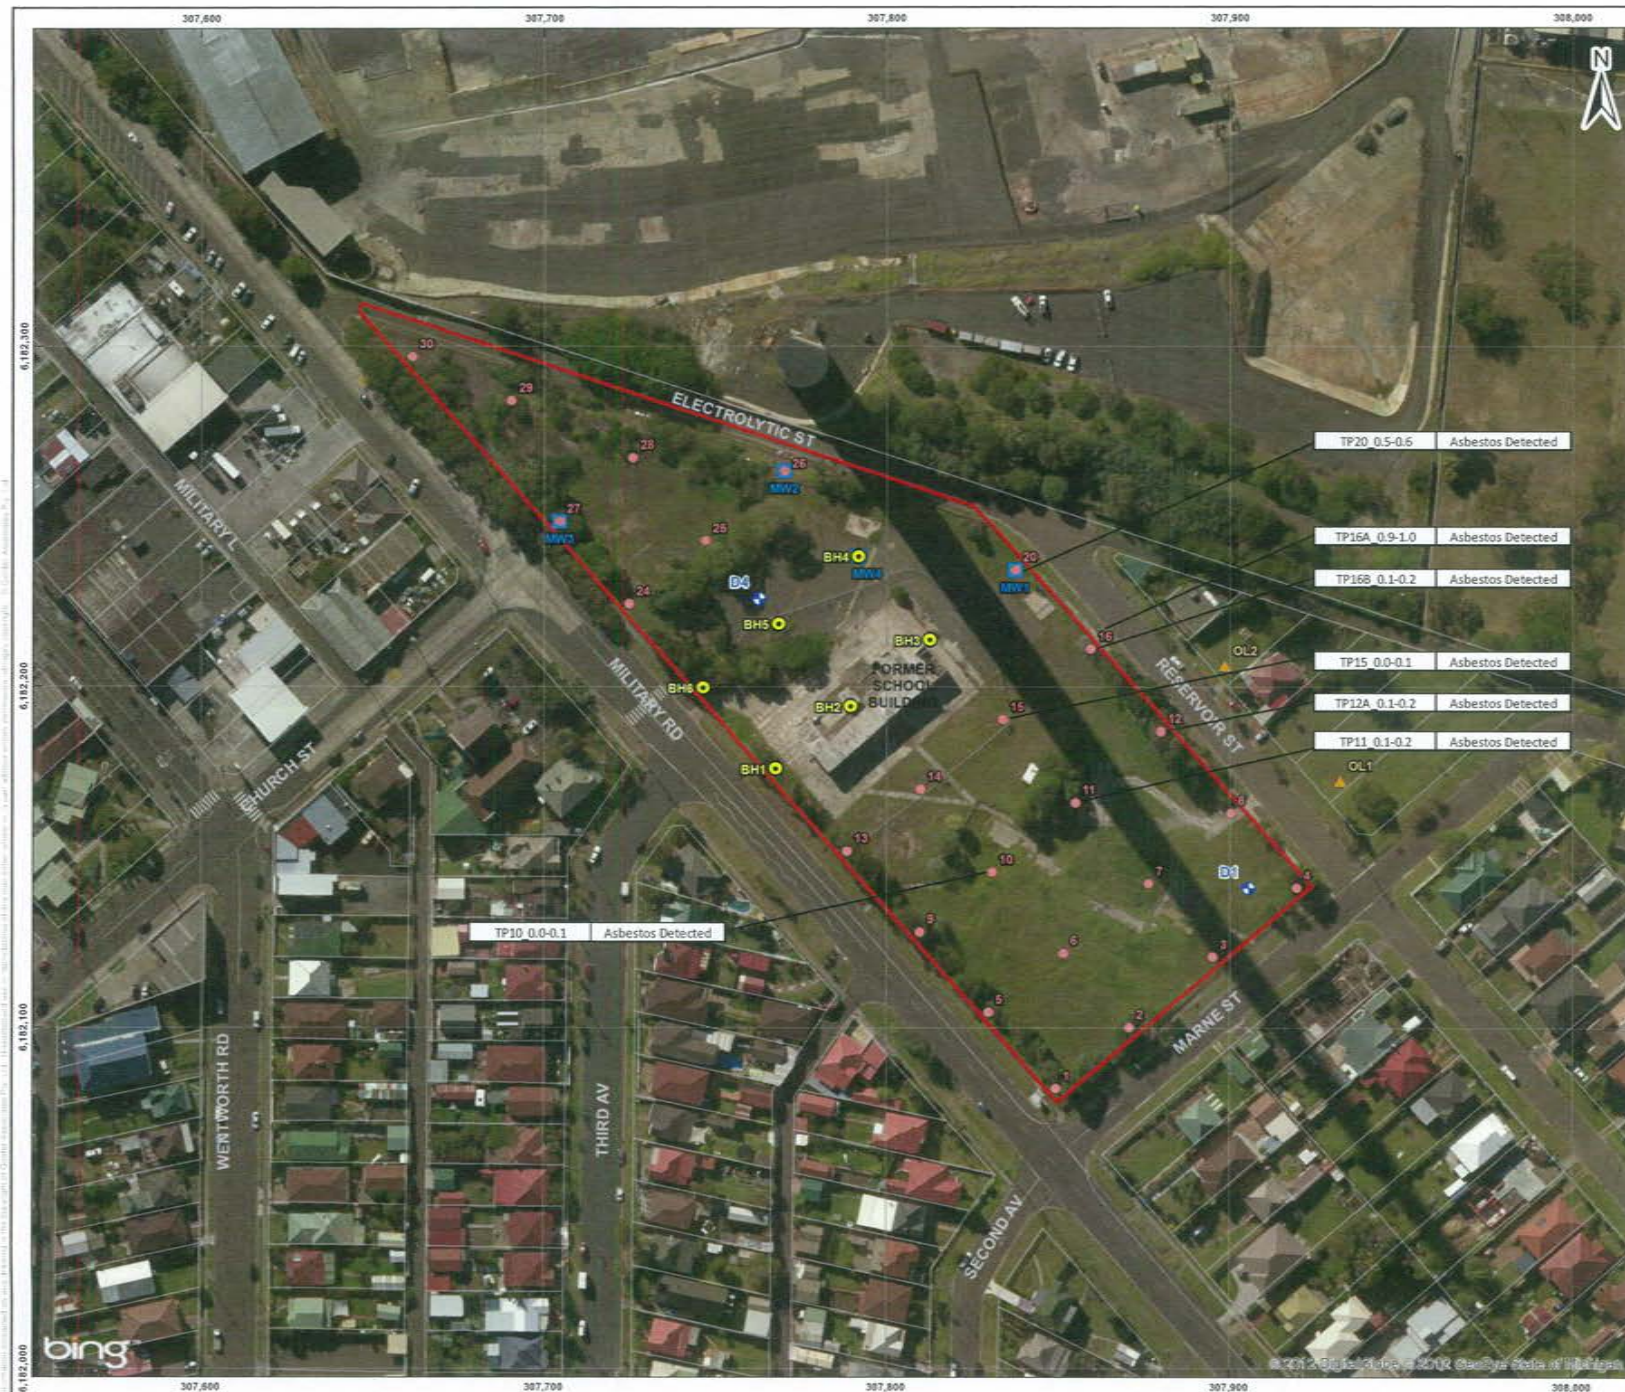
## PHASE II - ENVIRONMENTAL SITE ASSESSMENT - FORMER PORT KEMBLA PRIMARY SCHOOL

The area of concern associated to the Golder (2013) investigation locations are shown on Golder (2013) Figures 2 and 3 provided in Appendix B.
