# PRELIMINARY SITE INVESTIGATION REPORT

PROJECT: 13L Narromine Road Dubbo, NSW and Jannali Road,

CLIENT: Bathla Group

**REPORT NO: NE1295**

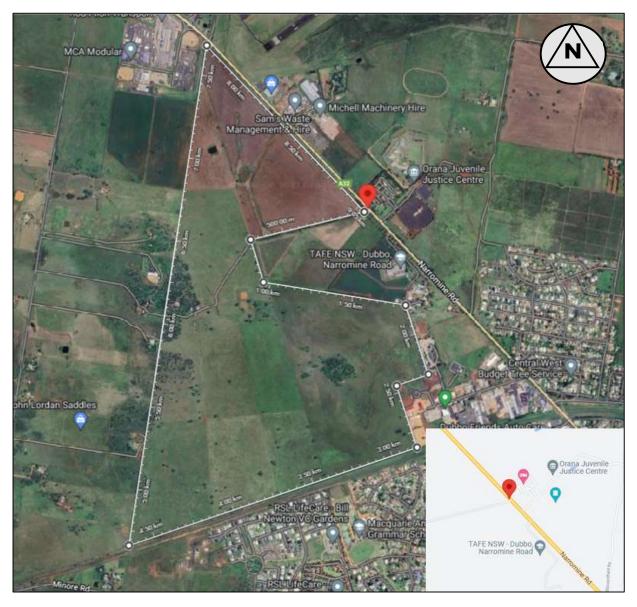
Figure 1. Site Location Plan

The site under investigation is situated at 13L (i.e., Lot 22 DP1038924) and Lot 7 DP223428 Narromine Rd, Dubbo NSW 2830 on the western side of Narromine Road and is approximately 400 km (by road) northwest of Sydney CBD. The site is irregular in shape and has a total area of 271,9 ha. The site is located within The Dubbo Regional Council. The site identification detail is presented in Table 1. The site location is also shown in Figure 1.

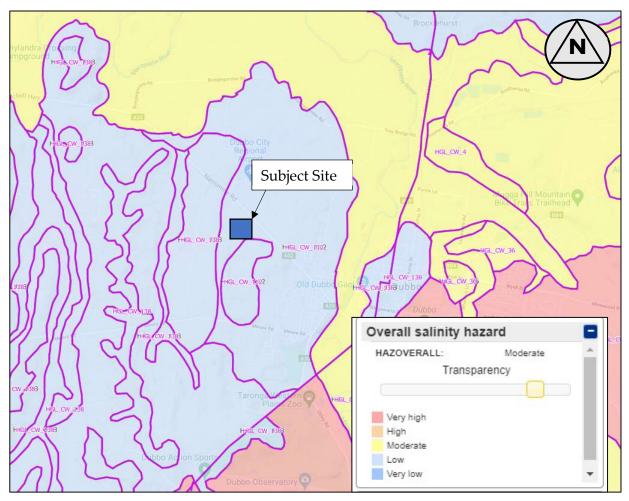
Figure 2. Salinity Potential Map

The eSPADE web app found at <a href="https://www.environment.nsw.gov.au/eSpade2WebApp">https://www.environment.nsw.gov.au/eSpade2WebApp</a> indicated that the site is in an area of low salinity potential (see Figure 2).

- ✓ Vegetation growth appeared healthy throughout the site.
- ✓ No water marks or salt crystals observed on the ground surface

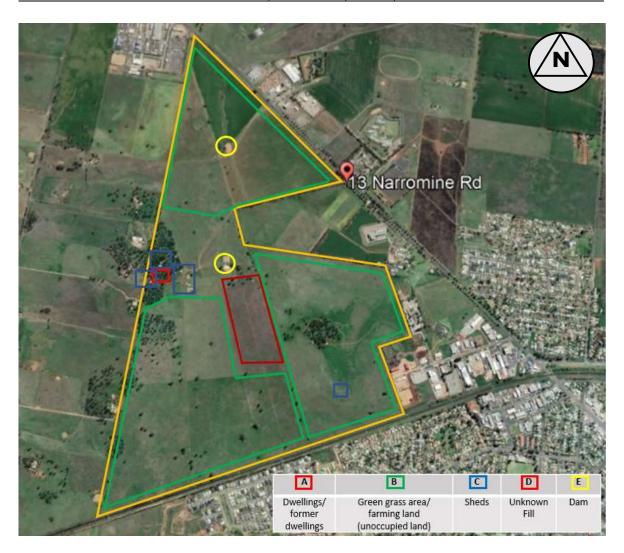
**Figure 3: Areas of Environmental Concerns**

AEC	Potential for Contamination	COPC	Contamination Likelihood
A – Areas of Dwellings/Sheds	Heavy metals may have been used underneath dwellings. Sheds or areas surrounding sheds may have been used as fuel storage, oil or drums of unknown content; asbestos sheeting, may include lead-based paints.	HM, OCP/OPP and Asbestos	Medium
B – Stockpiles and Site fillings	Contaminants from old vehicles or equipment, old generators, fuels and chemicals, rusted metal, wood, rubble material and general refuse may have spilled, leaked or been distributed onto underlying soil.	HM, TRH, PAH, BTEX and OCP/OPP	Medium
C – Areas of light agricultural/garden farm cropping	Heavy metals and pesticides used for light agricultural activities may pose potential risk of contamination	HM, TRH and OCP/OPP	Low
D – Fuel Storage	Mobile oil tanks, onsite fuel pumping stations and combustible fuel liquid storage containers may pose potential risk of contamination into soil via leakage.	HM, TRH, PAH and BTEX	Medium to High

- Areas of dwellings/sheds may currently (of have previously) stored fuel, oils, pesticides, zinc treated (galvanised) metals and/or lead based paints.
- Contaminants from the contents of the stockpiles, fuel barrels, oil storage tanks
  and heavy vehicles may have leaked, spilled or been distributed onto the
  underlying soil.
- Areas of possible cropping/farming activity may have introduced heavy metals or pesticides to the soil.
- Areas near mobile oil tanks and fuel storage tanks may have heavy metal, fuel and chemical contaminants leaked or spilled into the underlying soil.

To address identified AECs, intrusive soil/water sampling regime is recommended to determine what, if any, remediation is required to render the site fit for residential use. A soil sampling plan is to be developed based on a judgemental or systematic sampling pattern and risk-based assessment.

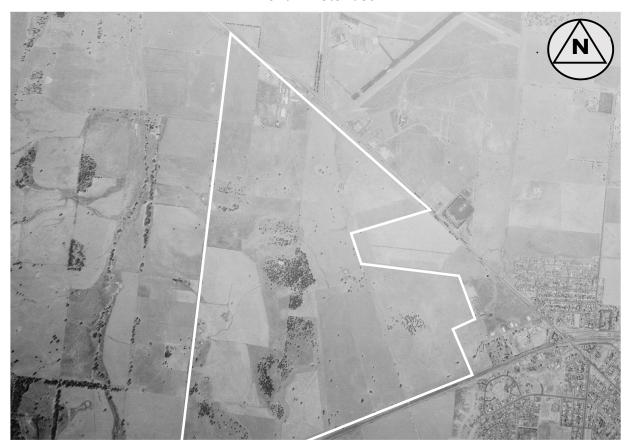
**Aerial Photo 1991**

The aerial photographs indicate that the site has been used for livestock/agricultural purposes. The site consists of a single-story house with multiple sheds that were noted to contain straw/hay bales, fuel barrels, chemicals, combustible liquid, generators and equipment, and storage of vehicles.
