Headfort House
95 Stanhope Road, Killara
Heritage Significance Assessment

Report prepared for Stockland

May 2017

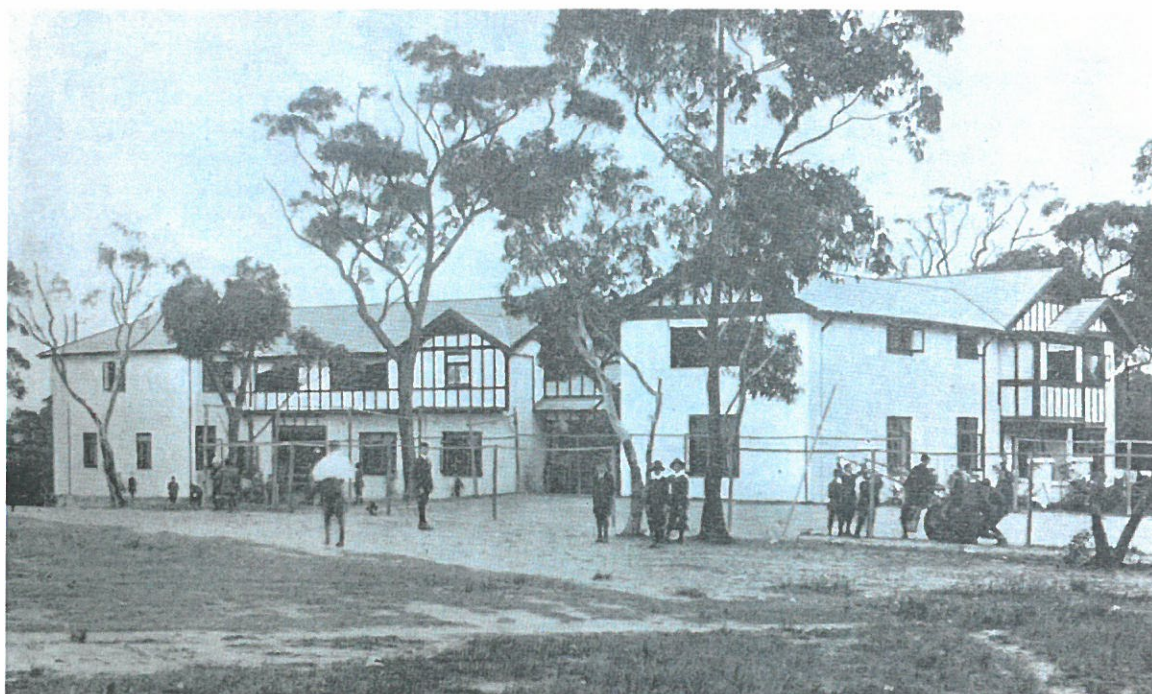
Figure 2.8 Photograph of Headfort School, taken in c1921. Headfort House is on the right. The building on the left has since been demolished. (Source: *The Headfort Chronicle: The Magazine of Headfort School, Killara*, p 3)

The school continued to grow with steadily increasing attendance.²² A photograph of the school taken in 1921 shows two connected two-storey buildings (one of these being Headfort House) with students in the surrounding gardens and a tennis court to the east of the school buildings (Figure 2.8). During the early 1920s, work was undertaken to improve sporting facilities including enlarging the tennis court, installing a cricket pitch and practice area, and construction of swimming pool.²³ In 1922, the students of Headfort School successfully raised funds for the construction of a mini rifle range and they were applauded for their initiative (Figure 2.9).²⁴ A newspaper article in January 1921 described the Headfort School as follows:

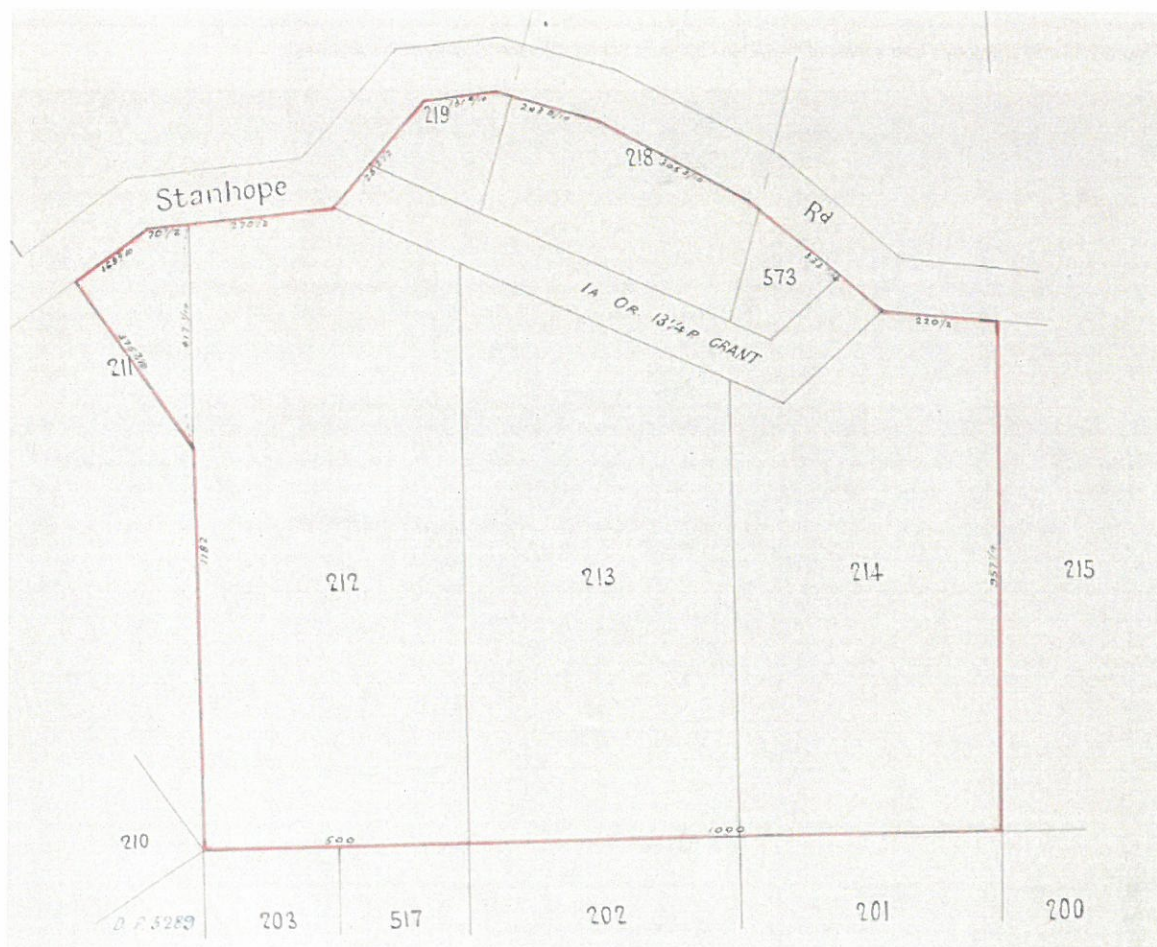
Figure 2.12 1934 plan of Congregational Union of NSW landholdings at Stanhope Road, Killara. (Source: CT 4664-126, LPI NSW)

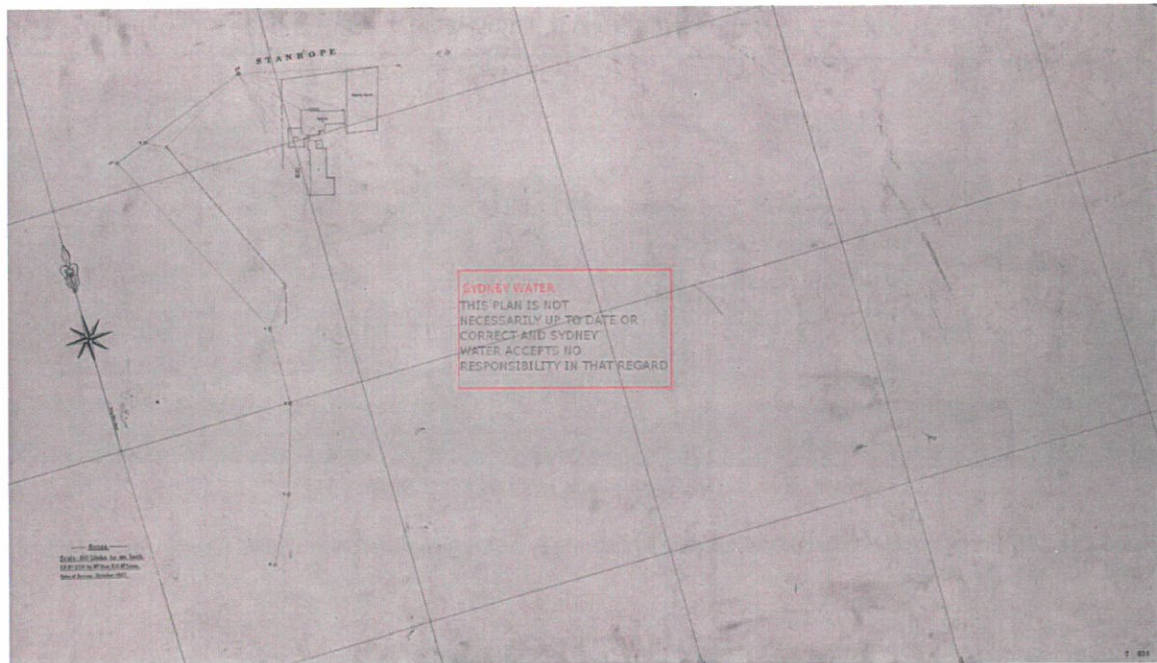
Figure 2.13 1927 Sydney Water survey of the Milton Grammar School. (Source: Sydney Water Archives)

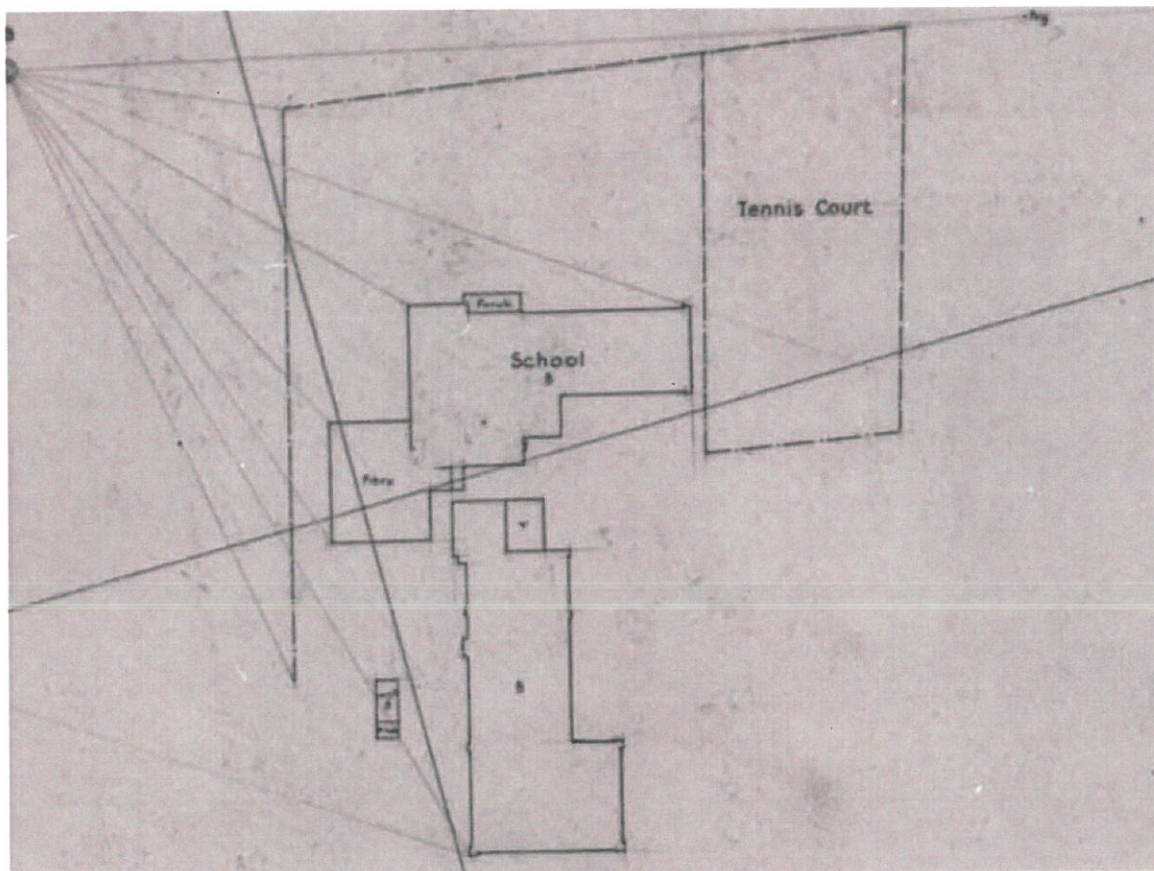
Figure 2.14 Detail of the 1927 Sydney Water survey of the Milton Grammar School. (Source: Sydney Water Archives)

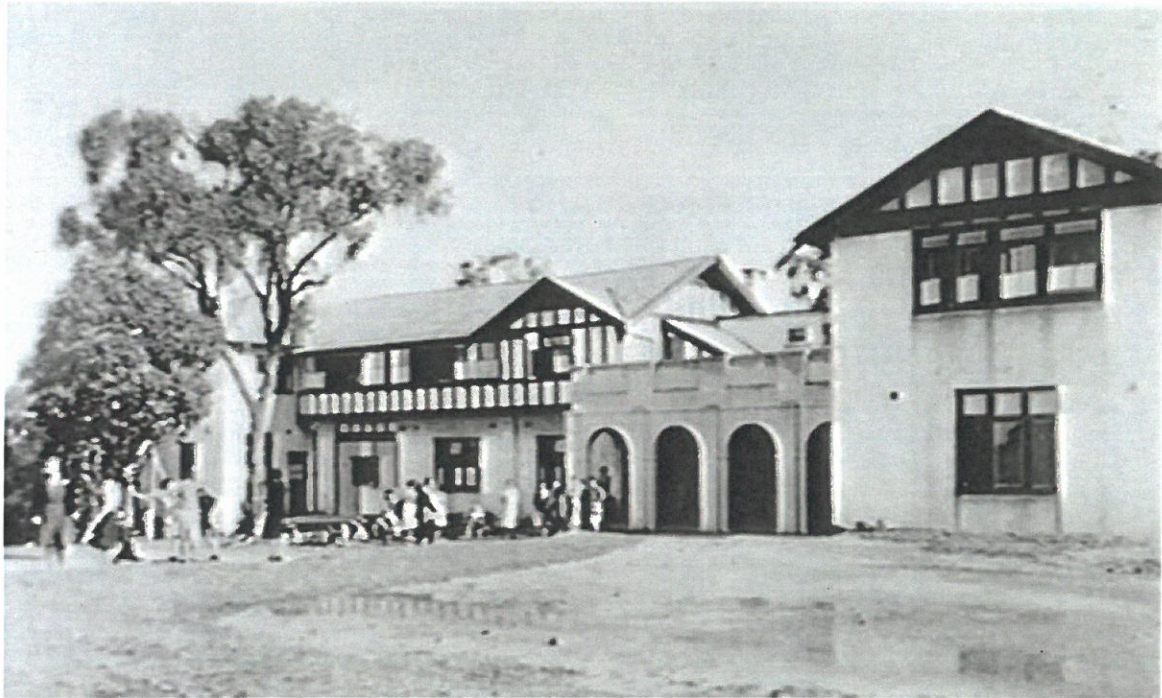
Figure 2.19 1942 view of the former school buildings, here being used by the Australian Women's Army Service. The east elevation of Headfort House is on the left. The arched structure was constructed in 1928. (Source: Australian War Memorial, viewed 22 February 2017 <<http://www.awm.gov.au/collection/P01343001>>)

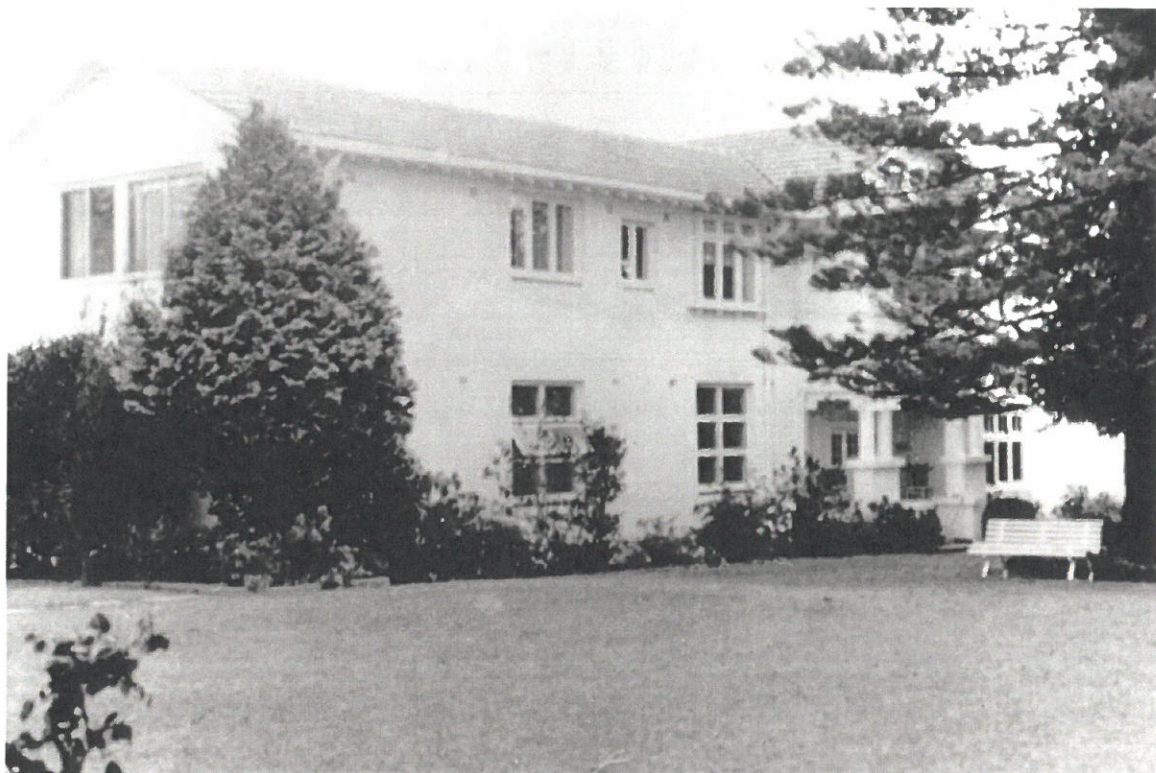
Figure 2.23 Headfort House c1950s, published in Cook, KM 1991, *The Railway Came to Ku-ring-gai*, Genlin Investments, Pymble. Note that the original windows in the chapel wing have been replaced. (Source: Ku-ring-gai Historical Society photographic collection)

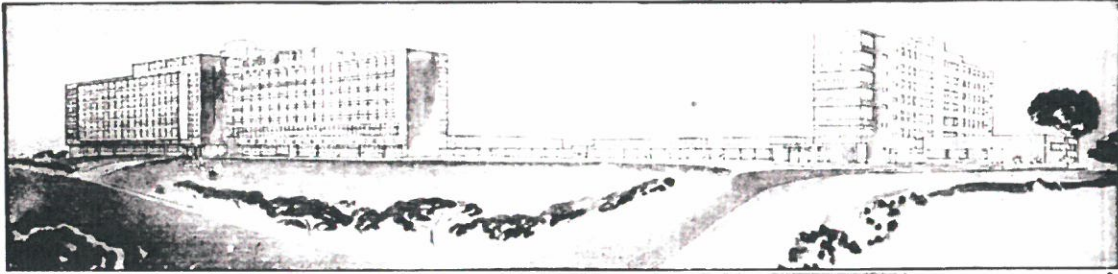
Figure 2.25 Published drawing of the proposed 250-bed hospital (not realised). (Source: *Catholic Weekly*, 12 October 1950)

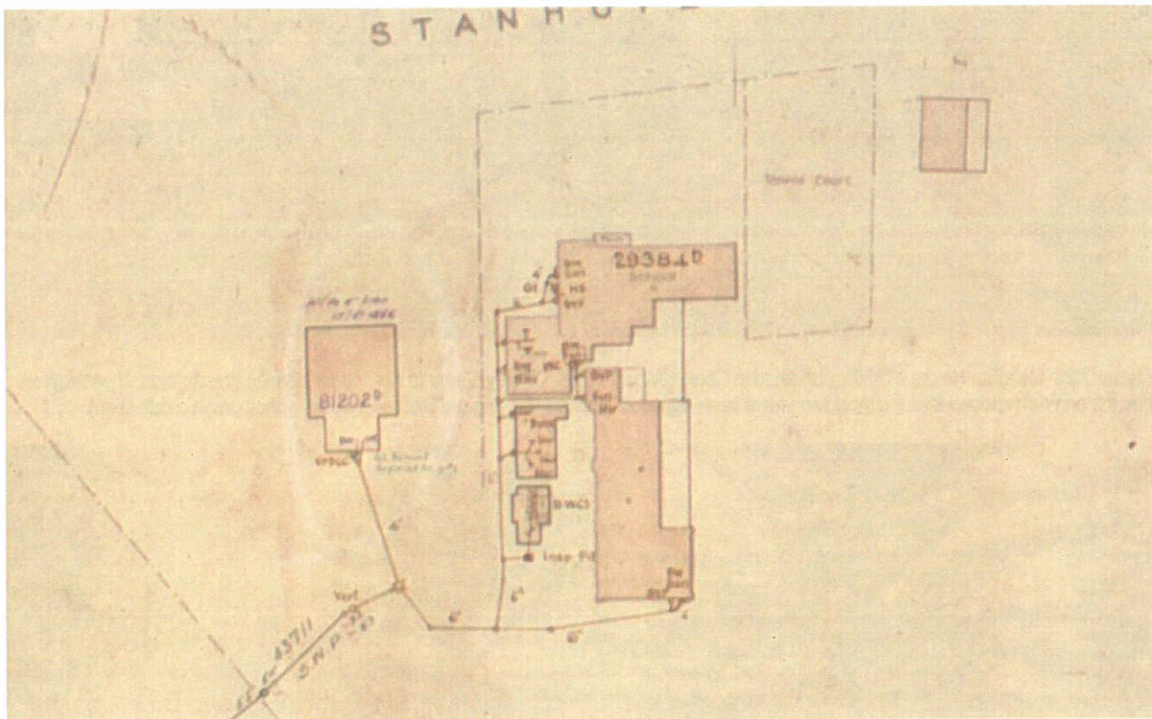
Figure 2.26 The Blackwattle Plan of the subject site, dating between 1927–c1953. (Source: Sydney Water Archives)

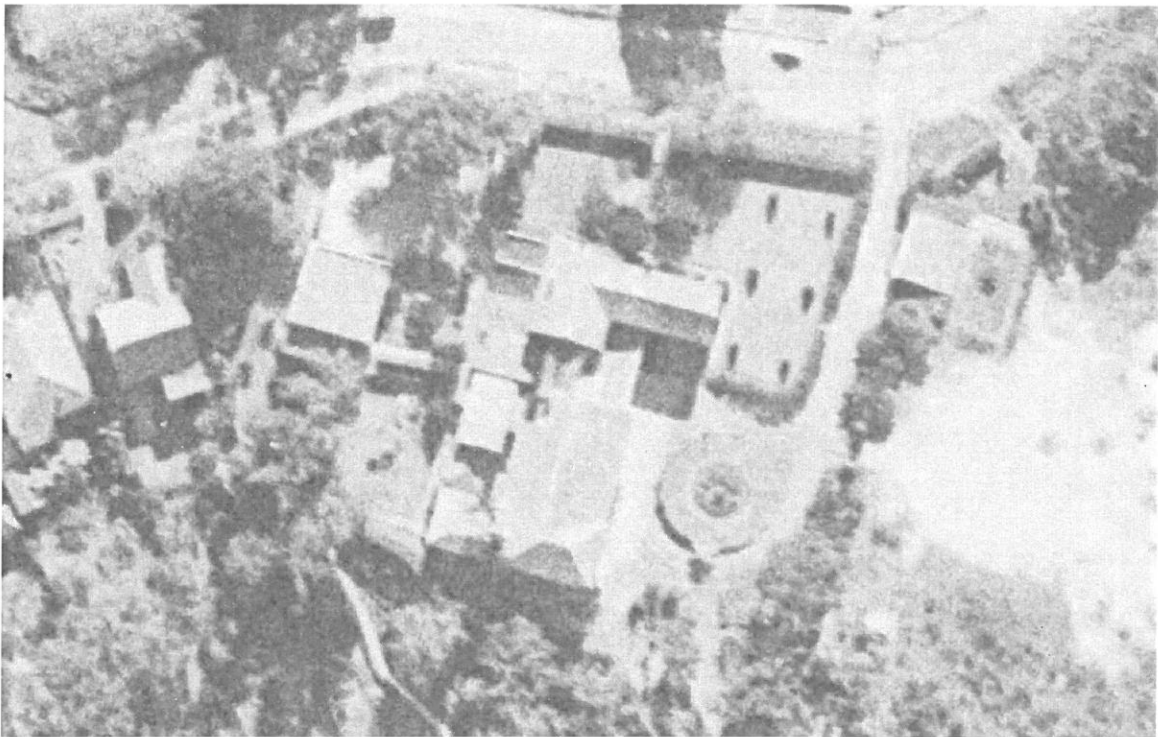
Figure 2.27 1956 aerial of the subject site showing buildings and immediate gardens, including established gardens on the tennis court, grotto and garage, of the Lourdes Hospital. (Source: LPI NSW)

shows the same buildings as the 1943 aerial of the study area with an additional building in the location of the WC (Figure 2.26). The 1956 aerial photograph shows the tennis court had become part of the gardens and a grotto had been constructed to the east of the hospital building. There was also an extension between the smaller buildings to the west of the main hospital/former school buildings (Figure 2.27).

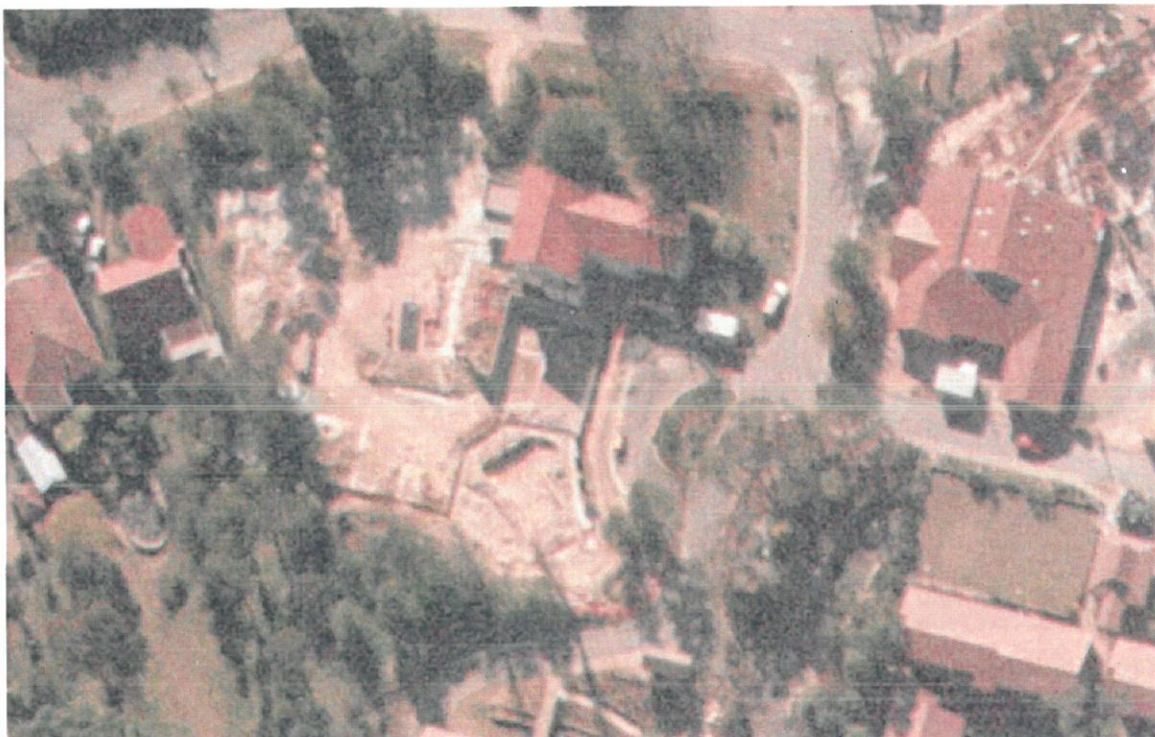
Figure 2.30 Detail of subject site on 1986 aerial showing one of the former school buildings already demolished and the footings of the new administration building. (Source: LPI NSW)

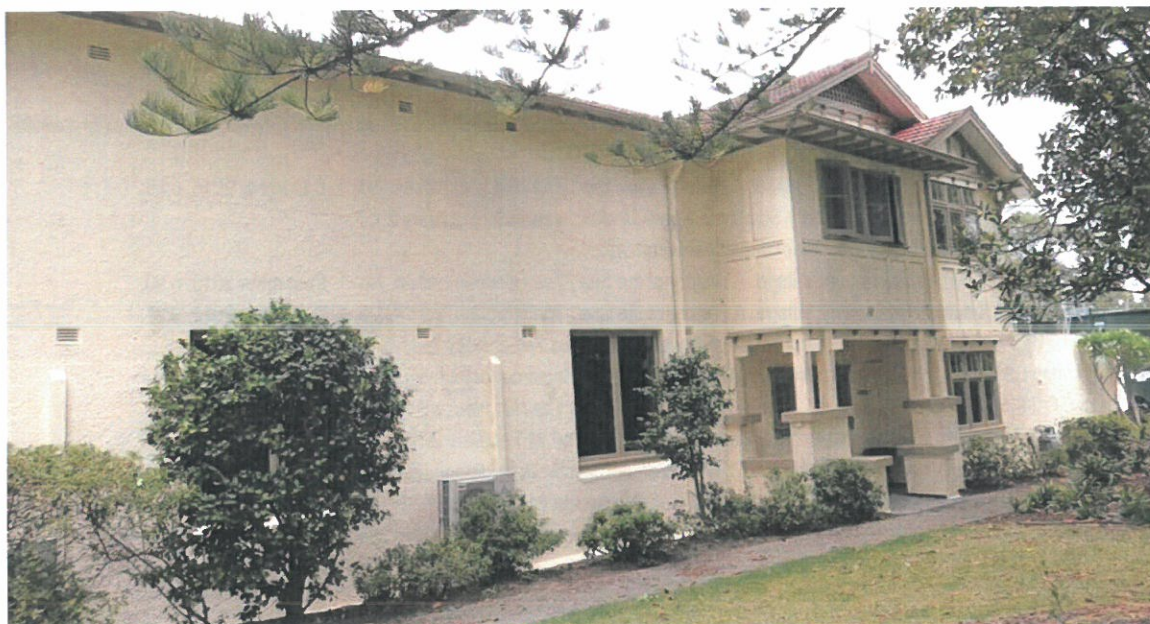
Figure 3.1 The north (front) elevation of Headfort House at 95 Stanhope Road, Killara (facing Stanhope Road), in its garden setting.
(Source: GML 2017)

The front of Headfort House addresses Stanhope Road (although the main entrance to the Chapel is on the southern side of the building) (Figure 3.1). The front of the building is parallel to the roadway, and a rectangular front yard—with perimeters defined by garden beds containing hedge plants—separates the building from Stanhope Road (Figure 3.2). The front yard consists primarily of open lawns. Three mature trees are located within the front lawn area—two large Norfolk Island pine trees and a Moreton Bay fig tree, the latter surrounded by a roughly circular garden. Other planting consists of small shrubs and ground covers, generally exotic species. The extent and form of the front garden—areas of flat lawns surrounded by hedges with some planting interspersed—largely matches the 1943 aerial photograph. However, the front garden currently extends further to the east than it did in 1943, when its eastern boundary roughly aligned with the eastern wall of Headfort House. Photographs dating from the late 1920s and 1930s show the front garden's northern and western perimeters further defined by timber post and rail fences with wire mesh infill; these fences no longer exist. On its eastern side was a fenced open area, possibly a tennis court.

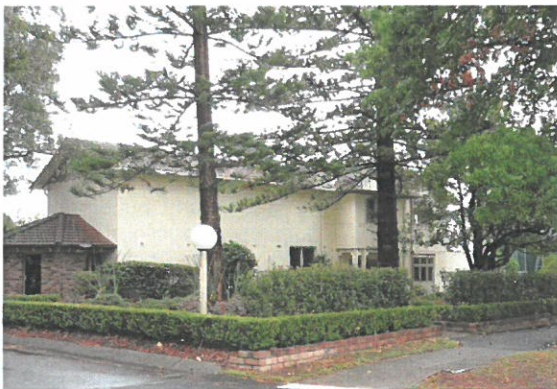
Figure 3.2 View of Headfort House from the northeast. The hedges around its front garden and large trees within the garden can be seen. (Source: GML 2017)

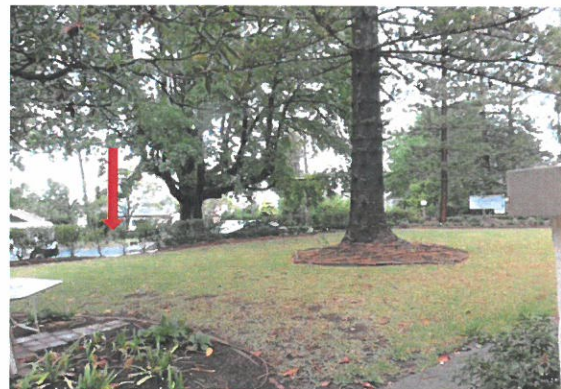
Figure 3.3 View across the front garden looking towards Stanhope Road. The gap in the garden edging at the property boundary (marked with an arrow) is likely the location of the original gateway to the property. (Source: GML 2017)

Historic photographs also show a meandering paved path through the garden leading from Stanhope Road to the front door of the building, with a branch of the path curving around to the western side of the building. Whereas this path no longer exists, a break in the (1980s?) brick garden edging on the Stanhope Road boundary is evidence of where the path was once started (the hedge plants are continuous across the gap) (Figure 3.3). The double-leaf timber joinery gates that marked the start of the path and the public entrance to the garden, as shown in a photograph from the 1930s, no longer exist. Although the three trees within the front yard are mature, only one of the pine trees appears to possibly exist in an aerial photograph dating from 1943. None of these trees appear in the 1927 photograph of the front of the building.

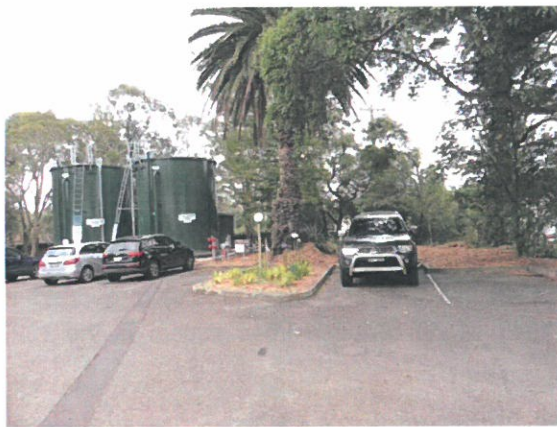
Figure 3.4 The carpark located to the west of Headfort House. (Source: GML 2017)

A driveway and small bitumen-paved carpark is located to the immediate west of the front garden and Headfort House. The carpark is bitumen paved with concrete kerb edging, possibly built c1980 (Figure 3.4). A curved concrete driveway leads to the carpark from Stanhope Road. The driveway has garden surrounds that are edged with narrow sandstone blocks (nominally 80mm thick). Dense vegetation—

mature trees and shrubs—largely screens the carpark from view from Stanhope Road to the west. Two large metal water tanks are located between the carpark and the western boundary of the site (Figure 3.4). It is not possible to tell if the driveway exists in the 1943 aerial photograph, but there was a cleared open area (possibly paved) in the location of the current carpark. To the south was located a detached building with flat or mono-pitched roof with lean-to structure on its southern side, possibly a verandah. This building no longer remains.

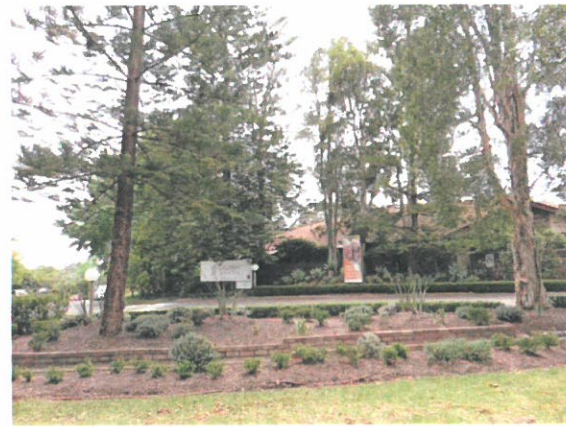
Figure 3.5 The main entrance to the LRV, as seen from the front yard of Headfort House. (Source: GML 2017)

The main entrance (vehicular and pedestrian) to the LRV from Stanhope Road is to the east of Headfort House and its front garden, where a roadway extends from Stanhope Road to a drop-off bay near the southeastern corner of Headfort House (Figure 3.5). A concrete footpath runs parallel to the roadway, through the front garden of Headfort House. Both driveway and path are most likely contemporary with the LRV complex (1980s).

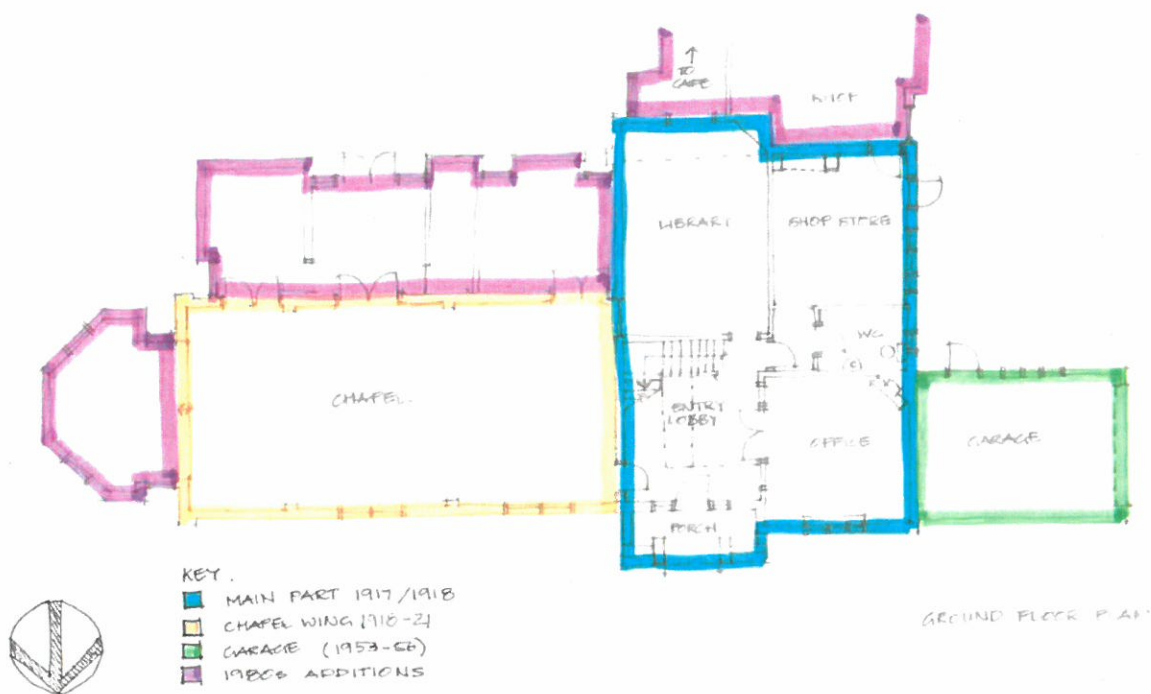
Figure 3.6 Sketch of the existing ground floor plan of Headfort House, coloured to show the construction periods of various components. (Source: GML)

External walls of Headfort House are generally masonry with painted stucco finish. The main roofs are pitched with red glazed terracotta tiles and painted metal eaves gutters. The architecture of the main part of the building is of the Arts and Crafts style, but the chapel wing is more austere externally, with little architectural decoration and a simplicity of form. The single storey portions of the building (garage and ancillary rooms to the chapel on its south and east sides) date from the mid to late twentieth century. Figures 3.6 and 3.7 show the current floor plans of the building, coloured to express the different construction periods of the various parts of the building.

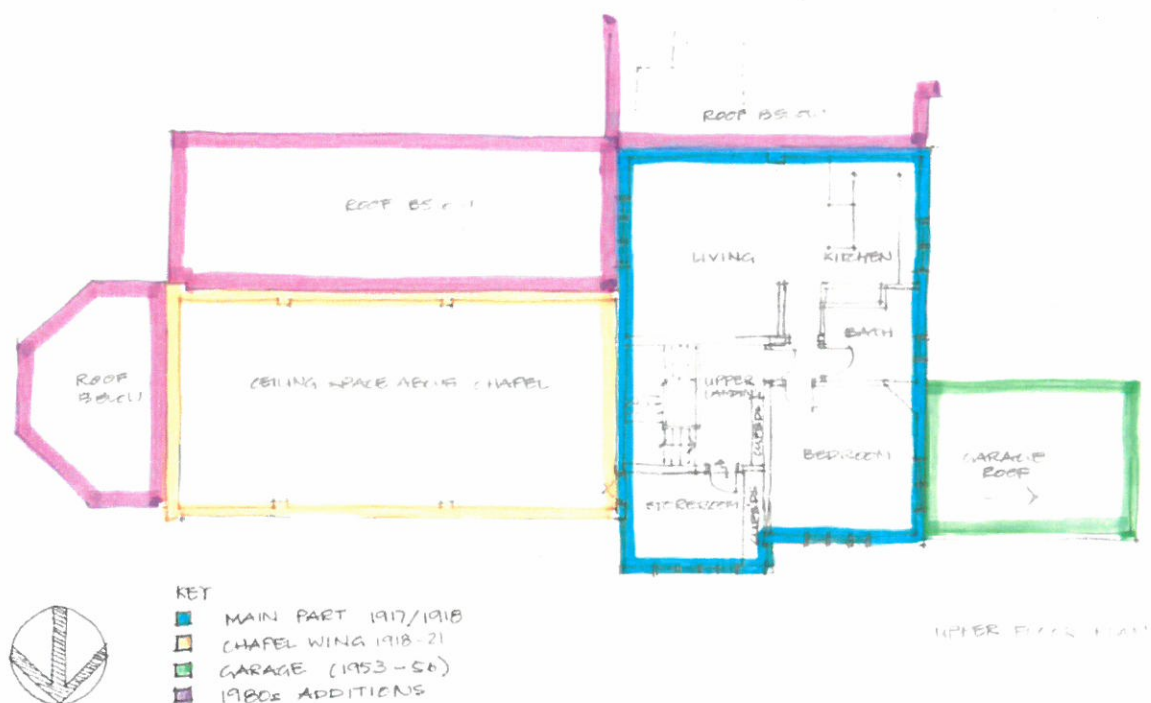
Figure 3.7 Sketch of the existing upper floor plan of Headfort House, coloured to show the construction periods of various components. (Source: GML)

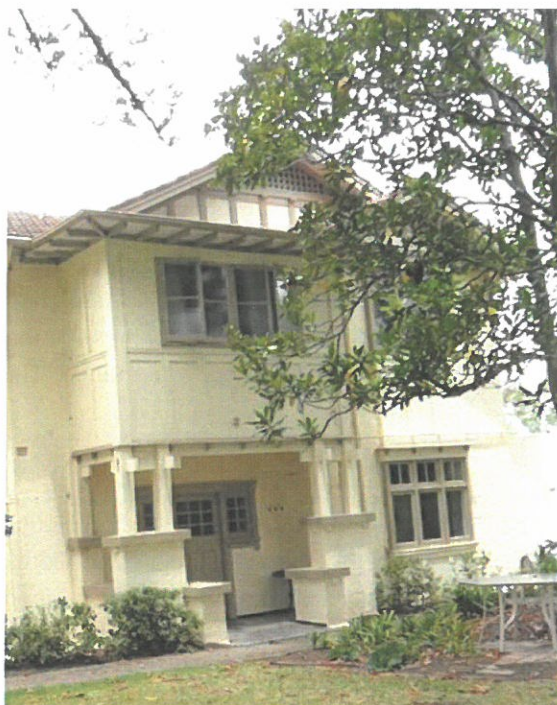
Figure 3.8 The north (front) elevation of the main part of Headfort House at 95 Stanhope Road, Killara (facing Stanhope Road), in its garden setting. (Source: GML 2017)

The north elevation of the main part of the building faces Stanhope Road (Figure 3.8). It has a double roof gable and features an entry porch which provides access to the building's original front door. The external walls are primarily masonry with painted stucco finish, although framed wall panels are a feature of the north elevation. These wall panels—the walls below the windows (ground and first floors)—are framed with fibrous cement sheet cladding, paint finished to match the stuccoed walls (Figure 3.9). The framed walls feature expressed vertical timber battens, which are also used on the building's gables. Although the timber battens are currently painted to match the walls, early photographs show that the expressed timber elements and window frames were originally painted or stained to be dark coloured, to contrast with the light coloured broad walls. Similar detailing is used on the gables on the north elevation. The two timber framed windows within the framed wall panel on the north elevation match those in early photographs, and are most likely original.

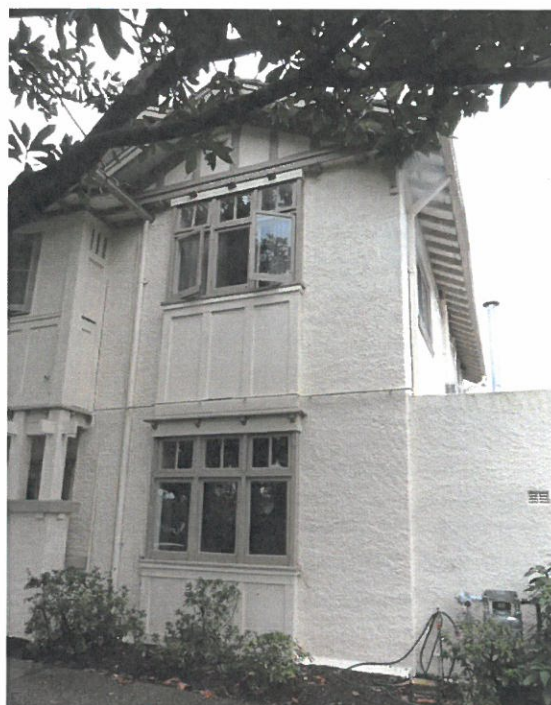
Figure 3.9 The framed wall panels below the windows on the north (front) elevation of Headfort House. (Source: GML 2017)

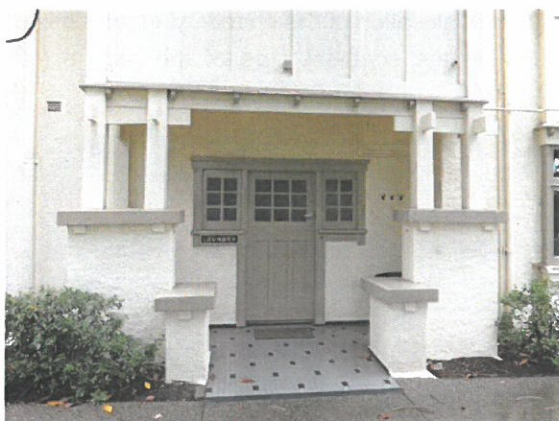
Figure 3.10 The entry porch and front door. (Source: GML 2017)

The recessed entry porch (north elevation) has two half-height stuccoed masonry piers with smooth rendered pediments and twin timber columns above (Figure 3.10). Faux projecting timber beams decorate the tops of the timber columns. The detailing of the entry porch matches the detailing visible in a 1920s photograph of the building. The soffit is timber boarded and painted, and is most likely original, although the surface mounted fluorescent light fitting is not. The floor has a slight fall away from the door, and is finished with (contemporary) tiles which extend beyond the masonry piers. It is likely that the floor of the porch has been adjusted to be slightly ramped in order to remove the step at the edge of the porch which can be seen in the c1930 photograph. There is a timber electrical box mounted high on the wall of the porch.

The front door is a high-waisted timber joinery door, with obscure glazing to its upper portion, divided into nine equal panes (Figure 3.10). Side-lights exist on both sides of the door, each with six equal panes. The door and sidelights appear to be original. The door and sidelights feature obscure patterned glass, a single type used throughout. The door has a contemporary stainless steel lever and lock.

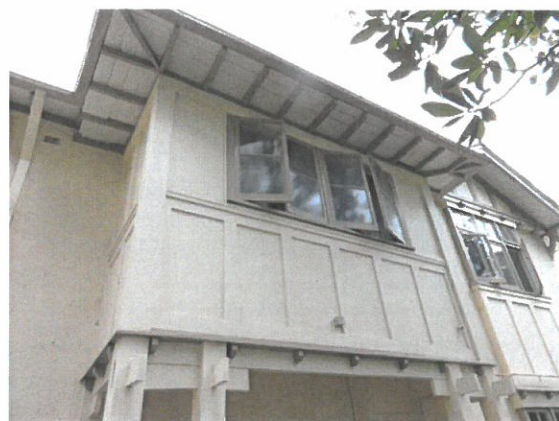
Figure 3.11 The verandah above the entry porch. The windows are a later addition. (Source: GML 2017)

Directly over the entry porch is a projecting framed structure that was originally built as a semi-recessed verandah, but which has now been enclosed (Figure 3.11). Walls are framed and clad with fibrous cement sheet to about one metre in height and feature expressed vertical timber battens, these being the original balustrades around the verandah. Above the balustrade level the original opening on the northern wall has been infilled with timber framed windows with casement sashes. There is a flat roof over the former verandah, with wide projecting eaves that are timber boarded with expressed timber rafters. The verandah structure remains substantially as originally built, except for the insertion of the timber framed window.

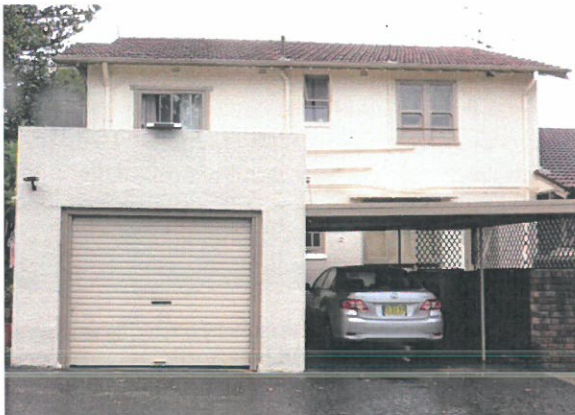
Figure 3.12 The west elevation of Headfort House. (Source: GML 2017)

The west elevation was designed as a secondary elevation, and is not as detailed as the north elevation (Figure 3.12). Masonry walls are stucco and paint finished. Eaves are timber boarded and raking with expressed timber rafters, matching those on the other elevations. The sandstone foundations are also visible on the western elevation.

There are three upper floor windows. The window near the northern corner—aluminium framed with sliding sashes—is a later addition; early photographs show no windows in this location. The central window is an awning window, which is most likely a replacement for an original window in the same

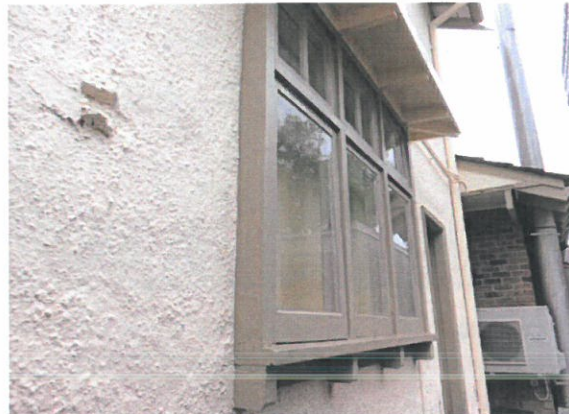
Figure 3.13 Detail of the large timber framed window, west elevation. (Source: GML 2017)

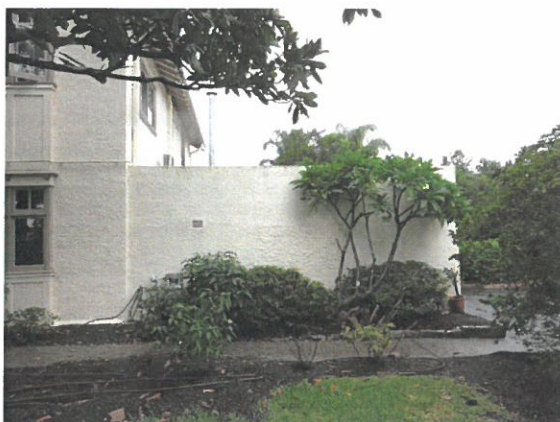
The garage is a single-storey masonry structure attached to the western elevation of Headfort House, close to its northern corner. Aerial Photographs and plans indicate that the garage is a later addition to the building, built between 1953 and 1956. The garage's external walls are stucco and paint finished, and extend up to form a parapet on three sides (Figure 3.14). The metal deck roof has a low pitch, and falls to a box gutter adjacent to the western wall. There is a metal roller door (contemporary) on its western elevation, and a single leaf door and window on its southern elevation. The door is a high-waisted timber joinery door with three lower panels, matching the door to the main bedroom; it has most likely been salvaged from elsewhere on the site and reused here (Figure 3.15). The small timber window has three equal casement sashes. It is also possibly salvaged from elsewhere on site: a similar window can be seen in early photographs on the north elevation of the chapel wing (which is no longer in place). There is steel framed carport lean-to on the southern side of the garage (late twentieth century).

Figure 3.14 The north elevation of the garage. (Source: GML 2017)

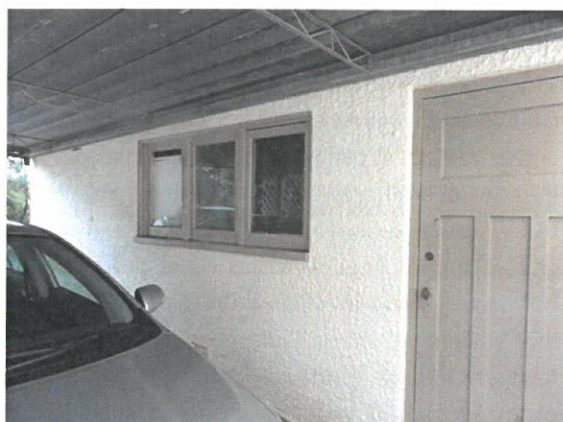
Figure 3.15 The south elevation of the garage, with door and window that are likely to have been salvaged from elsewhere on the site. (Source: GML 2017)

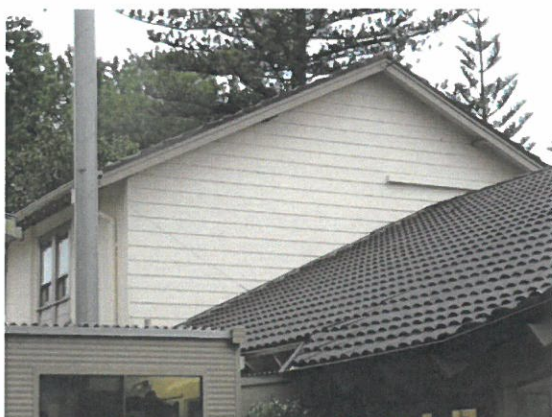
Due to the adjacent 1980s building on the southern side, only the upper wall of the south elevation is visible. This part of the wall is clad in fibrous cement planks. Eaves are sheet lined. There alterations are recent, and relate to the construction of the 1980s building. No original detailing is visible (Figures 3.16, 3.17).

Figure 3.16 The boarded gable is the only part of the south elevation of the main part of the building that is visible. The brown tiled roof in the foreground is part of the 1980s building. (Source: GML 2017)

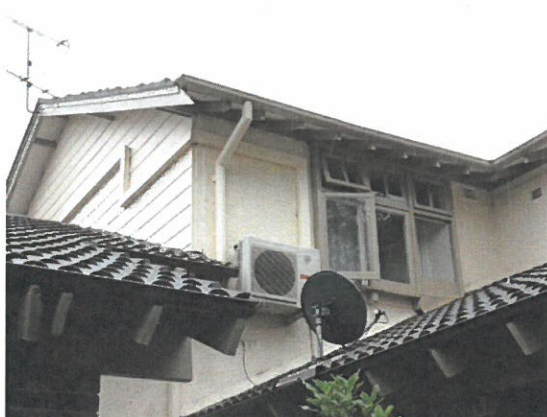
Only a small portion of the east elevation is visible, that being the upper floor external wall above the 1980s single storey additions to the Chapel wing. This wall is stucco and paint finished. The one window in this wall—timber framed, with three lower casement sashes and three upper awning sashes—matches those windows on the north and west elevations, and is most likely original (Figure 3.17).

Figure 3.17 The original timber window that exists in the upper part of the east elevation of the main part of the building. The boarded gable of the south elevation can be seen on the left. (Source: GML 2017)

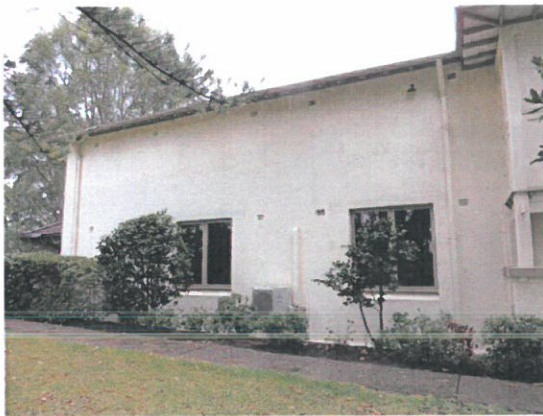
The chapel wing has masonry external walls with painted stucco finish, built on sandstone footings (visible on the north elevation). The pitched roof is tiled, and eaves are timber boarded with expressed timber rafters. A comparison of the building's current condition with early external photographs indicate that the overall size and form of the wing remains unchanged, although there have been changes to the wing's fenestration. Discontinuities in the stucco finish on the north and east walls indicate that several upper floor windows have been removed and the openings infilled—three windows on the north wall and one window on the east wall. On the north elevation, the two timber framed windows that currently exist on the ground floor have contemporary detailing, and are not original, although the location of these windows approximates the location of original window openings. There are three rows of terracotta wall vents on the north elevation which match those visible in early photographs (Figure 3.18).

Figure 3.18 The north (front) elevation of the chapel wing. 'Shadows' of former window openings can be seen in the stucco finish. (Source: GML 2017)

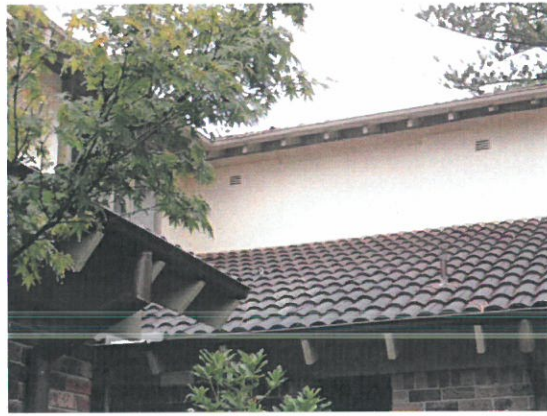
Most of the southern elevation is concealed by 1980s additions (Figure 3.19). However, 'shadows' in the stucco finish indicate upper floor openings that have been infilled. A row of high level wall vents remains, which match those on the northern elevations.

Figure 3.19 The upper part of the wall of the chapel wing can be seen above the 1980s tiled roofs. (Source: GML 2017)

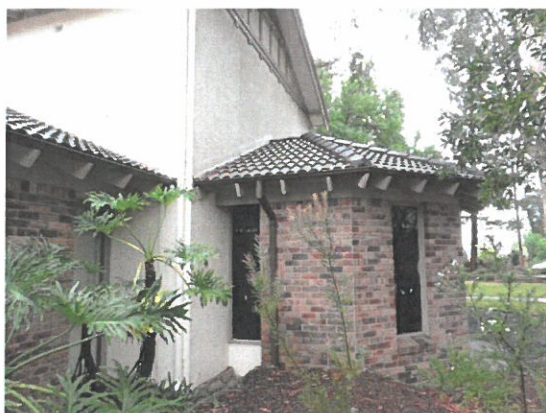
Single storey 'lean-to' additions were constructed in the 1980s on the southern and eastern sides of the Chapel (Figure 3.20). These additions have face brickwork external walls and hipped dark brown glazed tiled roofs with raking eaves with exposed timber rafters, matching the larger 1980s building located on the south side (and connected to) Headfort House.

Figure 3.20: The 1980s addition on the eastern side of the chapel wing. (Source: GML 2017)

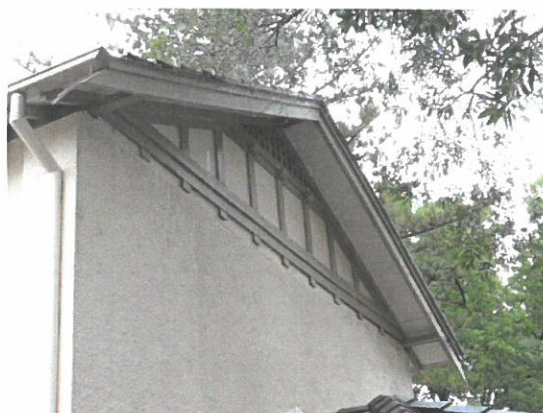
The eastern gable is finished in fibrous cement sheet with exposed timber battens and decorative timber trims. Battens are arranged in a lattice pattern at close to the ridge. This corresponds with the gable detailing that can be seen in early photographs. It also matches the detailing of the main gable on the north elevation (Figure 3.21).

Figure 3.21 The eastern gable of the chapel wing. The shadow in the stucco below shows the location of the window that was originally located in this wall. (Source: GML 2017)

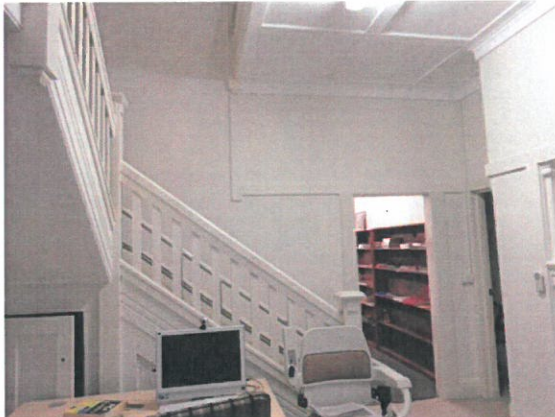
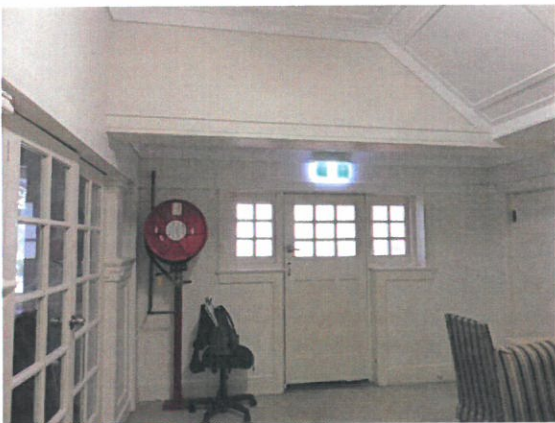
The entry lobby retains its original layout and proportions, and timber detailing is largely intact (Figures 3.22–3.25). Walls are smooth set and painted, and floors framed and carpeted. Skirtings are 150mm high with curved top edge: these are used consistently throughout the building and appear to be original. The ceiling is sheet-lined and battened with profiled plaster cornice. A simple timber batten rail runs around the walls at door-head height. An original window/hatch under the stair has been blocked in, but the recess and timber surrounds remain intact. A small timber joinery door gives access to the storeroom under the stairs.

Figure 3.22 The entry lobby, looking towards the southern wall. (Source: GML 2017)

Figure 3.24 The north wall of the entry lobby, with front door and sidelights. (Source: GML 2017)

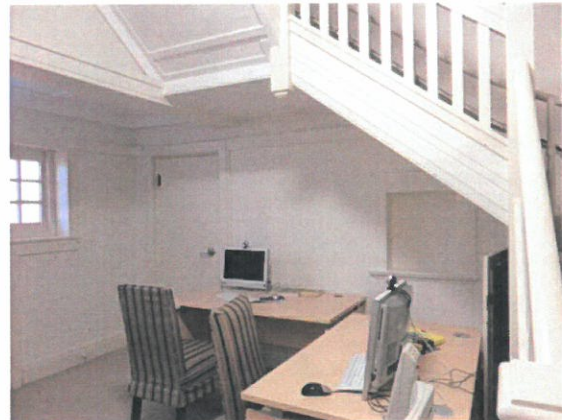
The single leaf door leading to the chapel (timber frame, flush door) is not original (Figure 3.23). The doorway to the office has elaborate built-in joinery at its sides, but the glazed door leafs themselves are not original, and there are signs that indicate that the opening has been adapted to accommodate these door leafs (Figure 3.25). The stair is timber framed with timber newel posts and handrails most likely original. The grooved stair rails appear to be more recent however, and perhaps relate to the installation of the chair lift that runs on the inside face of the balustrade. It is unclear if other parts of the balustrades are also recent replacements for original components.

Figure 3.23 The east wall of the entry lobby, with door to the chapel. (Source: GML 2017)

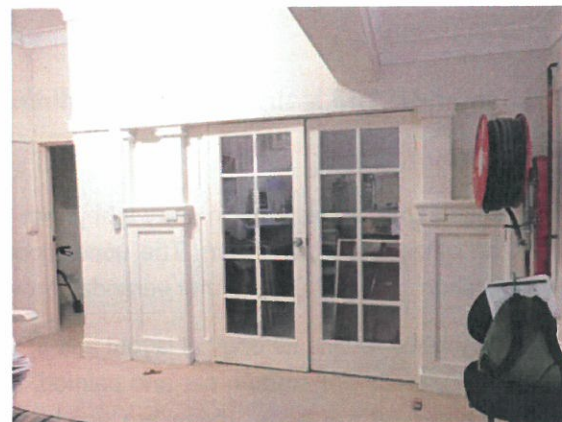
Figure 3.25 The door to the office, as seen from the entry lobby. (Source: GML 2017)

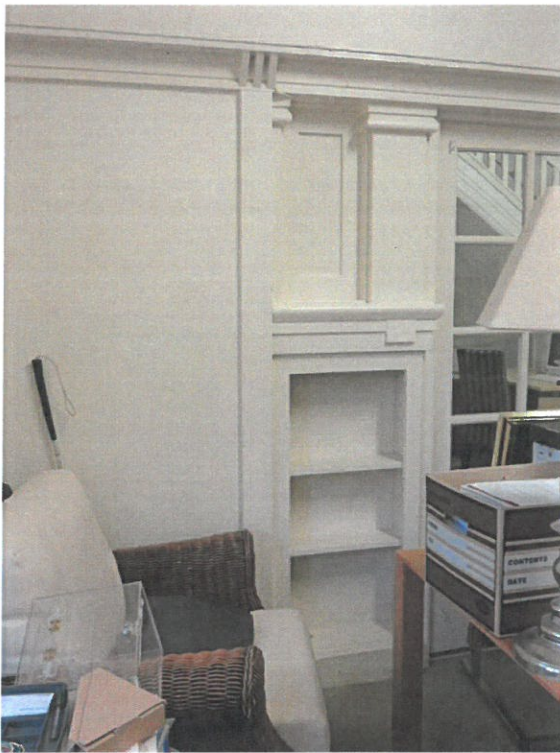
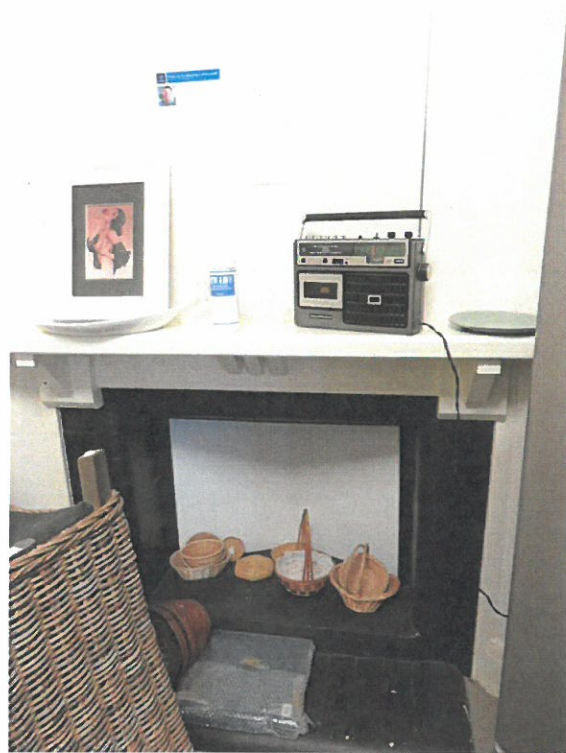
The floor of the office consists of tongue and groove timber boards with carpet finish. The walls and ceiling are smooth set and the room's plaster cornices and timber skirtings match those in the entry hall. A grooved timber rail runs around all walls at door head height. Built-in timber joinery fixtures, consisting of open shelves and other decorative features, frame the door on either side (Figure 3.26). The built-in timber window seat/storage box is a later addition. There is a fireplace in the southwestern corner with painted brick hearth and surrounds, and a timber mantelpiece (Figure 3.27). The style of the timber joinery in the space is consistent with the Arts and Crafts style, although it is unclear if the grooved timber wall rail is original. Two gridded wall grilles are located at high level in the western wall.

Figure 3.26 The timber joinery adjacent to the door of the office. (Source: GML 2017)

Figure 3.27 The fireplace in the office. (Source: GML 2017)
