Headfort House
95 Stanhope Road, Killara
Heritage Significance Assessment

Report prepared for Stockland

May 2017

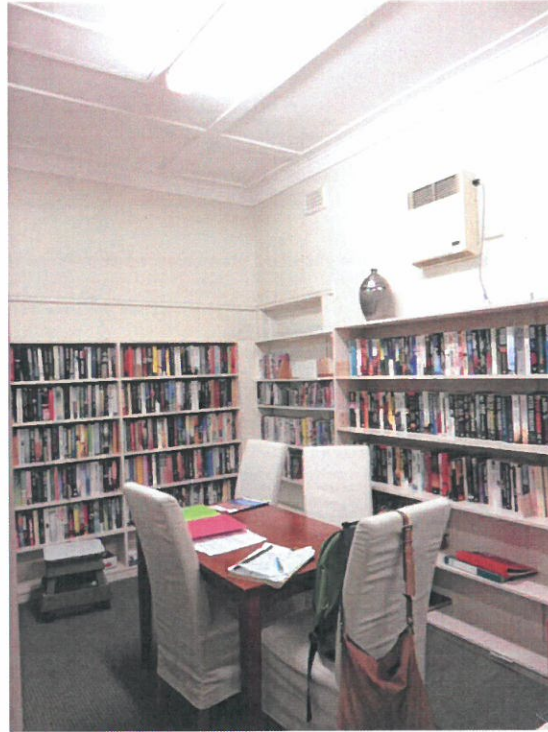
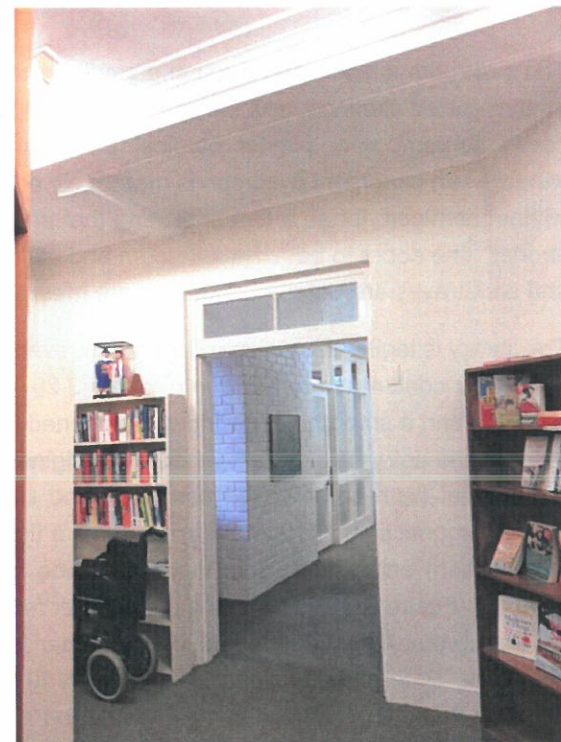
The library is legible as a single large room, even though it is partly subdivided by a glazed screen wall which is a contemporary addition (Figures 3.29–3.31). It has a framed floor with carpet finish, smooth set walls and a smooth set ceiling with battened detail. The room's plaster cornices and ceilings match those in the entry hall and are most likely original. There is a lower section of ceiling adjacent which is not original (with small coved cornices), and its form and finishes are likely to relate to the 1980s building connection. Parts of the room have a timber skirting which matches that in the entry lobby. At the southern end of the room there is a wide opening which allows access into the 1980s building adjacent (Figure 3.31). This has a timber door frame and highlights with obscure glazing, but no doors. On the northern wall is an opening with timber frame leading to the entry lobby, but again there is no door leaf. Both of these doorways are likely to be original. On the eastern wall there is a blocked-in doorway that previously led to the chapel, and it is unclear if this opening is original (Figure 3.29). On the eastern wall at high level are two air grilles that match those in the office, and are original. In the southwestern corner the splayed wall is suggestive of a chimney breast. Bookshelves placed hard against this wall indicate that even if a fireplace remains behind the shelves, no protruding mantelpiece or hearth remains.

Figure 3.29 The library, looking towards the northeastern corner. The former doorway to the chapel can be seen behind the bookshelves. (Source: GML 2017)

Figure 3.31 The doorway in the southern wall that leads to the 1980s building. (Source: GML 2017)

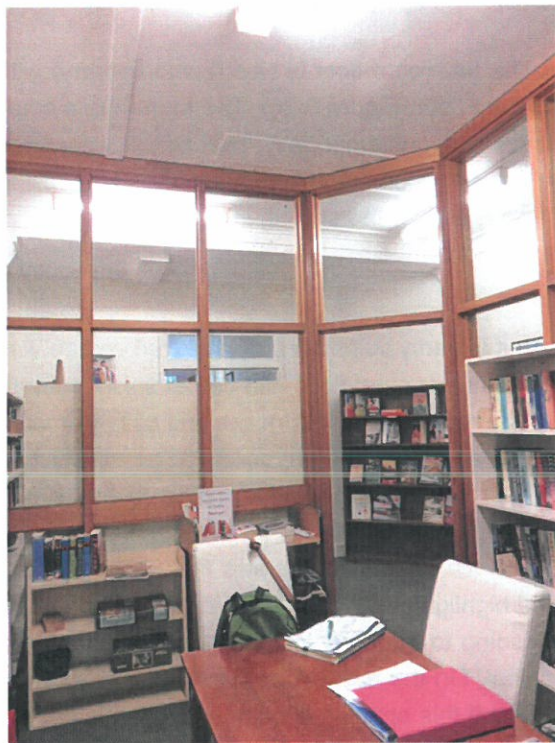
Figure 3.30 The contemporary glazed screen wall that divides the room. (Source: GML 2017)

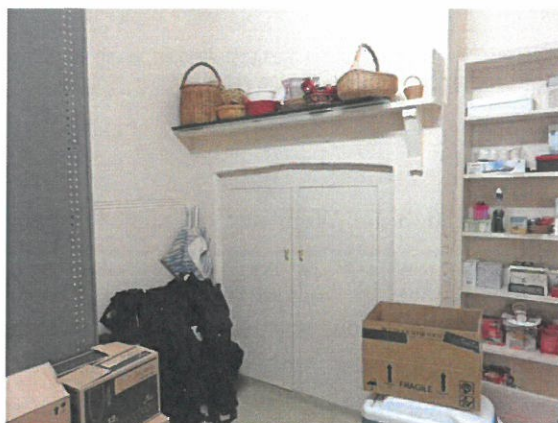
Figure 3.32 The former cooking hearth in the southeastern corner of the shop store. (Source: GML 2017)

The shop store is accessible from the shop, which is located in the 1980s building. The shop store was likely to have originally been a kitchen; there is a large former cooking hearth in the southeastern corner (Figure 3.32). The former hearth now contains a built-in cupboard, but the original timber mantelpiece remains above. Floors are vinyl sheeted (1980s?) with coved vinyl skirtings. The floor is framed, except for a large concrete section close to the cooking hearth, the extent of which is defined by cracking in the vinyl floor sheeting. Walls are smooth set, with a dado line formed in the plaster that extends around the room. Ceilings are smooth set and without any cornice. The two doors into the room are flush doors. The door that led to the shop is a new opening. The doorway to outside is possibly an early or original opening, but the door leaf is new (Figure 3.33).

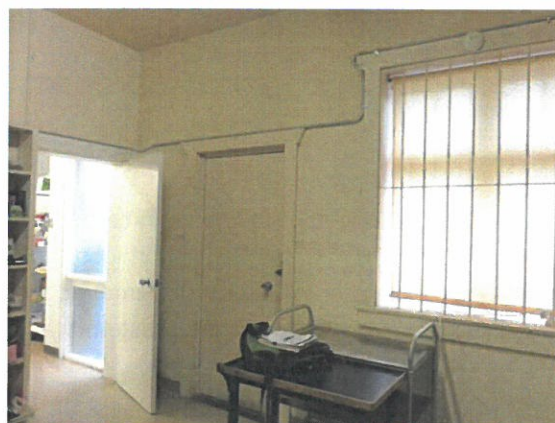
Figure 3.33 The southeastern corner of the shop store. The door on the right leads outside. (Source: GML 2017)

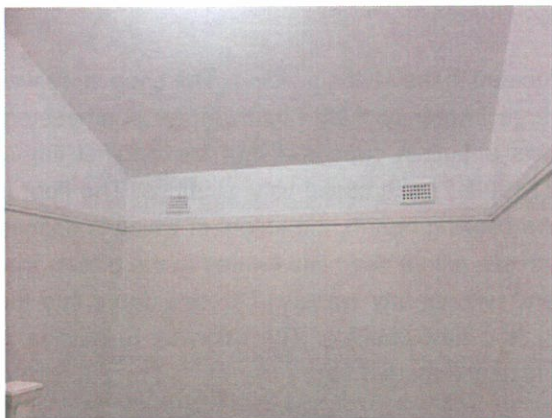
The upper landing is a large circulation space at the top of the stair that leads from the entry lobby. Both the stair and upper landing have carpeted framed floors. Walls and ceilings are smooth set, and the ceiling is raking above the stair. There are no cornices, but two air vents exist at high level on the eastern wall above the stair; the air grilles suggest that this wall was originally an external wall, and that the chapel wing was a later addition (Figure 3.34). The raking ceiling, which rakes downwards to the east, suggests that the roof over the stairwell originally raked in the same line as the ceiling. This adds weight to the suggestion that the hipped junction of the chapel wing's roof was constructed after the roof over the main part of the building was completed.

Figure 3.34 The upper part of the eastern wall of the upper landing, above the stair. The air grilles suggest this was originally an external wall. (Source: GML 2017)

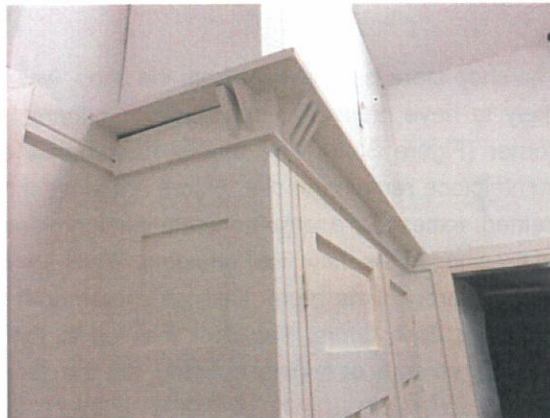
A grooved timber rail runs at door head height around the walls. Skirtings are original on the eastern wall (stair rails) and northern walls, but a different profile skirting has been used on the other walls. On the western wall is a timber joinery cupboard, the upper portion of which is clearly contemporary. The lower portion (up to door head height) is detailed to match other original timberwork in the house, and is most likely original, although it has been relocated from elsewhere; the timber rail on the wall runs along the wall behind the cupboard (Figure 3.35). The timber balustrade at the landing has been replaced, although the newel posts are original.

Figure 3.35 The joinery unit in the upper landing, which appears to have been relocated from elsewhere in the building. (Source: GML 2017)

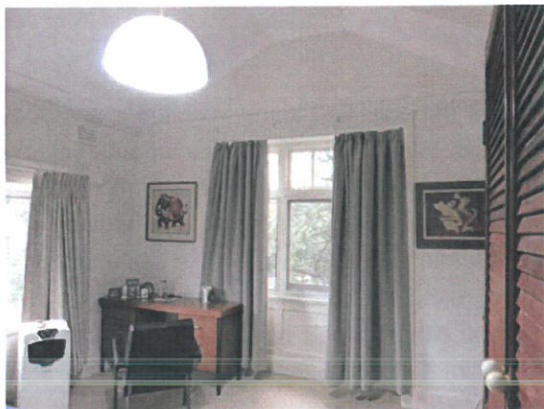
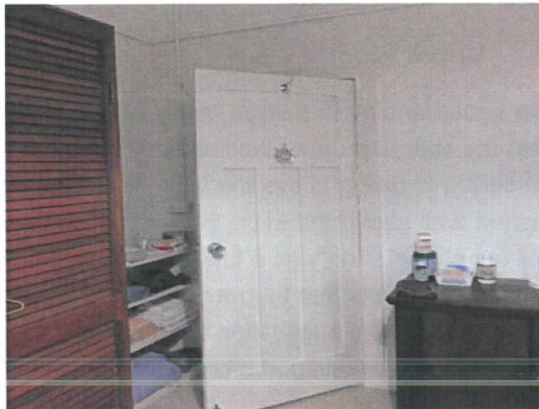
The bedroom has a framed floor with carpet finish (Figures 3.36, 3.37). Walls and ceilings are smooth set, with the ceiling partly raking. Cornices are contemporary coved plaster cornices. Timber skirtings match those in the entry hall, and a grooved timber rail runs around all walls at door head height. The aluminium-framed window in the western wall is of recent construction, but the door appears to be original—the door leaf is a high-waisted timber joinery door, and the door frame is timber (Figure 3.37). Door hardware is however contemporary. Below the window on the northern wall the framed wall has expressed timber battens, matching the external detail (Figure 3.36). The small hall adjacent to the bedroom matches the bedroom in finishes, skirtings and rails. However, unlike the bedroom it has no cornices.

Figure 3.36 The wall of the bedroom. (Source: GML 2017)

Figure 3.37 The original door into the bedroom. (Source: GML 2017)

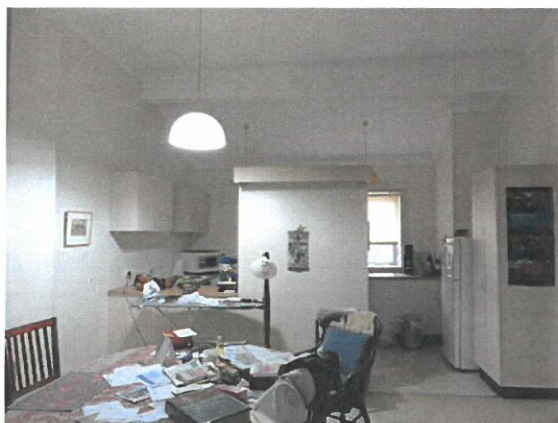
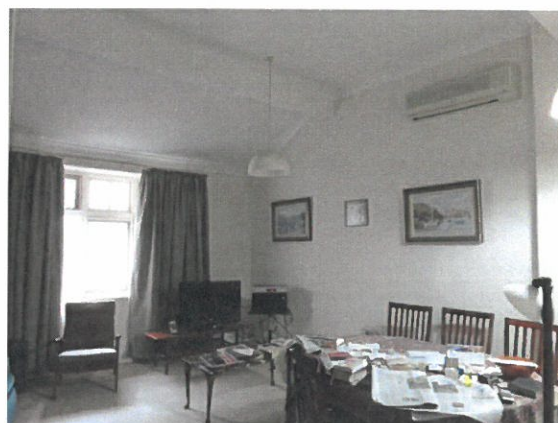
The living room and kitchen are located within a single large room at the southern end of the building (Figures 3.38–3.39). Floors are framed with carpet or sheet vinyl finish. Walls and ceilings are smooth set. The ceilings are partly raking, and have contemporary plaster coved cornices. Skirtings are contemporary, as are all fixtures and fittings. The timber window in the eastern wall is original and matches other windows in the building.

Figure 3.38 The living room, looking west towards the kitchen. (Source: GML 2017)

Figure 3.39 The southeastern corner of the living room. (Source: GML 2017)

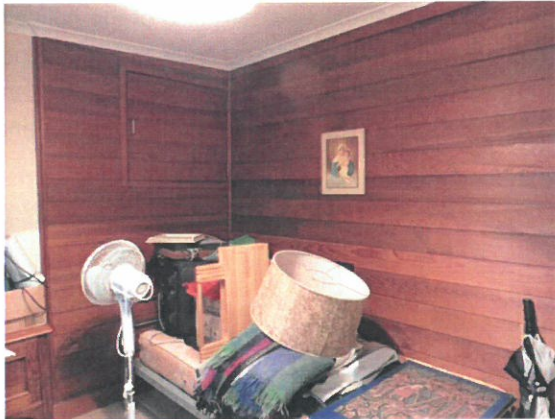
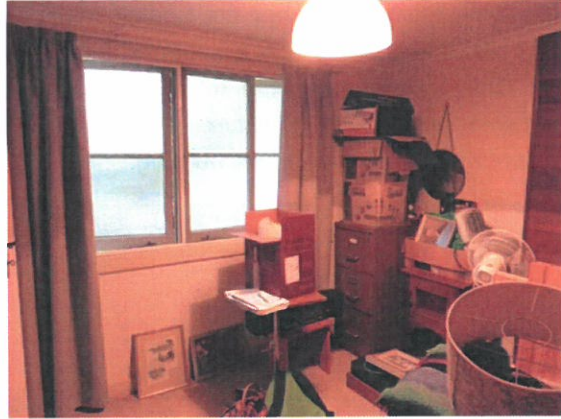
The storeroom/former verandah is accessed from the upper landing (Figures 3.40–3.42). There is a step down into the storeroom at the doorway, the raised form visible beneath the carpet suggesting a stone or concrete door threshold beneath the carpet. The floor of the storeroom is carpet finished over a framed floor. The ceiling is smooth set and rakes slightly down to the north. Cornices are contemporary coved plaster cornices. The southern wall and half of the eastern wall (the masonry walls) are lined with horizontal Western Red Cedar boards, most likely installed to cover the original stucco finish on these walls (Figure 3.40). The remainder of the eastern wall, as well as the northern wall, is framed and lined with smooth set sheet lining (Figure 3.41). The western wall is concealed by built-in cupboards (late twentieth century), but at the rear of the cupboards the original stucco wall is visible. The door leaf is a contemporary flush door but the timber door frame is possibly original.

Figure 3.40 The cedar boarding on the south and east walls of the storeroom. The small door in the panelled wall gives access to the chapel's ceiling space. (Source: GML 2017)

Figure 3.41 The north wall of the storeroom. (Source: GML 2017)

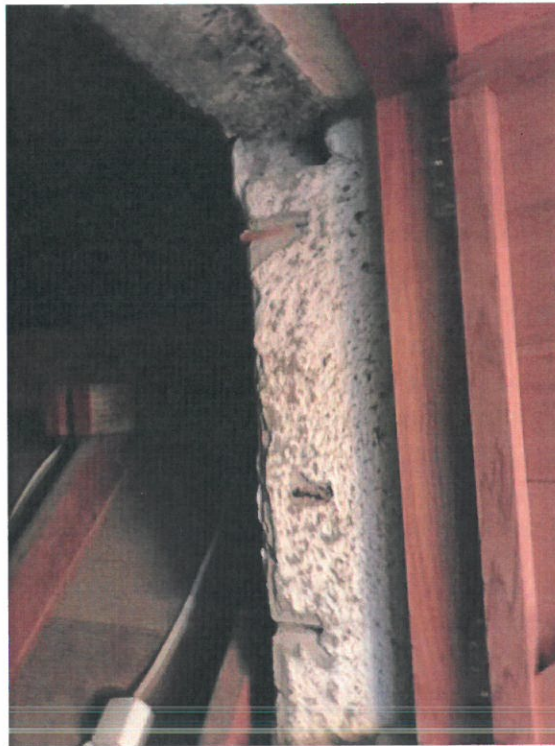
Figure 3.42 When opened the access door allows for views of the building's original external stucco finish and the space above the ceiling of the chapel. (Source: GML 2017)

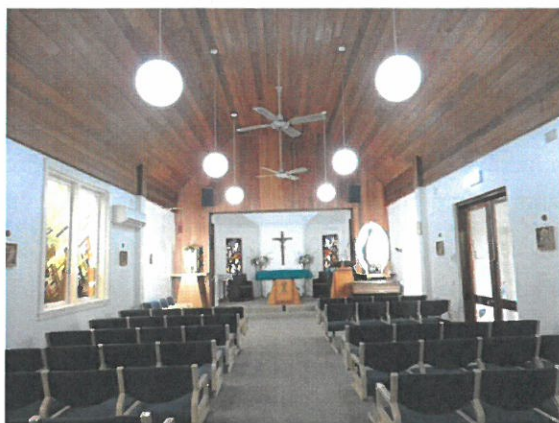
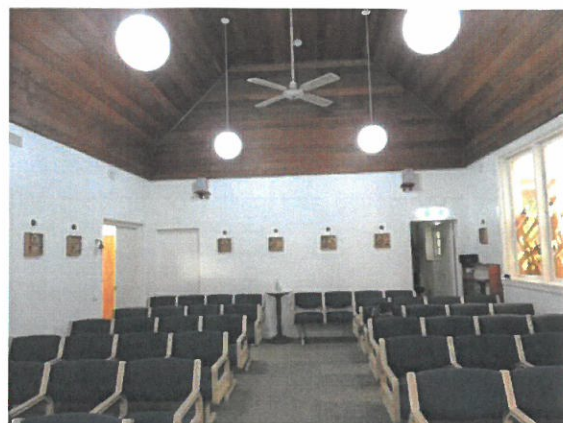
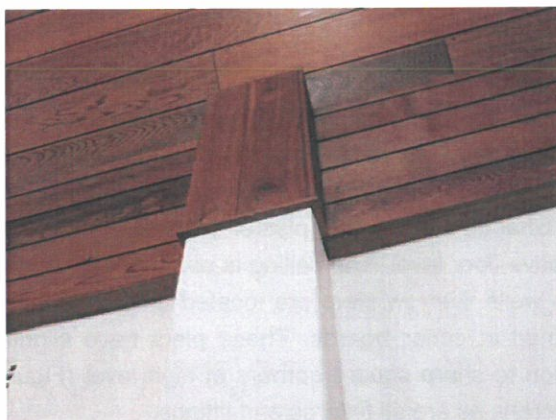
The chapel is a double-height space occupying the whole of the chapel wing (originally the chapel wing had two storeys within the same volume of space) (Figures 3.43–3.46). The floor is framed with carpet finish. Walls are generally smooth set, although western red cedar boarding has been used as a lining on the eastern wall, and upper sections of the northern, southern and western walls. These walls also feature high level air grilles at regular intervals. ‘Shadows’ in the wall plaster suggest a horizontal dado once ran around the room at about 1200mm above floor level. The ceiling is partly raking, and is lined with cedar boards to match those used on the walls. Narrow piers are located on the northern and southern walls, their uppermost portion also lined in cedar boards. These piers have slightly rounded corners for most of their height, but transition to sharp square corners at high level (Figure 3.45). Doors and windows into the room are contemporary, as are all fixtures and fittings.

Figure 3.43 The chapel, looking east. (Source: GML 2017)

Figure 3.44 The chapel, looking west. (Source: GML 2017)

Figure 3.45 A typical wall pier in the chapel. (Source: GML 2017)

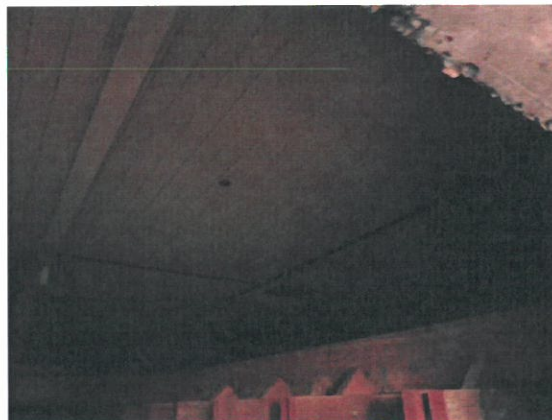
It is possible to view the ceiling space above the chapel, through a small access door in the storeroom on the upper floor (Figure 3.46). The view of the ceiling space reveals the original tongue and groove boarded ceiling intact above the cedar ceiling, which runs across the entire length of the space. Dark lines on the ceiling are possible indications of locations of former walls, indicating that there was at one time a central corridor with rooms on both sides. The ceiling space also shows that walls of the upper floor within the wing were smooth set, with a horizontal dado formed in the plaster. Wall vents can be seen, which are of a slightly different detail to those in the main part of the building, being installed flush with the wall rather than slightly proud of the finished wall surface.

Figure 3.46 The original boarded ceiling remains above the newer cedar ceiling in the chapel. The dark lines possibly indicate the former location of walls. (Source: GML 2017)

The Chapel wing has lost much of its integrity internally. The upper floor has been removed, and a new double-height space created. No original doors, windows, fixtures or fittings remain. A new cedar ceiling and wall linings have been installed, although the original boarded ceiling of the original upper floor remains intact above the new ceiling, and in good condition.

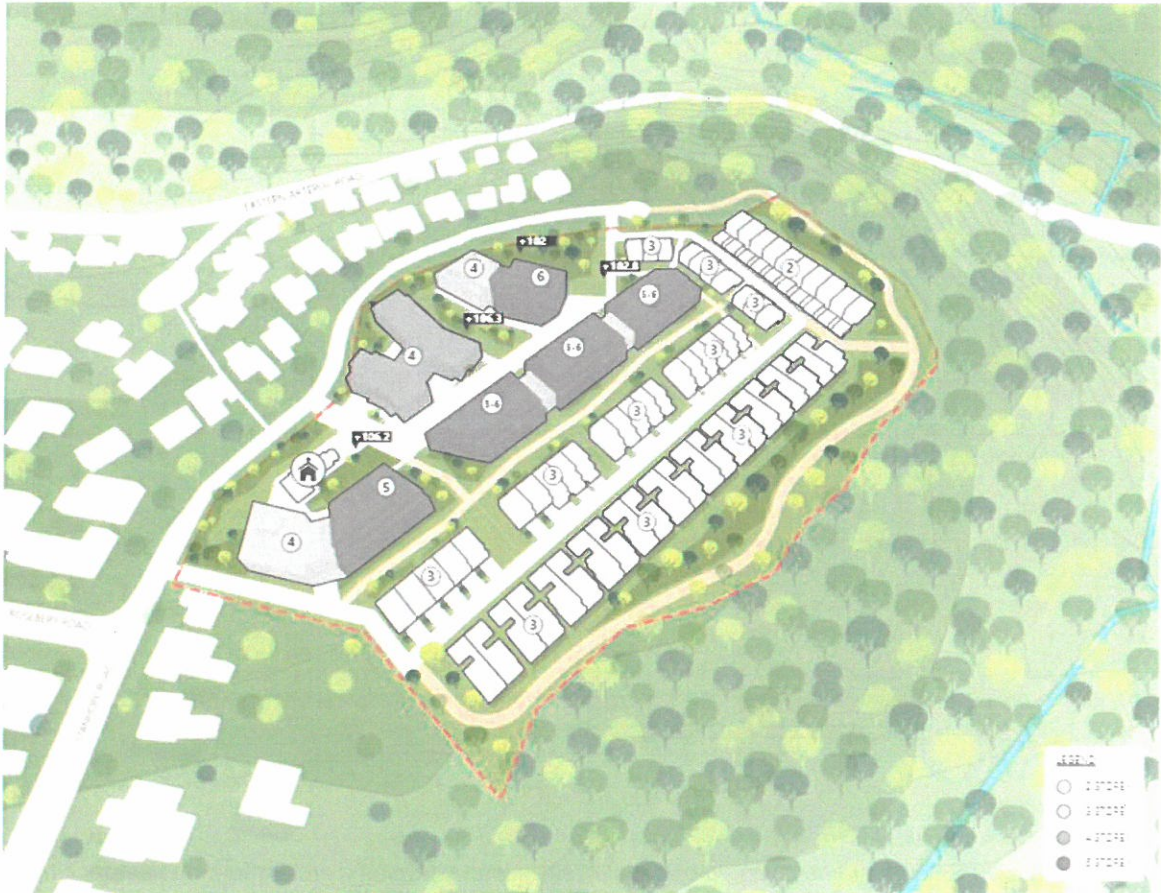
Figure 18 Masterplan showing building scale

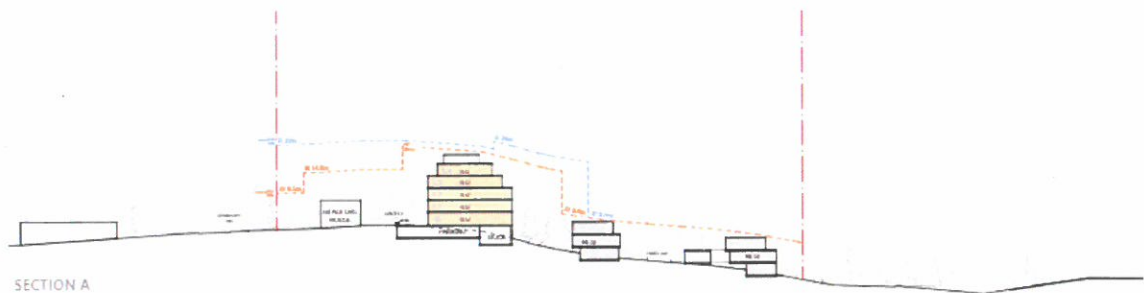
Figure 19 Section plan showing Headfort House and illustrative masterplan development

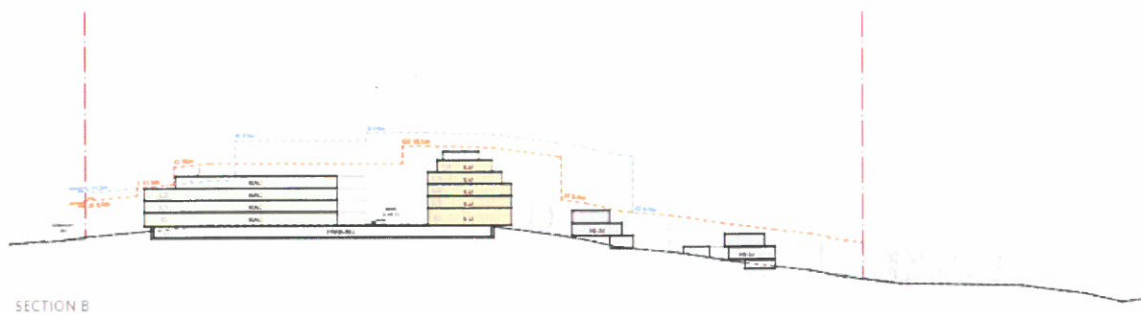
Figure 20 Section plan showing proposed illustrative masterplan development and setback from Stanhope Road
