**DPHI Gateway Conditions - 921 Punchbowl, Punchbowl NSW**

**Assessment of Acid Sulfate Soils – Direction 4.5**

## **ACID SULPHATE SOIL ASSESSMENT (ASSA)**

921 Punchbowl Road, Punchbowl NSW

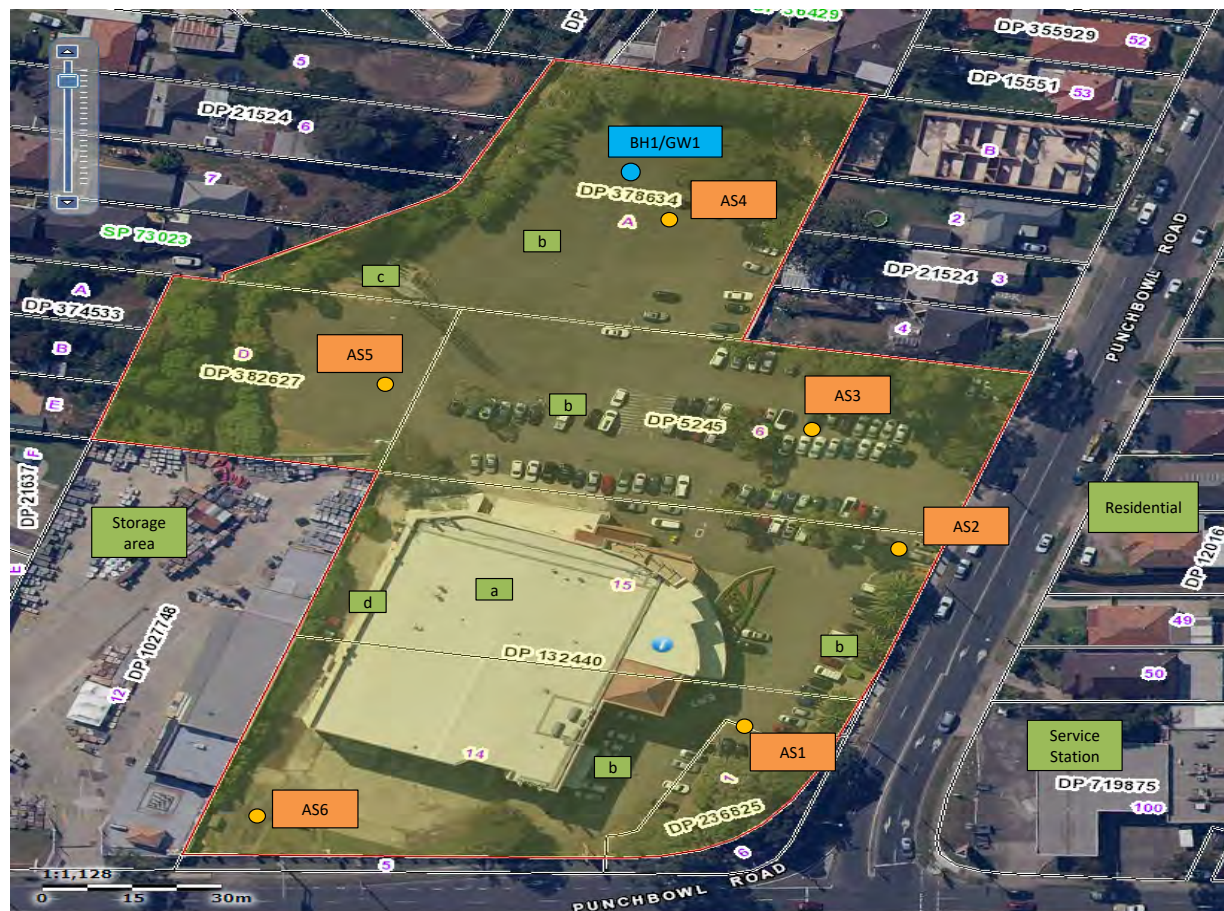
| | | Figure<br>2 | Westwood Pty Ltd |

| <b>Key</b><br><br>Site Location<br><br>Benviron Group 2016<br>FES Acid Sulphate Soil Locations | | DRAWN<br>EY | <b>Site Features &amp; Borehole Locations Plan</b> |
