# Existing Building Services Condition Report

**230655 PARK ROYAL HOTEL  
REDEVELOPMENT**

**Client:**  
UOL

**Date:**  
24/03/2025

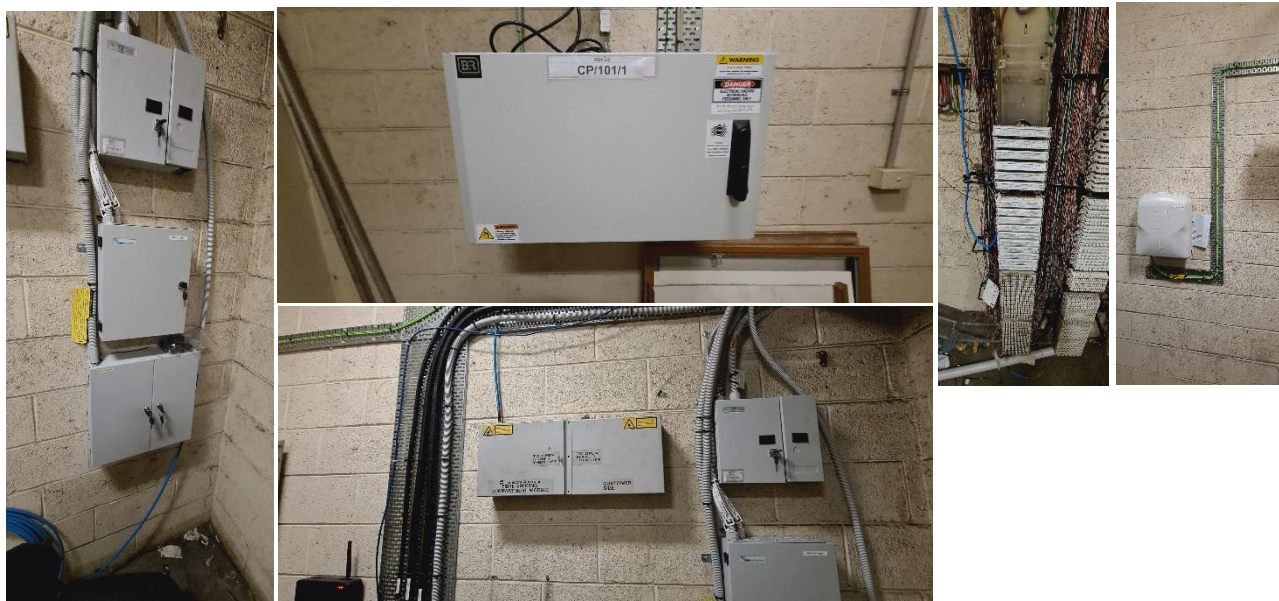
Figure 4-5: MDF Room

The main communications room is located in the upper basement and serves as the central point of communication incoming services from the street. The site currently has NBN and other service providers terminating their services in the MDF room. The room and services could be retained in its current location for existing and future development needs however needs to be cleaned, repainted and finished internally to the current requirements of S009.
