HERITAGE IMPACT STATEMENT

29 AUG 2007

CLAYDON PARK

75 CROOBYAR ROAD
MILTON NSW 2539

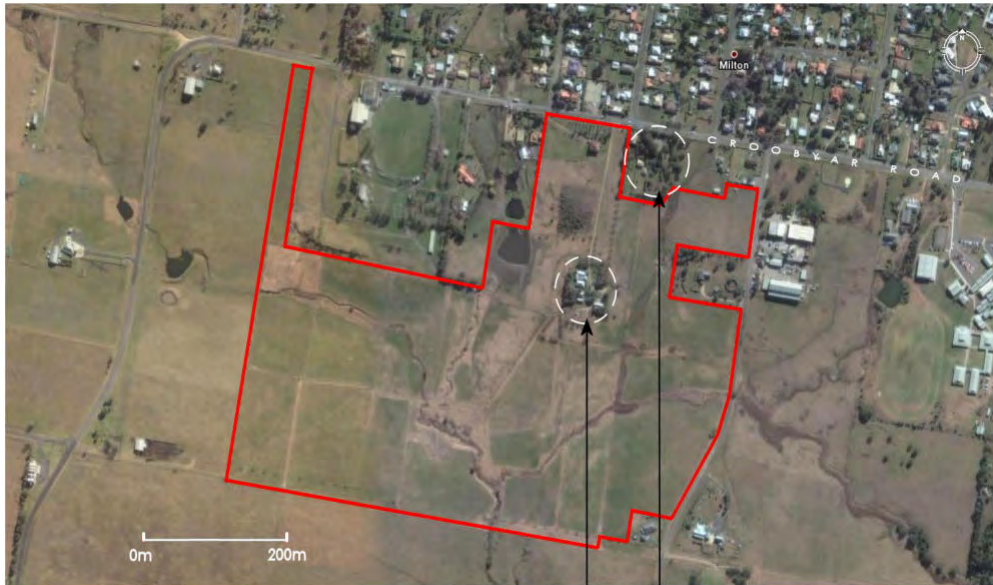
Fig. 1.0 Site Aerial Photograph

A. Residence (former church)

B. Claydon Park Dairy Farm buildings

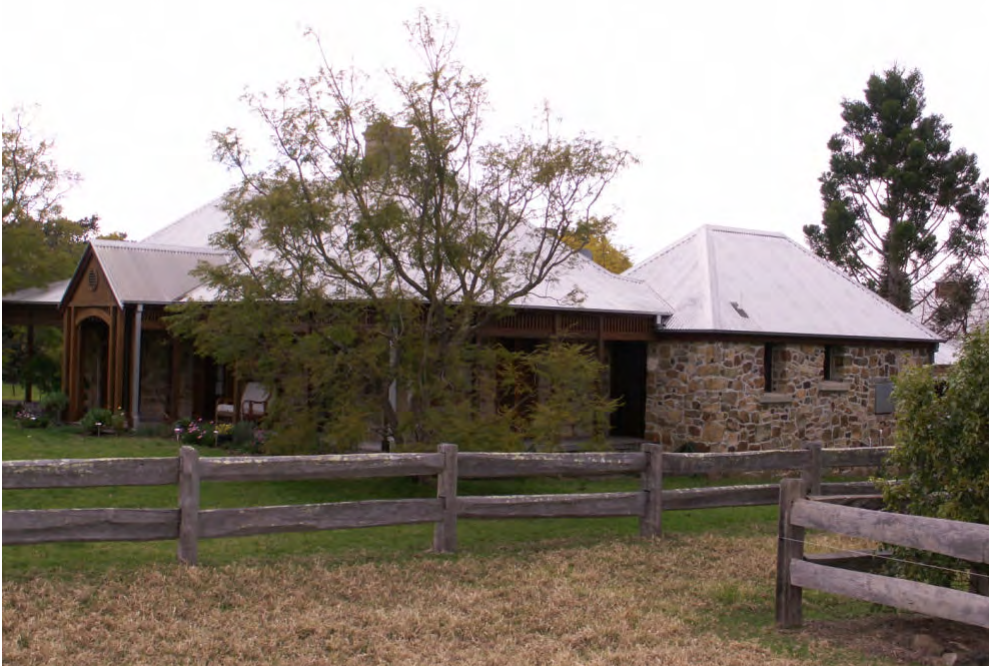
Fig. 2.1 Western side of Homestead – note more recent addition of service 'wing' hipped roof module

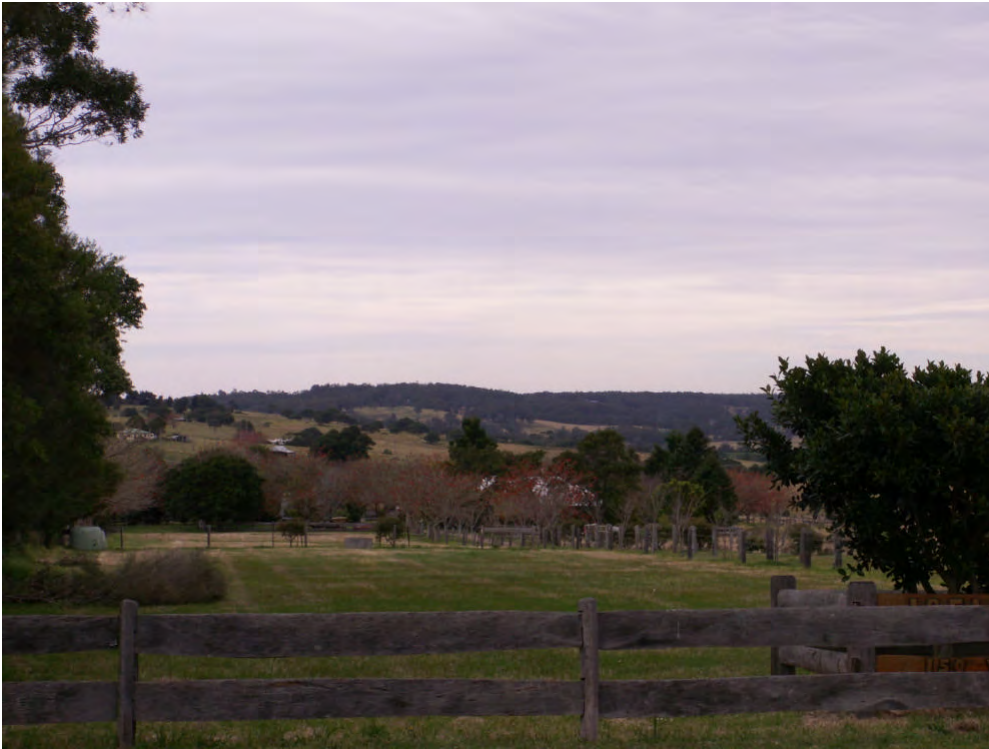
Fig. 3.0 Central Southern vista over Claydon Park – Front fence to Croobyar Park in foreground, entry drive along tree line on RHS

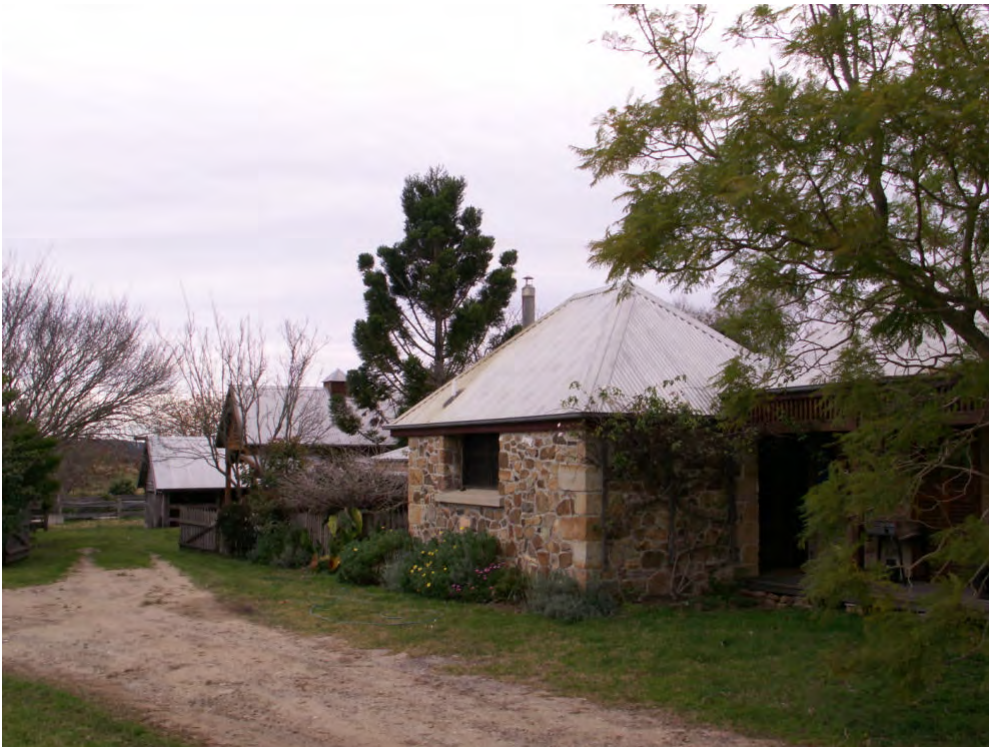
Fig. 3.1 Eastern side of Homestead and Outbuildings beyond – note in foreground is historically recent addition as is farm vehicle garage in middle ground, original dairy structure in background

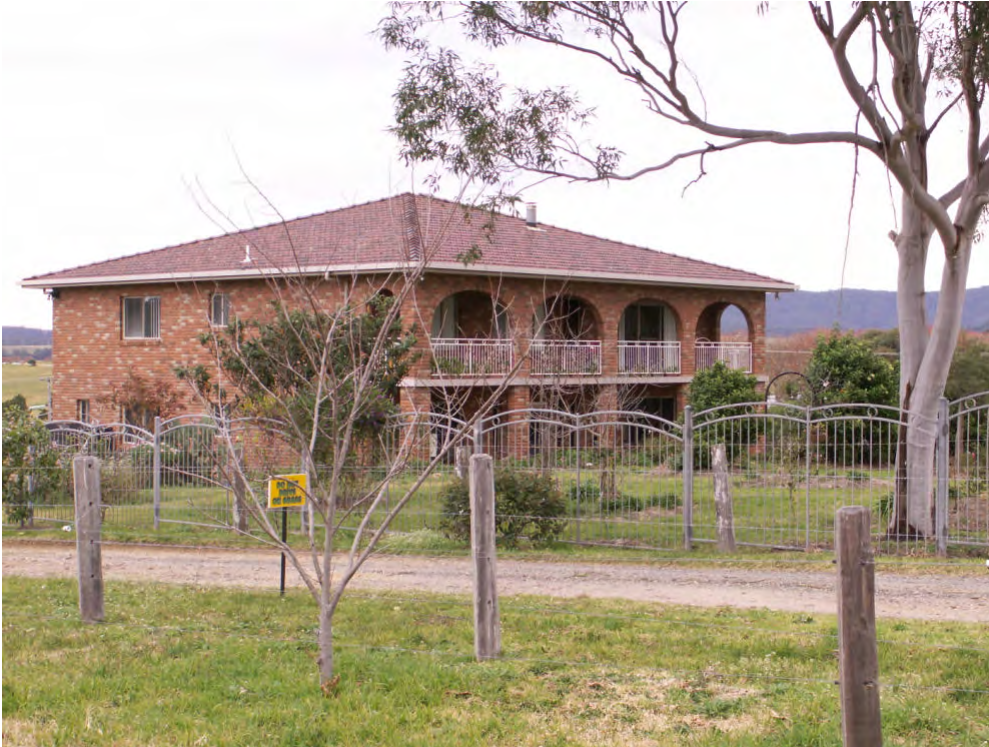
Fig. 3.2 Detail view – Existing two storey Dwelling – part of proposed Nursing Care Facility

The existing two storey dwelling component is incorporated as a corner element, in its complete form, of the courtyard formation, being retained on the North-East corner of the complex.

Its large pyramid roof form will remain intact, with the complex extending Westwards with a minor link then a major pavilion, lowering in visual mass and roof height as it terminates further down the sloping site.

A verandah form has been added to the frontage and two return sides of the existing dwelling component that successfully reduces the visual bulk of this element.

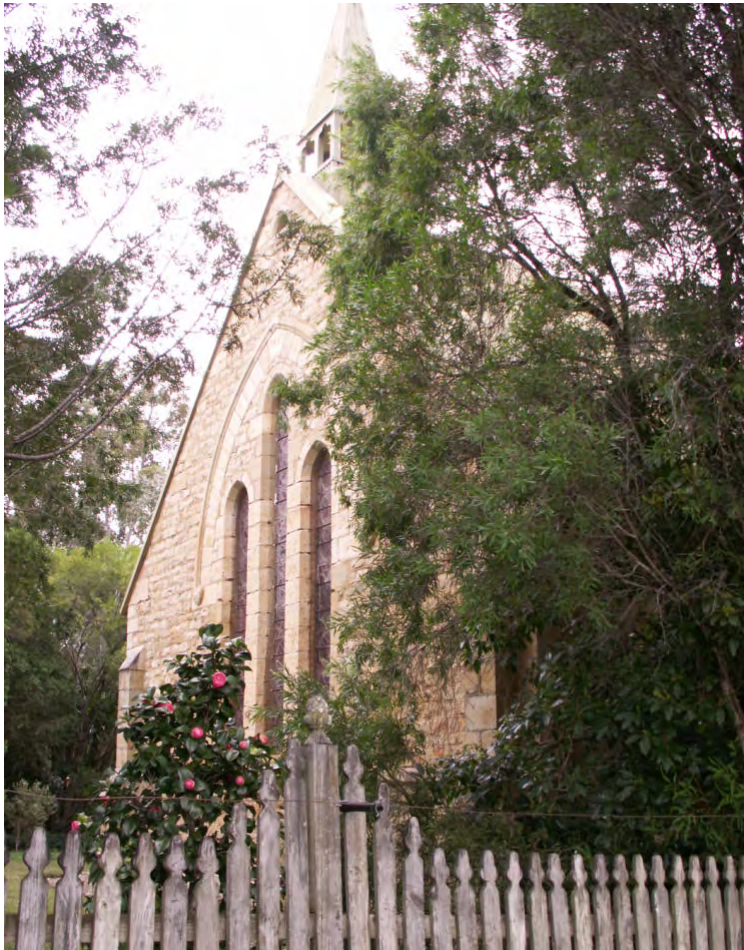
Fig. 4.0 Residence (Old Church) as viewed from Claydon Park

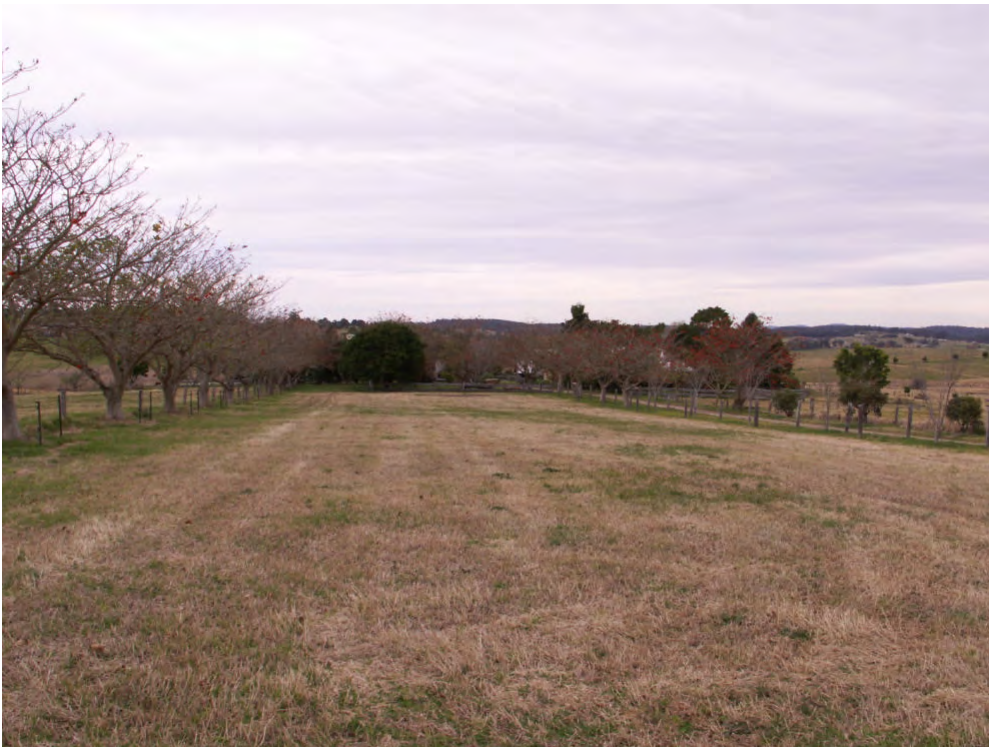
Fig. 4.1 Claydon Park Dairy Farm Complex

The intense landscape planting already established around its site will provide a recognizable visual screen and frame that preserves its visual qualities.

The Claydon Park Complex has been carefully planned for its new uses not to have a negative impact on its inherent qualities. However, it is suggested that certain conservation policies be adhered to as indicated within this report. This will ensure its ongoing value to the Milton community as a link to the earliest establishment of the town and its progress through history.

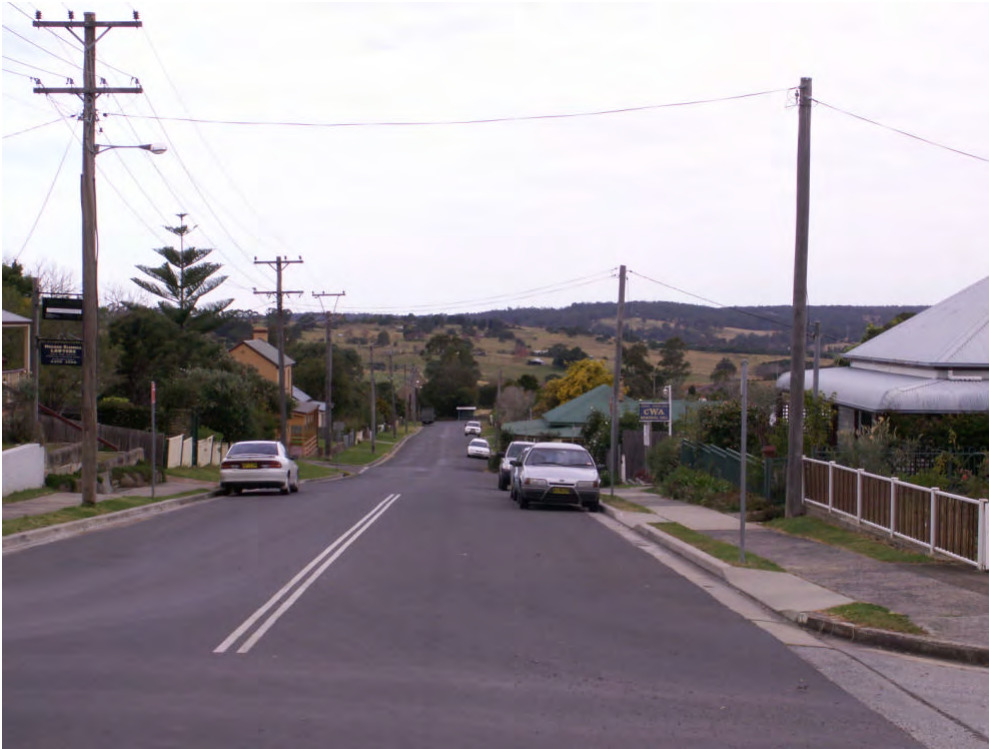
Fig. 5.1.1 View South along Wason street – Residence (Old church building) located left of distant 'T' intersection with Croobyar Road. Note large tree in Residence yard on road centre, with rural vista gap on RHS of centre.

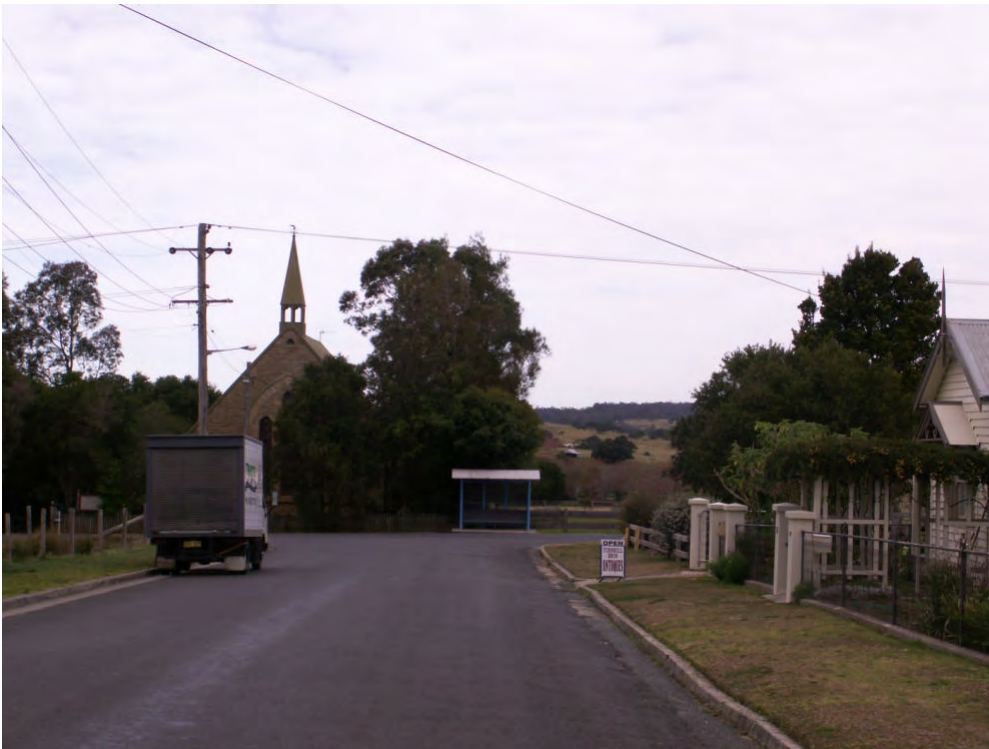
Fig. 5.1.2 Intersection Detail – Wason Street & Croobyar Road – note rural vista on RHS over Claydon Park to distant farmland – Dairy complex screened by existing trees

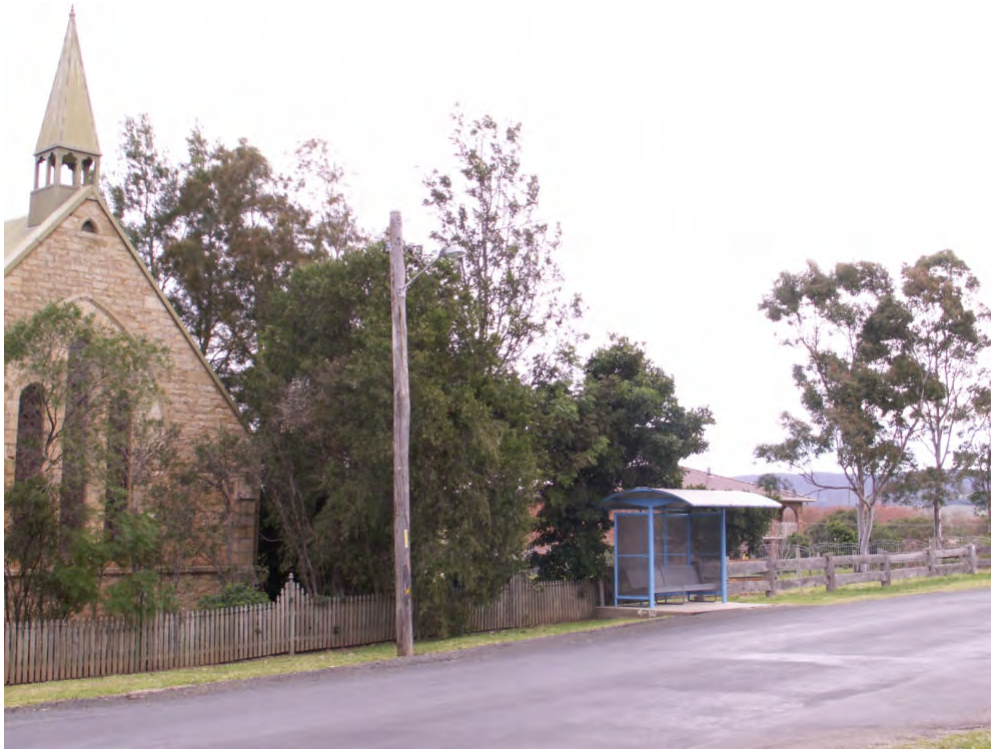
Fig. 5.1.3 Streetscape Detail – Residence, Bus Shelter and distant Claydon Park two storey Dwelling along Croobyar Road

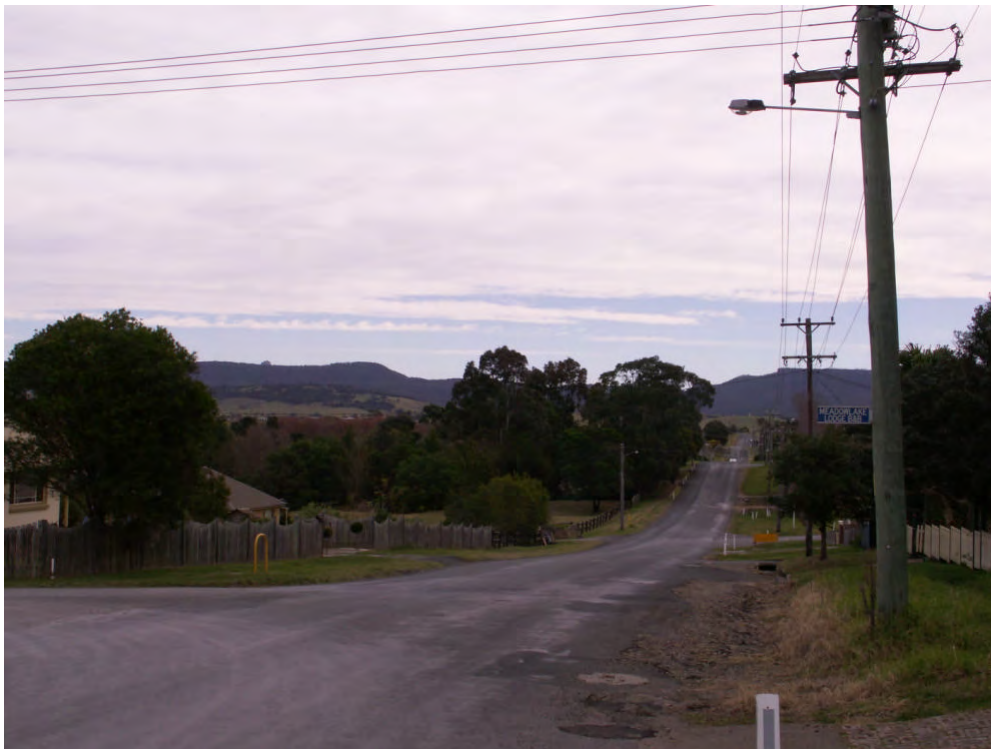
Fig. 5.1.4 Streetscape – view West along Croobyar Road – large group of trees in middle ground identify Residence & Graveyard site, totally screened from view.

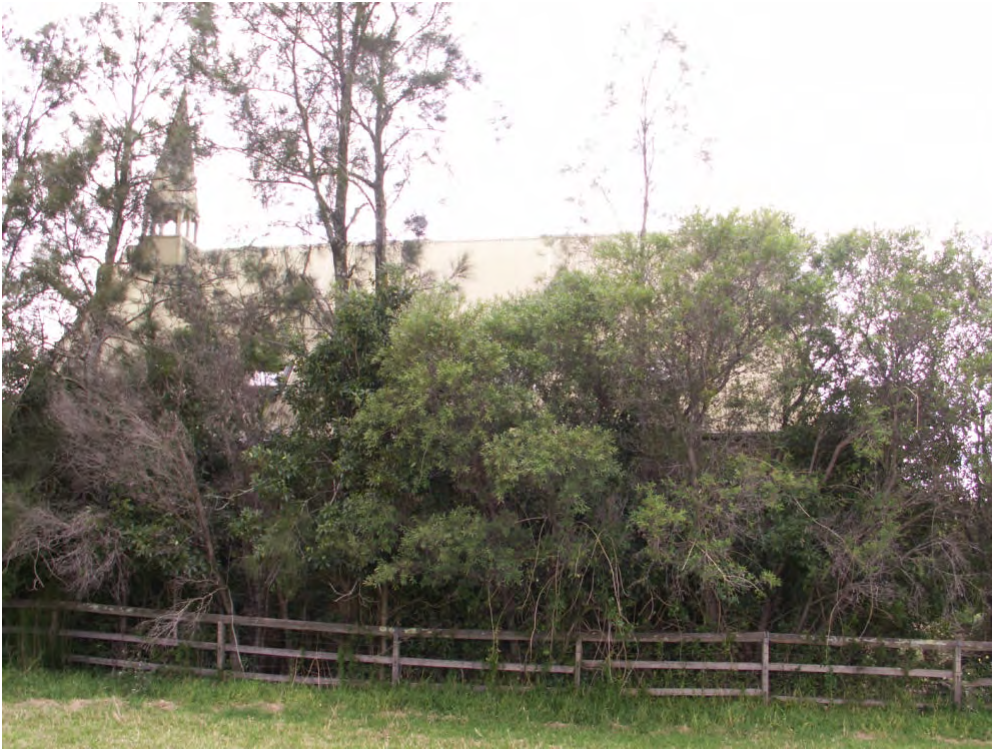
Fig. 5.1.5 Western boundary – Residence & Graveyard – note existing thick landscape screen, hiding much of the building's visual presence

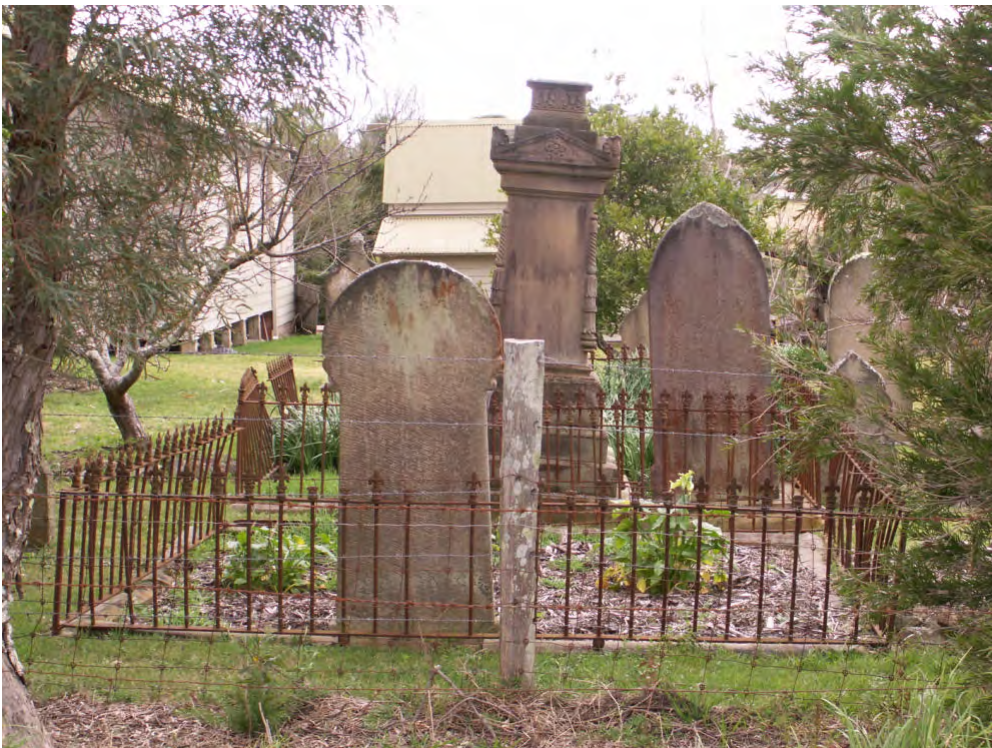
Fig. 5.1.6 Graveyard view – Sarah Claydon's headstone visible in foreground, in close proximity to Residence Western boundary

It is worthy of note that one of the founders of Claydon Park, Sarah Claydon, is buried within the Graveyard attached to the old church property, and that the burial site is possible to view from the grassed gap area within Claydon Park, thus making available to visitors and residents of Claydon Park this important connection to the early founders of Milton.

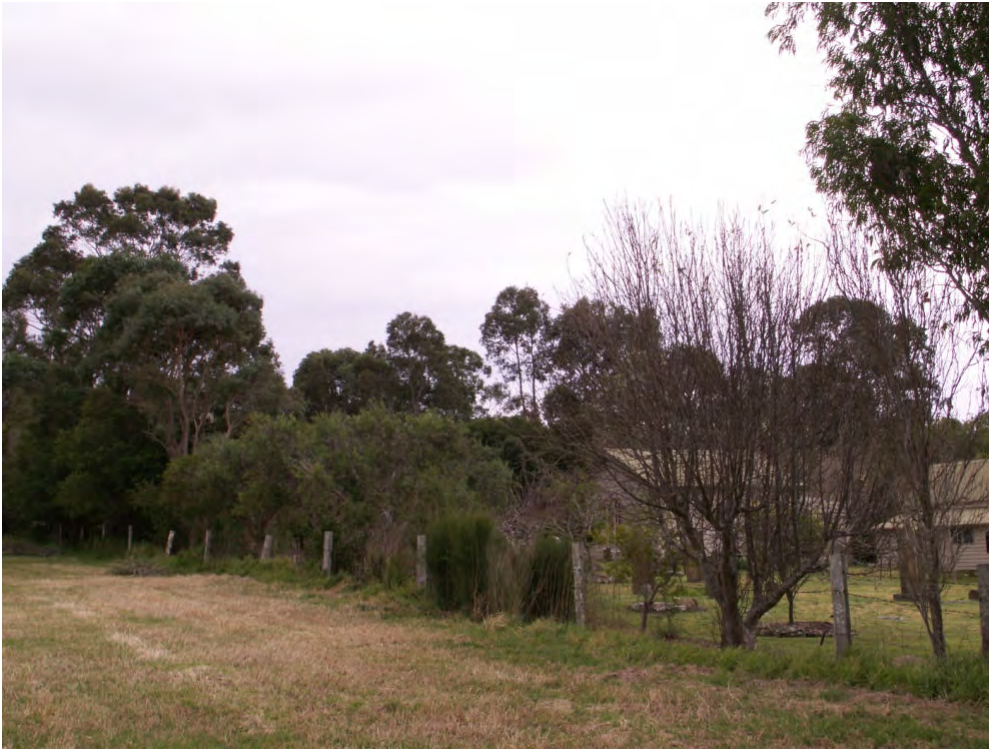
Fig. 5.1.7 Southern boundary – tree screen hides Graveyard, Old Church Hall and Cottage behind Residence – Common boundary to Claydon Park

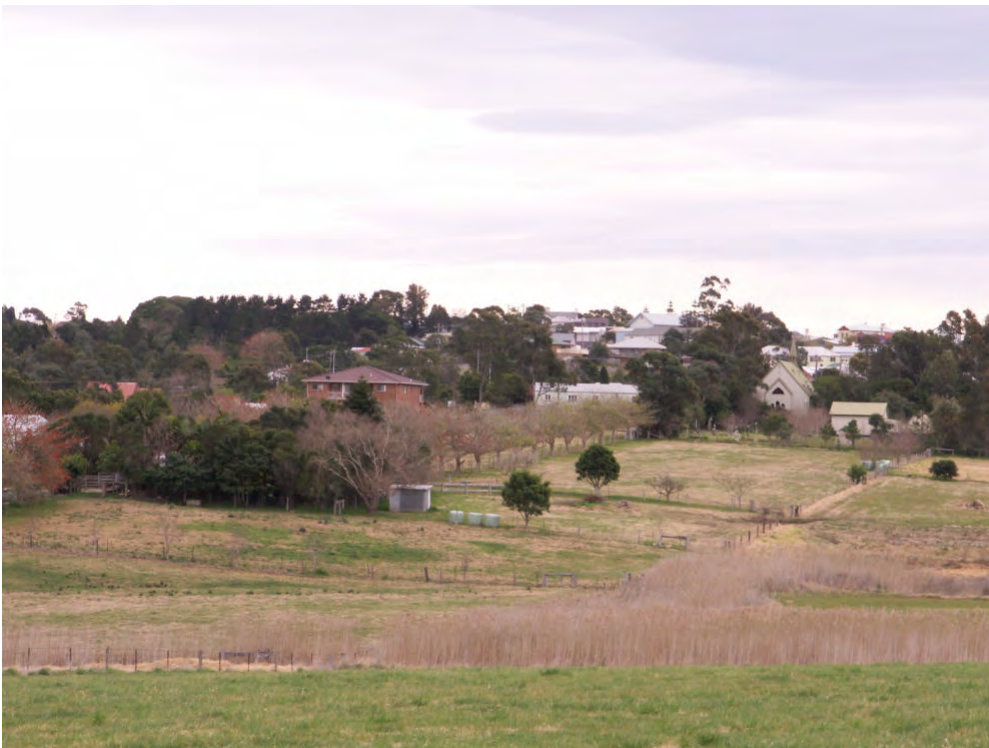
Fig. 5.1.8 Vista North – over Claydon Park with residence and Graveyard in middle ground to RHS and two storey dwelling to LHS – Claydon Park building complex in centre hidden by tree screen

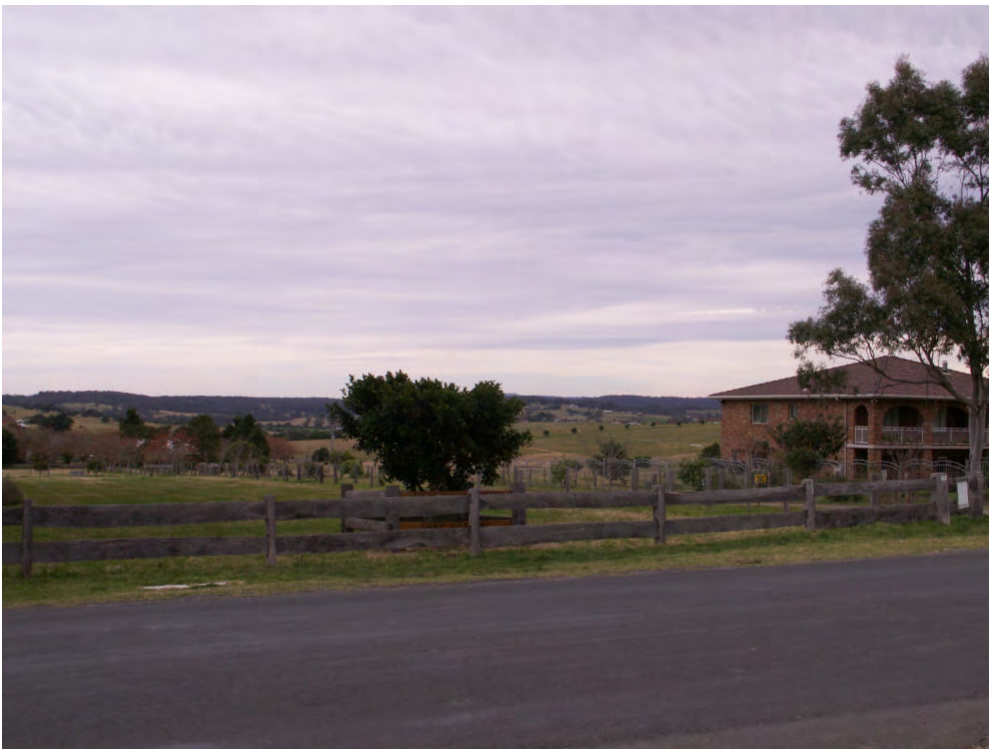
Fig. 5.2.2 Vista to South-West past two storey Dwelling – view to distant ridge line should be preserved

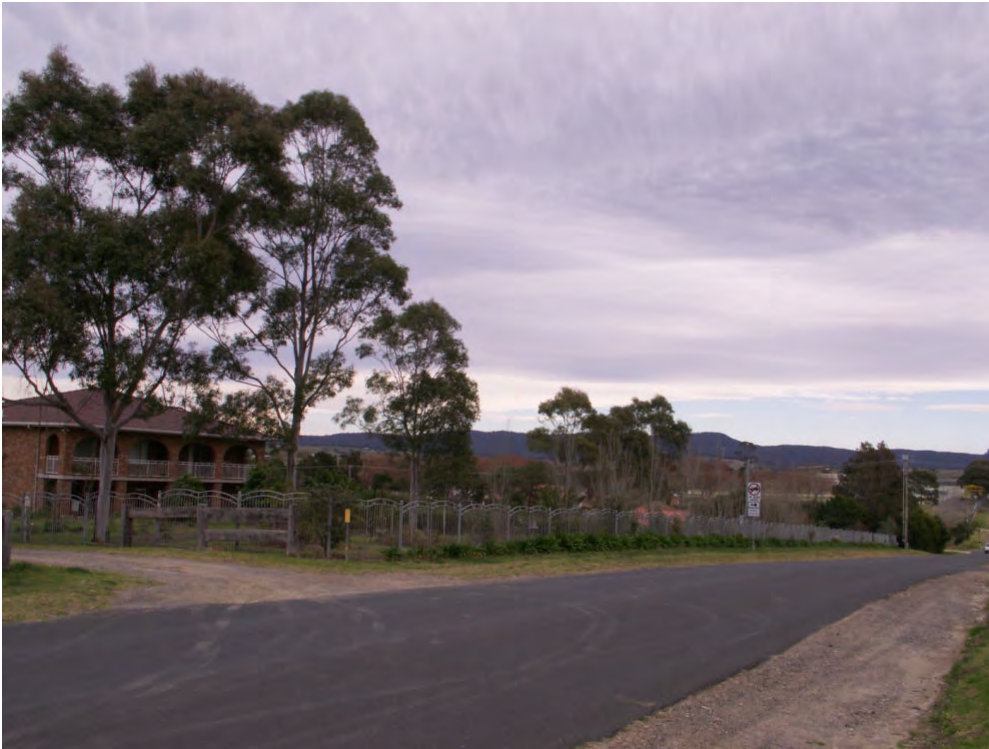
Fig. 5.2.3 Streetscape to proposed Nursing Facilities development area

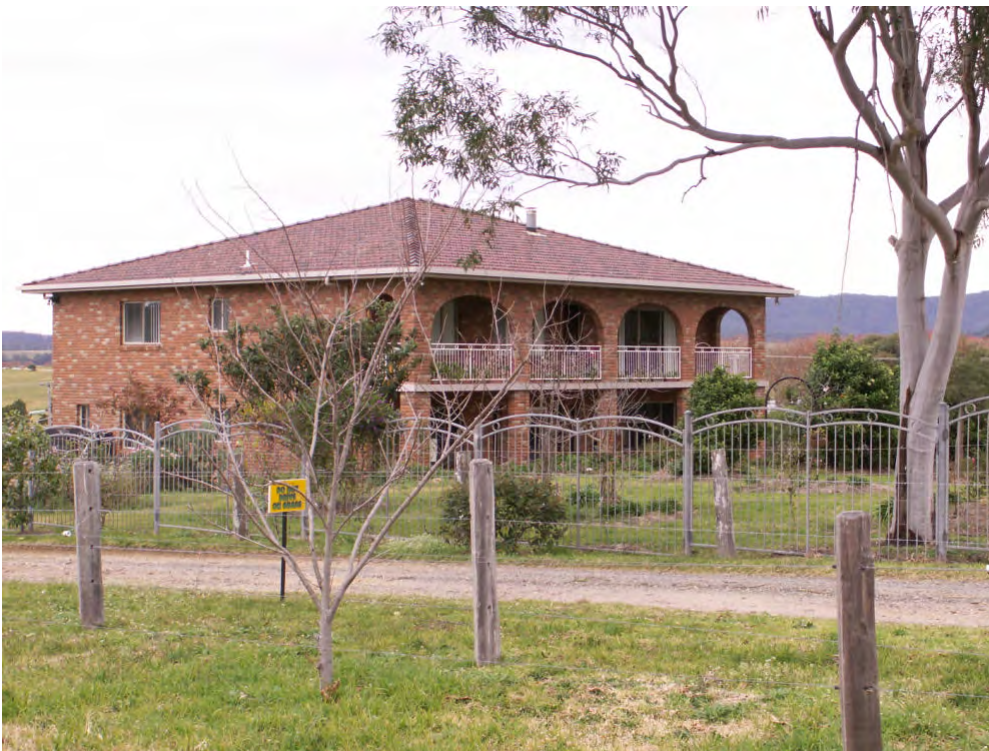
Fig. 5.2.4 Detail view – Existing two storey Dwelling – part of proposed Nursing Care Facility

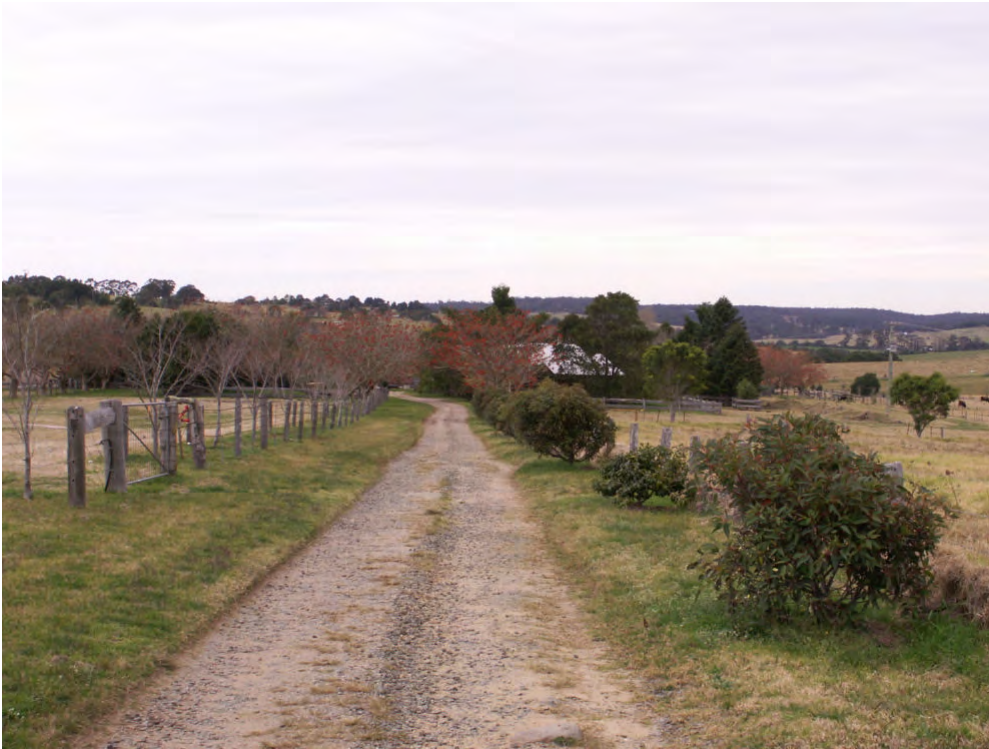
Fig. 5.3.1 Entry Drive – Claydon Park Dairy Complex – only Homestead partly visible

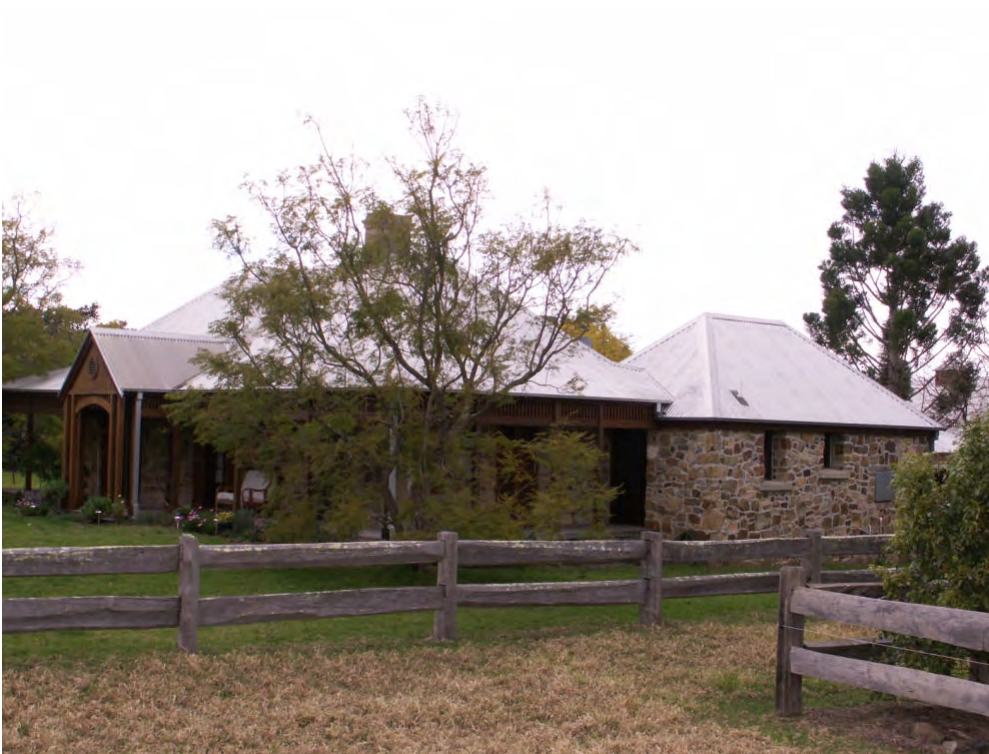
Fig. 5.3.2 Western side of Homestead – note more recent addition of service 'wing' hipped roof module to Southern end

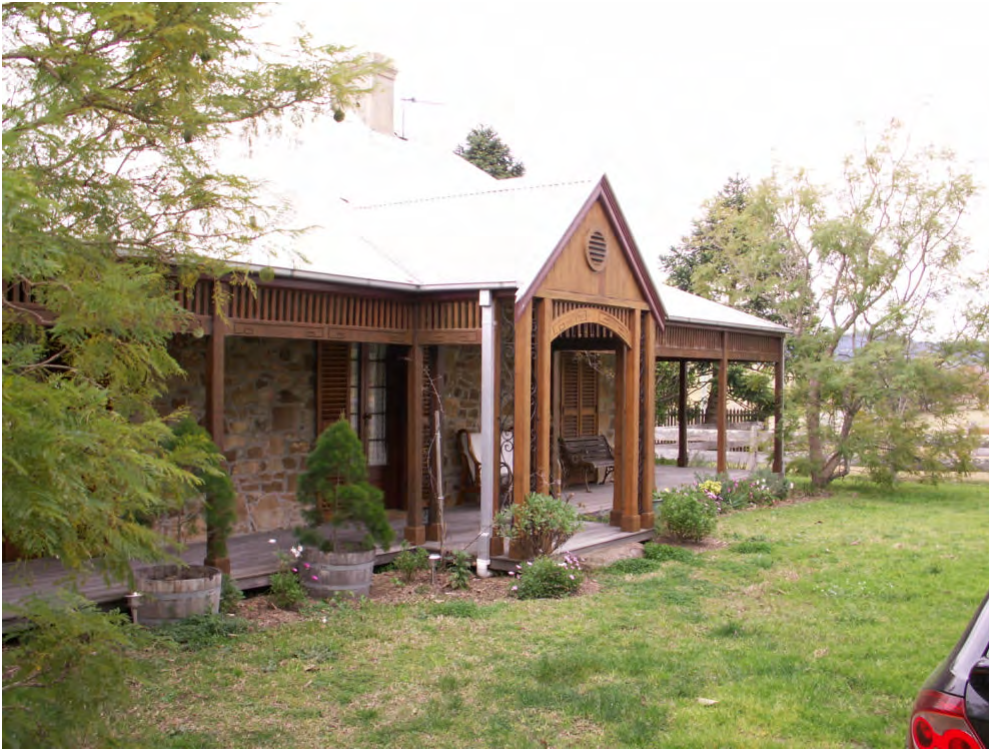
Fig. 5.3.3 North frontage of Homestead – note posts and fretwork not original, however sympathetic to heritage character

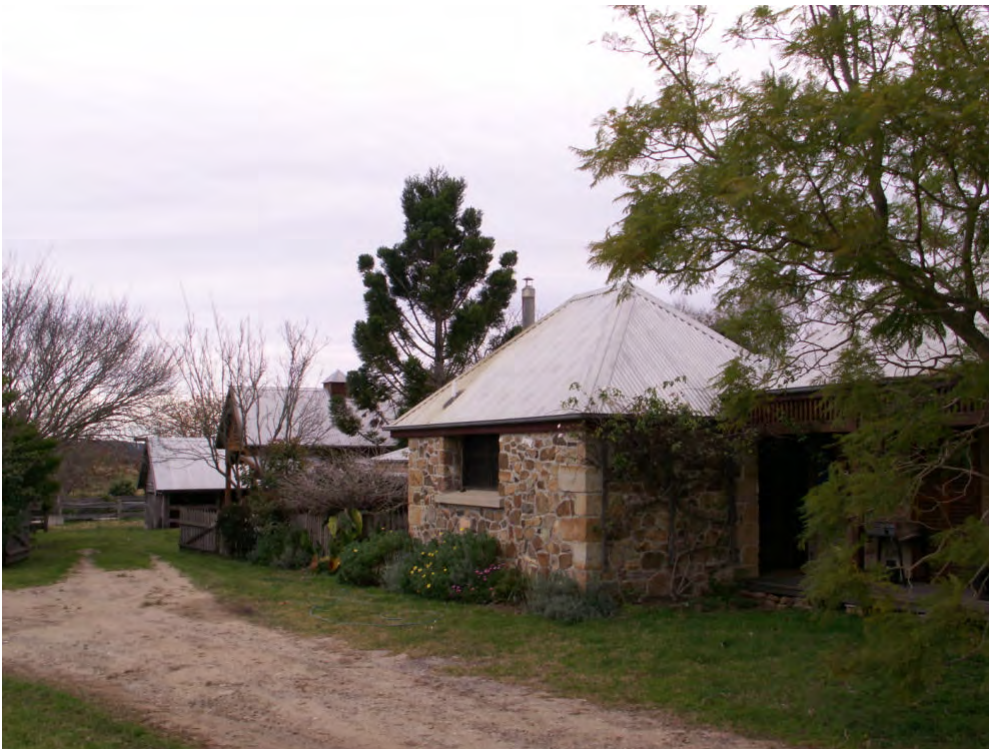
Fig. 5.3.4 Eastern side of Homestead and Outbuildings beyond – note in foreground is historically recent Homestead addition, as is farm vehicle garage in middle ground, original dairy structure in background

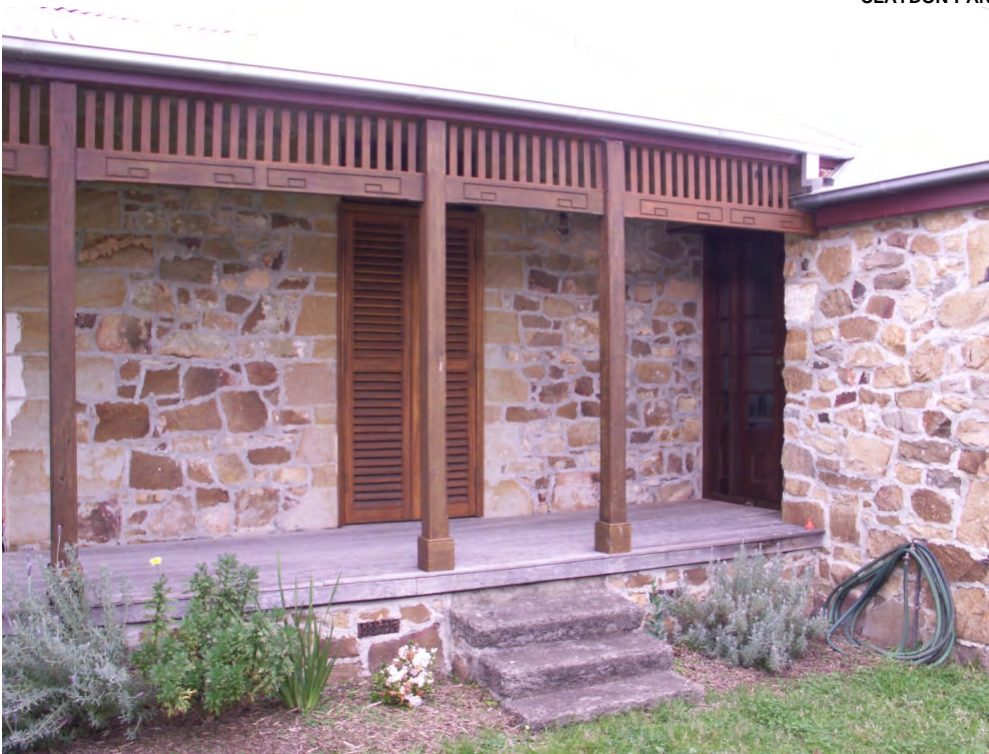
Fig. 5.3.5 Detail view of Homestead Western side verandah – note step down in roof pitching height to allow recent wing addition to acknowledge original building form.

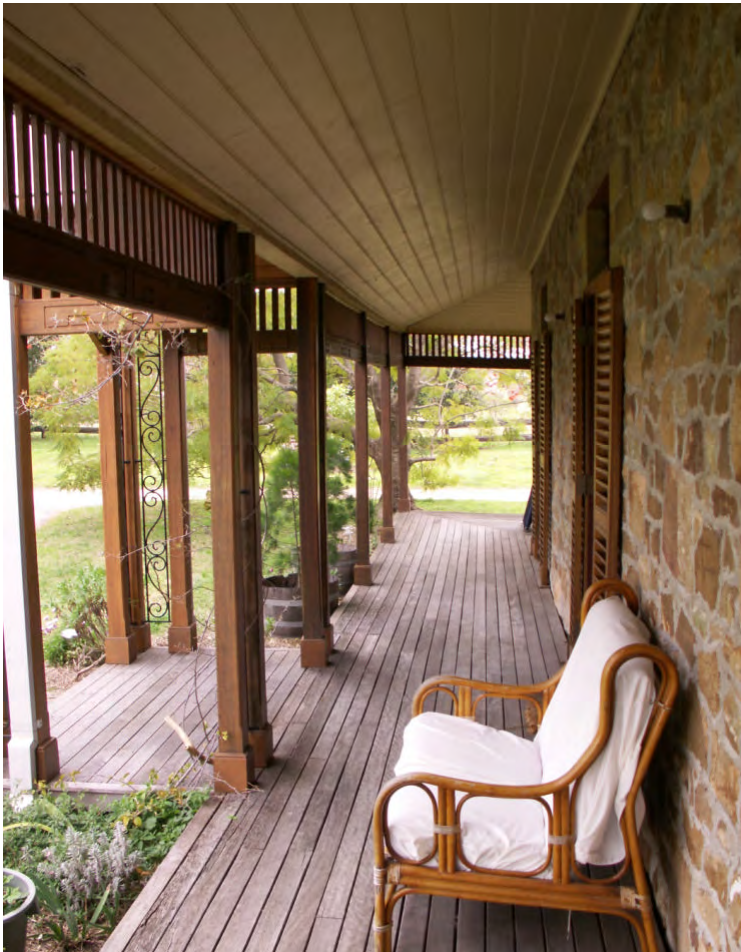
Fig. 5.3.6 Homestead front verandah detail

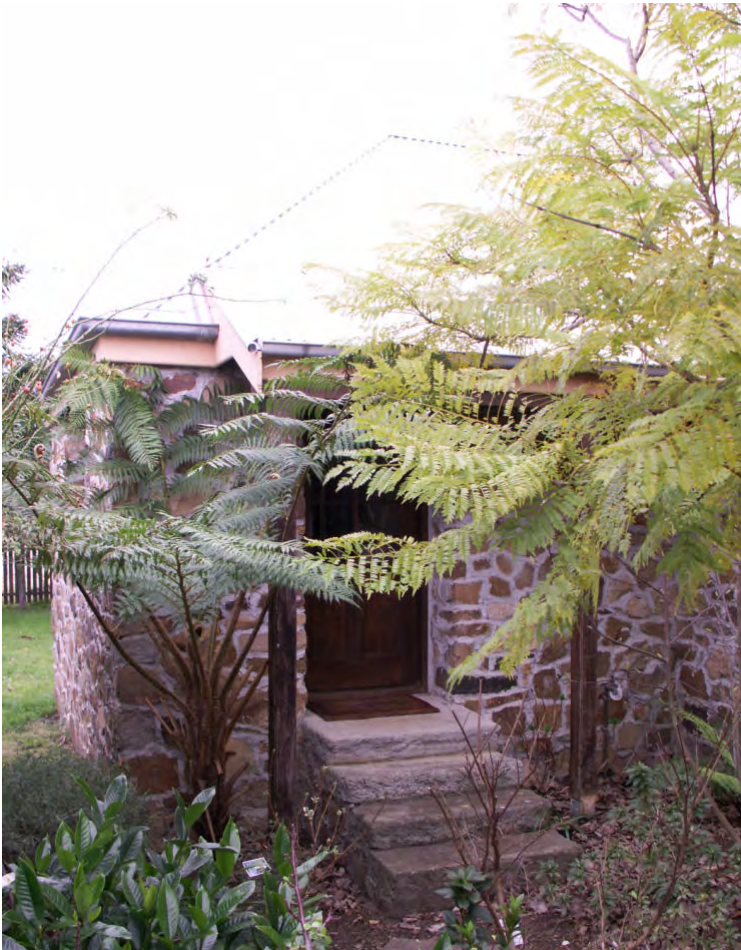
Fig. 5.3.7 Western service wing rear porch opening into private courtyard

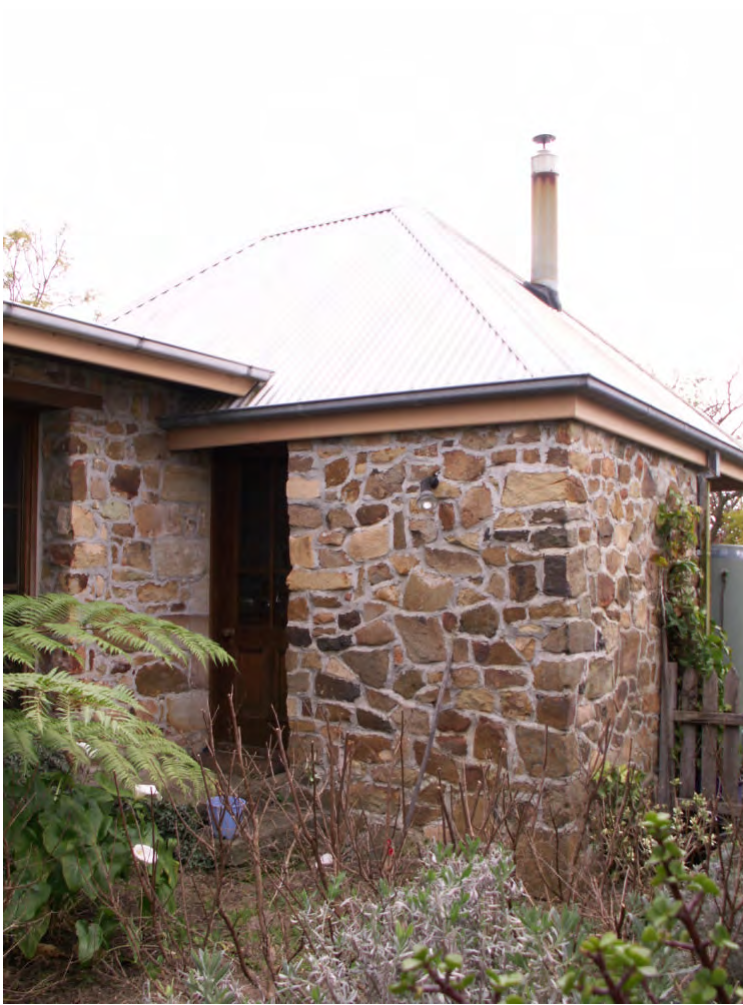
Fig. 5.3.8 Eastern service wing addition showing rear entry from private courtyard

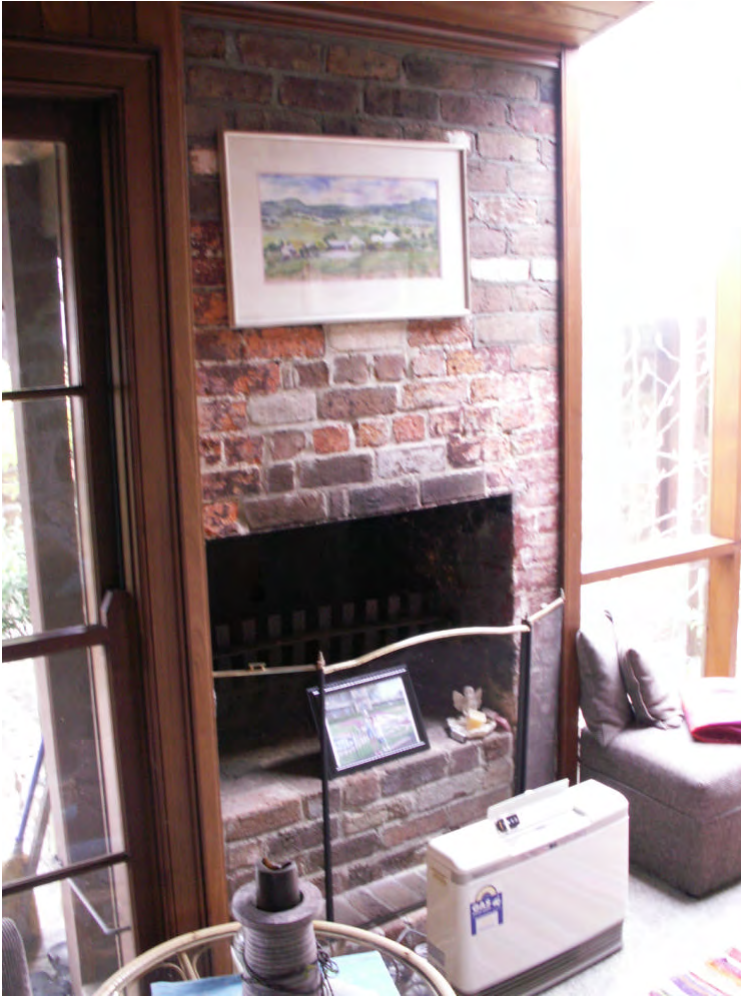
Fig. 5.3.9 Remnant Kitchen cooking hearth from original rear portion of homestead retained as fireplace element

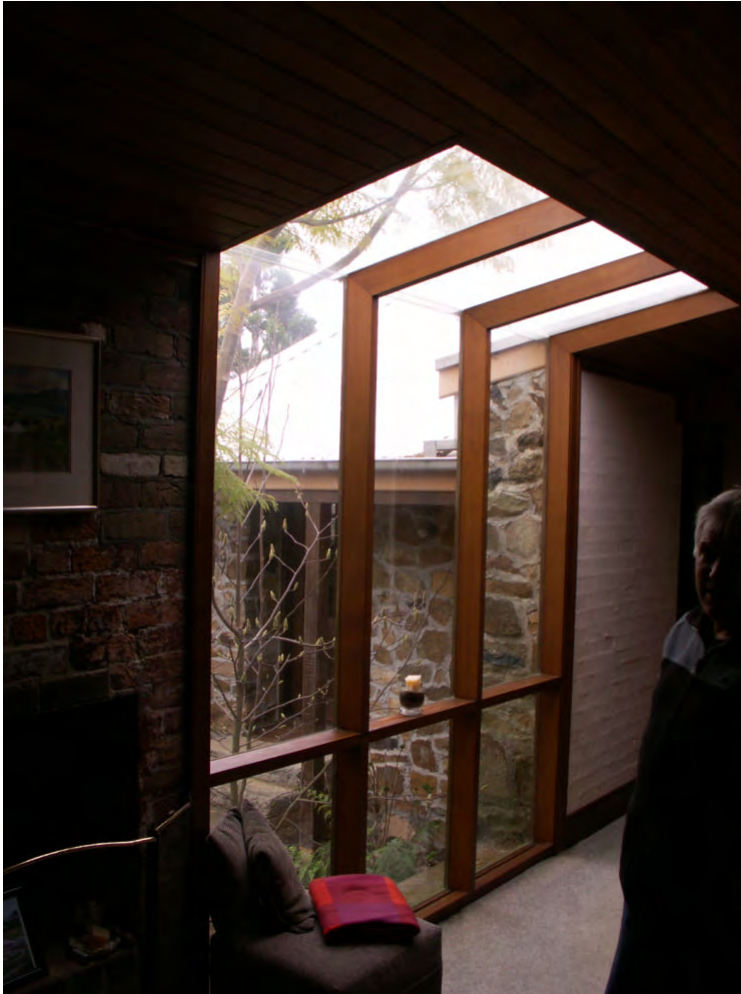
Fig. 5.3.10 Inclusion of 'Modern' conservatory element within new rear walls of Homestead mixes old and new in a practical way

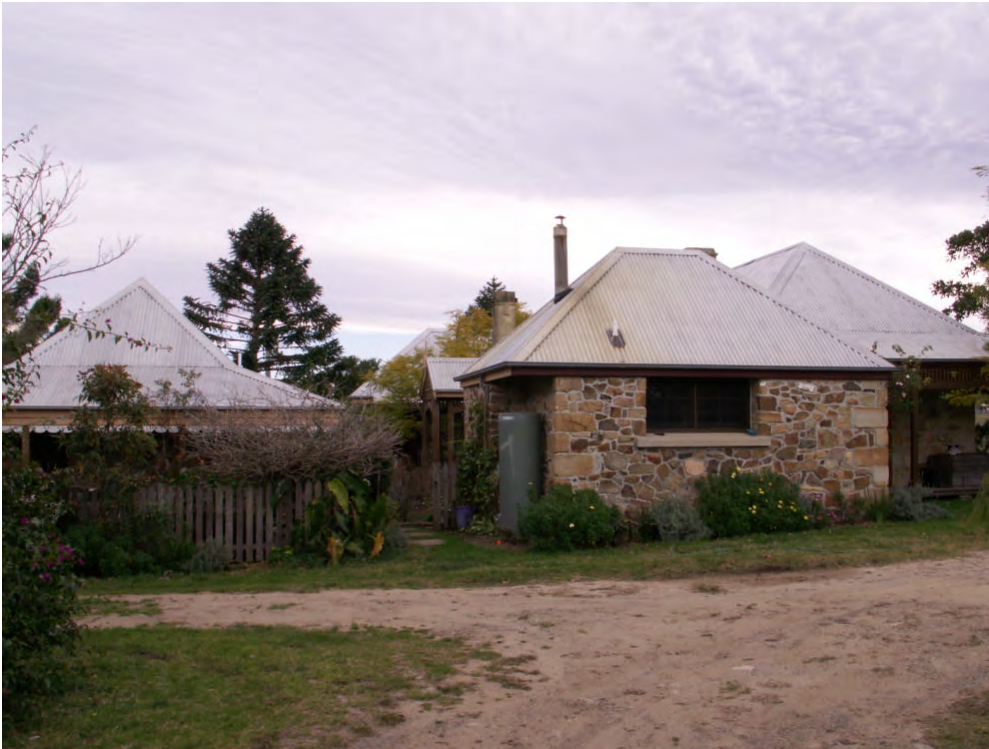
Fig. 5.3.11 East Elevation hipped roof forms appropriate use of materials, mix comfortably together in the building complex

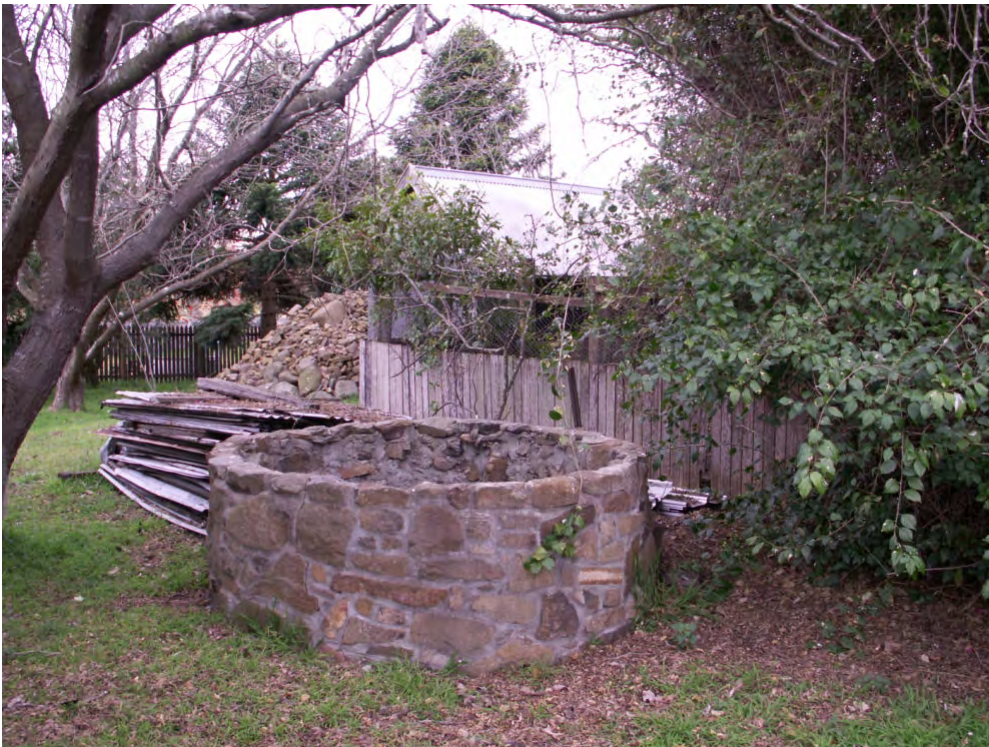
Fig. 5.3.12 Original well protected by recent stone wall located within the centre of the building complex
