HERITAGE IMPACT STATEMENT

29 AUG 2007

CLAYDON PARK

75 CROOBYAR ROAD
MILTON NSW 2539

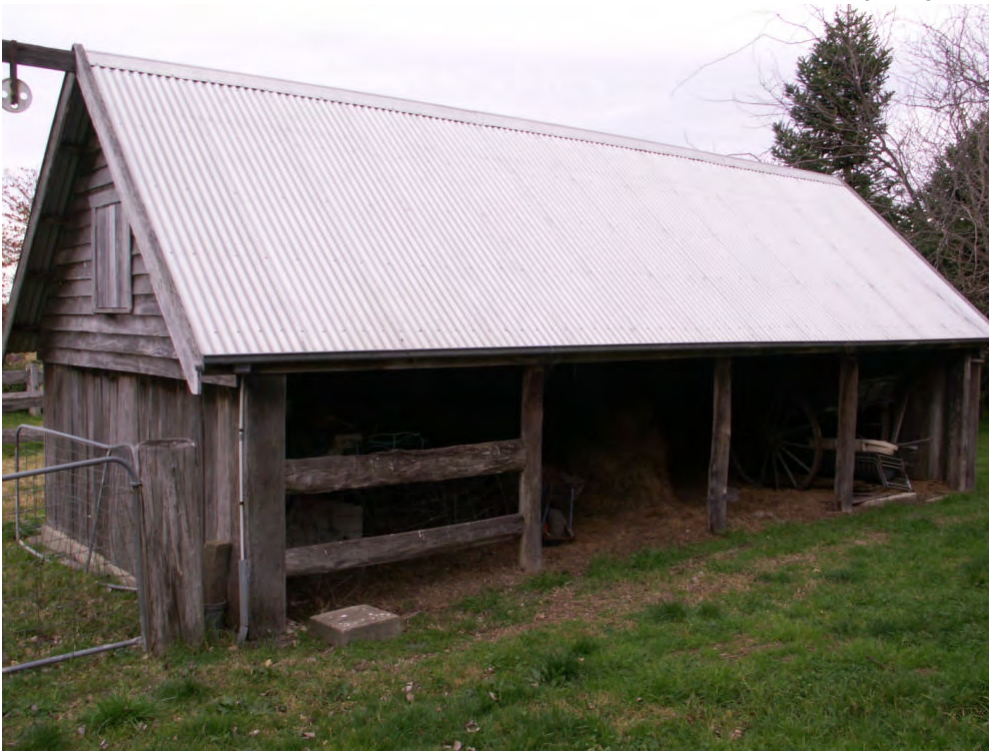
Fig. 5.3.13 Original in-line dairy building

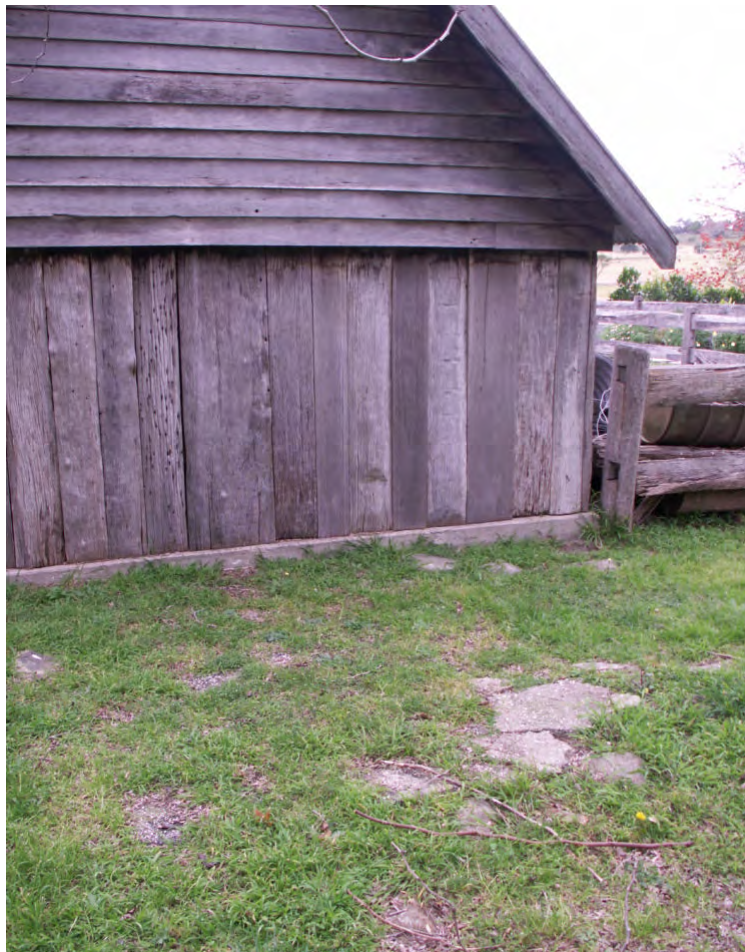
Fig. 5.3.14 West Elevation of original Dairy building with remnants of original concrete paving batches at ground level (foreground)

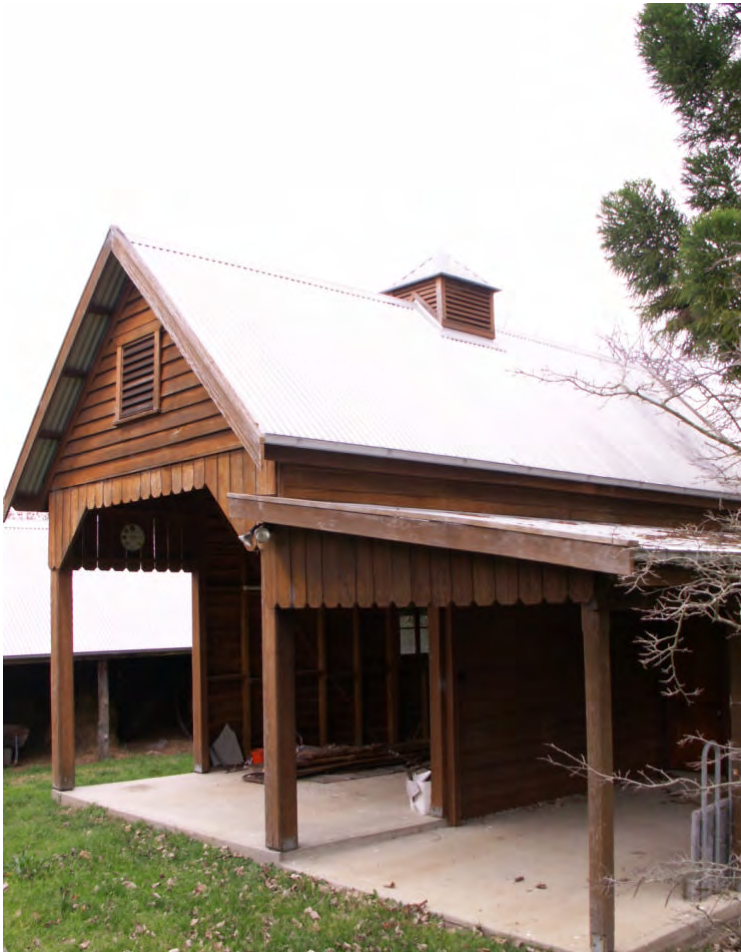
Fig. 5.3.15 Timber farm machinery shed and carport – more recent construction in a sympathetic style and materials used

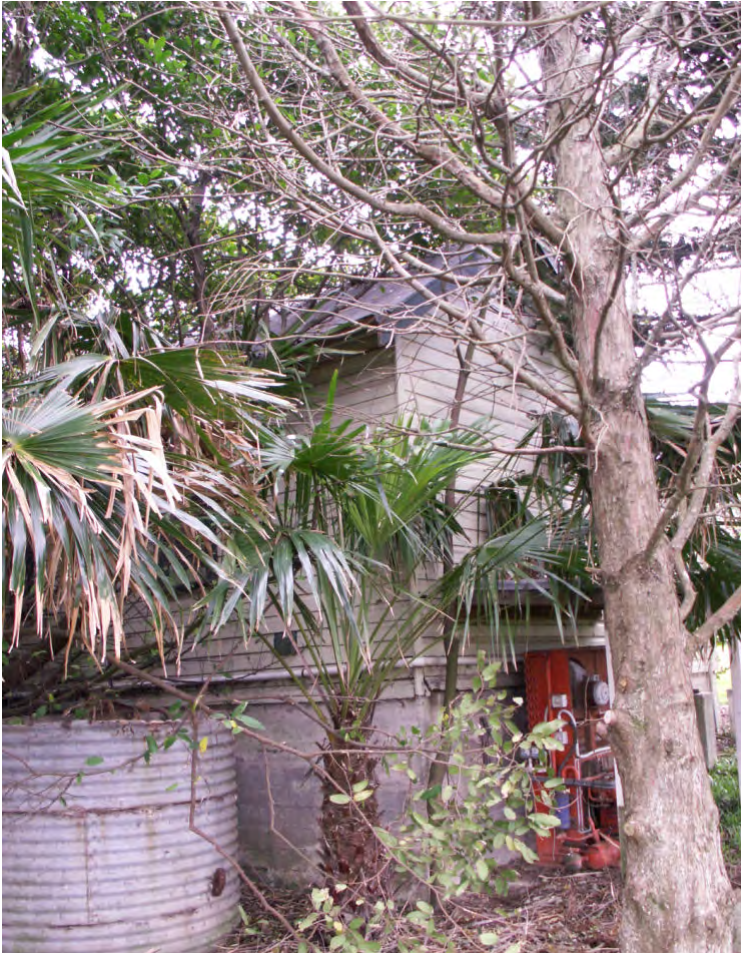
Fig. 5.3.16 Original timber storage building for milking facilities

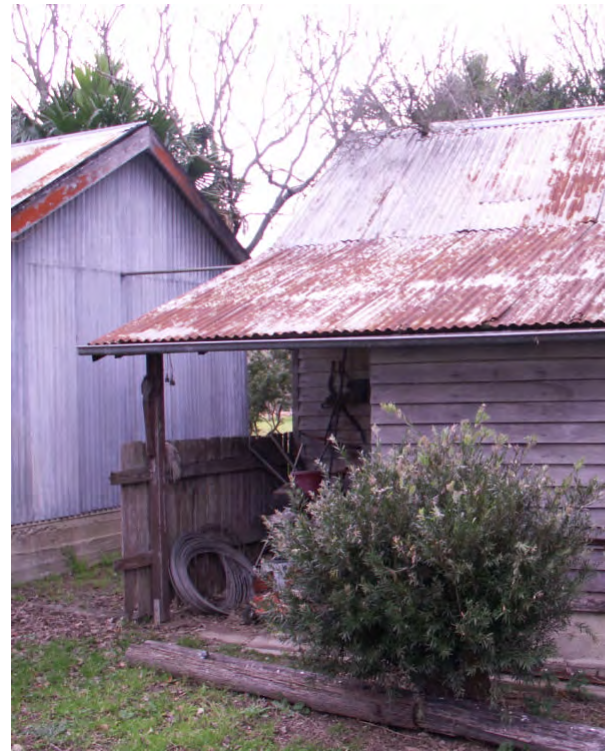
Fig. 5.3.17 South-East corner of 'new' dairy constructed around 1930, with rainforest section in foreground. This was planted by current owner

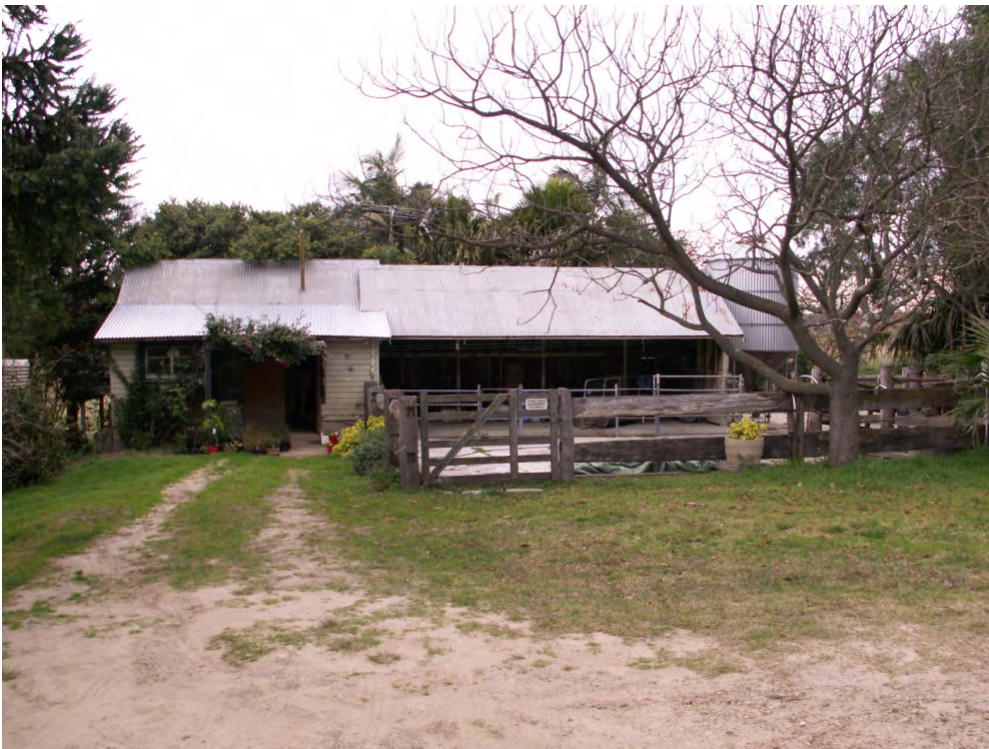
Fig. 5.3.18 Current Milking shed and holding yard

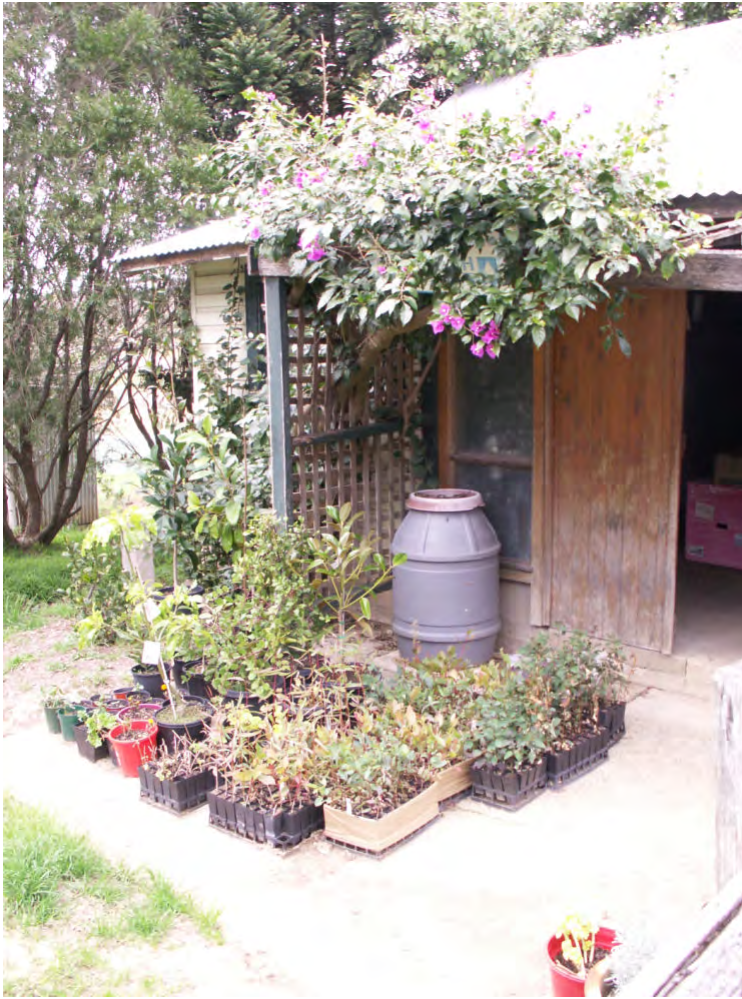
Fig. 5.3.19 Seedling & plant propagation area ready for transplanting to farm tree planting areas

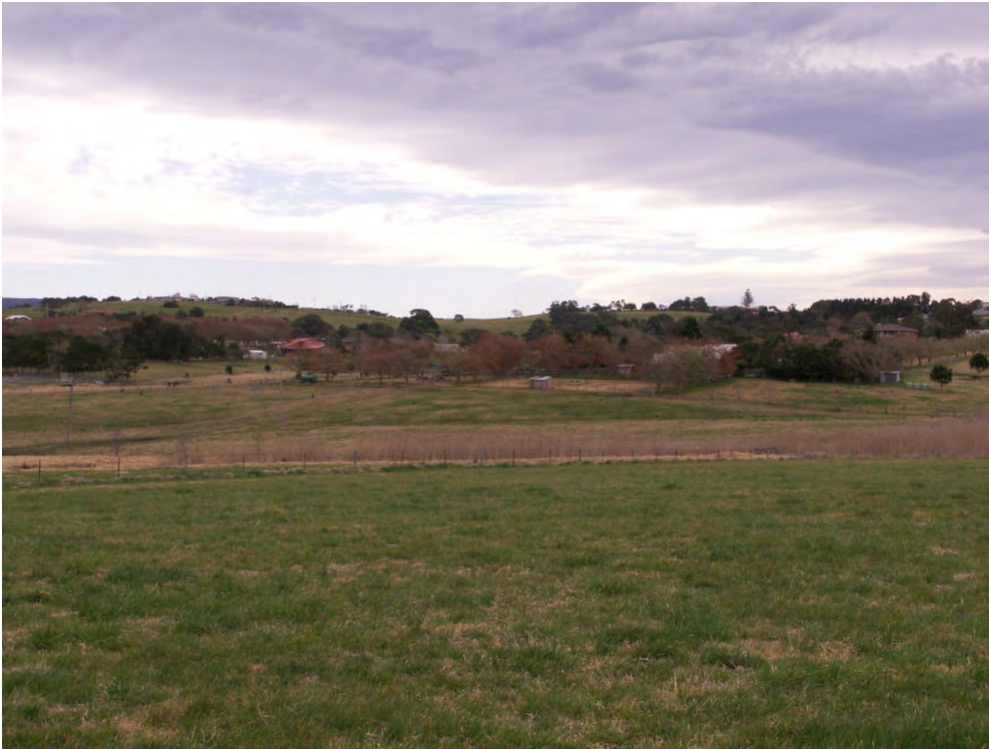
Fig. 5.4.1 Northern view over farm, building complex in centre, showground area to left, edge of Milton township on right

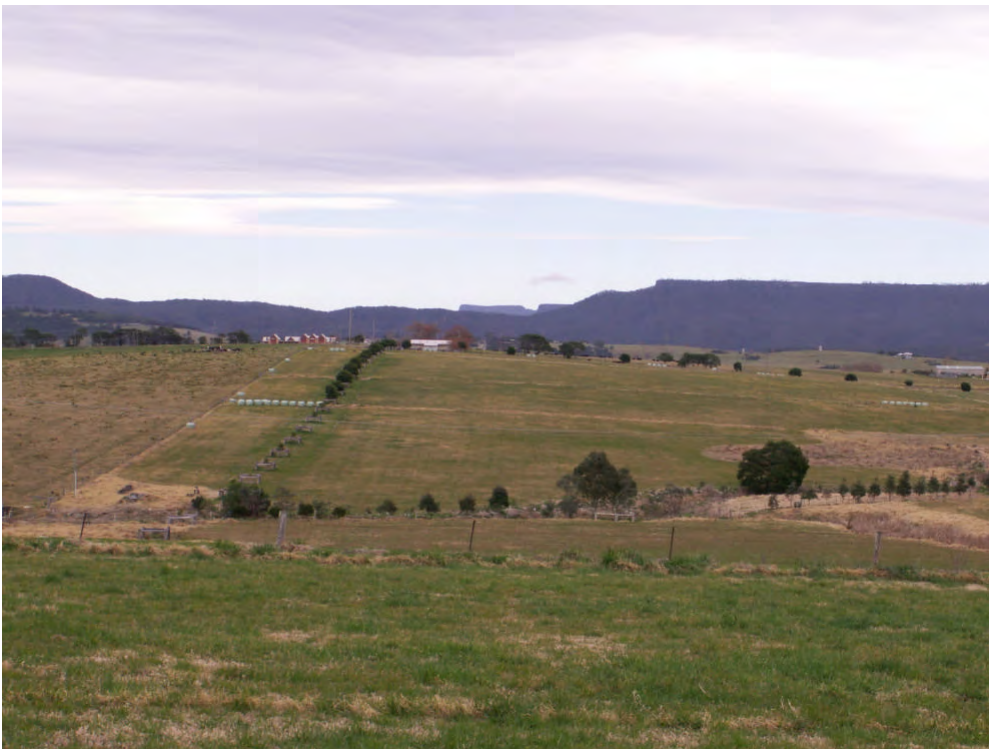
Fig. 5.4.2 Westward view over farm – note ficus & magnolia tree line Northward of Southern property boundary

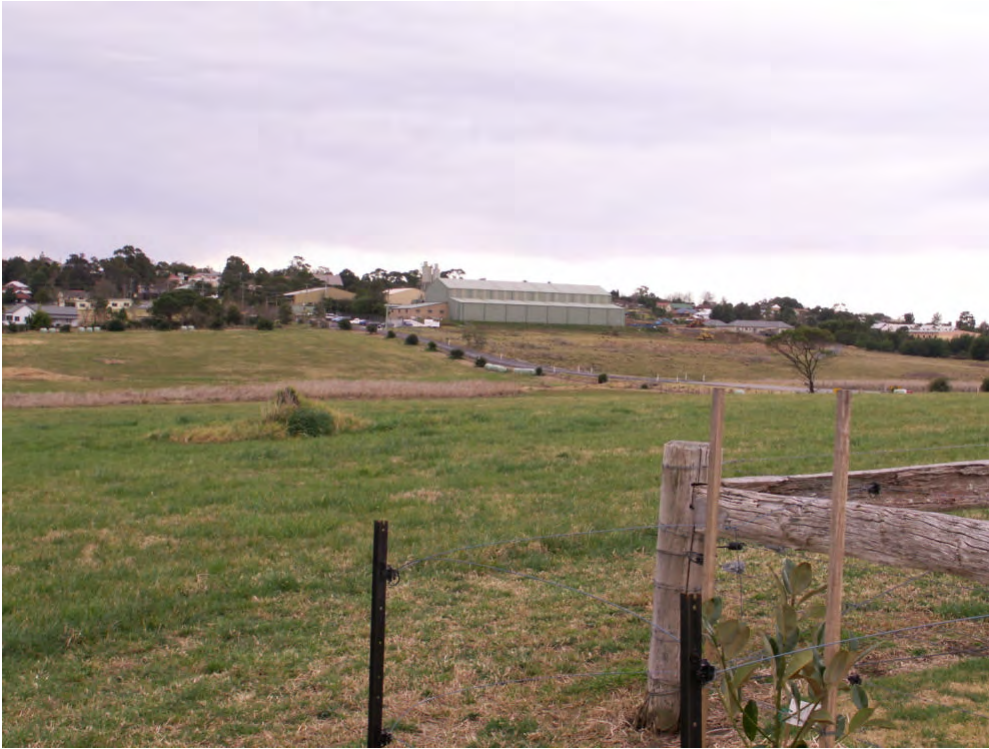
Fig. 5.4.3 Eastward view over farm – note unfortunate visual intrusion of commercial shed opposite farm on Wilfords Lane, however note Fig Tree lin in Eastern boundary of Claydon Park

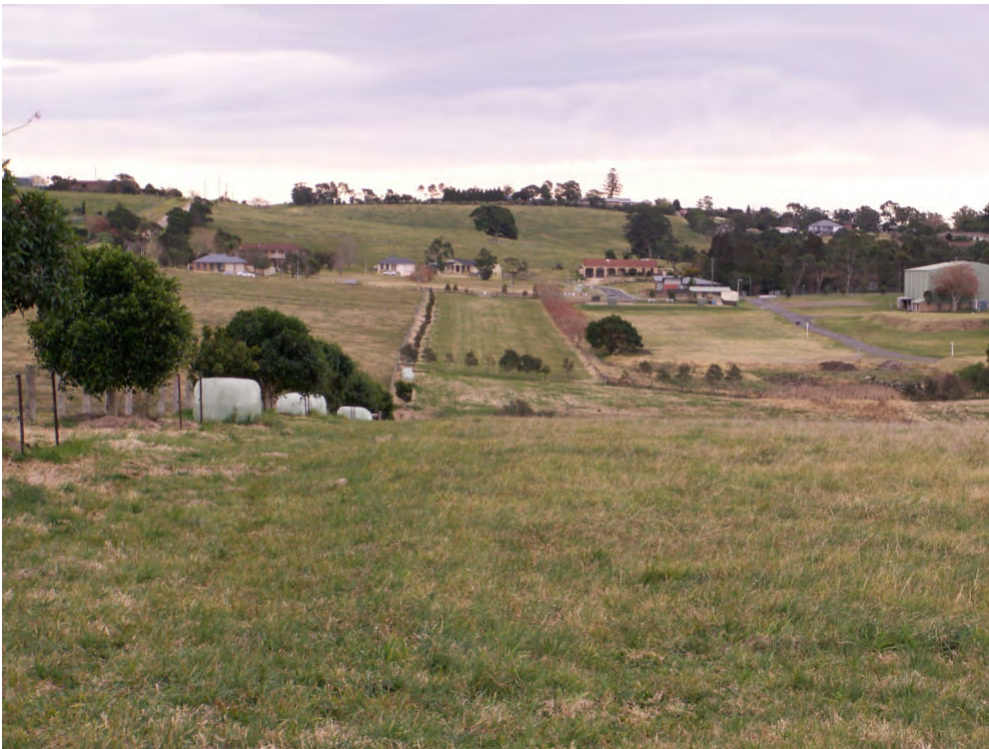
Fig. 5.4.4 North view along West boundary of site – note the finger of land adjacent to showground between tree lines will form basis of one access point into new development area – open space along finger and land in foreground will be retained as agricultural uses

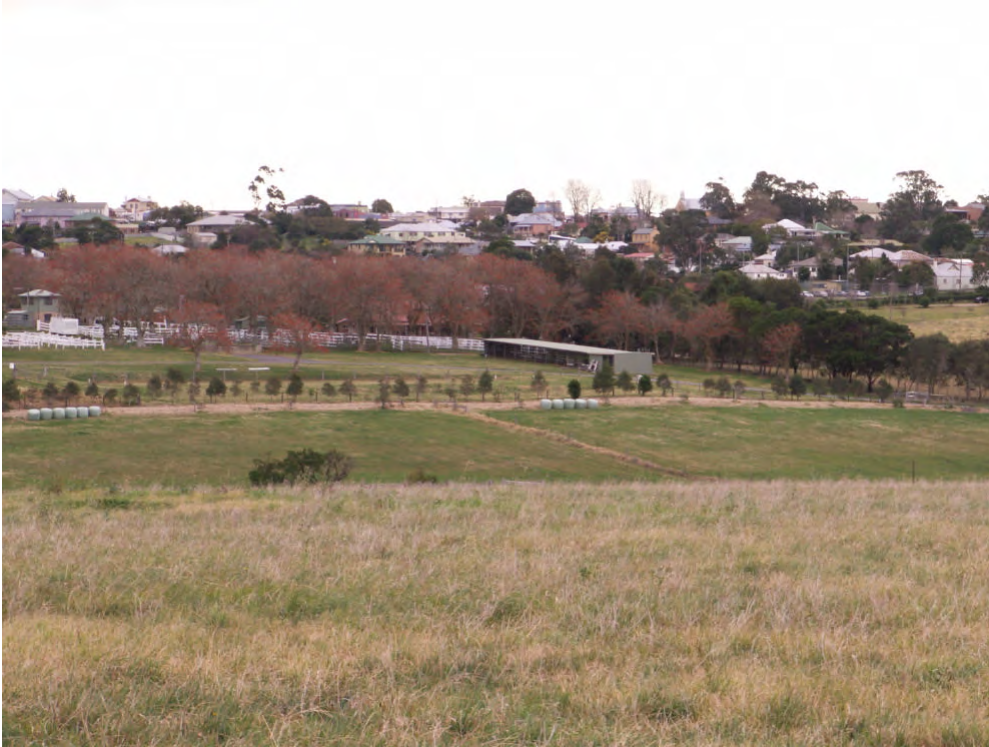
Fig. 5.4.5 North view from farm over showground to town urban area – note significant contribution to visual character by prominent mature trees

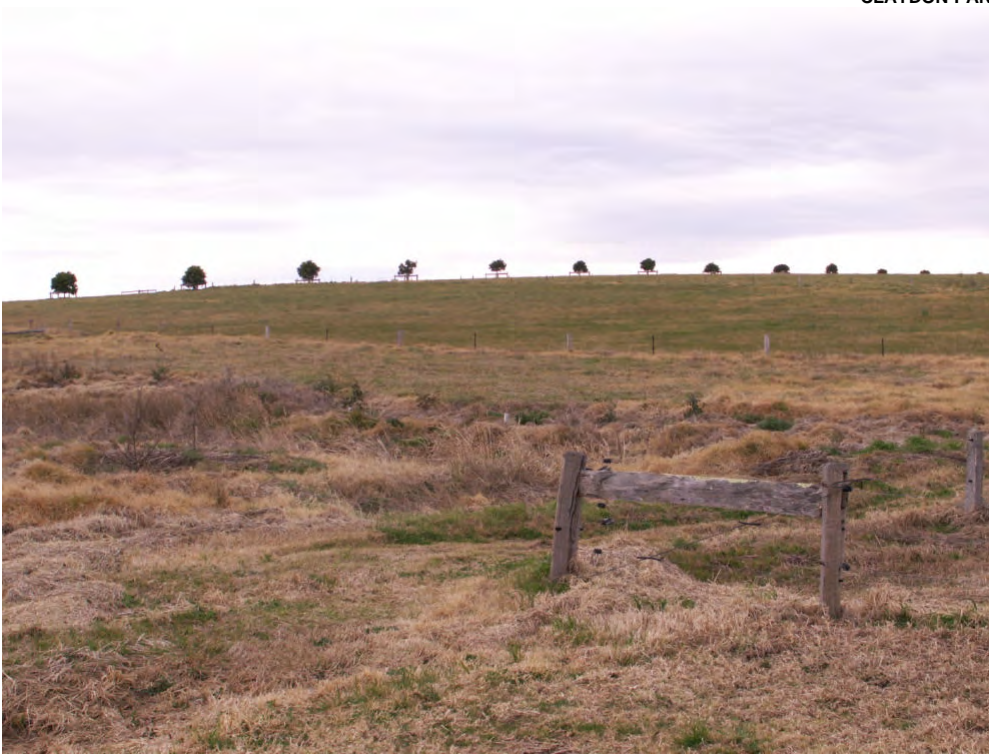
Fig. 5.4.6 Fig Tree line delineates Southern boundary – note middle ground to be reserved for agricultural use – foreground water course to be large water body

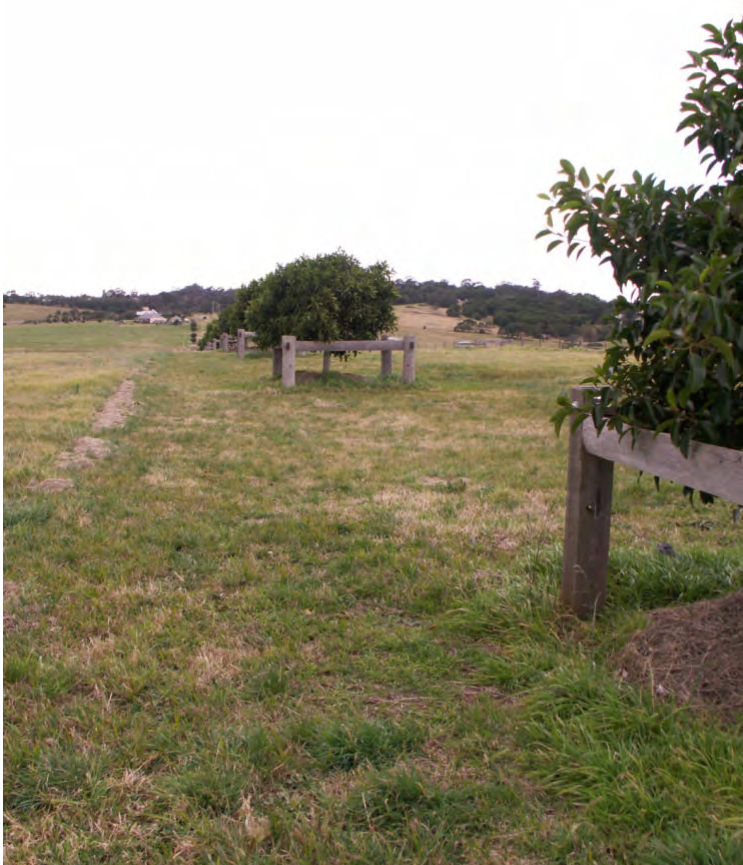
Fig. 5.4.7 Detail of Fig plantings – In time these will mature to become a major landscape feature and will edge a proposed rear walking trail around the site

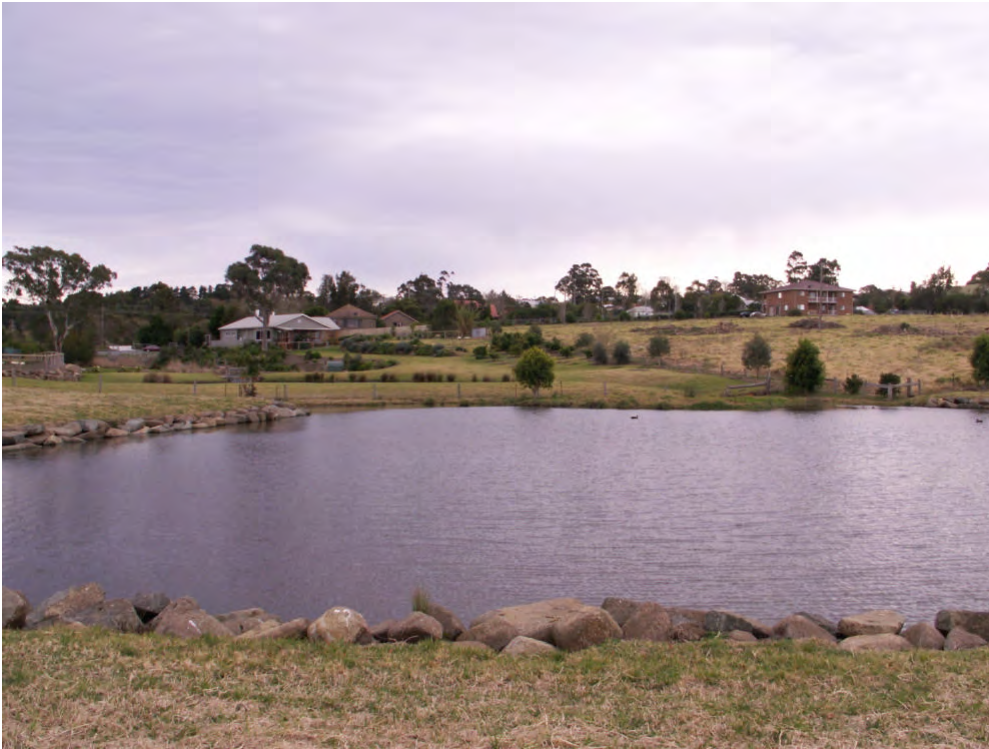
Fig. 5.4.8 Recent dam on Western side of Homestead – Looking North from site towards neighbour and grassed paddock behind two storey dwelling as site for Residential Care Facility

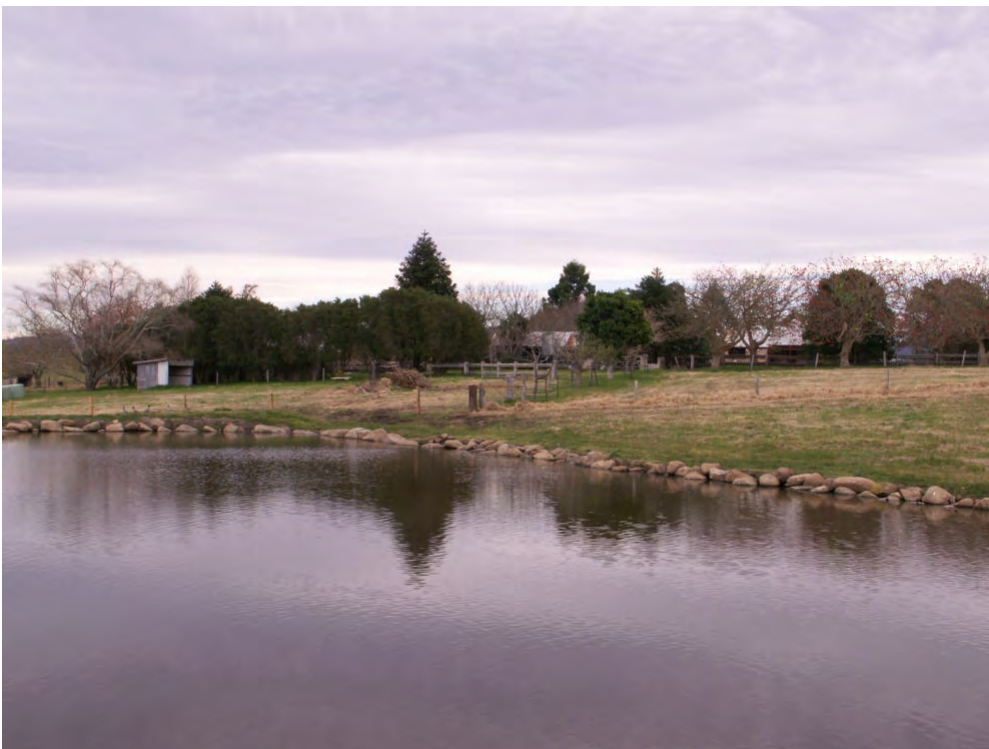
Fig. 5.4.9 Dam on Eastern side of Claydon Park dairy building complex – note impact of substantial tree planting screening all buildings and also making the extent of this complex

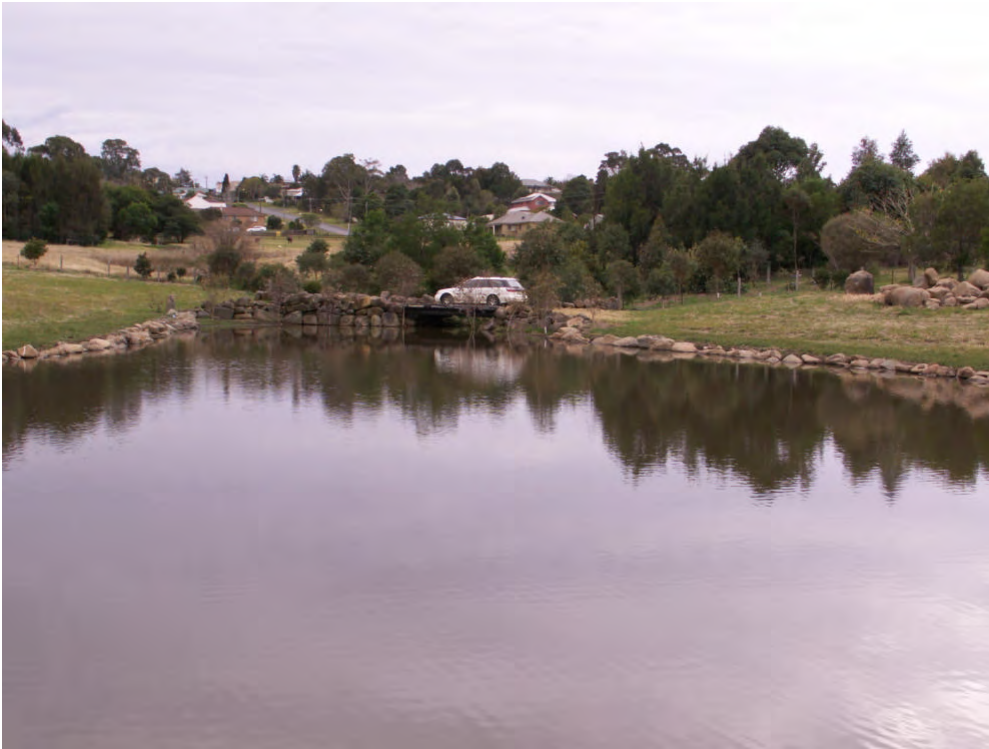
Fig. 5.4.10 View over East dam towards township – note bridge over water course, well established planting in riparian zone, Fig Tree screen commencing on LHS
