62-80 Rowe Street and 20 First Ave Eastwood

DEMOLITION REPORT

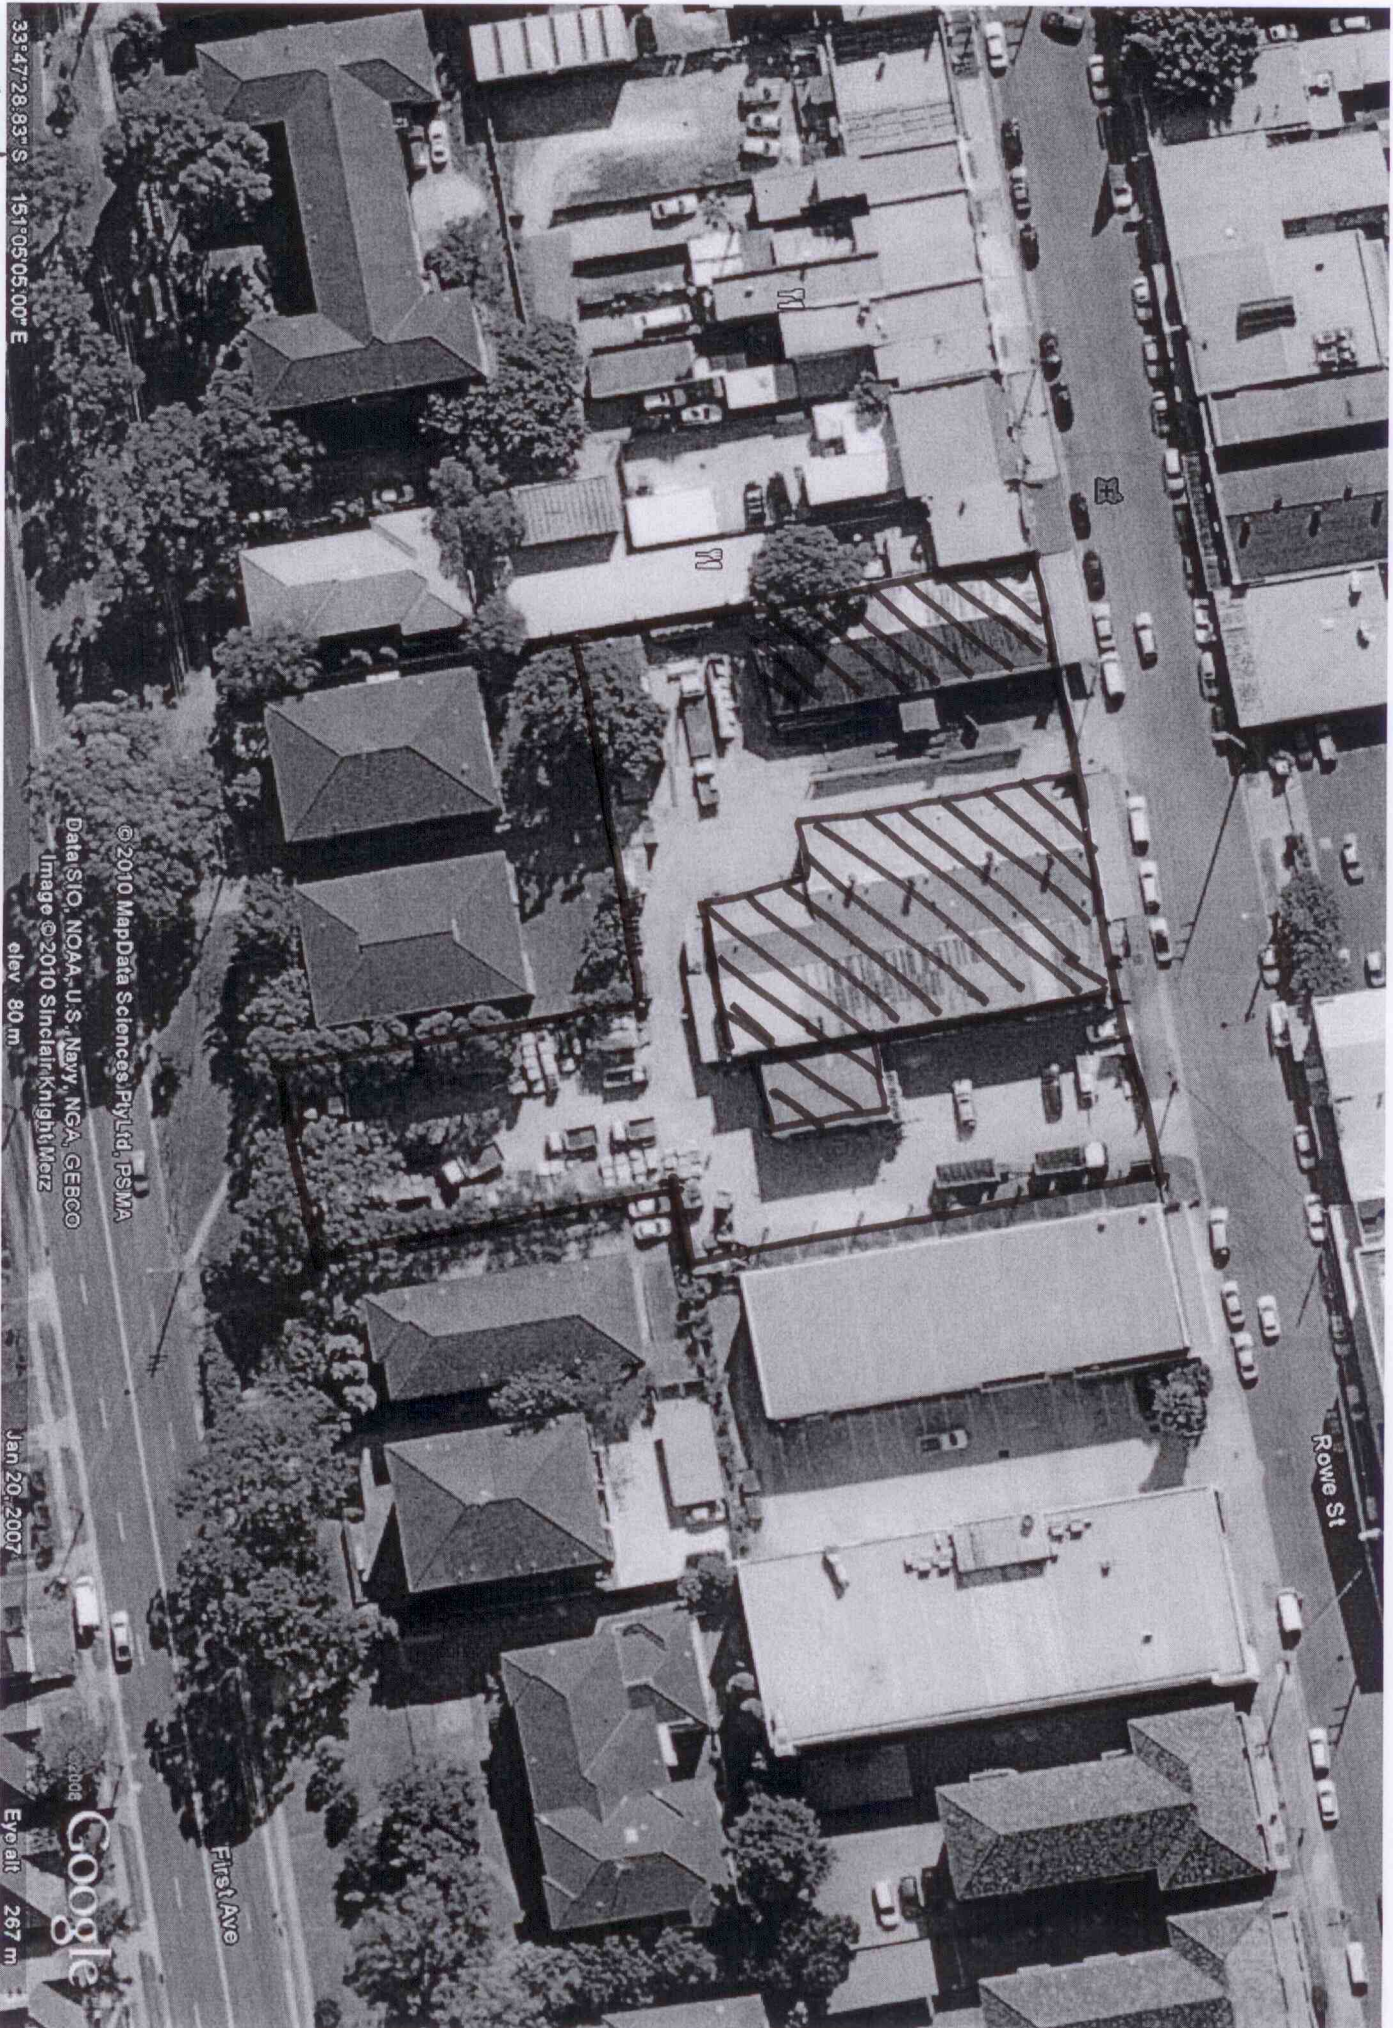
62-80 ROWE ST EASTWOOD

EXISTING

BUILDINGS TO BE DEMOLISHED
