PROJECT
LAKE MUNMORAH CATHOLIC HIGH SCHOOL
48 - 54 CARTERS ROAD, LAKE MUNMORAH

TITLE
STAGING PLAN

DRAWING TITLE
Tree Protection and Removal Plan

DRAWING NUMBER
T-02

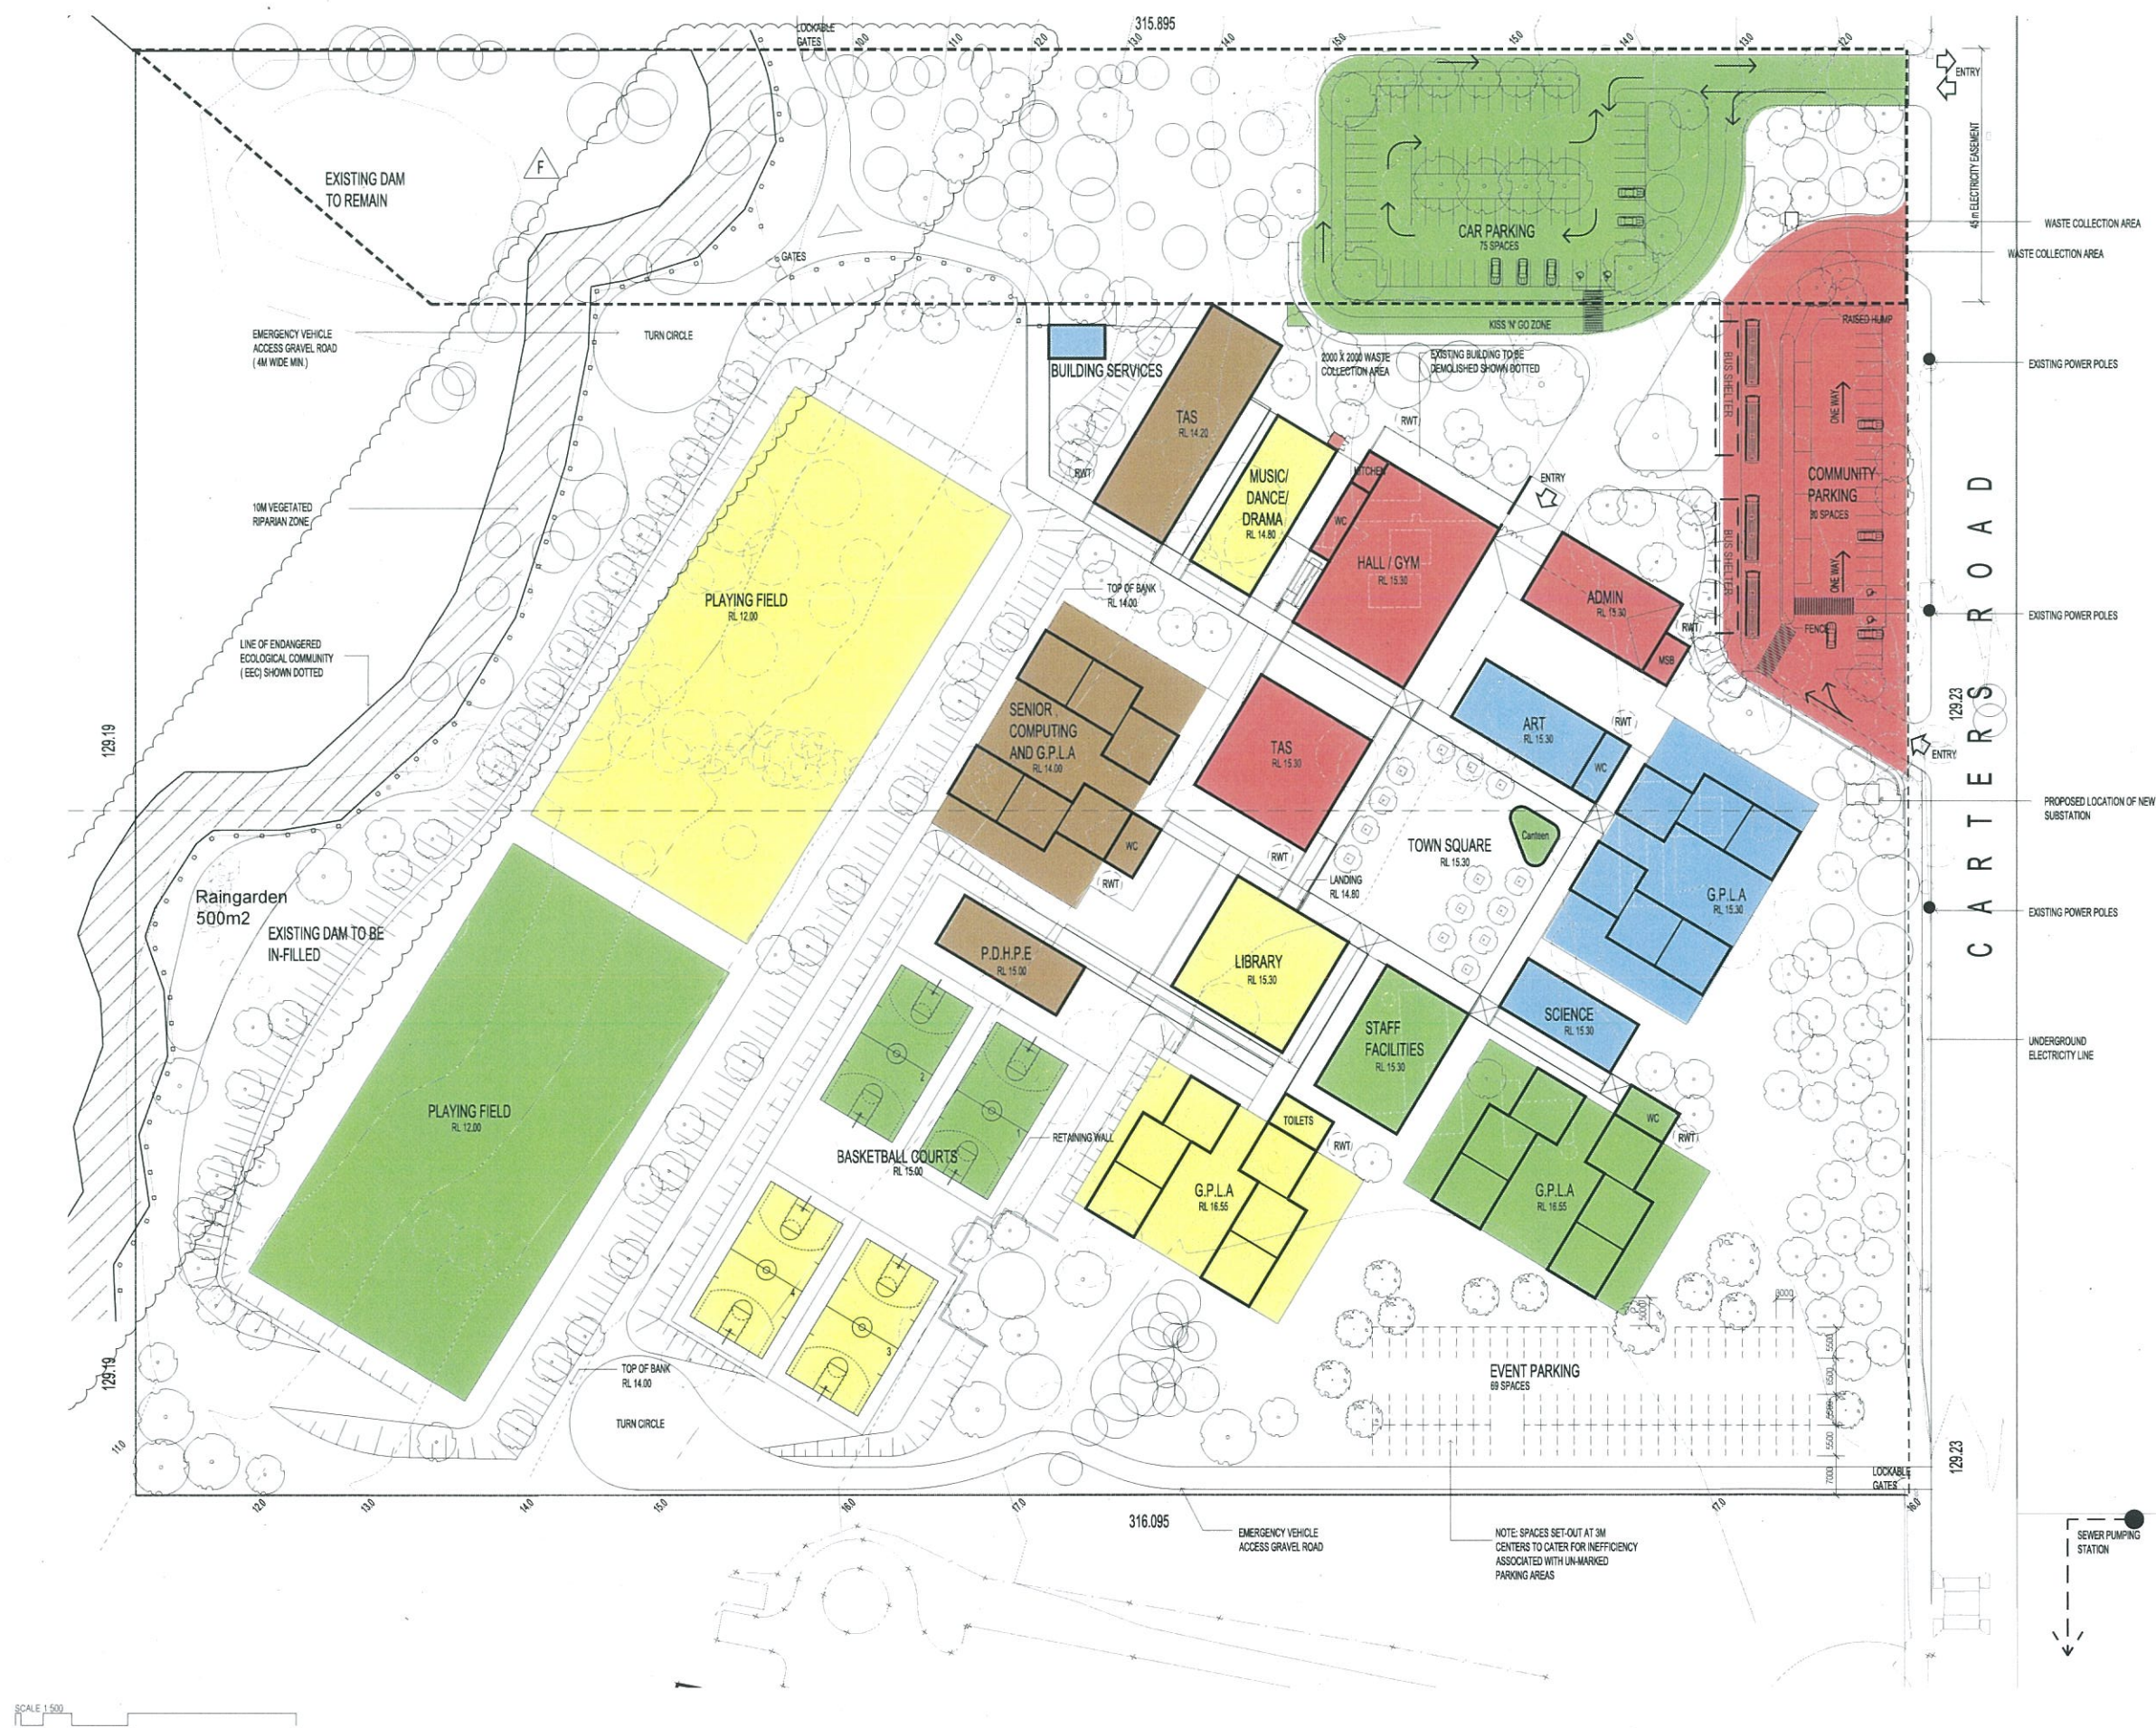
SCALE 1:500 @ B1	CHECKED MG
DRAWN MK	APPROVED
PLANT DATE 15/04/2013	
PROJECT No DBB 2301	DRAWING No A004
	ISSUE F

STAGING LEGEND		BUILDINGS
STAGE 1	A,B,C	
STAGE 2	D,E,F,R	
STAGE 3	G,H,J	
STAGE 4	K,L,M	
STAGE 5	N,P,Q

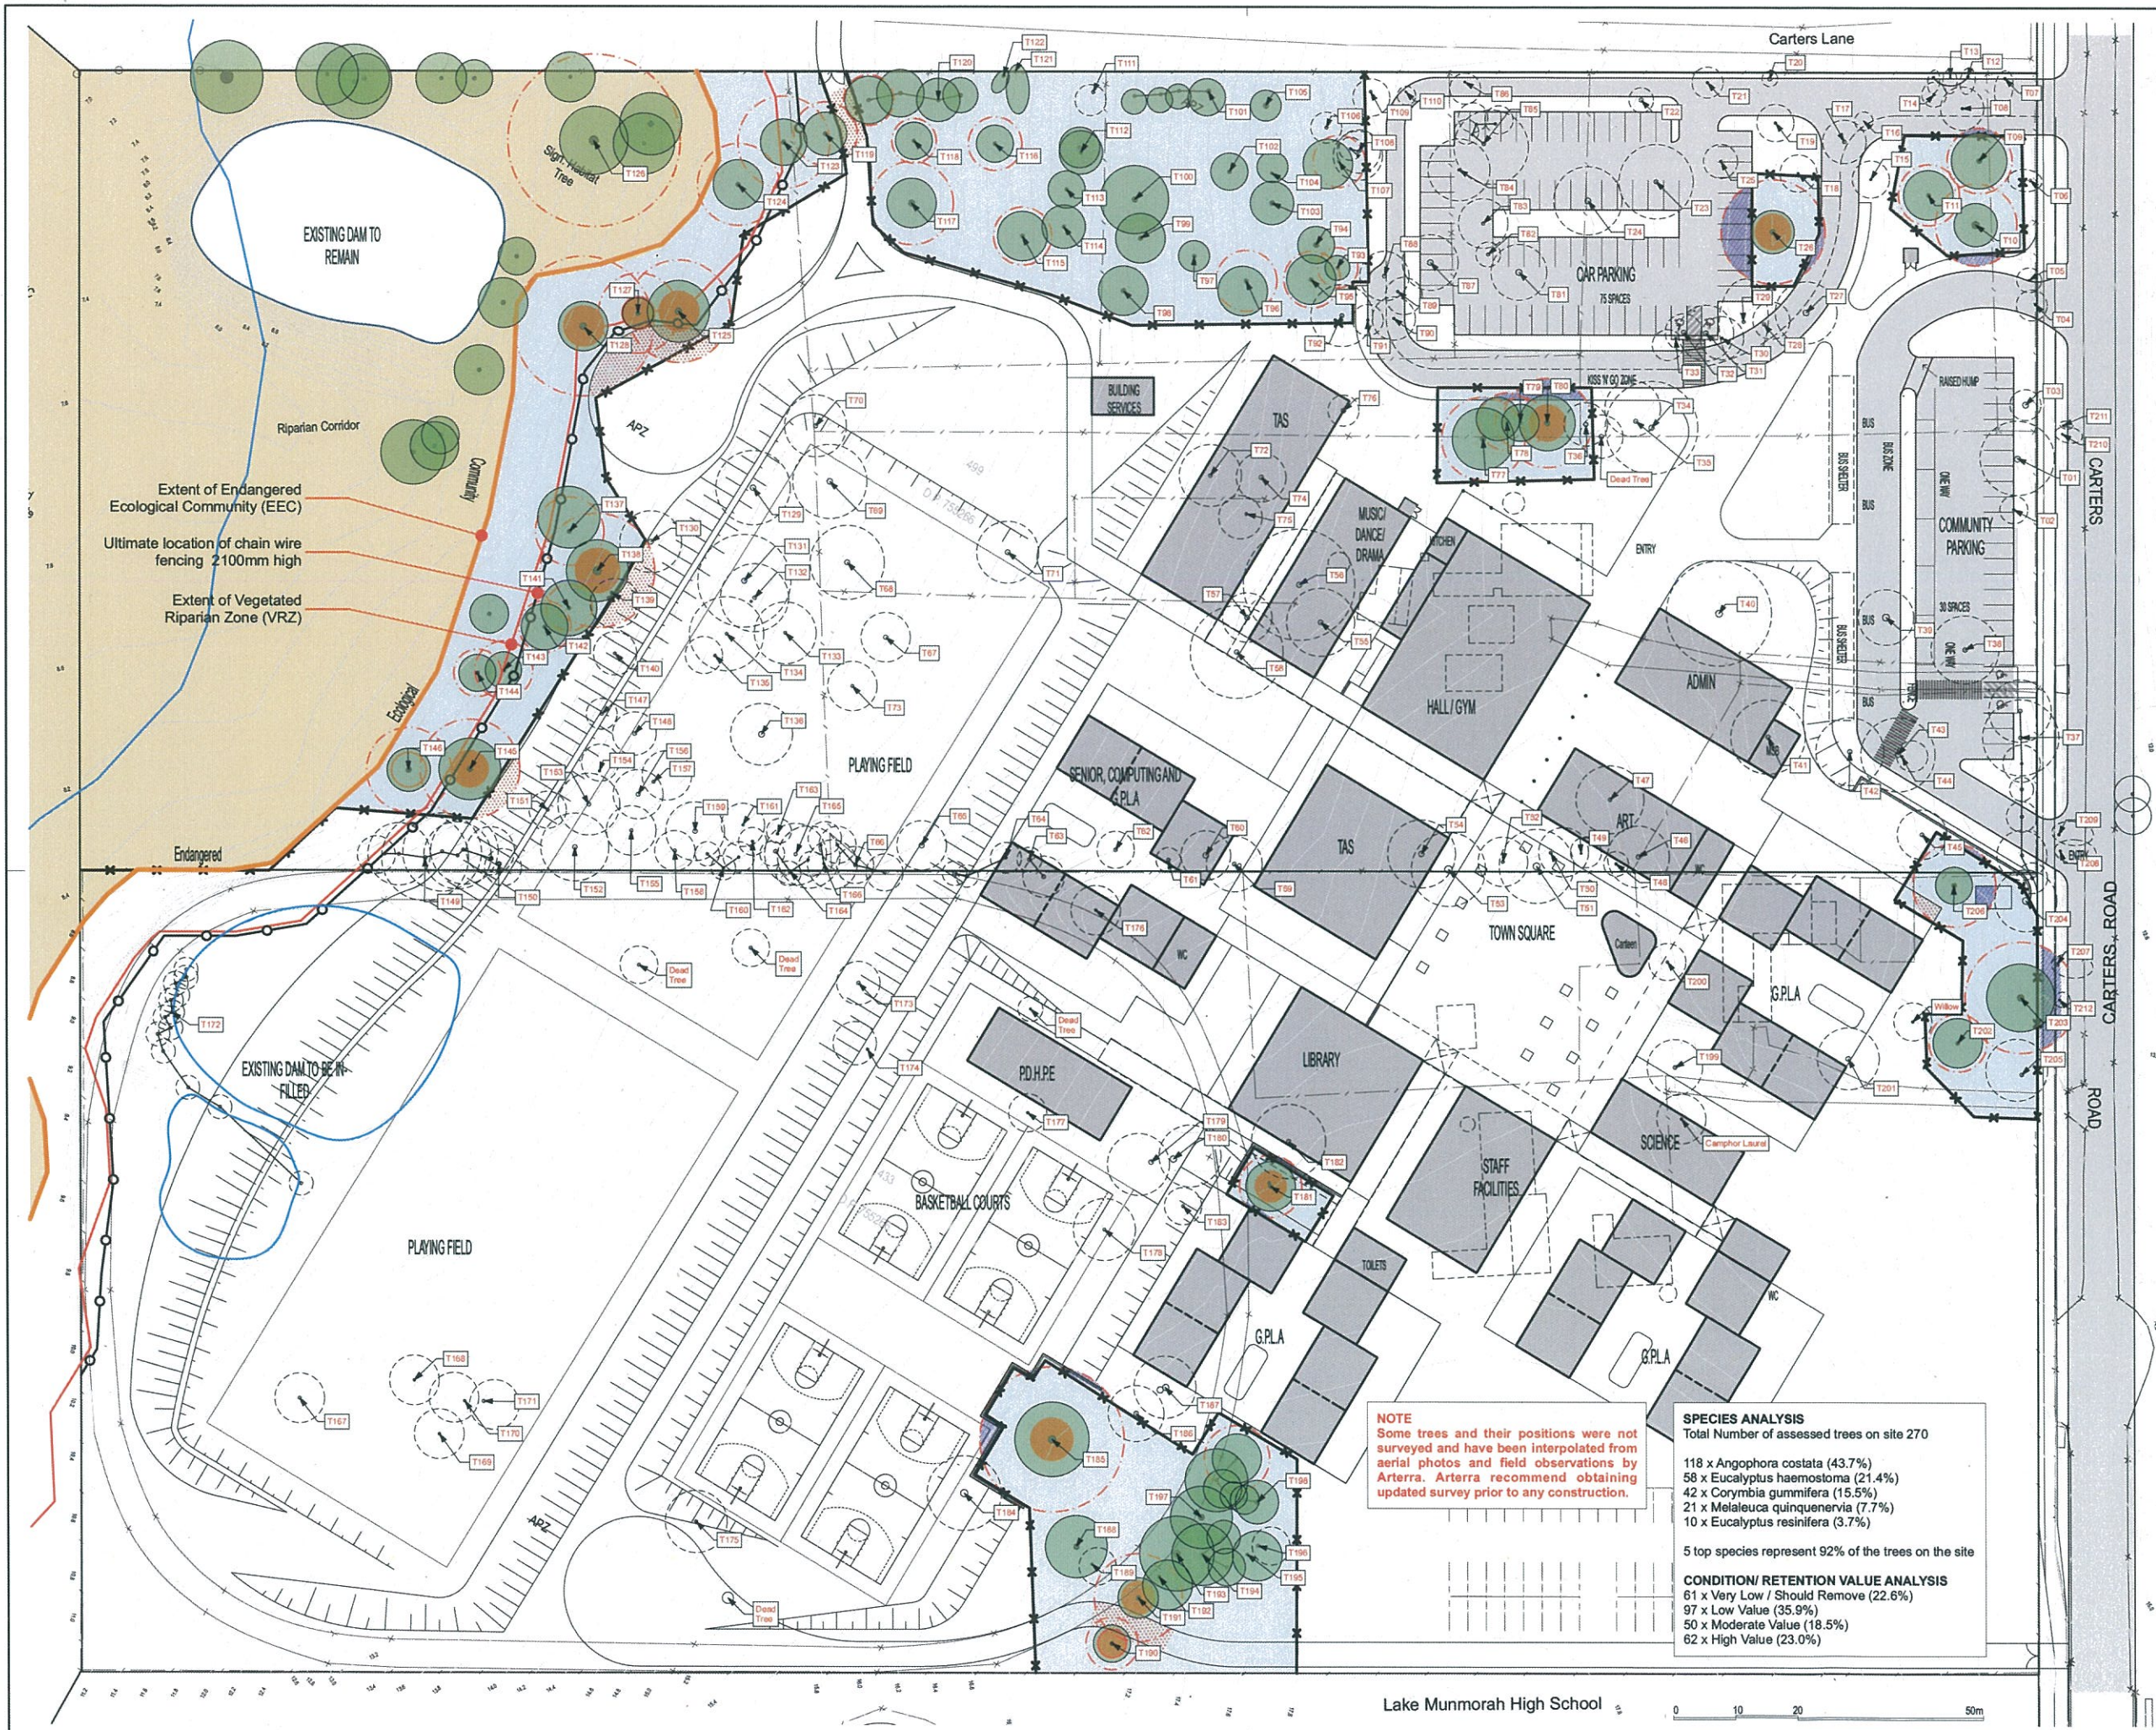
- Existing Tree Retained
- Existing Tree Removed
(Note: no TPZ's shown for these trees)
- Proposed Tree Protection Zone - consolidated area and temporary fencing
- Loss of roots due to excavation
- Surface impact to be managed - minimal root loss expected
- Nominal Tree Protection Zone Radius (TPZ)
- Nominal Structural Root Zone (SRZ) shown where relevant
- Tree Identification Number
- Approximate extent of EEC
- Proposed Future Building
- Existing building to be demolished
- Existing fencing

1. Refer to the accompanying Arboricultural Impact Assessment Report for full description of trees, measurements and methods used to assess the trees. Also provides details of proposed tree protection measures.

2. All trees outside of the extent of works shall be retained and protected. Seek advice from the nominated, superintendent and/or the Consulting Arborist for all works or access requirements that may impact on trees outside of the extent of works illustrated on this plan.

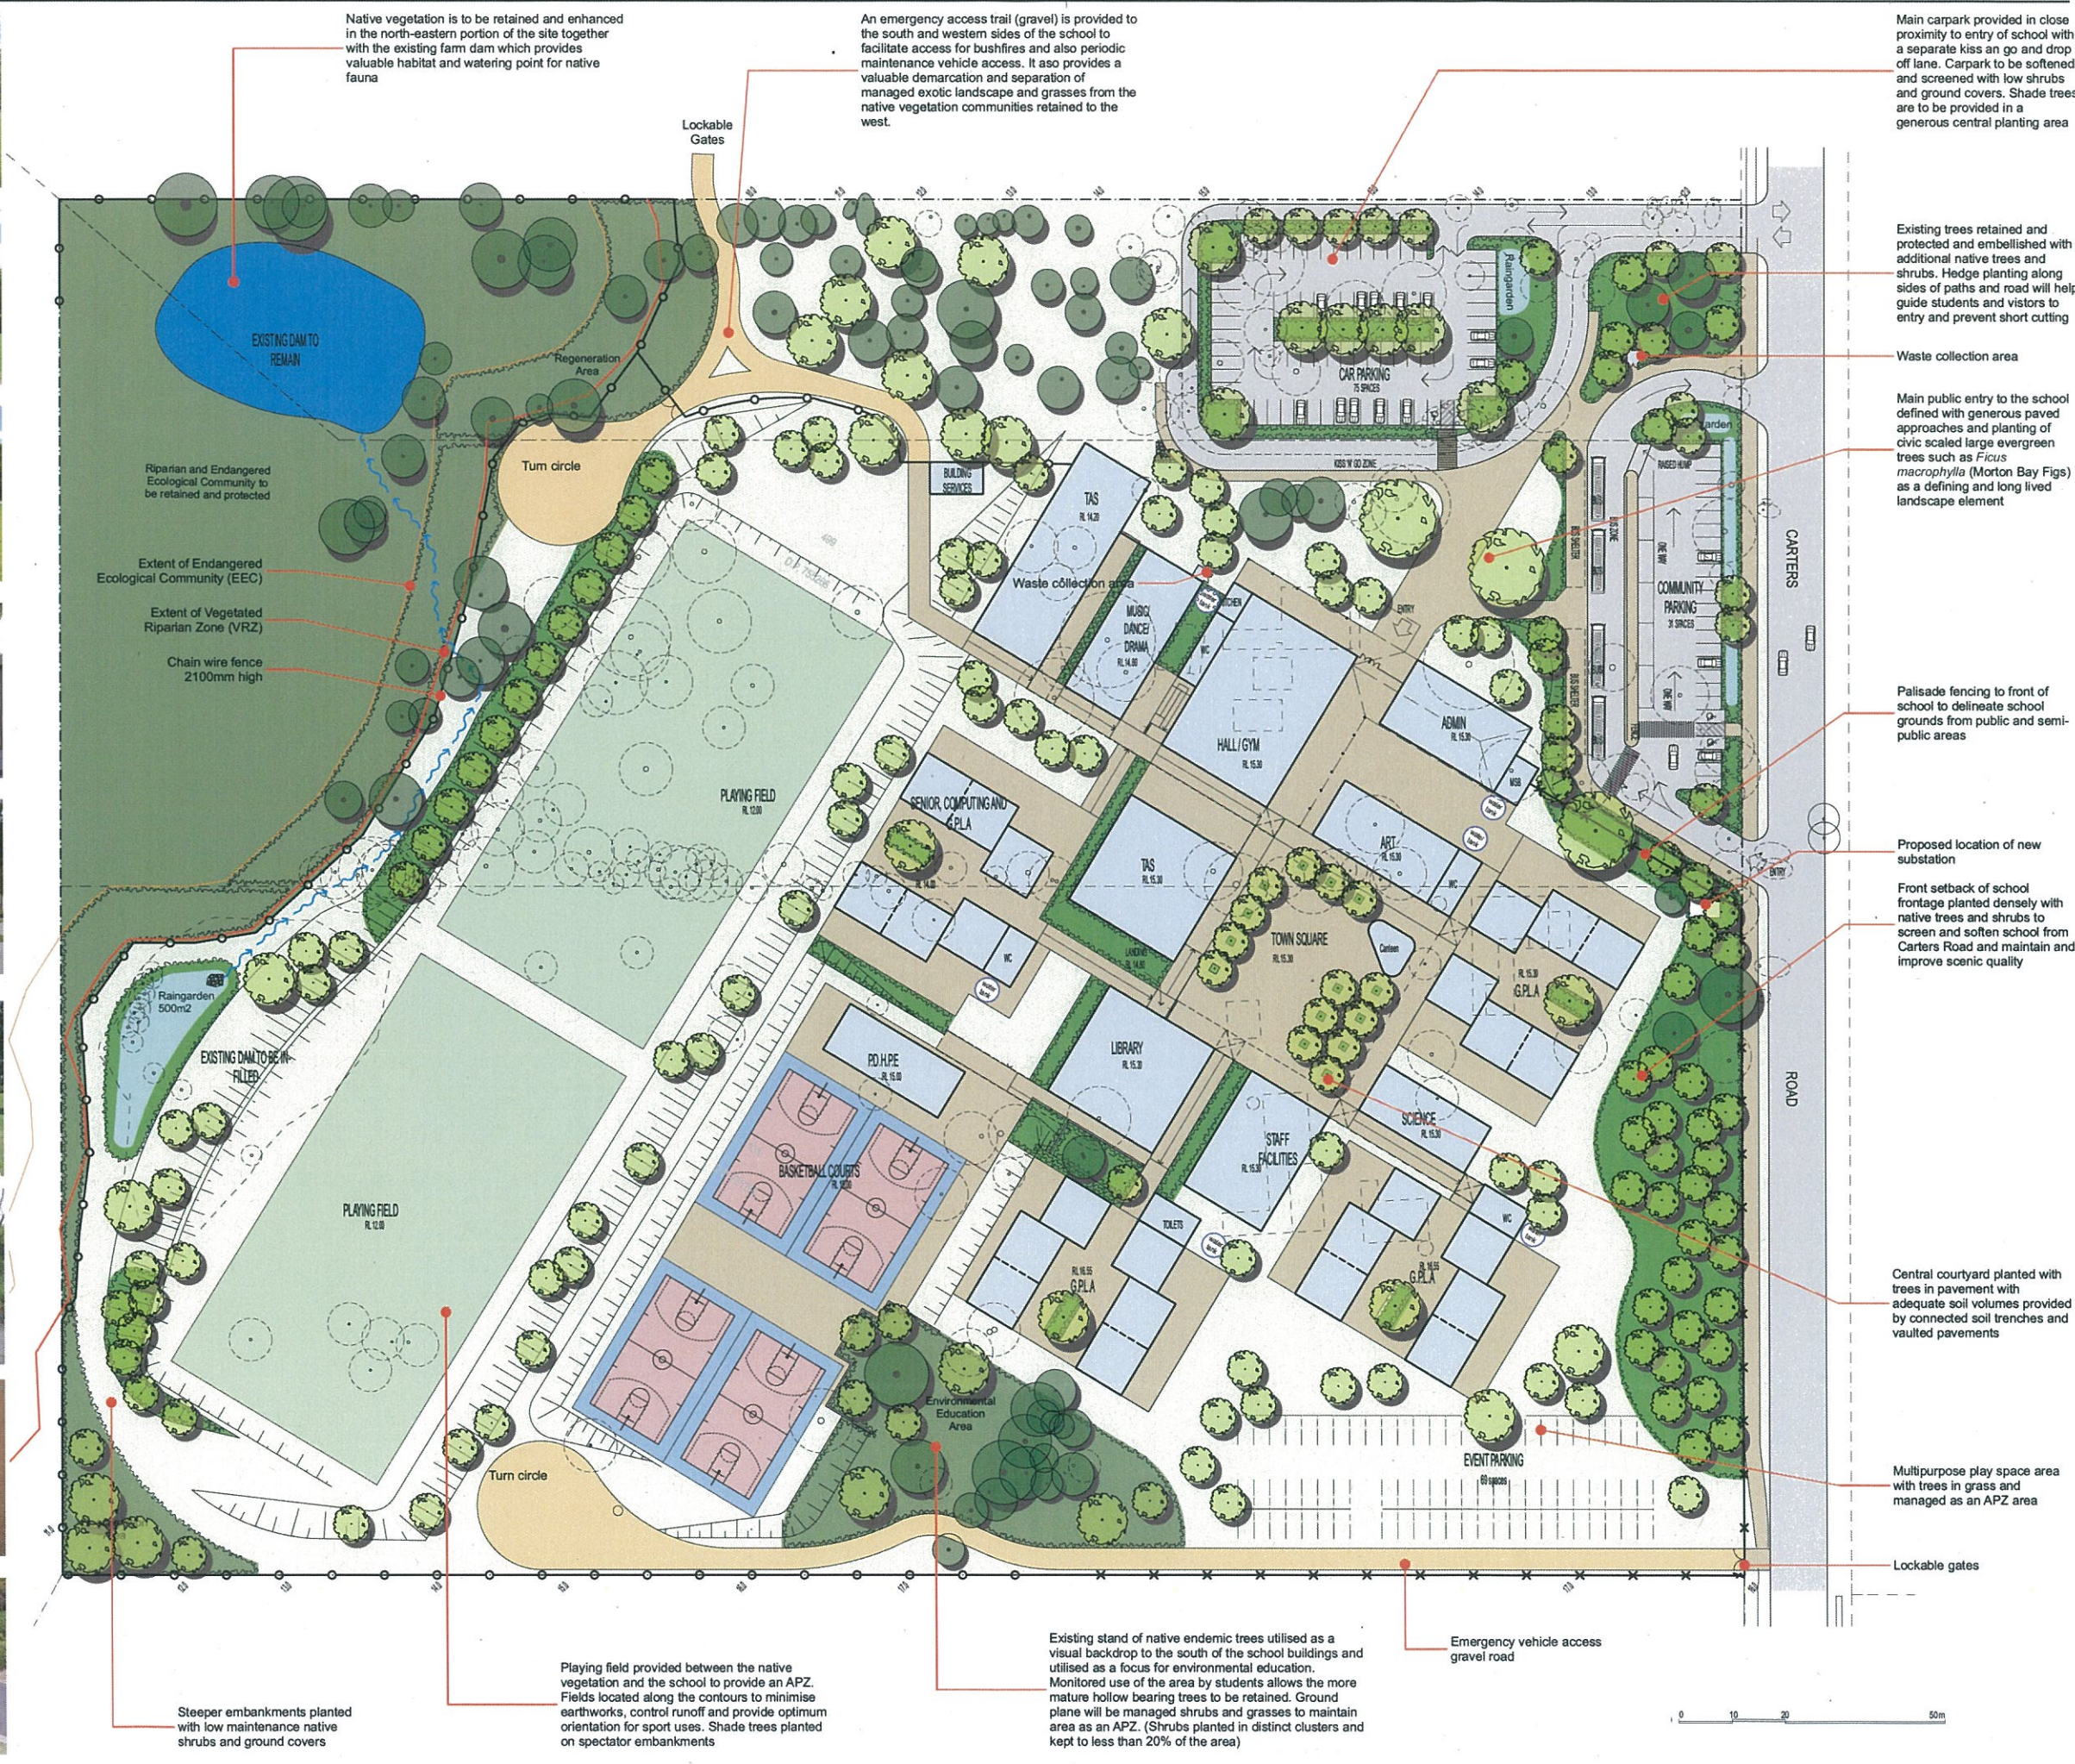
Lake Munmorah High School

NOTE
Some trees and their positions were not surveyed and have been interpolated from aerial photos and field observations by Arterra. Arterra recommend obtaining updated survey prior to any construction.

CONDITION/RETENTION VALUE ANALYSIS
61 x Very Low / Should Remove (22.6%)
97 x Low Value (35.9%)
50 x Moderate Value (18.5%)
62 x High Value (23.0%)
