Mulgoa Excavations Pty Ltd C/-  
Precise Planning

Hazardous Material Protocol:  
25 Martin Road,  
Badgerys Creek, NSW.

P1404242JR05V01  
August 2016

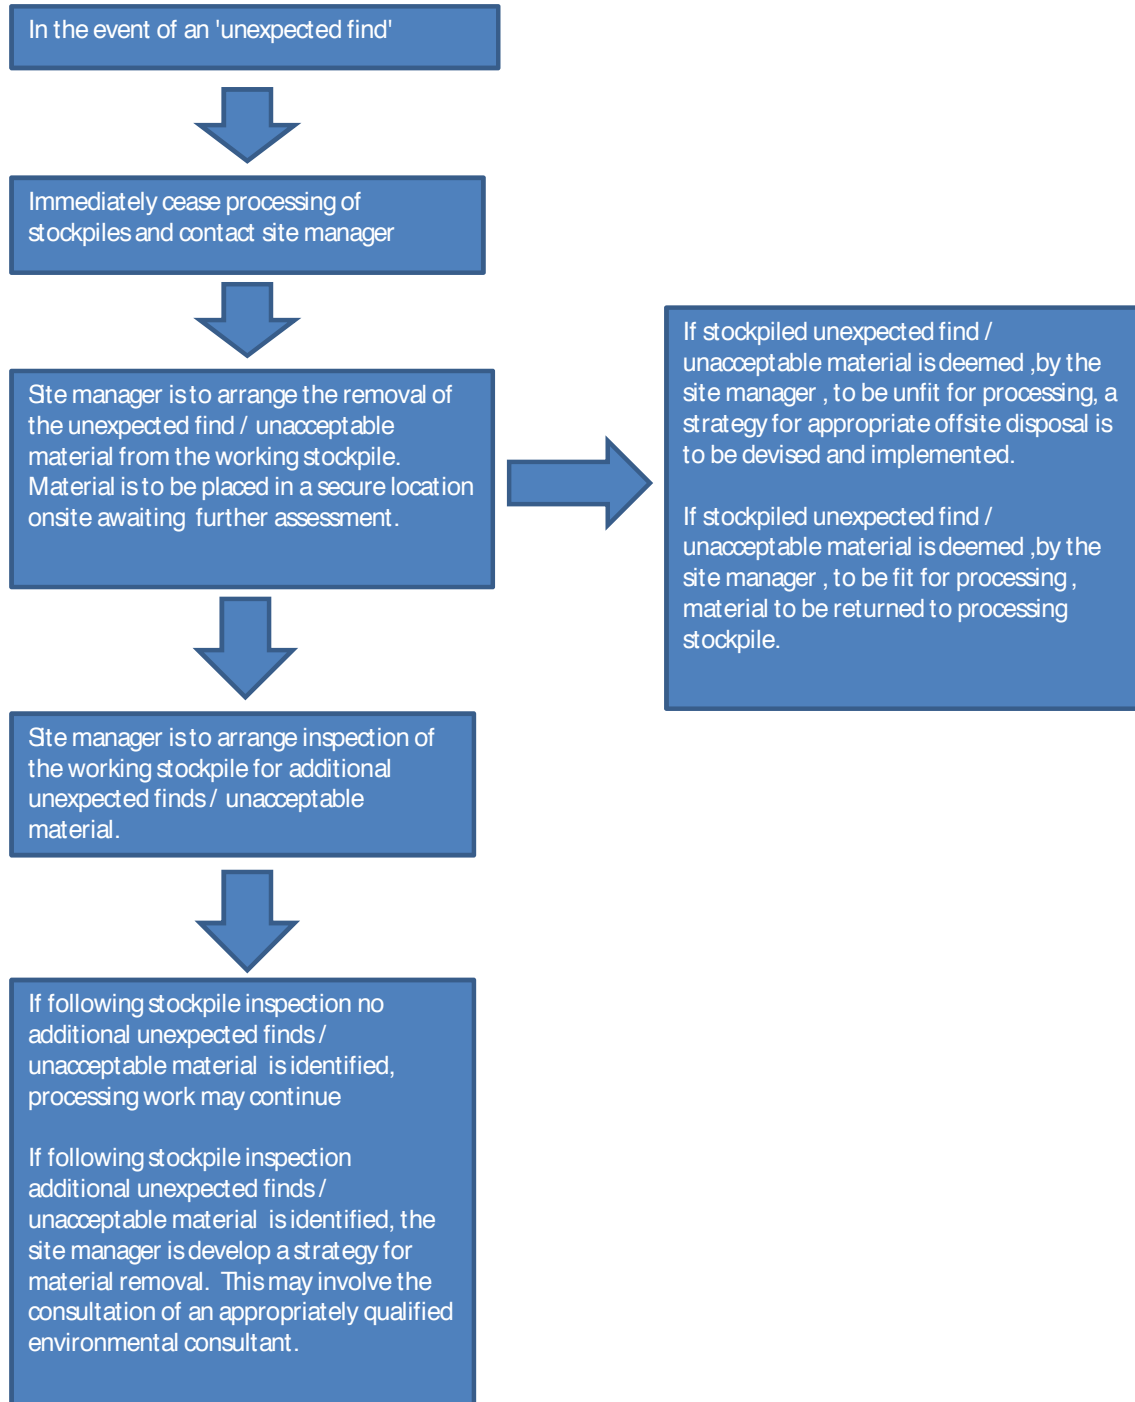
## Unexpected Finds Protocol

A flow chart outlining unexpected finds protocol is found in Attachment A.

## **8            Attachment A – Unexpected Finds Protocol**
