Remediation Action Plan

Edmondson Park Town Centre
Campbelltown Road
Ingleburn NSW 2565

Frasers Property

November 2015

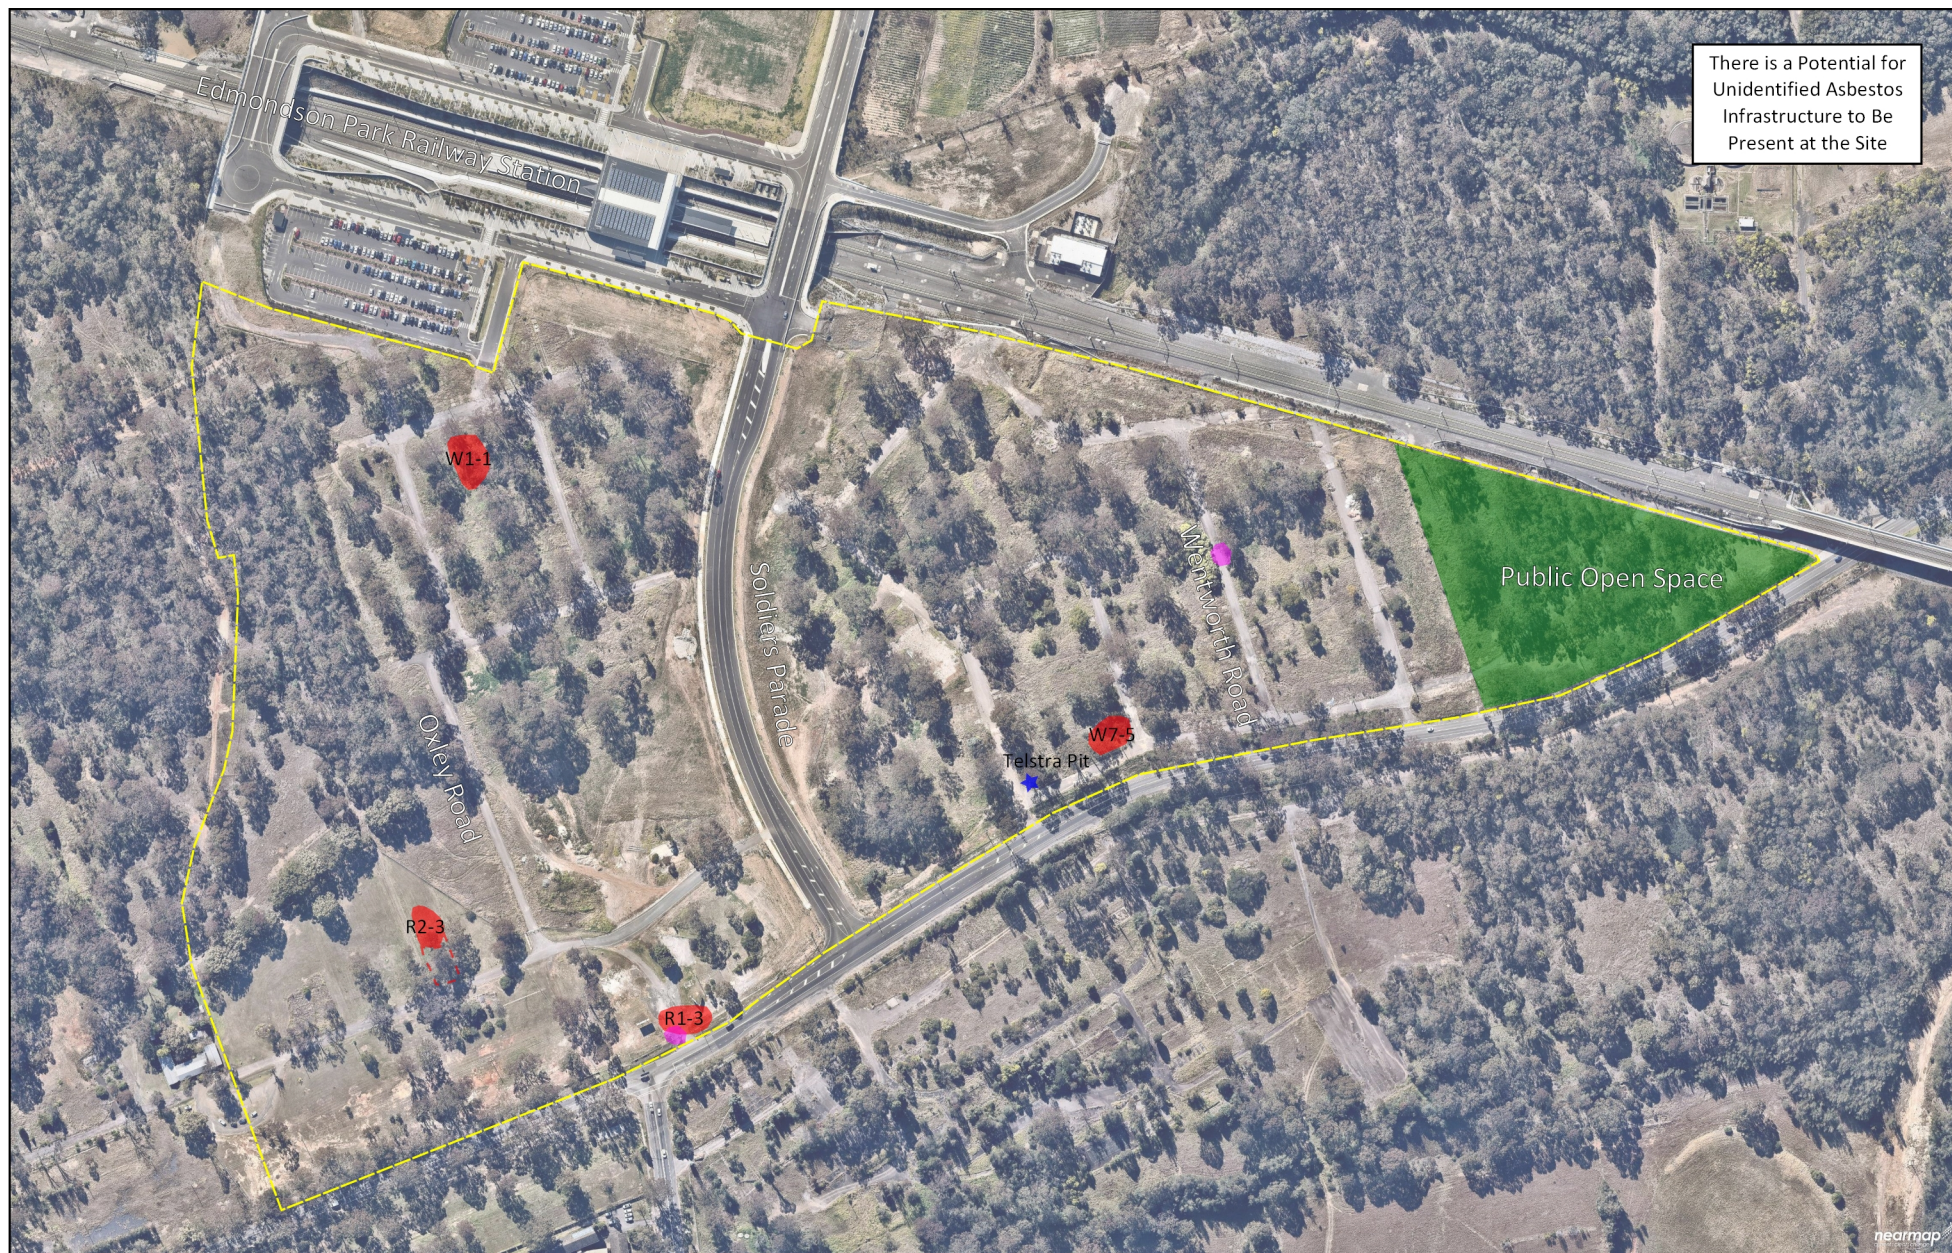
FIGURE 4 – REMEDIATION AREAS

- Approximate Site Boundary
- Removal of Surface Asbestos Fragments
- Proposed Remediation Areas
- Potential Area of Remediation
(Depending on Extent of Asbestos Pipe)

Refer to **Figure 4 – Remediation Areas**.

Surface fragments of ACM sheeting were identified on Wentworth Road towards R8. Weathered fragments of ACM were observed in the vicinity of R1-3. These areas will require remediation and subsequent clearance. The proposed remediation areas are shown in **Figure 4**.
